NC DEPARTMENT OF TRANSPORTATION
 DIVISION OF HIGHWAYS
 STRUCTURE MANAGEMENT UNIT

ATTENTION: **PRIORITY MAINTENANCE ISSUED**

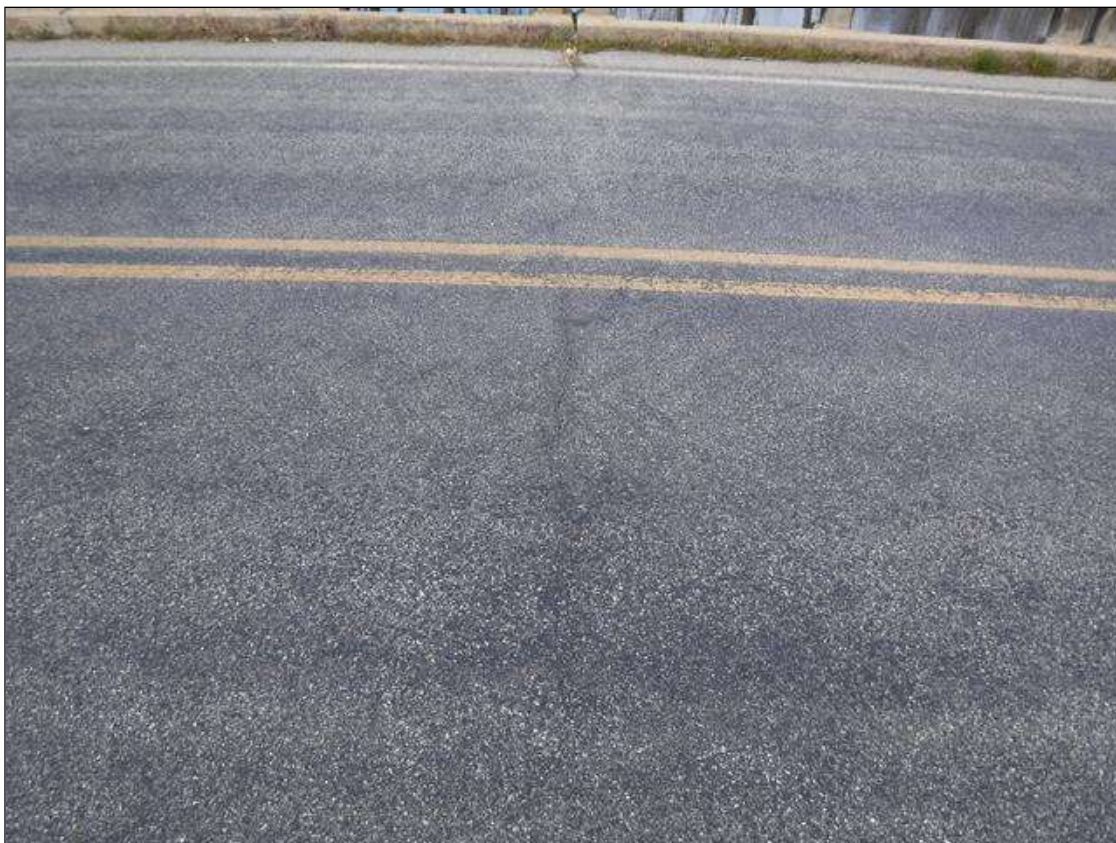
Span 1 Wearing Surface: TRANSVERSE CRACKING OVER BENT 1 END BENT 1 SIMILAR

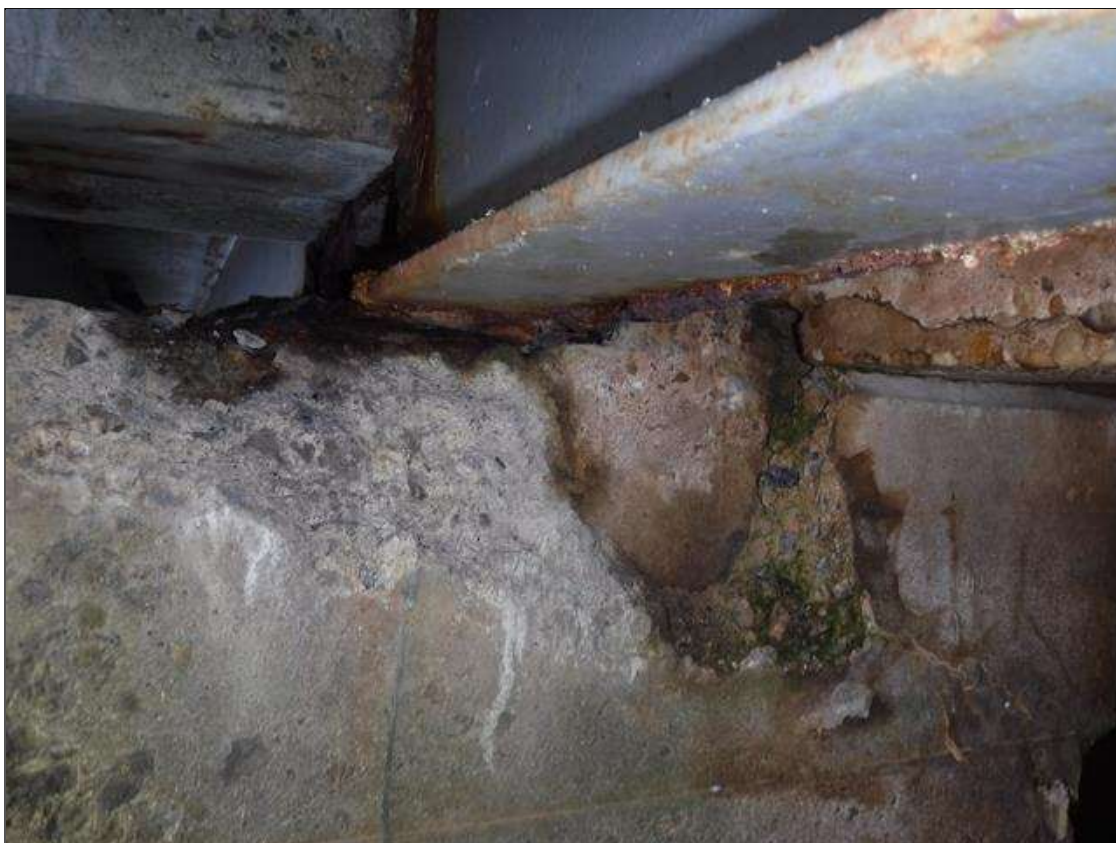
Bent 1 Cap 1: 10" X 20" LONG SPALL IN FACE OF CAP UNDER BEAM 2 SPAN 1 SIDE

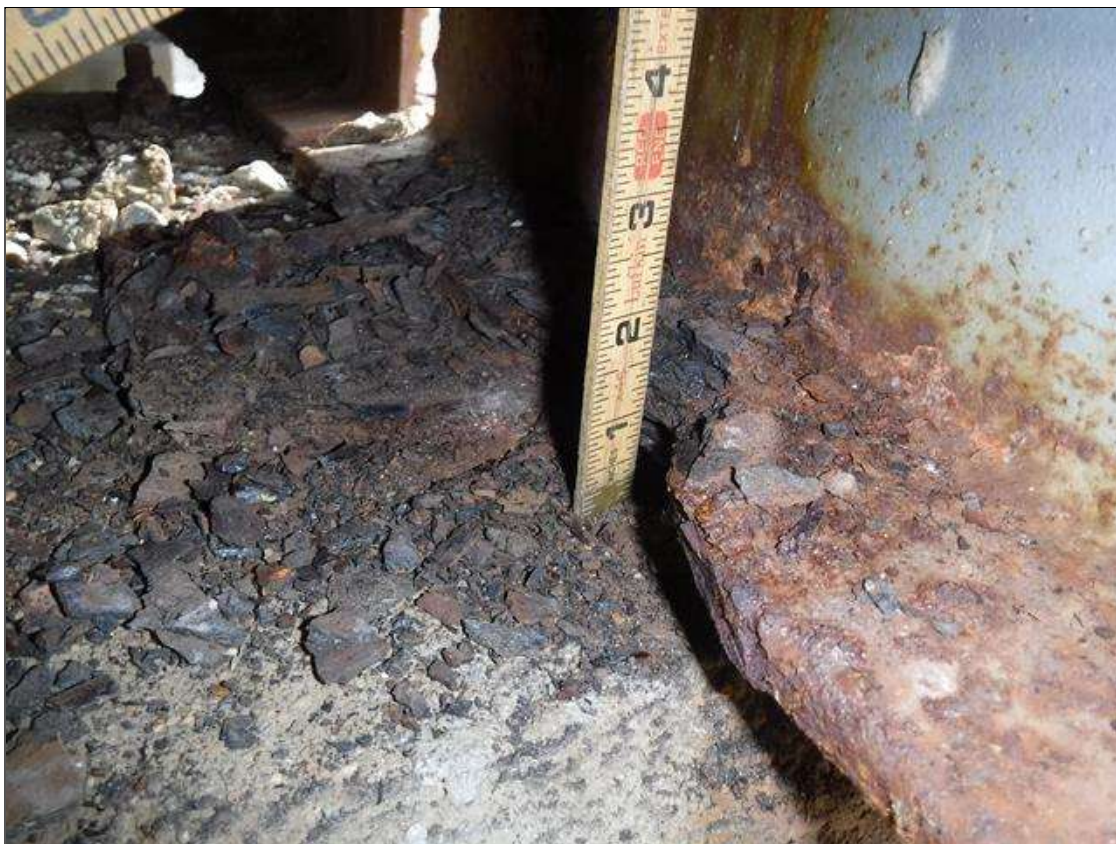
Span 1 Beam 10: SECTION LOSS BOTTOM FLANGE BENT 1 100 % 1 IN WIDE 16 IN LONG PRIORITY MAINTENANCE ISSUED

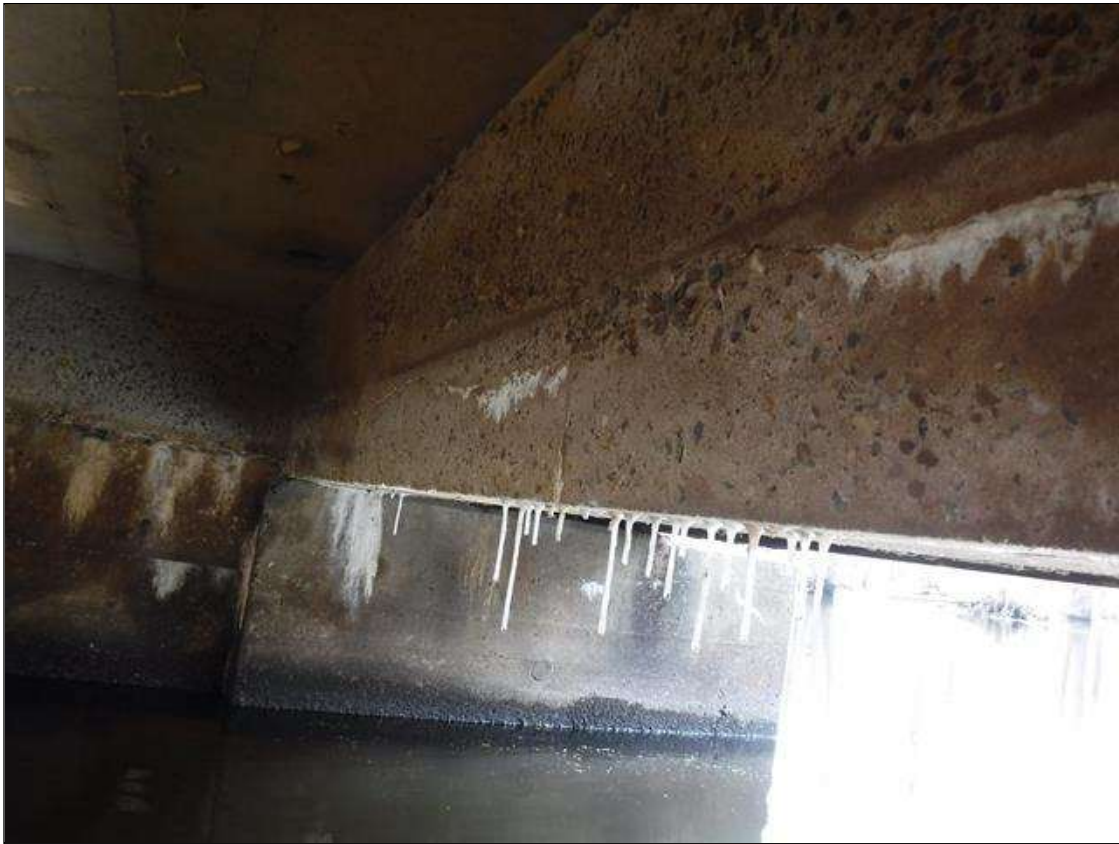
Span 2 Beam 8: CRACKING WITH EFFLO

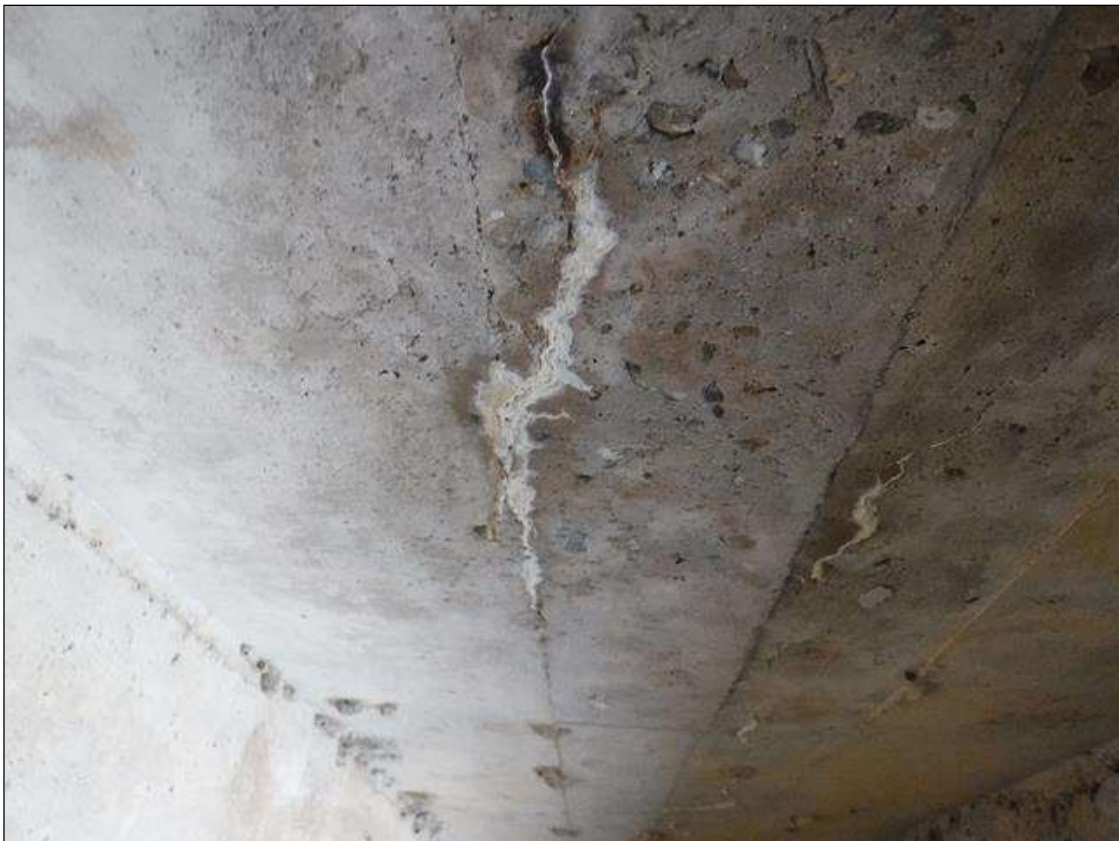
Span 2 Deck: EFFLO LEAKAGE IN BOTTOM OF DECK BAY 5

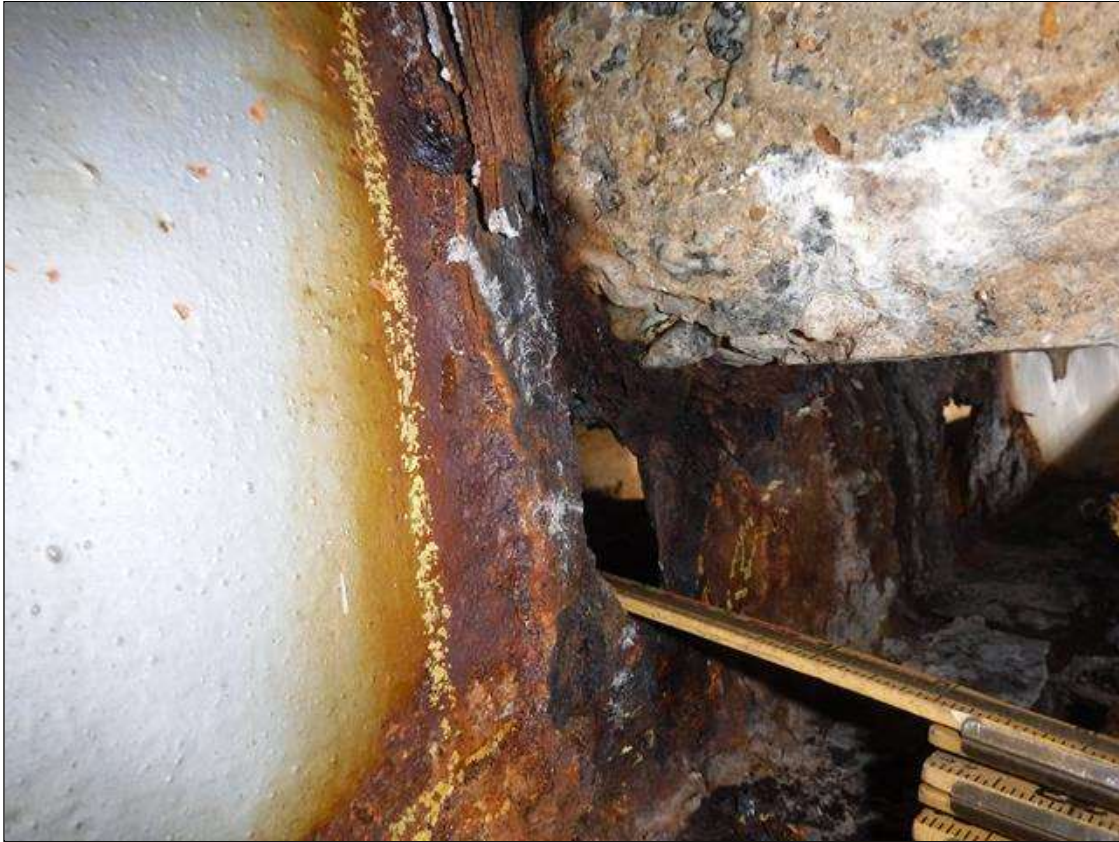
Span 2 Beam 9: SECTION LOSS BEAM BENT 2 - 2" DIAMETER HOLE 100 % 1 IN WIDE X 3 FOOT LONG , WEB 5/16 IN REMAINING 3 IN HIGH PRIORITY MAINTENANCE ISSUED

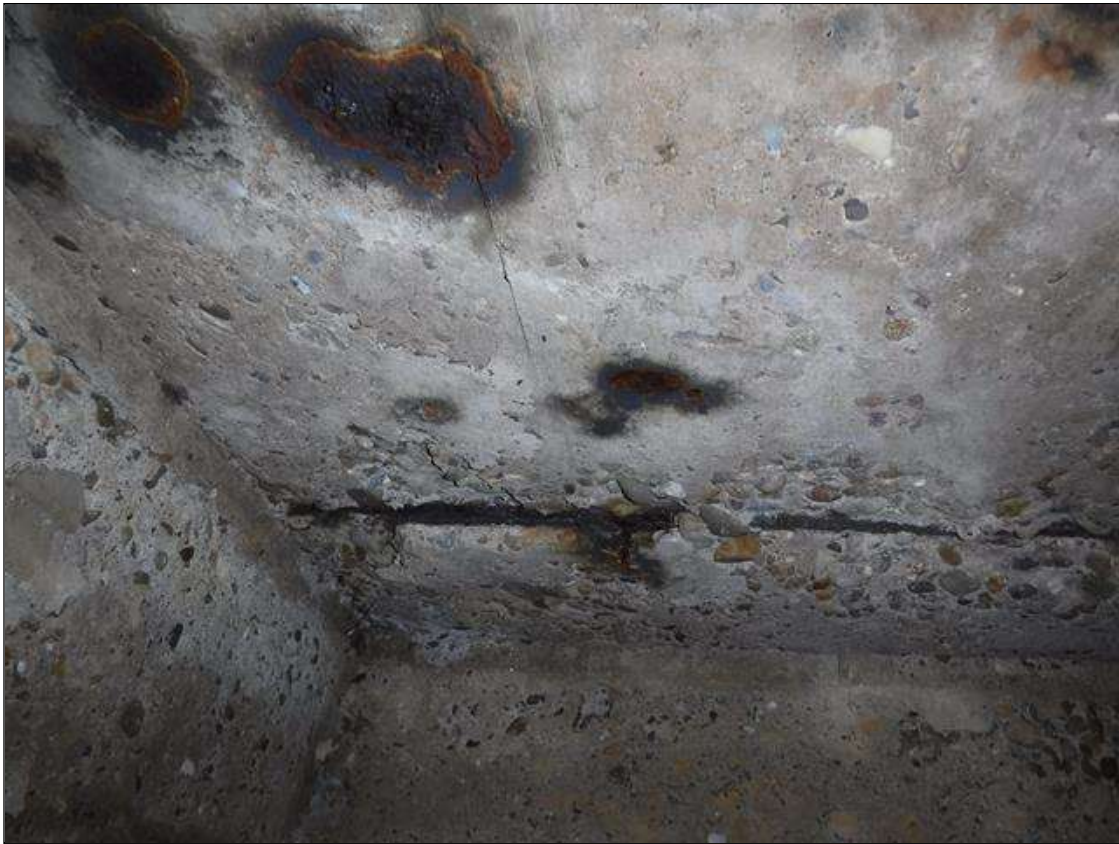
Span 5 Deck: SURFACE SPALLS WITH EXPOSED STEEL UNDER BAY 3

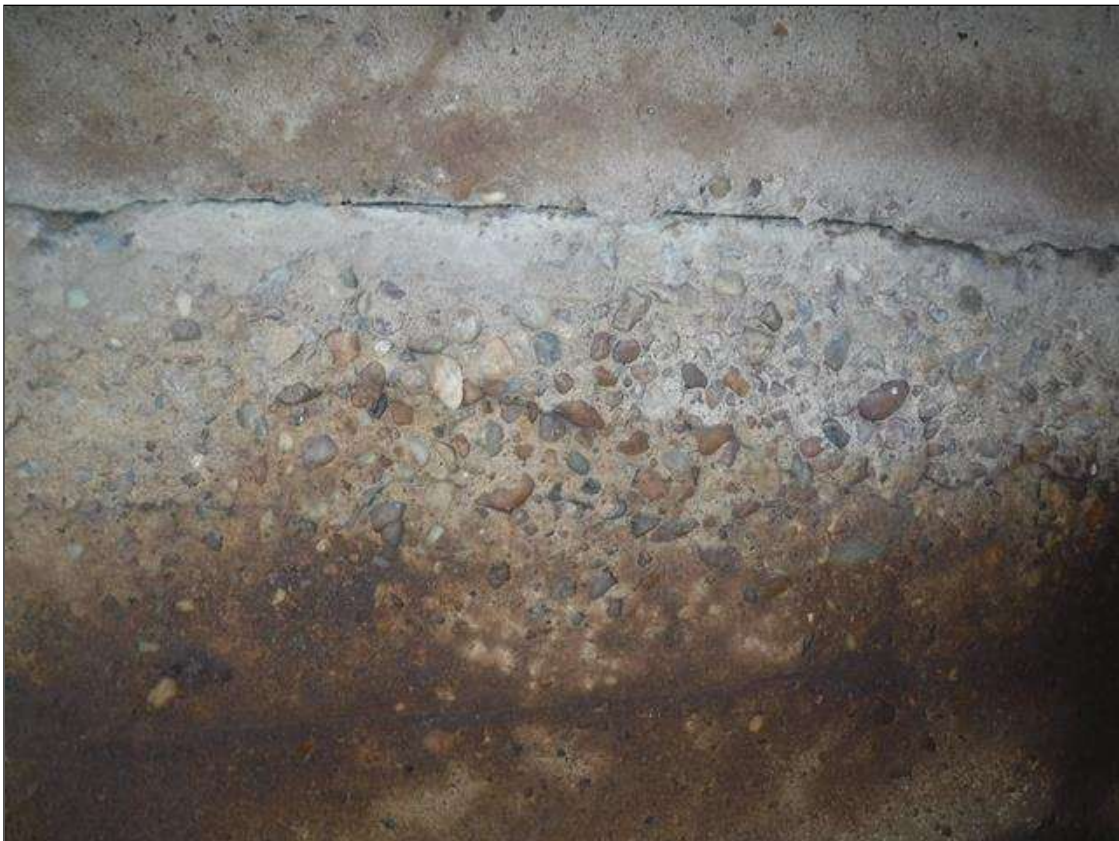
End Bent 2 Abutment/Backwall : ABRASION

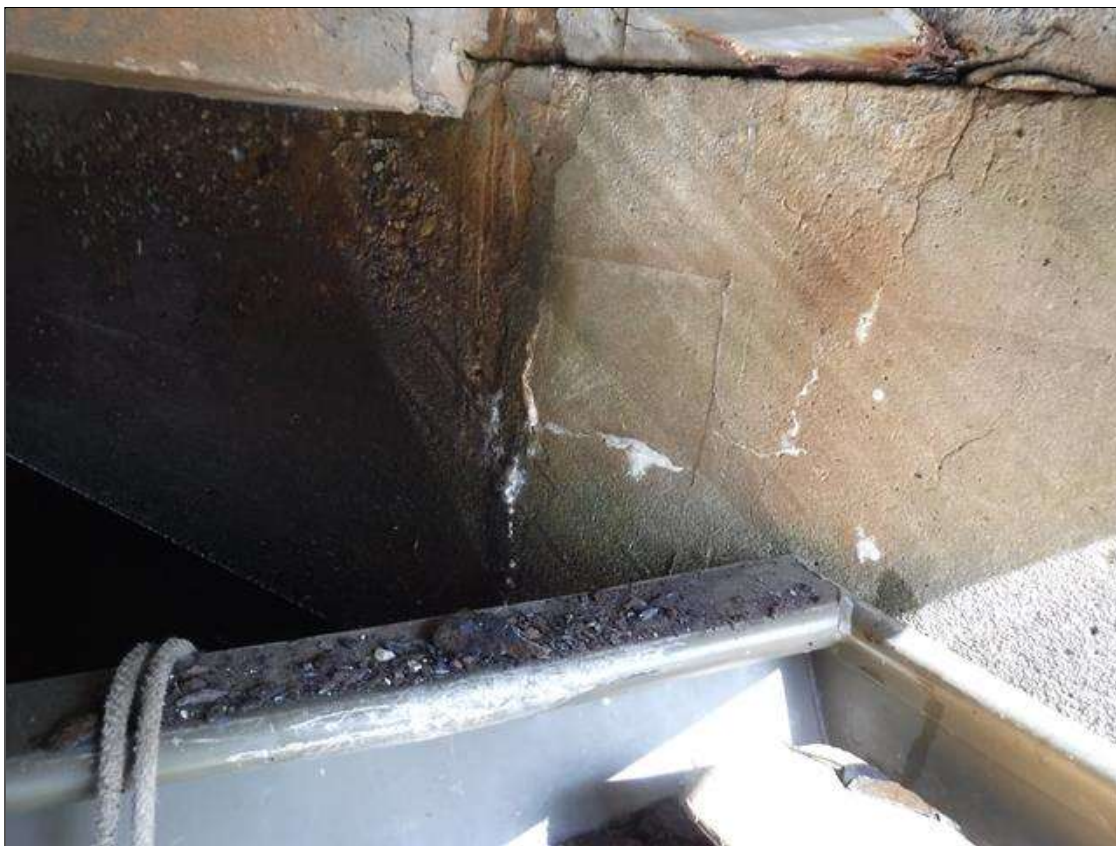
End Bent 2 Abutment/Backwall : CRACKING IN FACE OF CAP UNDER BEAM 9

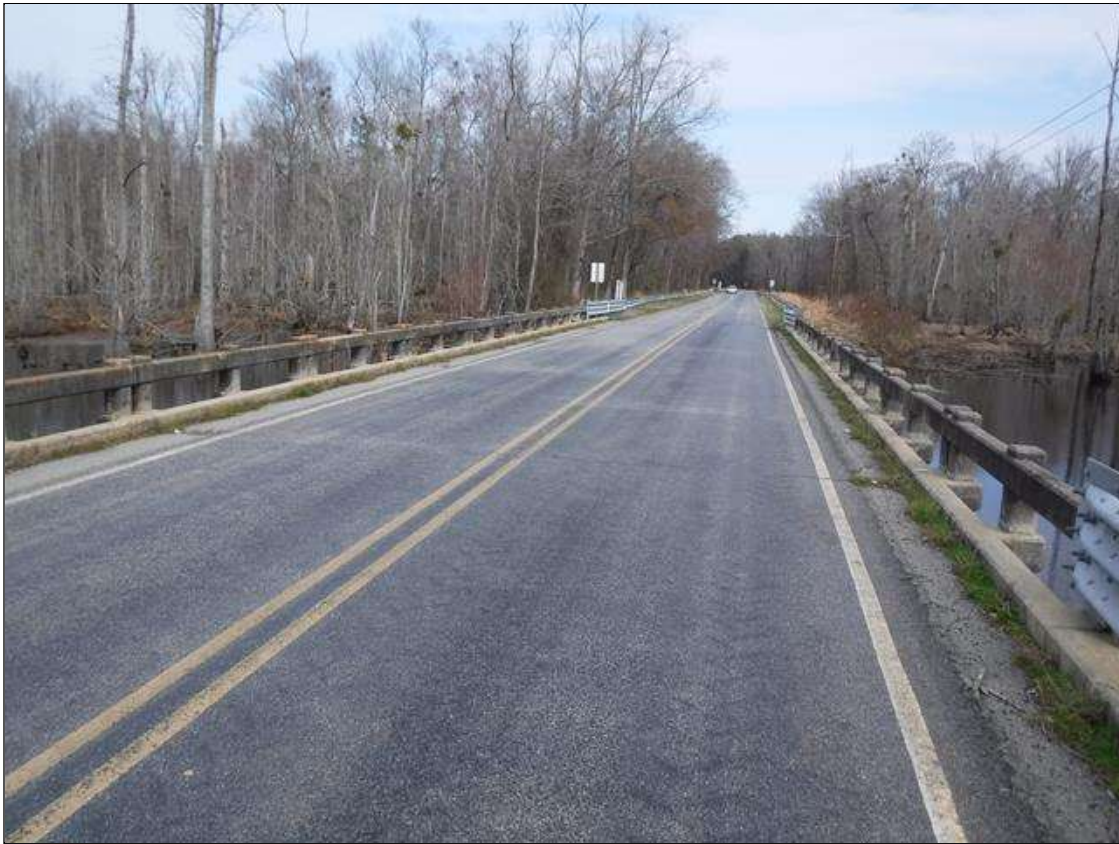
ASPHALT WEARING SURFACE

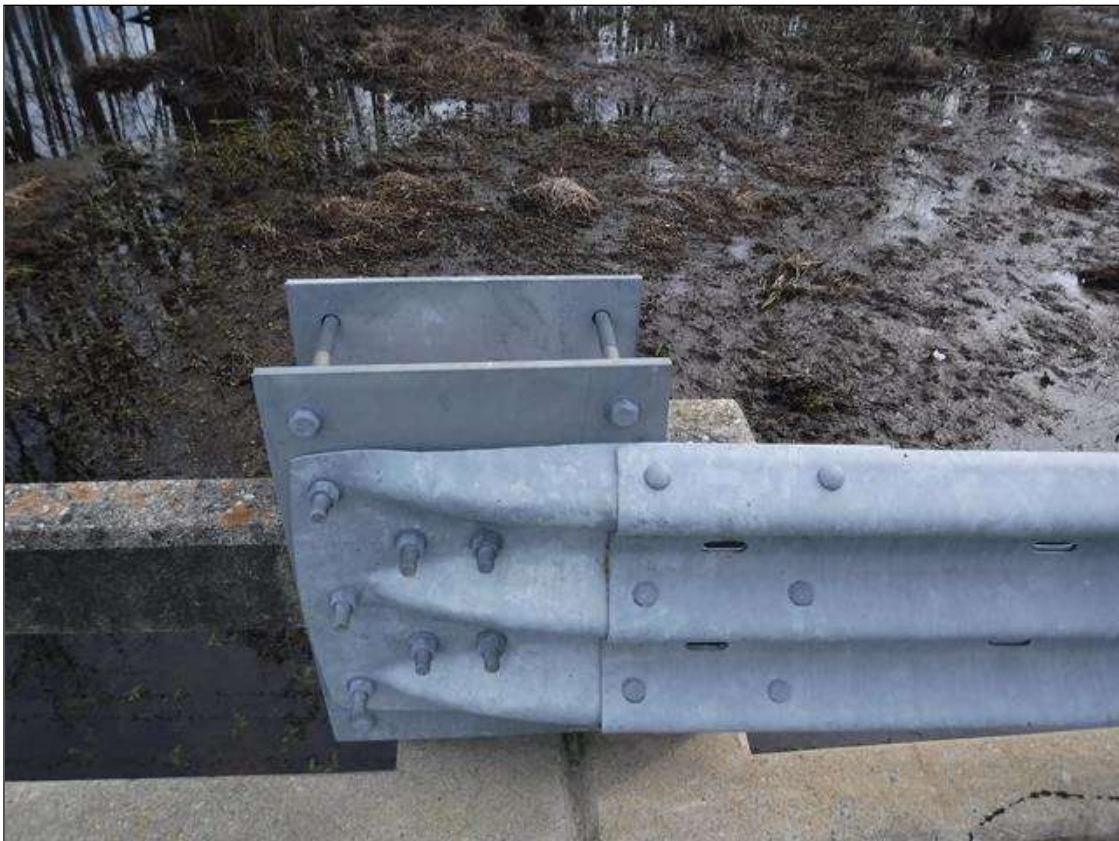
GUARDRAIL ATTACHMENT

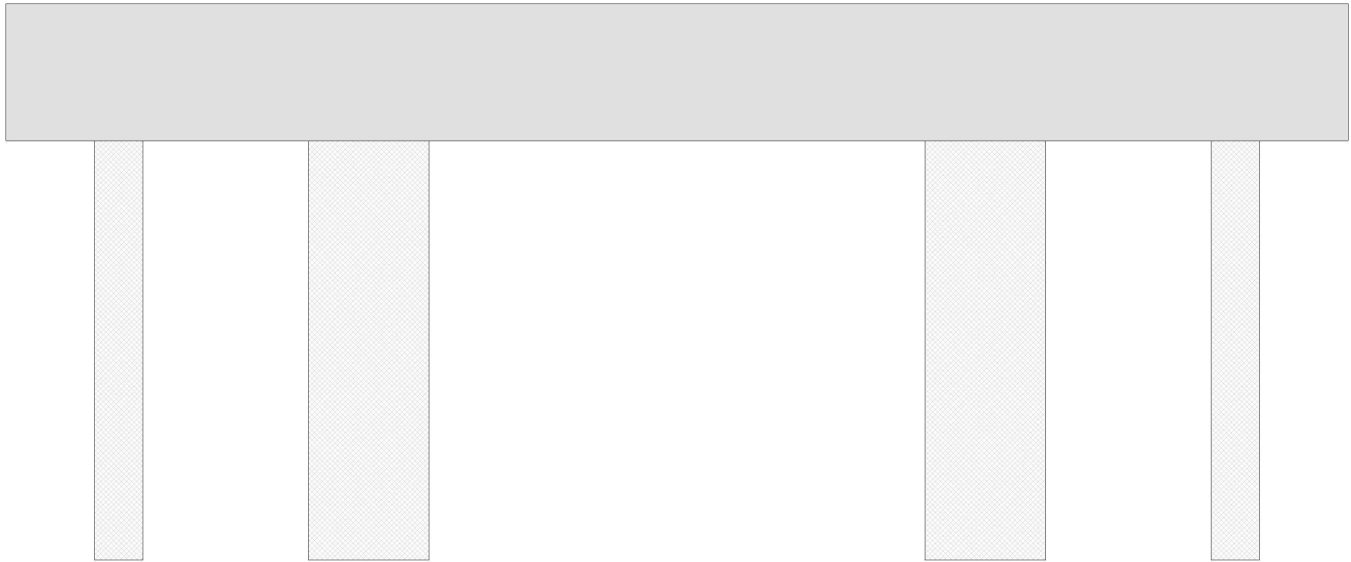
Cap Information			Material Cast-in-Place Concrete							
Length	Width	Height	Left Overhang	Right Overhang	Left Beam to End of Cap.	Right Beam to End of Cap.				
27.750 ft.	2.500 ft.	2.833 ft.	2.333 ft.	2.333 ft.	1.833 ft.	1.833 ft.				
Subcap Information			Material							
Length	Width	Height	Left Overhang	Right Overhang	Left Pile to Splice.					
Sill Information			Material							
Length	Width	Height								
Pile #	Material	Spacing	Width/Dia.	Height	Length	Orientation	Driven?	Replacement?	Removed?	Collar?
1	Concrete	5.167 ft.	1 ft.			Vertical	No	No	No	No
2	Concrete	12.75 ft.	2.5 ft.			Vertical	No	No	No	No
3	Concrete	5.167 ft.	2.5 ft.			Vertical	No	No	No	No
4	Concrete		1 ft.			Vertical	No	No	No	No
Bent/Abutment #: 1			Similar Bents: 2,3,4
