NC DEPARTMENT OF TRANSPORTATION
 DIVISION OF HIGHWAYS
 STRUCTURE MANAGEMENT UNIT

ATTENTION: PRIORITY ACTION REQUEST, CHANGE IN TYPICAL SECTION SKETCH, NEWLY STRUCTURAL DEFICIENT, CHANGE IN END BENT SKETCH, CHANGE IN NBI RATING FOR ITEM 60.

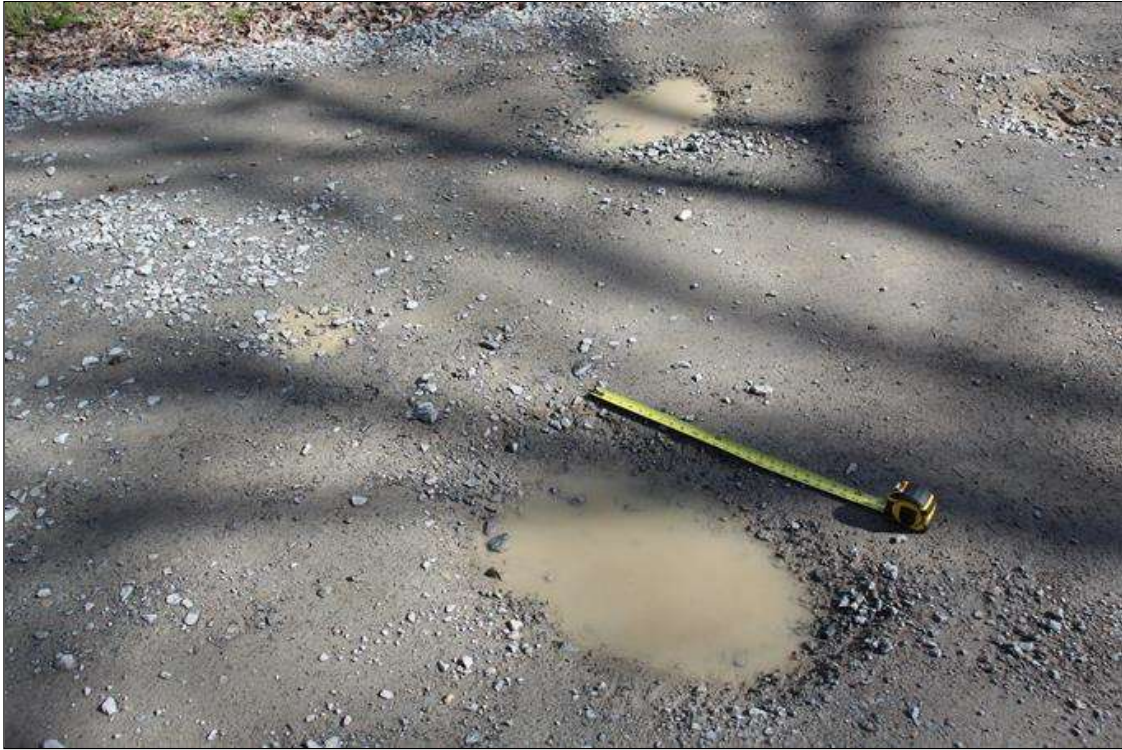
TWO (2) POTHOLES UP TO 2.5 FT X 2 FT LONG X 3 IN DEEP IN WEST APPROACH PAVEMENT.

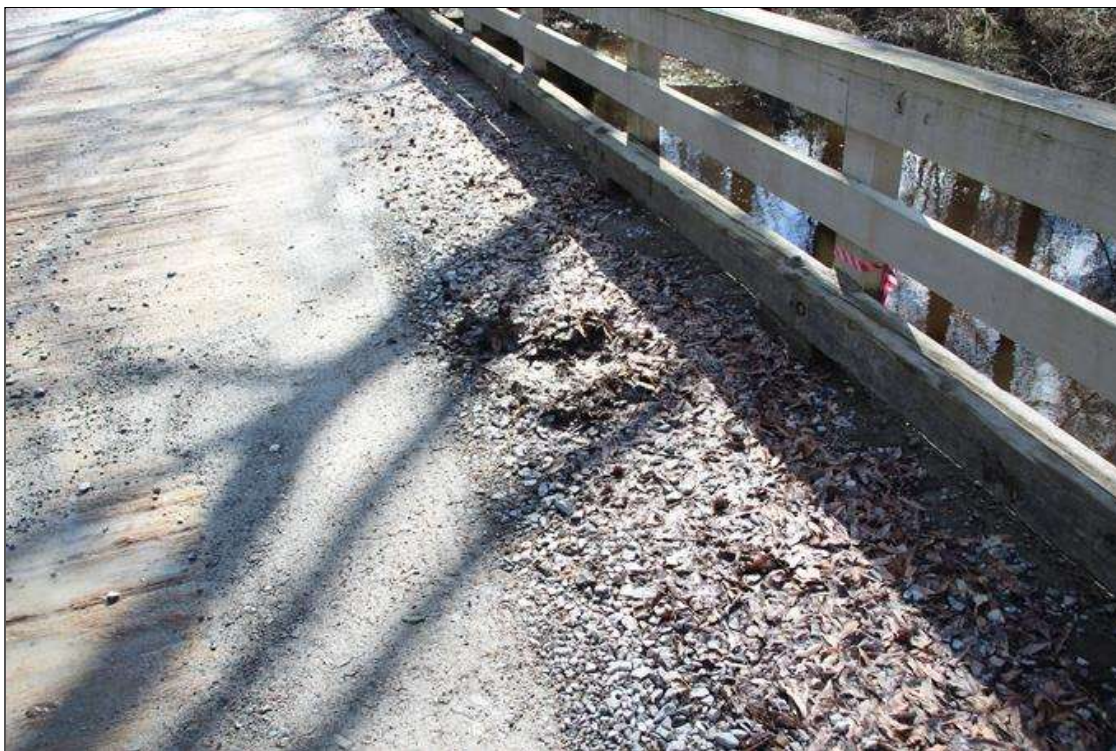
Span 1 Deck: LOOSE AGGREGATE FOR 3 FT WIDE X FULL SPAN LENGTH ALONG BOTH BRIDGE RAILS.

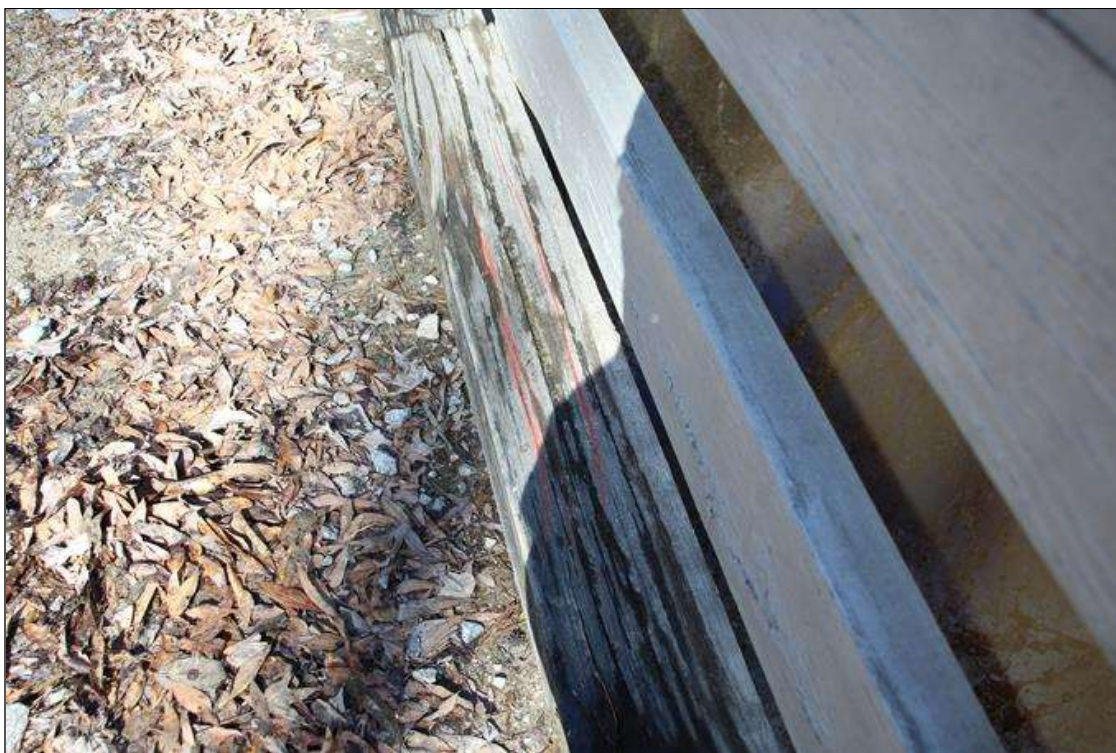
Span 1 Left Bridge Rail: UP TO 1/4 IN WIDE X 1 IN DEEP LONGITUDINAL CHECKS IN THE CURB RAIL FOR FULL BRIDGE LENGTH.

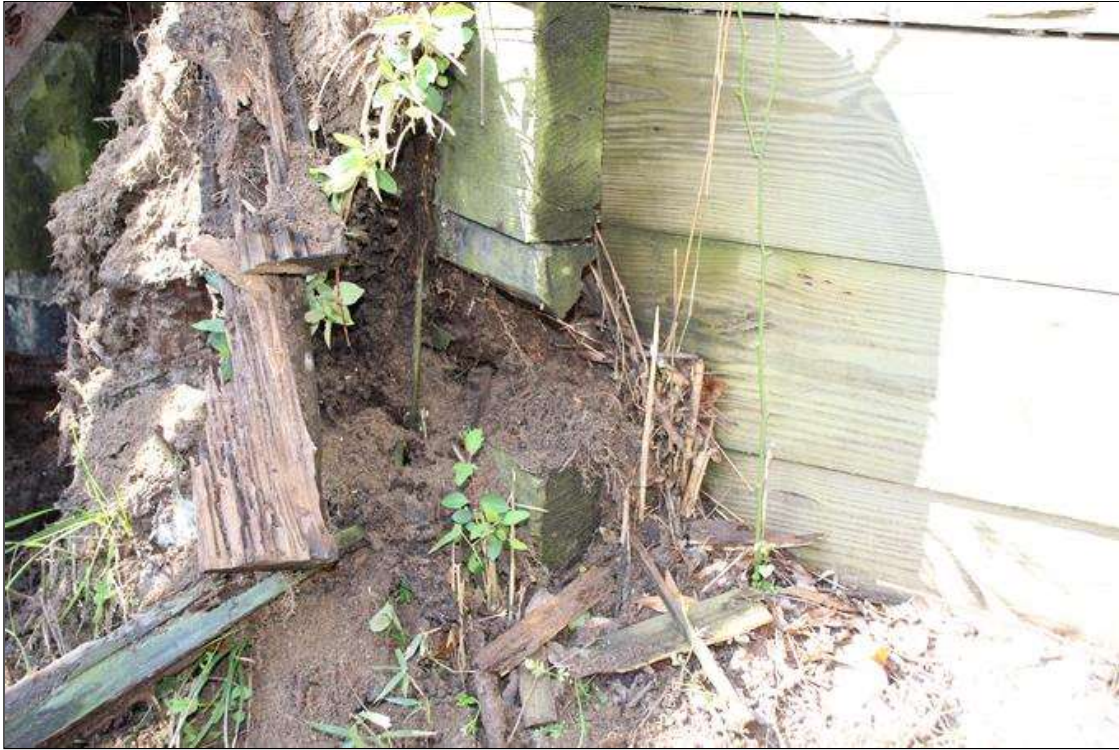
End Bent 1 Abutment/Backwall : SEVERE DETERIORATION OF SOLDIER PILE DUE TO DECAY AT NORTH END OF END BENT 1 ABUTMENT. 3 FT WIDE X 9 IN HIGH X 3 IN DEEP AREA OF BULKHEAD BOARD IS MISSING WITH SOIL SPILLING THROUGH. 10 IN WIDE X 6 IN HIGH X UP TO 3 IN DEEP AREA OF SECTION LOSS IN THE SECOND BULKHEAD BOARD IN BOTTOM AT NORTH END (PAR).

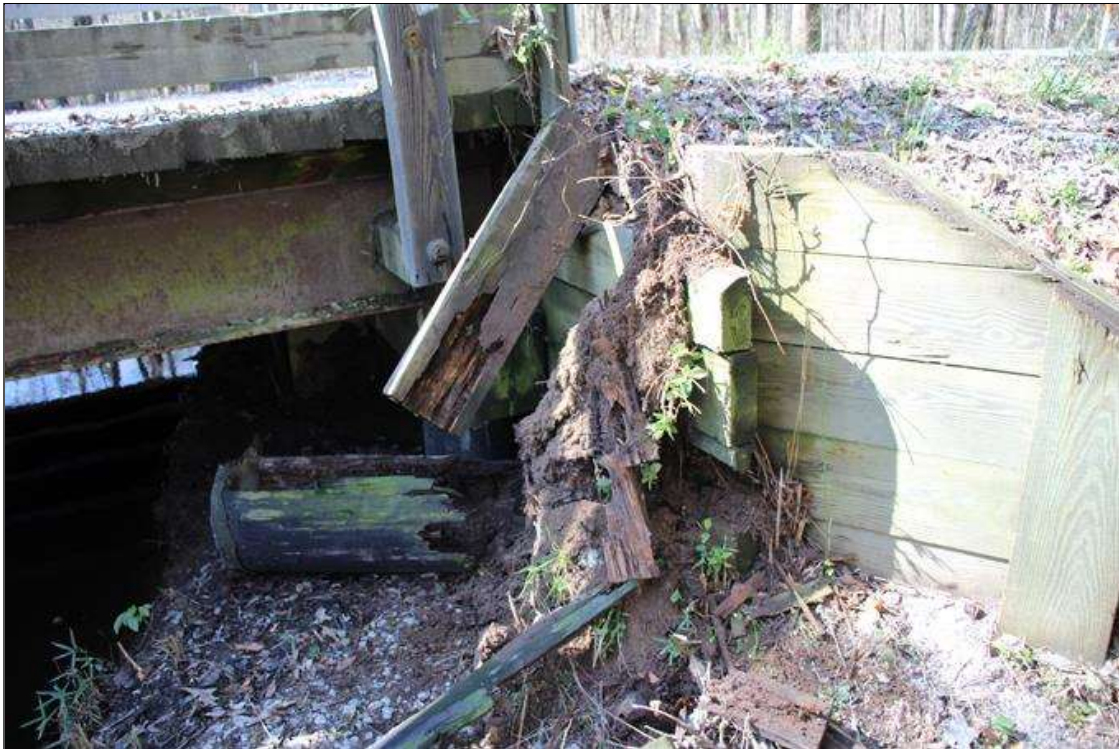
End Bent 1 Abutment/Backwall : SEVERE DETERIORATION OF SOLDIER PILE DUE TO DECAY AT NORTH END OF END BENT 1 ABUTMENT. 3 FT WIDE X 9 IN HIGH X 3 IN DEEP AREA OF BULKHEAD BOARD IS MISSING WITH SOIL SPILLING THROUGH. 10 IN WIDE X 6 IN HIGH X UP TO 3 IN DEEP AREA OF SECTION LOSS IN THE SECOND BULKHEAD BOARD IN BOTTOM AT NORTH END (PAR).

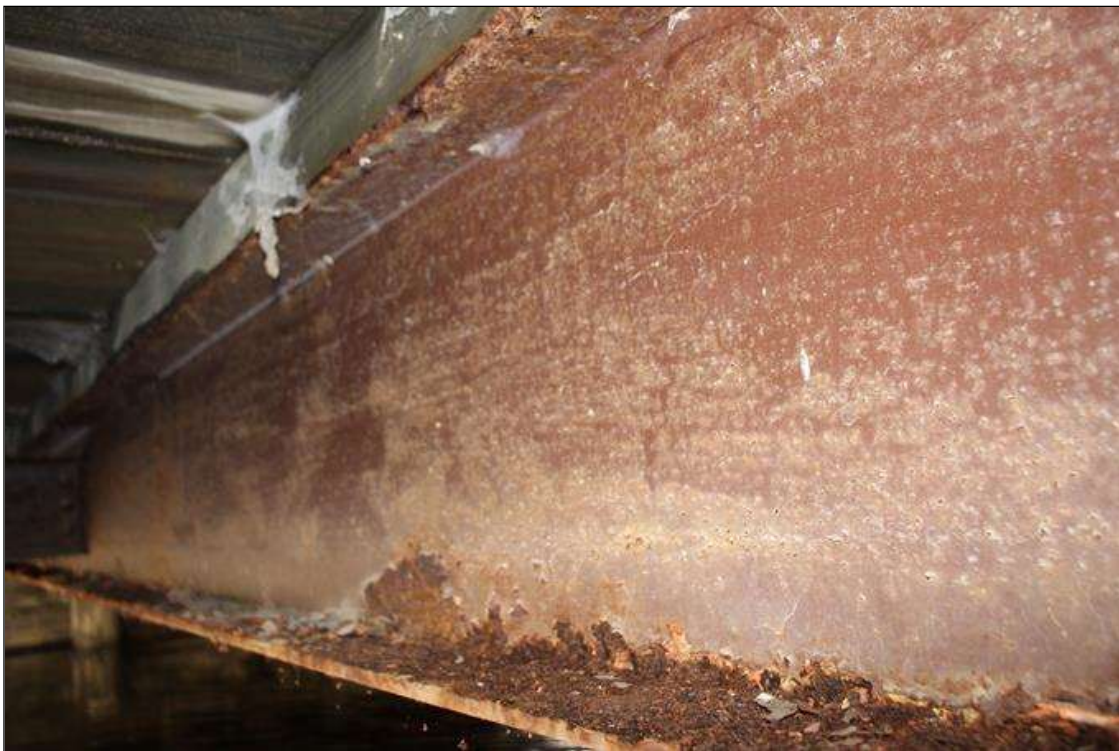
Span 1 Beam 2: MODERATE SURFACE CORROSION ON EDGES OF TOP FLANGES THROUGHOUT AND IN AREAS ON THE BOTTOM FLANGE.

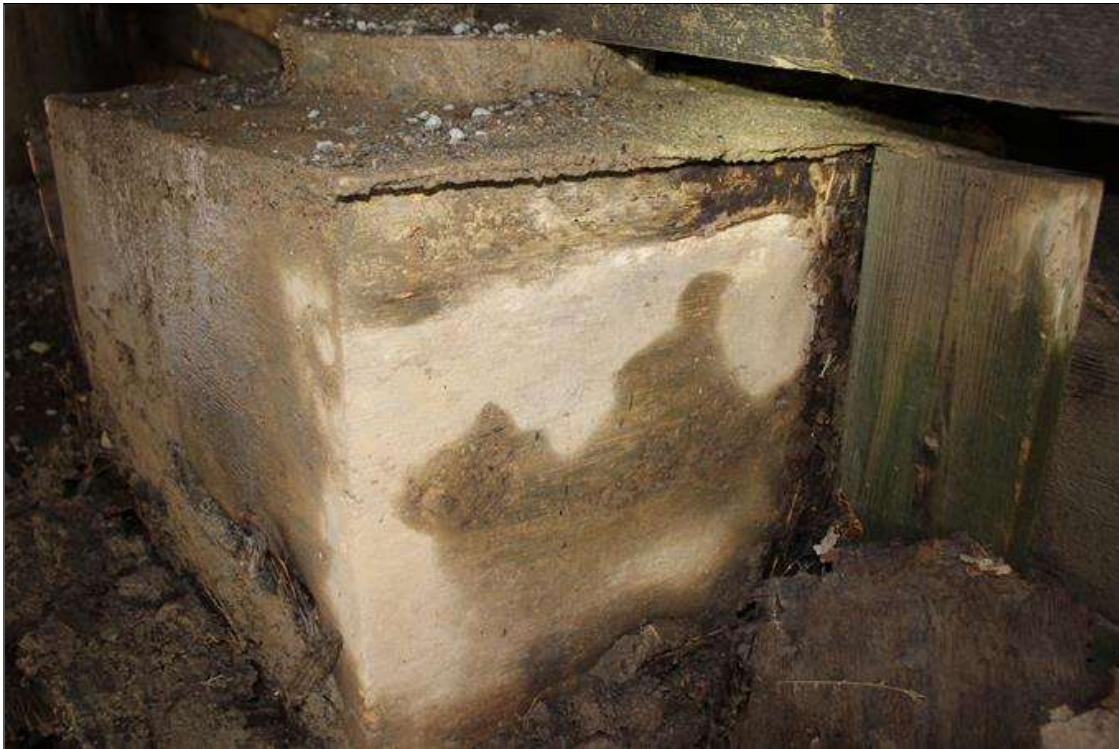
PILE 2 AT END BENT 1 IS ENCASED IN CONCRETE.

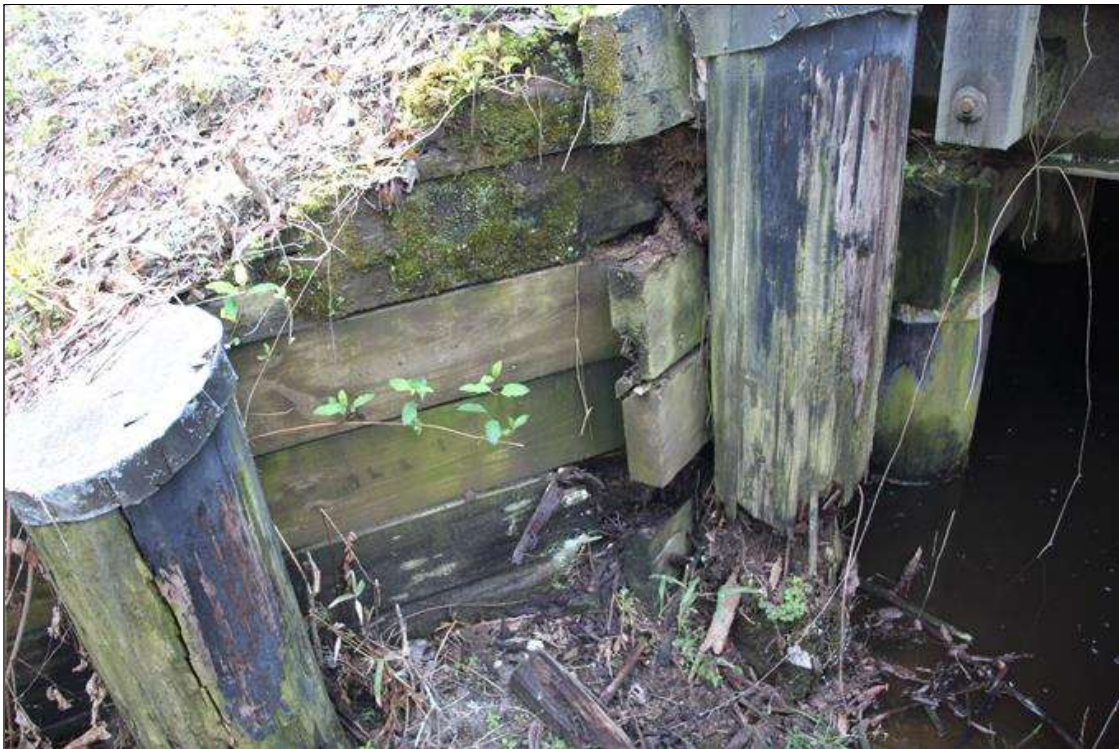
End Bent 2 Abutment/Backwall : UP TO 3 FT HIGH AREA OF SEVERE DECAY WITH UP TO 70% SECTION LOSS IN SOLDIER PILE AT NORTH END. 3 BULKHEAD BOARDS BEHIND THIS SOLDIER PILE EXHIBIT SEVERE DECAY UP TO 1 FT WIDE X 9 IN HIGH X 3 IN WIDE WITH SOIL SPILLING THROUGH (PAR).

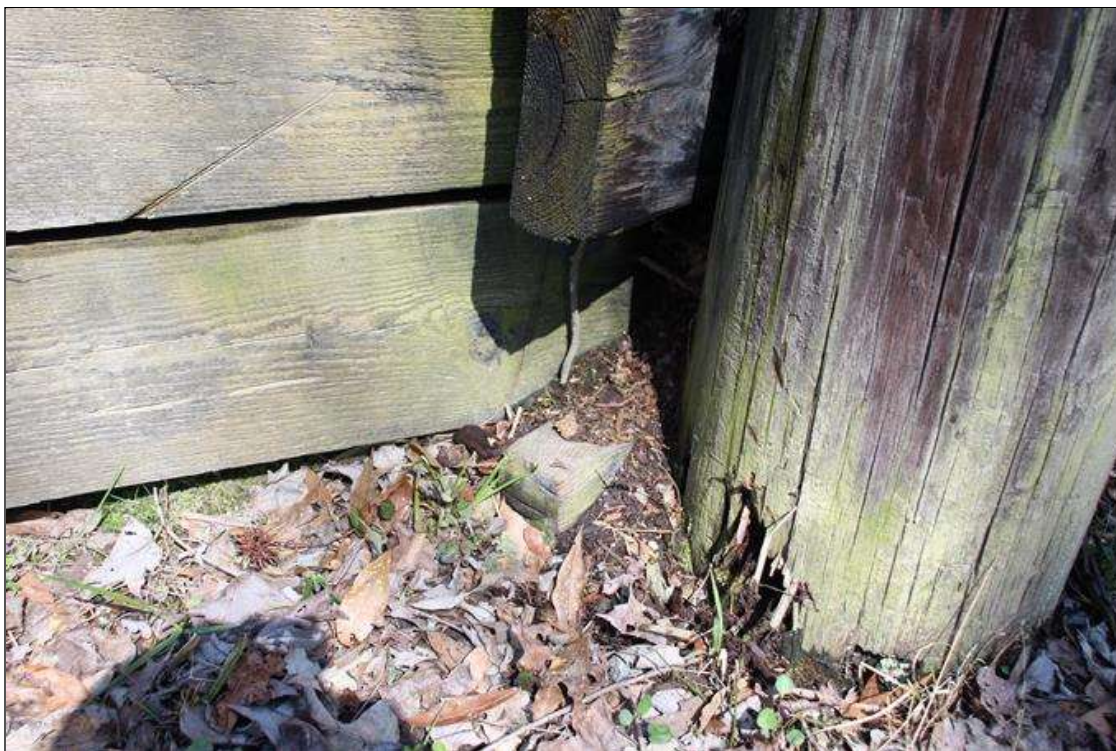
End Bent 1 Abutment/Backwall : 10 WIDE X 9 IN HIGH X 3IN DEEP AREA OF SECTION MISSING IN BOTTOM BULKHEAD BOARD AT SOUTH END.

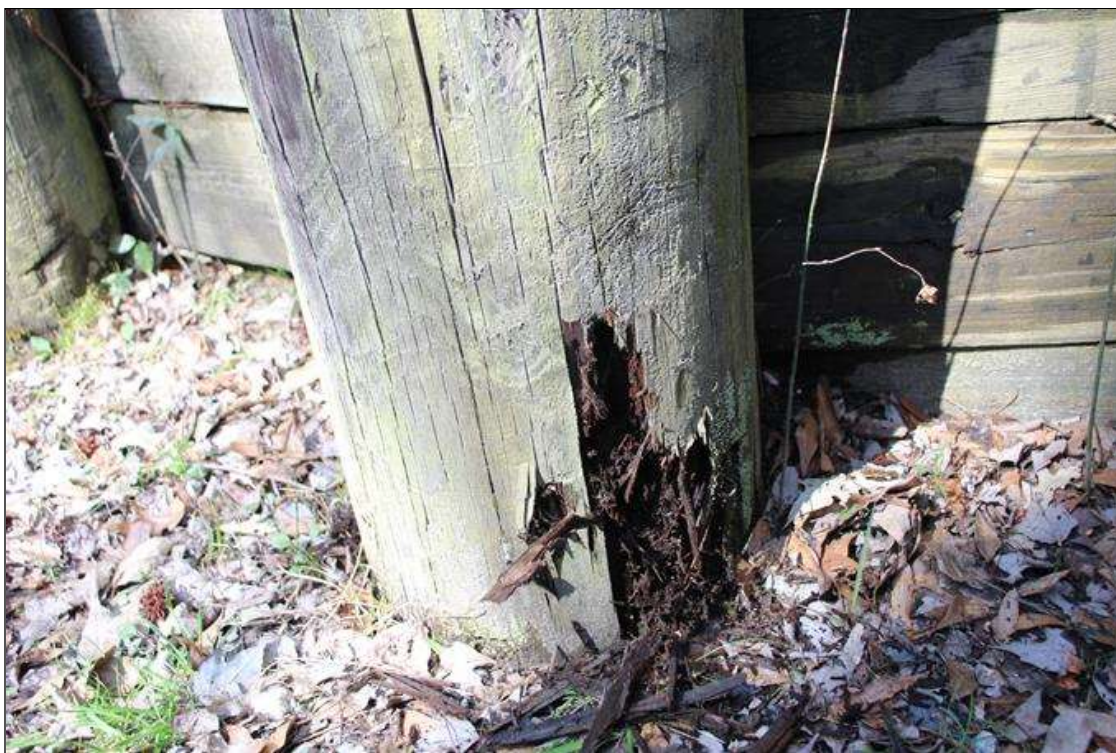
End Bent 1 Abutment/Backwall : UP TO 8 IN HIGH X FULL DIAMETER OF THE BOTTOM SOLDIER PILE HAS MODERATE DECAY AT THE GROUND SURFACE.

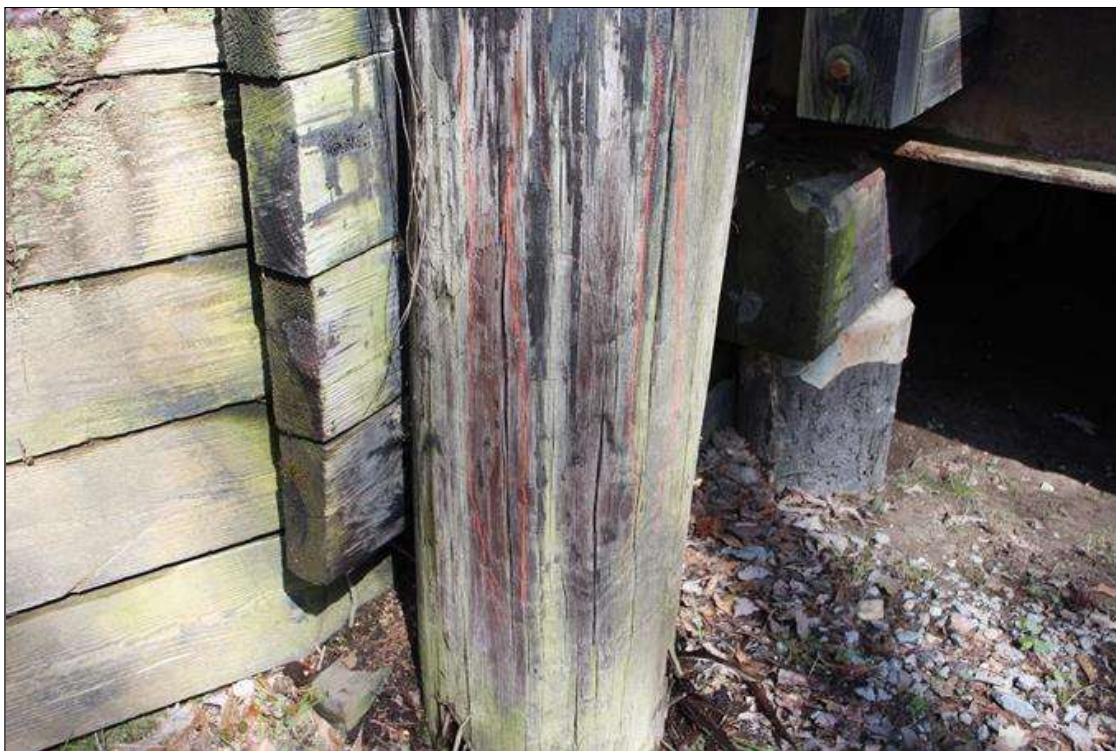
End Bent 1 Abutment/Backwall : 3/16 IN WIDE X 1 IN DEEP VERTICAL CHECKS FOR FULL HEIGHT IN SOUTH FACE.

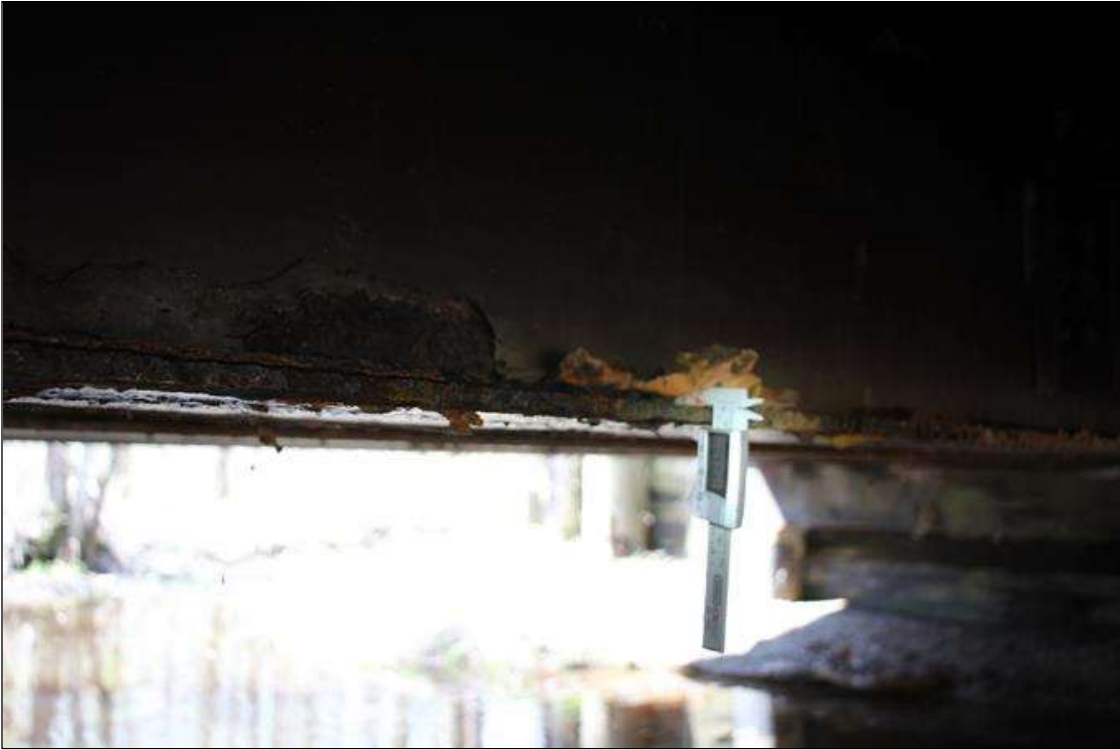
Span 1 Beam 5: HEAVY SURFACE CORROSION FOR FULL FLANGE WIDTH X 7 FT LONG IN BOTTOM FLANGE, STARTING AT 13.5 FT FROM BEAM END AT END BENT 1 . UP TO 0.41 IN SECTION REMANING (PAR).

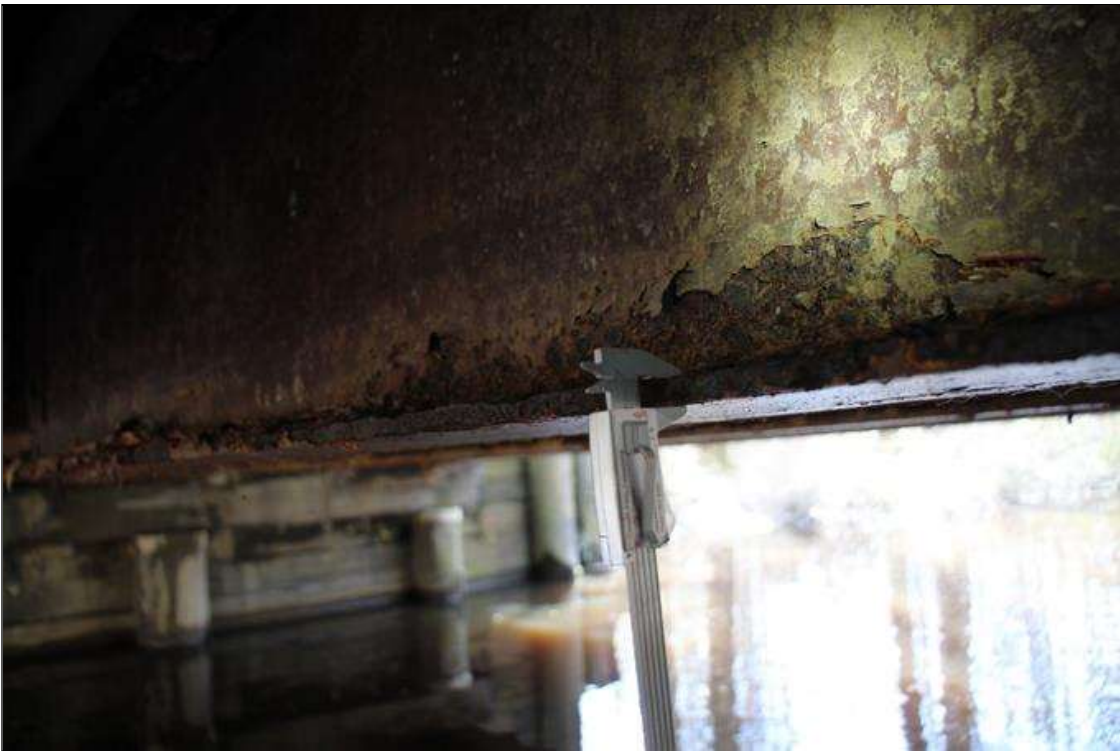
Span 1 Beam 4: HEAVY SURFACE CORROSION FOR FULL FLANGE WIDTH X 18.5 FT LONG IN BOTTOM FLANGE, STARTING AT 7.5 FT FROM BEAM END AT END BENT 1 . UP TO 0.36 IN SECTION REMANING (PAR).

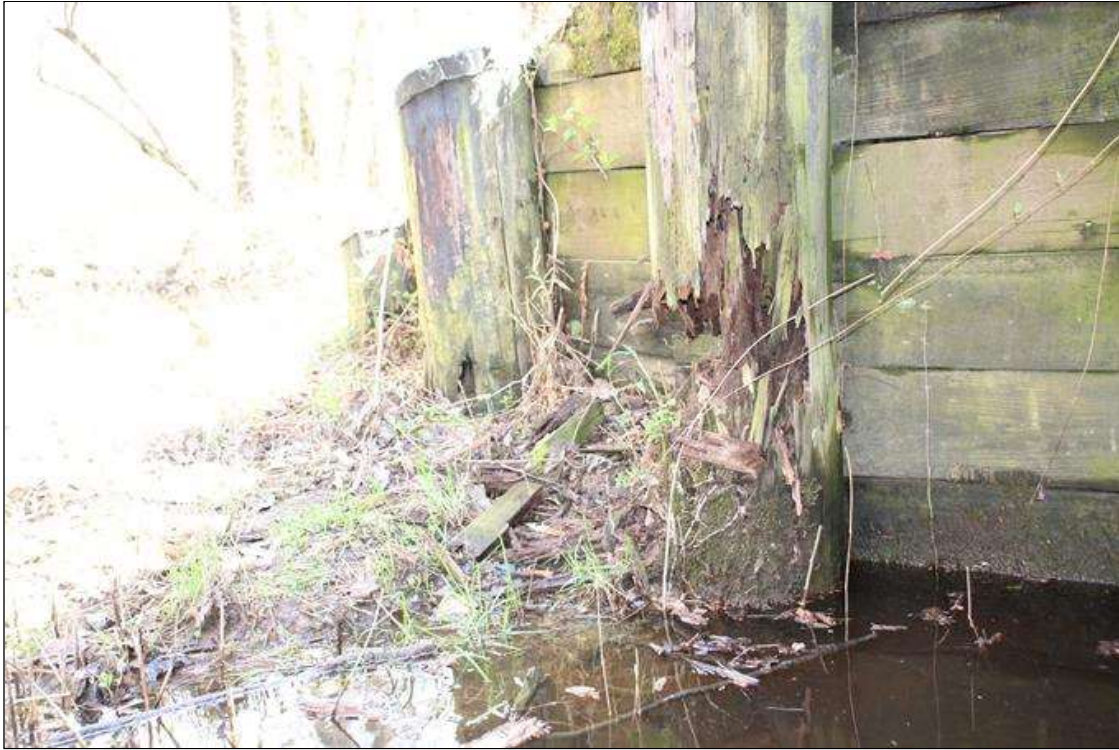
End Bent 2 Abutment/Backwall : UP TO 3 FT HIGH AREA OF SEVERE DECAY WITH UP TO 70% SECTION LOSS IN SOLDIER PILE AT NORTH END. 3 BULKHEAD BOARDS BEHIND THIS SOLDIER PILE EXHIBIT SEVERE DECAY UP TO 1 FT WIDE X 9 IN HIGH X 3 IN WIDE WITH SOIL SPILLING THROUGH (PAR).

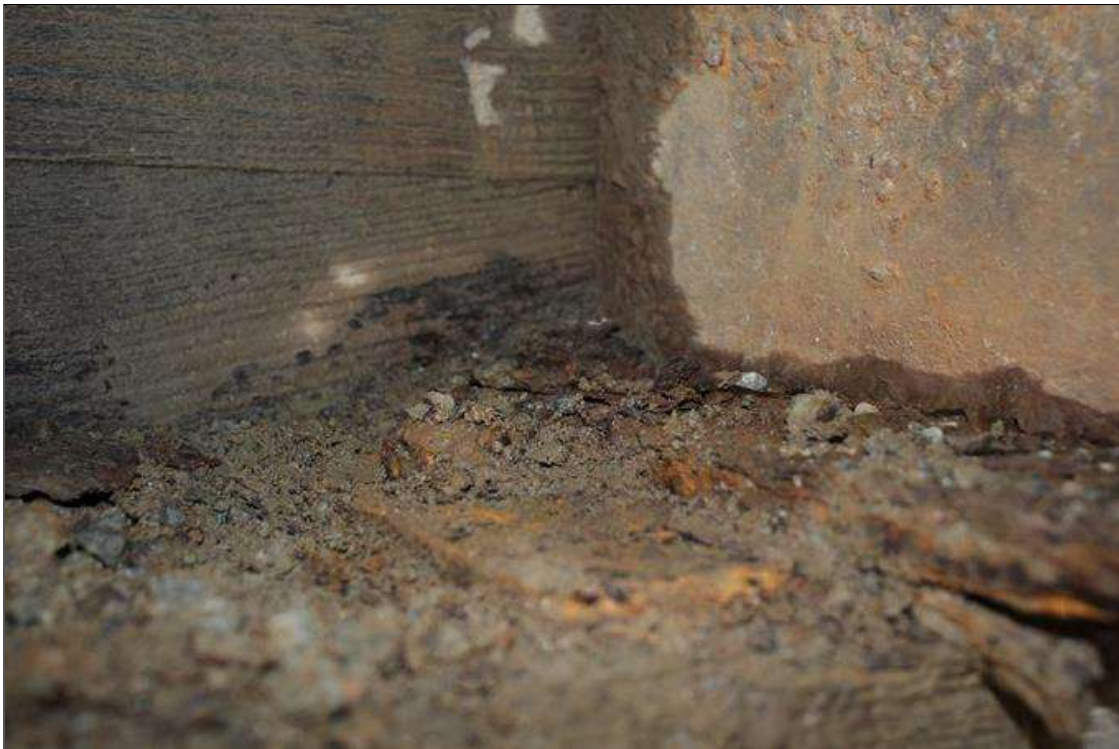
Span 1 Beam 3 Far Bearing: MODERATE TO HEAVY SURFACE CORROSION ON BEARING PLATE.

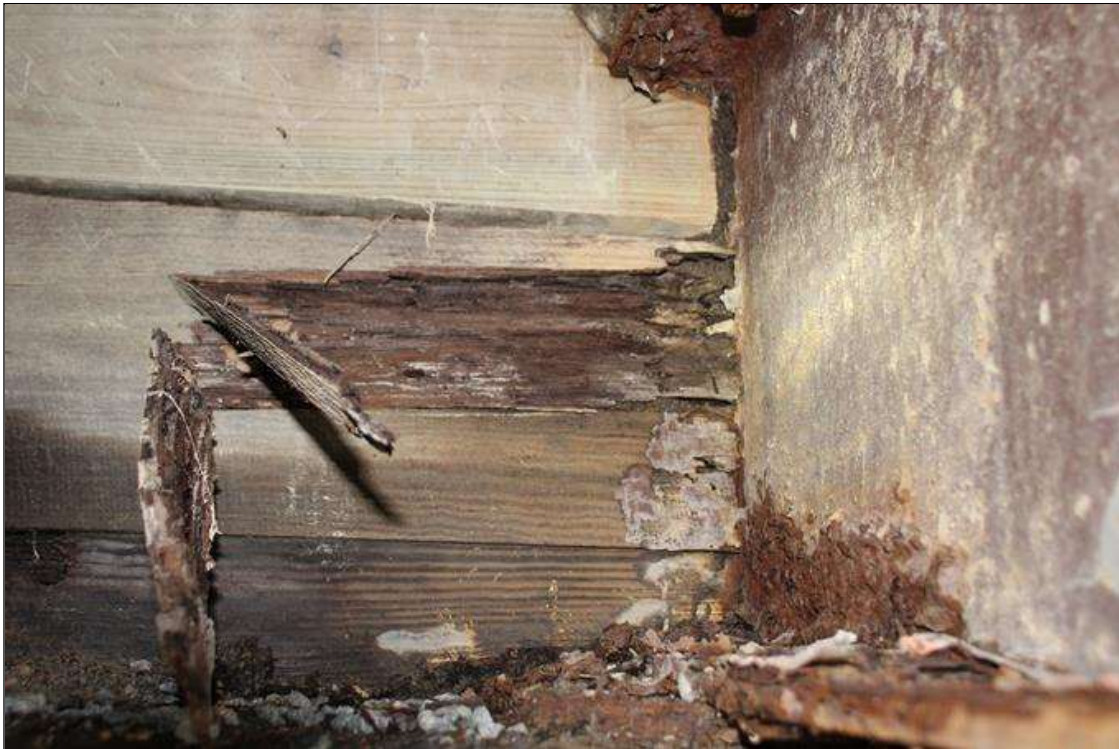
End Bent 2 Abutment/Backwall : 3 FT WIDE X 1 FT HIGH X 3 IN DEEP AREA OF SEVERE DECAY IN THE BACKWALL BULKHEAD BOARDS BEHIND BEAM 5 AND IN BAY 5 WITH SOIL SPILLING THROUGH (PAR).

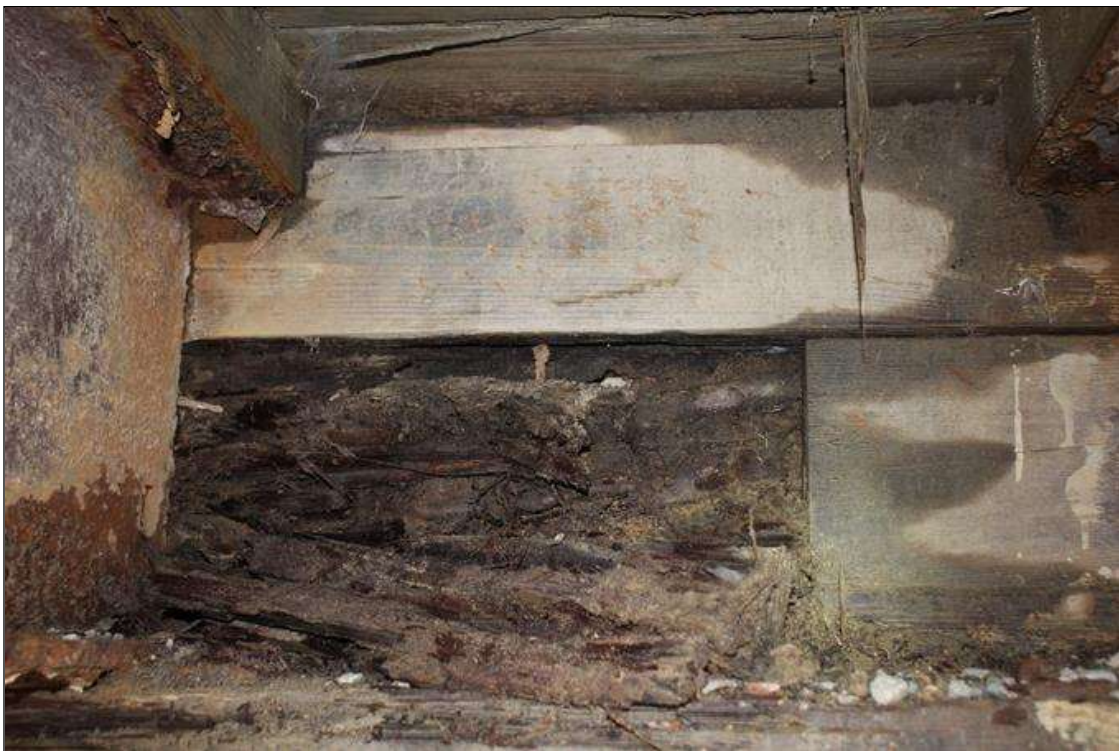
End Bent 2 Abutment/Backwall : 3 FT WIDE X 1 FT HIGH X 3 IN DEEP AREA OF SEVERE DECAY IN THE BACKWALL BULKHEAD BOARDS BEHIND BEAM 5 AND IN BAY 5 WITH SOIL SPILLING THROUGH (PAR).

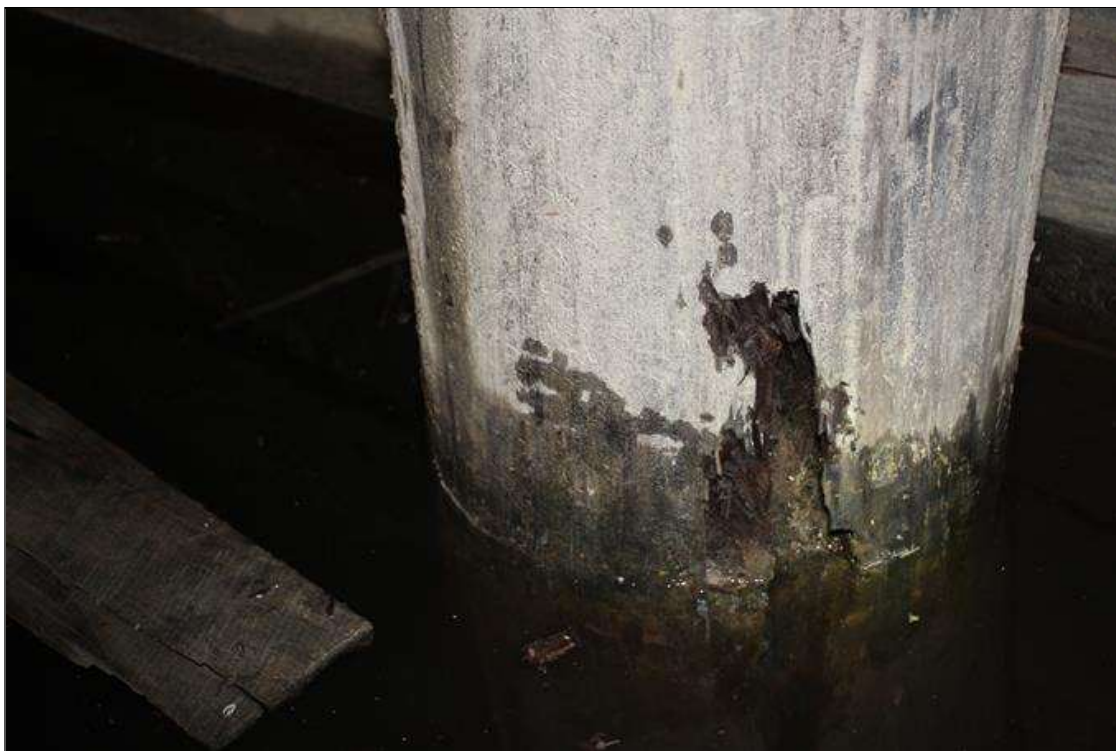
End Bent 2 Pile 3: 8 IN HIGH X 3 IN WIDE X 1 IN DEEP SECTION LOSS IN SOUTHWEST FACE, STARTING AT WATER LEVEL.

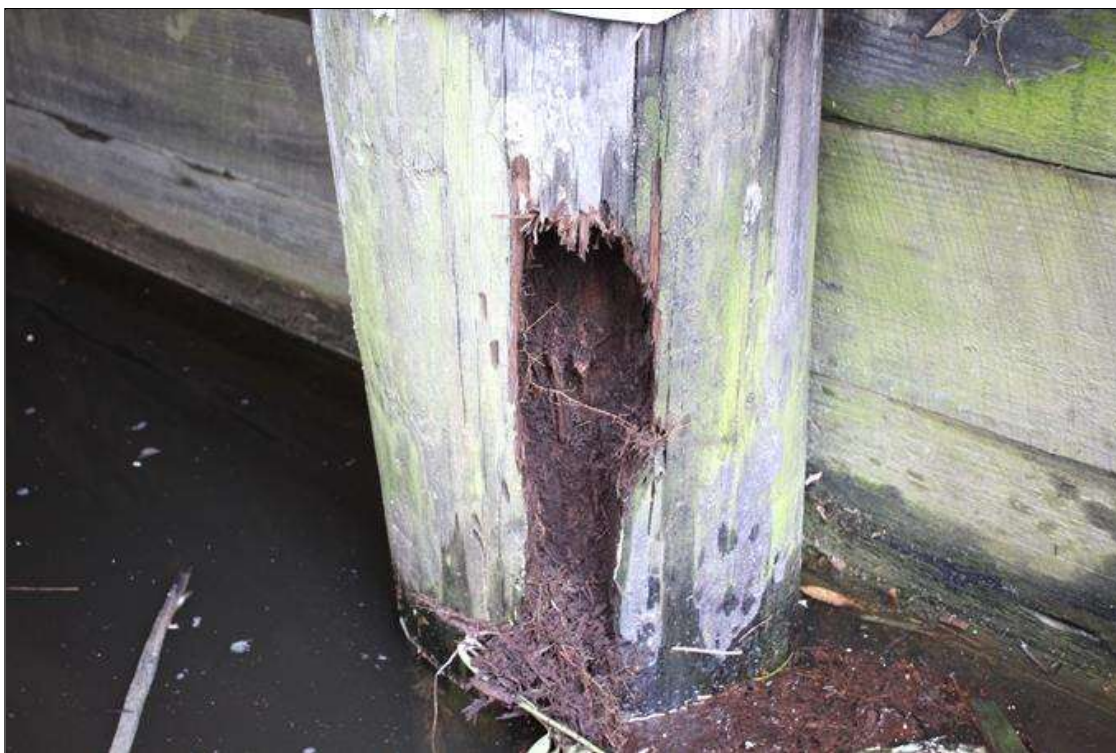
End Bent 2 Pile 4: 20 IN HIGH X 5 IN WIDE X UP TO 3 IN DEEP AREA OF SECTION LOSS DUE TO DECAY STARTING AT WATER LEVEL IN SOUTHWEST CORNER (PAR).

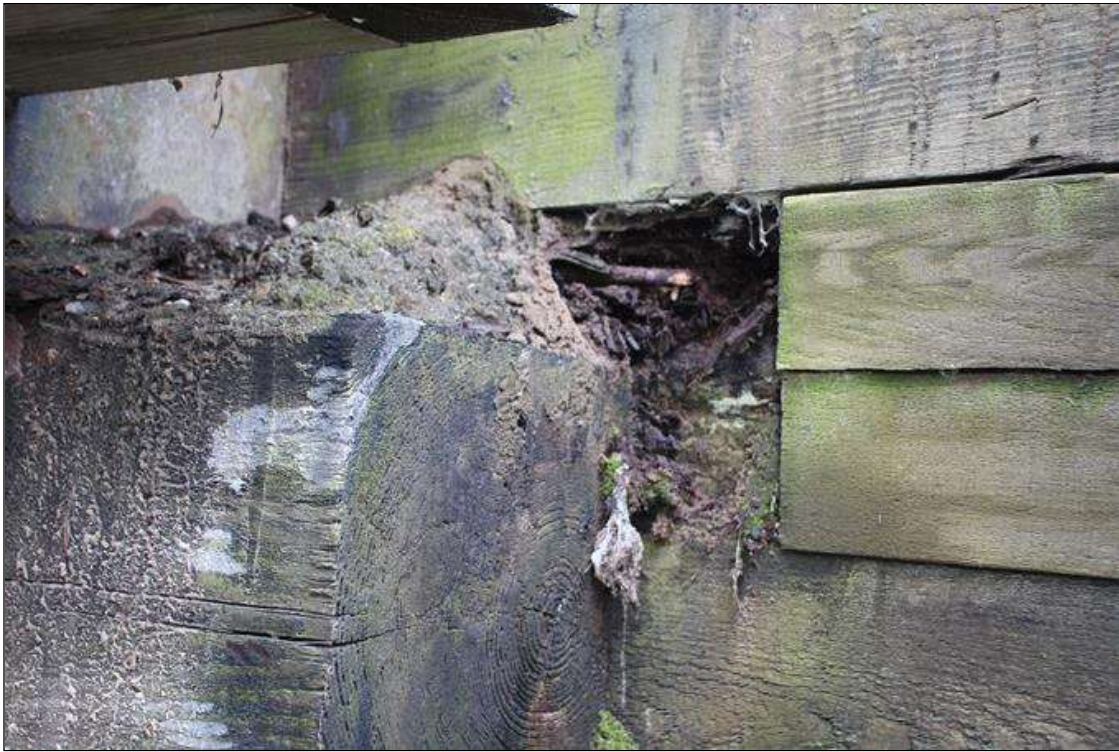
End Bent 2 Abutment/Backwall : UP TO 1 FT WIDE X 8 IN HIGH X 3 IN DEEP AREA OF DECAY AND SECTION LOSS WITH SOIL SPILLING THROUGH BEHIND THE CAP AT SOUTH END OF END BENT 2 (PAR).

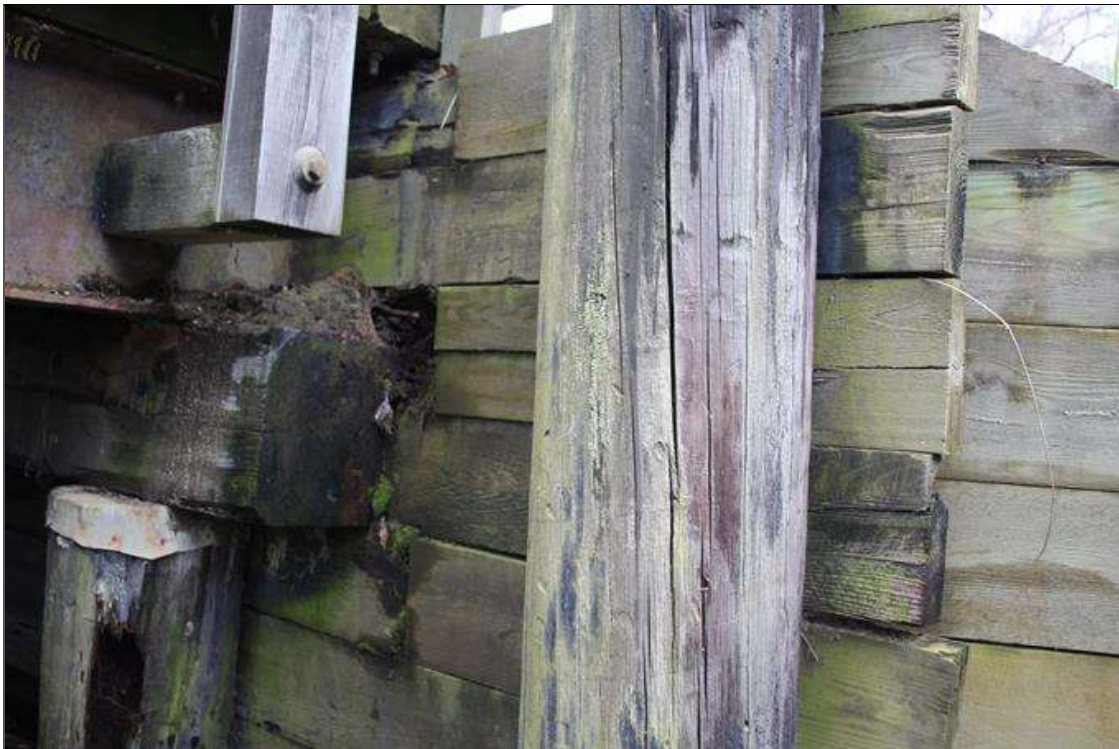
End Bent 2 Abutment/Backwall : UP TO 3/16 IN WIDE X 2 IN DEEP VERTICAL CHECKS IN SOUTHWEST FACE OF SOLDIER PILE AT SOUTH END.

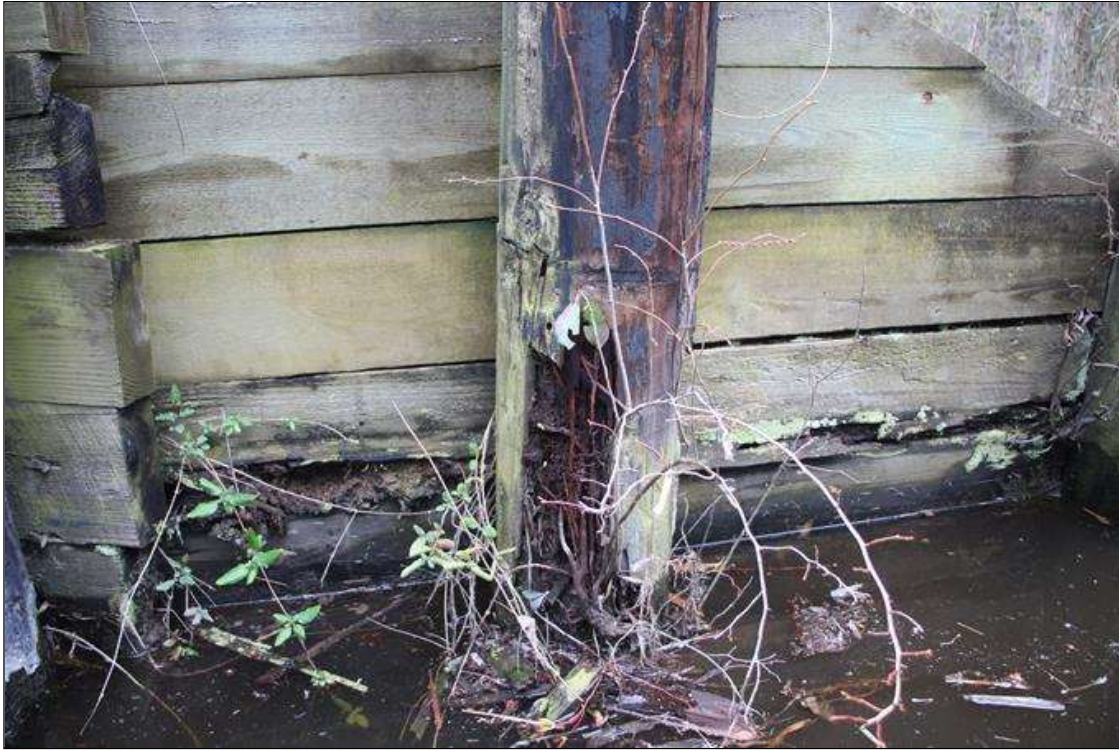
5 FT LONG X 9 IN HIGH X UP TO 3 IN DEEP AREA OF SEVERE DECAY WITH SOIL SPILLING THROUGH IN THE BOTTOM BULKHEAD BOARD. 2 FT HIGH X 3/4 IN DIAMETER X UP TO 3 IN DEEP AREA OF SEVERE DECAY AND TREE ROOTS IN THE FIRST SOLDIER PILE FROM SOUTH END OF THE ABUTMENT AT END BENT 1 (PAR).

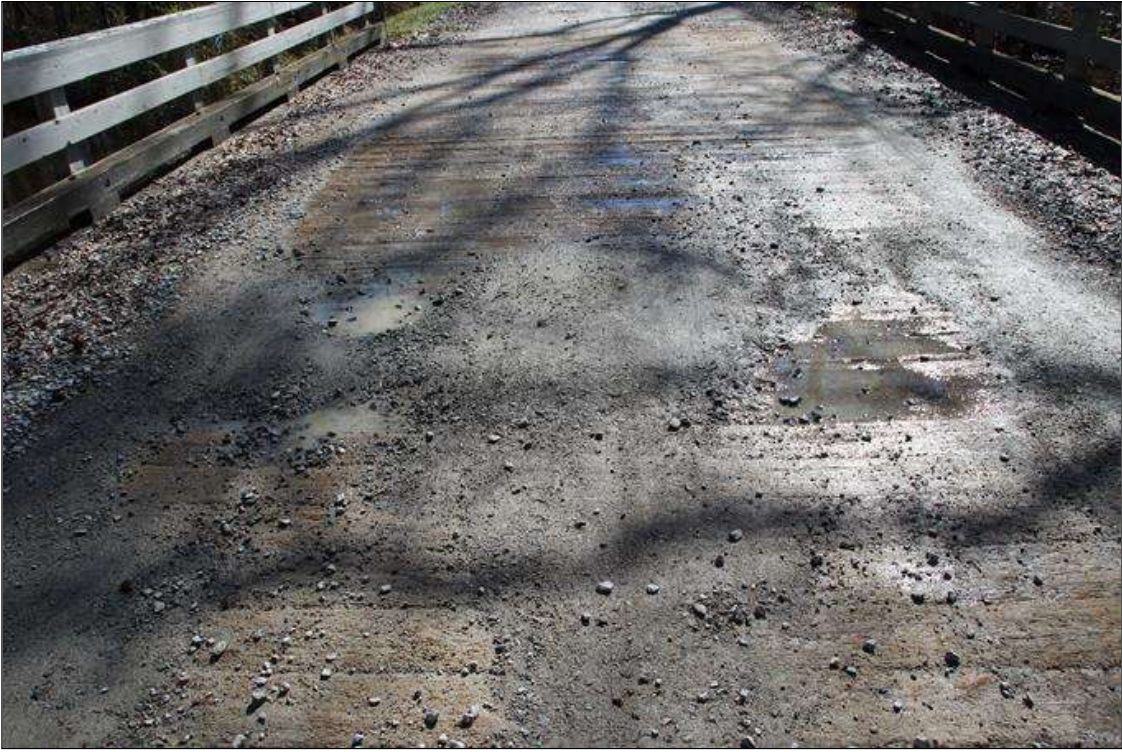
TOP OF DECK LOOKING EAST.

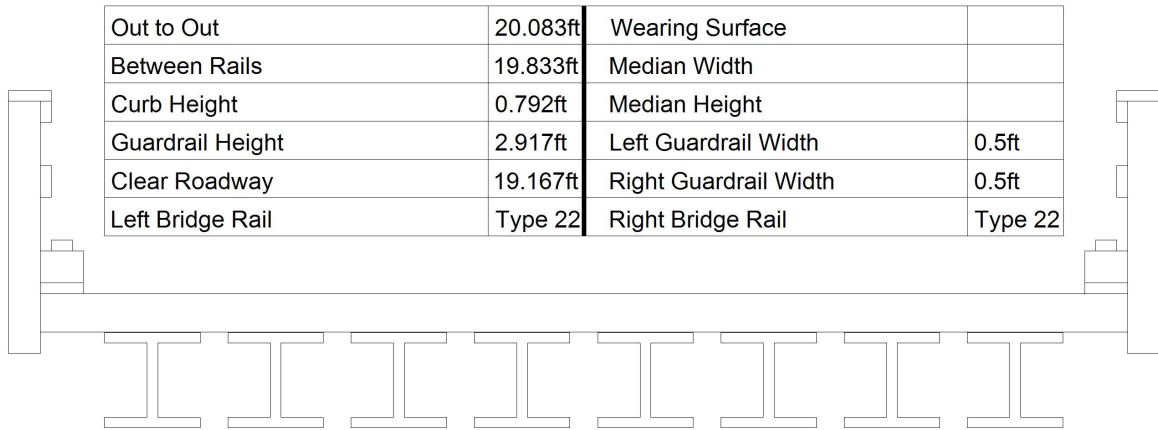
Out to Out	20.083ft	Wearing Surface	
Between Rails	19.833ft	Median Width	
Curb Height	0.792ft	Median Height	
Guardrail Height	2.917ft	Left Guardrail Width	0.5ft
Clear Roadway	19.167ft	Right Guardrail Width	0.5ft
Left Bridge Rail	Type 22	Right Bridge Rail	Type 22

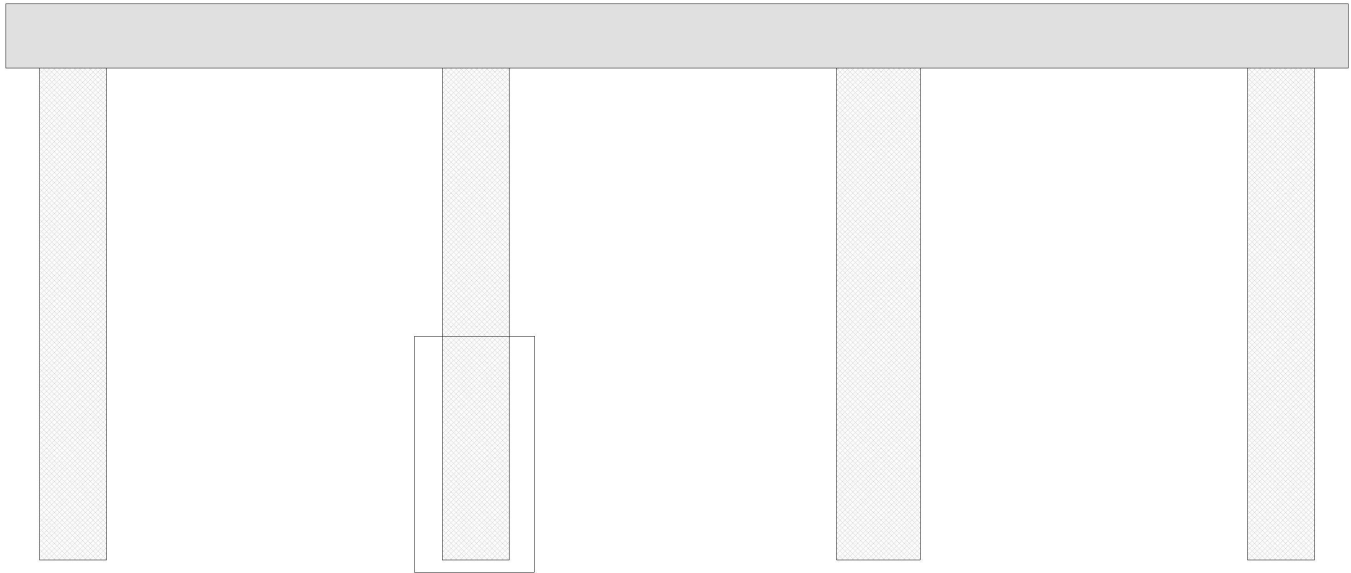
Cap Information			Material Timber							
Length	Width	Height	Left Overhang	Right Overhang	Left Beam to End of Cap.	Right Beam to End of Cap.				
20.000 ft.	.812 ft.	.959 ft.	1.000 ft.	1.000 ft.	1.000 ft.	1.000 ft.				
Subcap Information			Material							
Length	Width	Height	Left Overhang	Right Overhang	Left Pile to Splice.					
Sill Information			Material							
Length	Width	Height								
Pile #	Material	Spacing	Width/Dia.	Height	Length	Orientation	Driven?	Replacement?	Removed?	Collar?
1	Timber	6 ft.	1 ft.			Vertical	No	No	No	No
2	Timber	6 ft.	1 ft.			Vertical	No	No	No	YES
3	Timber	6 ft.	1.25 ft.			Vertical	No	No	No	No
4	Timber		1 ft.			Vertical	No	No	No	No
Bent/Abutment #: 1			Similar Bents:
