> PROJECT NO. 15BPR.40 BUNCOMBE __ COUNTY BRIDGE NO. 100495

SHEET 1 OF 2

STATE OF NORTH CAROLINA DEPARTMENT OF TRANSPORTATION DECK UNDERSIDE REPAIR SPANS A & C

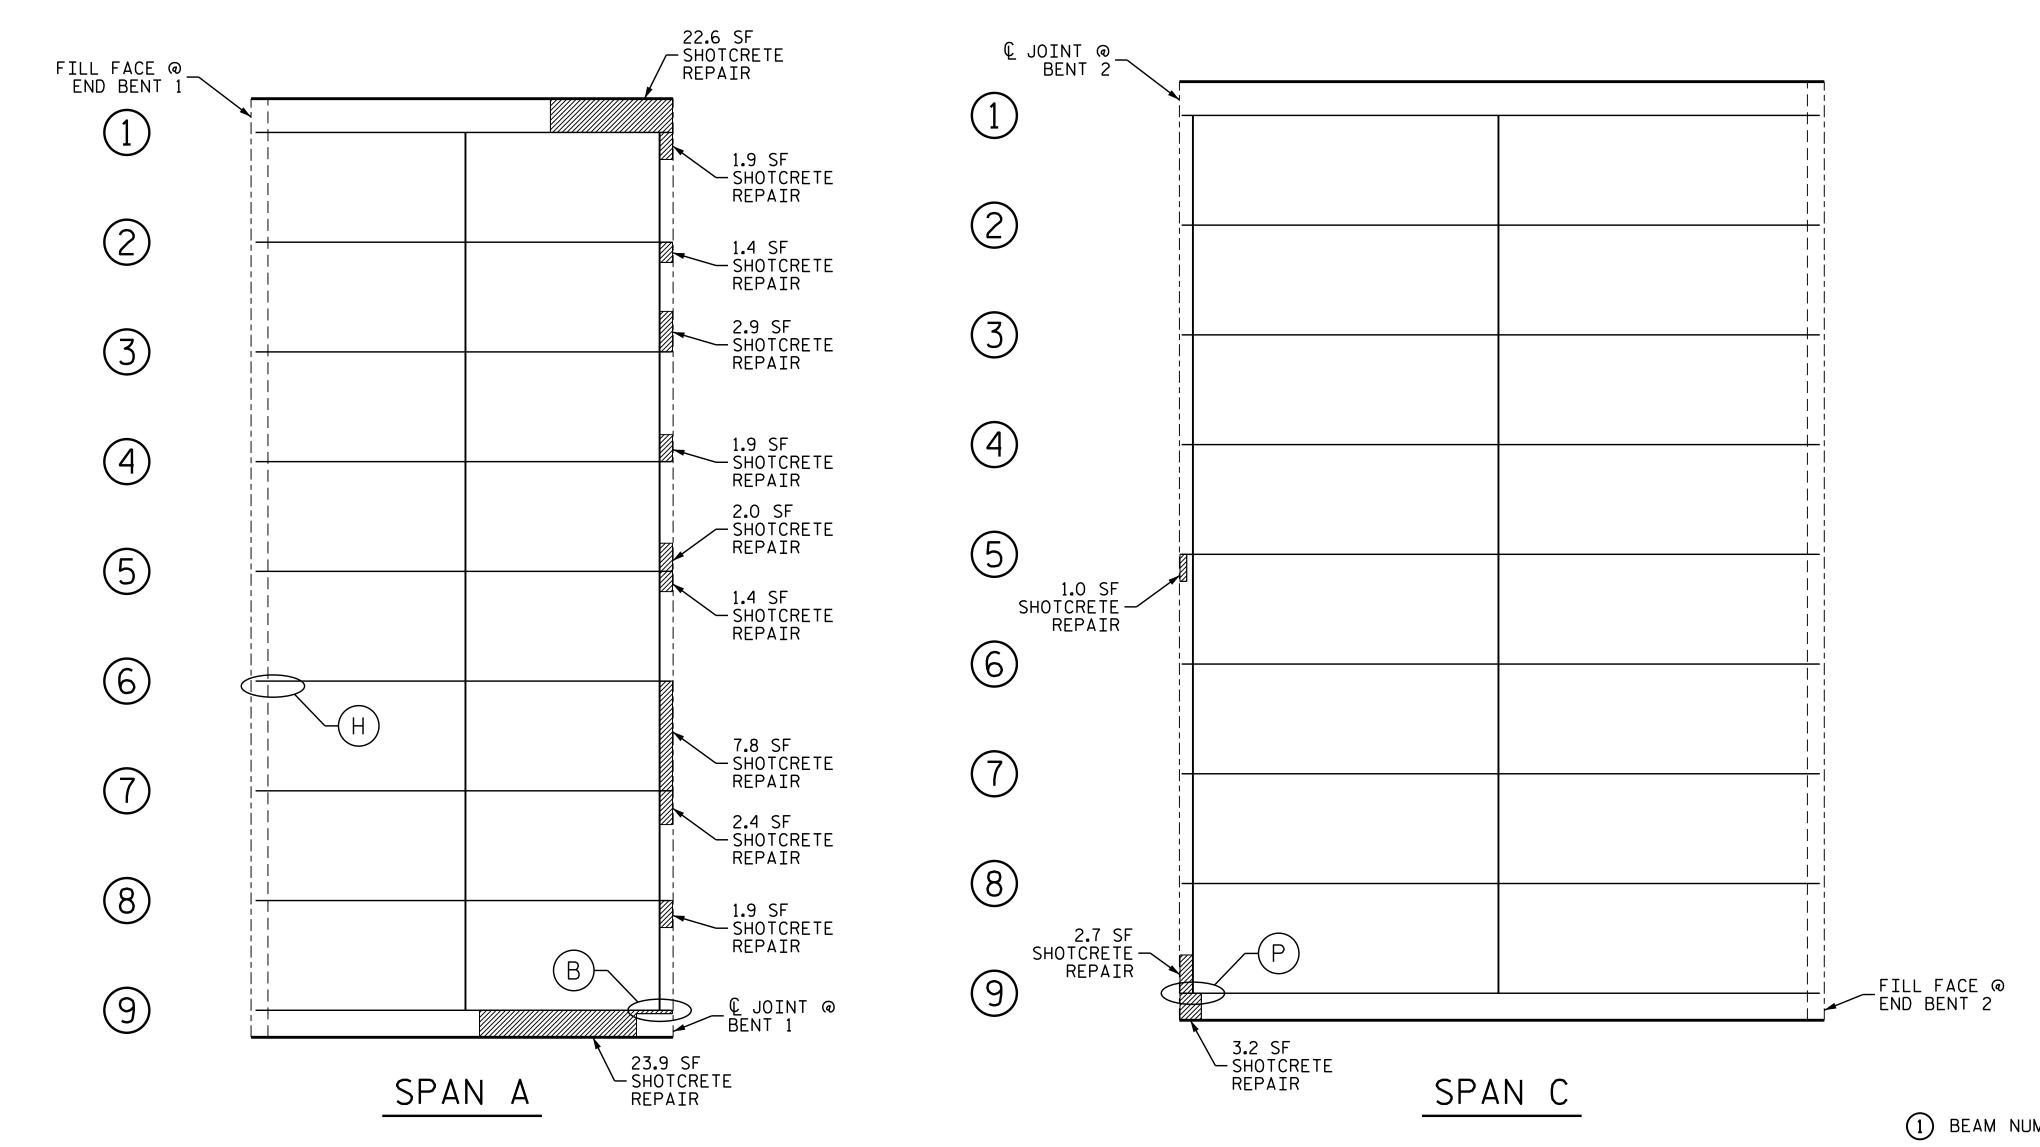
ANTICIPATED STEEL REPAIR LOCATIONS						
SPAN	BEAM	LOCATION	DIM "A"	DIM "B"	DIM "E"	DIM "F"
Α	9	BENT 1	* 13"	80″		
С	9	BENT 2	-	6 ¹ /2"	22″

(* SEE DETAIL "A")

FOR UNDERSIDE OF DECK REPAIRS. SEE "OVERHANG, DIAPHRAGM AND BRIDGE RAIL REPAIR DETAILS" SHEET.

FOR OVERHANG REPAIRS. SEE "OVERHANG, DIAPHRAGM AND BRIDGE RAIL REPAIR DETAILS" SHEET.

FOR GUSSET PLATE REPAIR, CONTRACTOR IS TO FIELD VERIFY DIMENSIONS OF EXISTING GUSSET PLATE AND REPLACE WITH LIKE KIND.

FOR BEAM PLATING REPAIR. SEE "BEAM PLATING REPAIR DETAILS" SHEETS. FOR BRIDGE JACKING. SEE "JACKING DETAILS" SHEET.
