PROJECT NO. 15BPR.40 BUNCOMBE COUNTY BRIDGE NO. 100495

STATE OF NORTH CAROLINA DEPARTMENT OF TRANSPORTATION

SUBSTRUCTURE REPAIR
BENT 1
SPAN A FACE

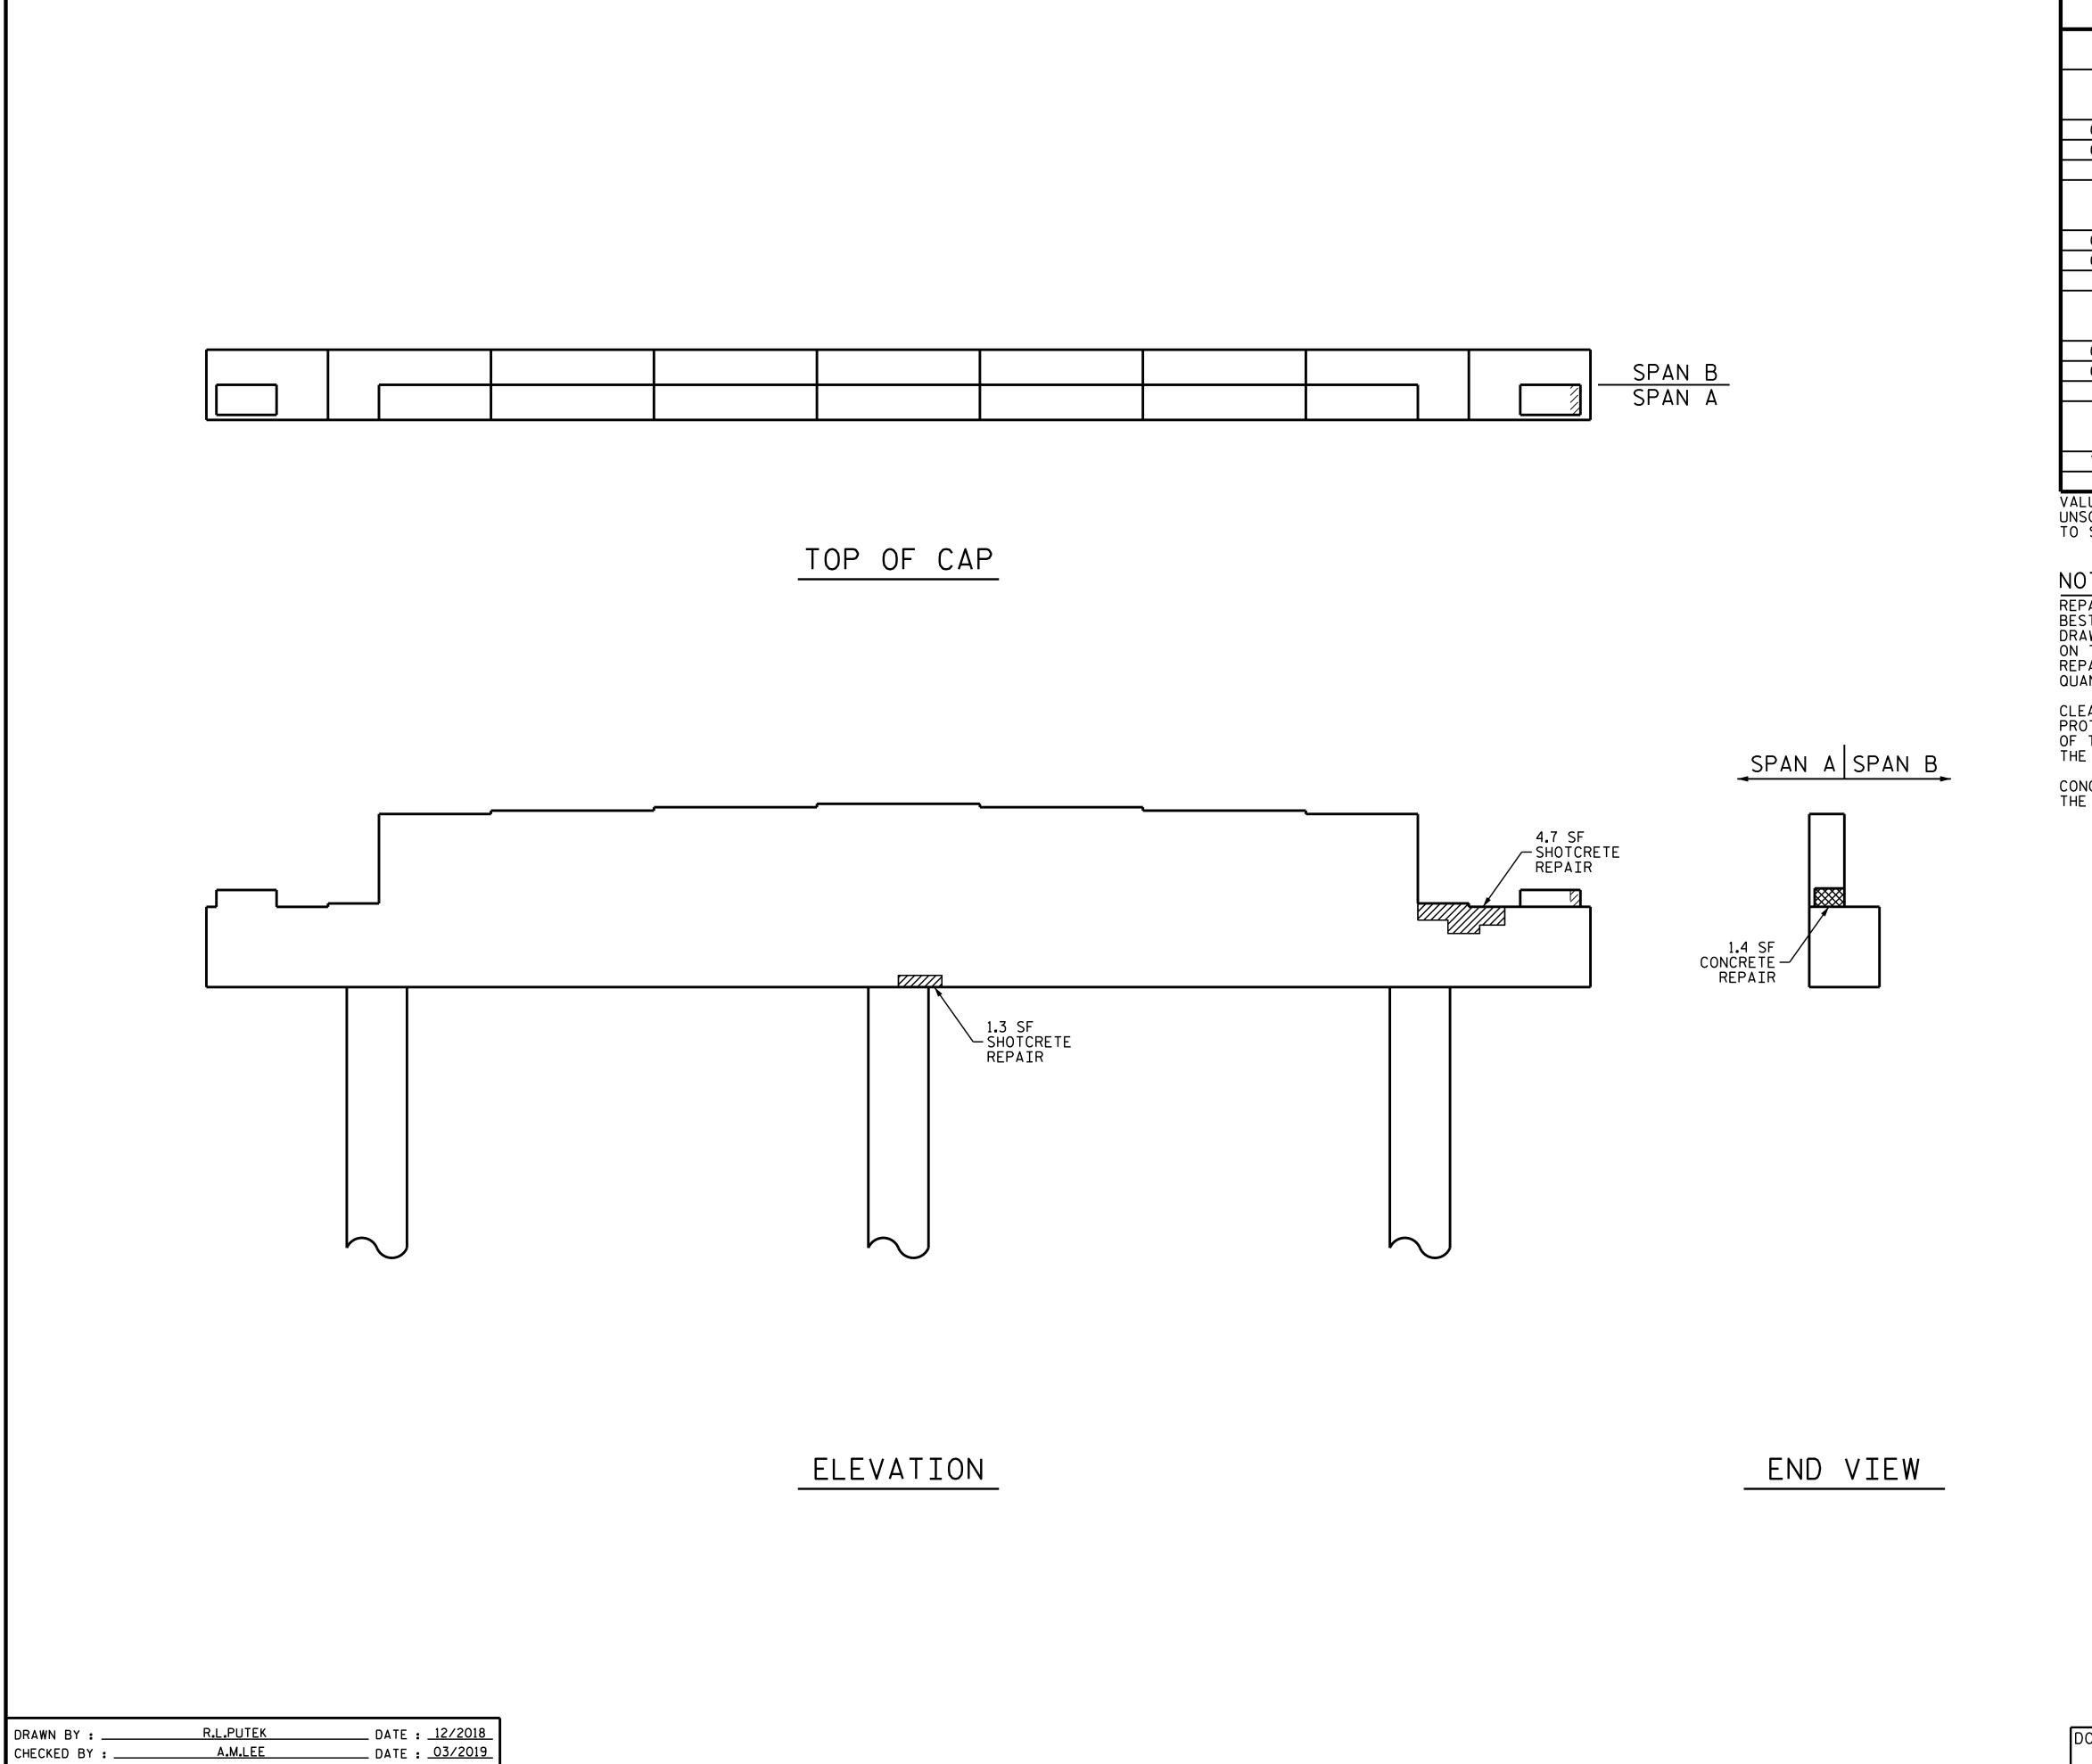
AS-BUILT REPAIR QUANTITY TABLE				
BENT 1 SPAN A FACE	QUANTITIES			
DENT I STAN A FACE	ESTIMATE		ACTUAL	
SHOTCRETE REPAIRS	AREA SQ.FT.	VOLUME CU.FT.	AREA SQ.FT.	VOLUME CU.FT.
CAP	7.4	3.7		
COLUMN	0.0	0.0		
CONCRETE REPAIRS	AREA SQ.FT.	VOLUME CU.FT.	AREA SQ.FT.	VOLUME CU.FT.
CAP	0.0	0.0		
COLUMN	0.0	0.0		
EPOXY RESIN INJECTIO	LIN.FT.	LIN.FT.		
CAP	0.0			
COLUMN	0.0			
EPOXY COATING		SQ.FT.	SQ.FT.	
TOP OF BENT CAP		241.5

CLEAN AND REMOVE DEBRIS FROM THE TOP OF THE CAP AND APPLY EPOXY PROTECTIVE COATING. EPOXY COATING SHALL BE APPLIED TO THE TOP SURFACE OF THE CAP. THE CONTRACTOR SHALL NOT COAT THE AREA OF THE CAP BENEATH THE MASONRY PLATES. FOR EPOXY COATING, SEE SPECIAL PROVISIONS.
