HOLE REPAIRS TYPE II
FOR REPRESENTATION ONLY

PROJECT NO. 15BPR.20
HENDERSON COUNTY
STATION: 35+30.22 -L-

<small>AECOM TECHNICAL SERVICES OF NC, INC. 701 CORPORATE CENTER DRIVE, SUITE 475 RALEIGH, NC 27607 (919) 854-6200 www.aecom.com AECOM License No. F-0342</small>		STATE OF NORTH CAROLINA DEPARTMENT OF TRANSPORTATION RALEIGH REHABILITATION STRUCTURAL STEEL REPAIRS			
REVISIONS					
NO.	BY:	DATE:	NO.	BY:	DATE:
1			3		
2			4		
SHEET NO. S-88 TOTAL SHEETS 129

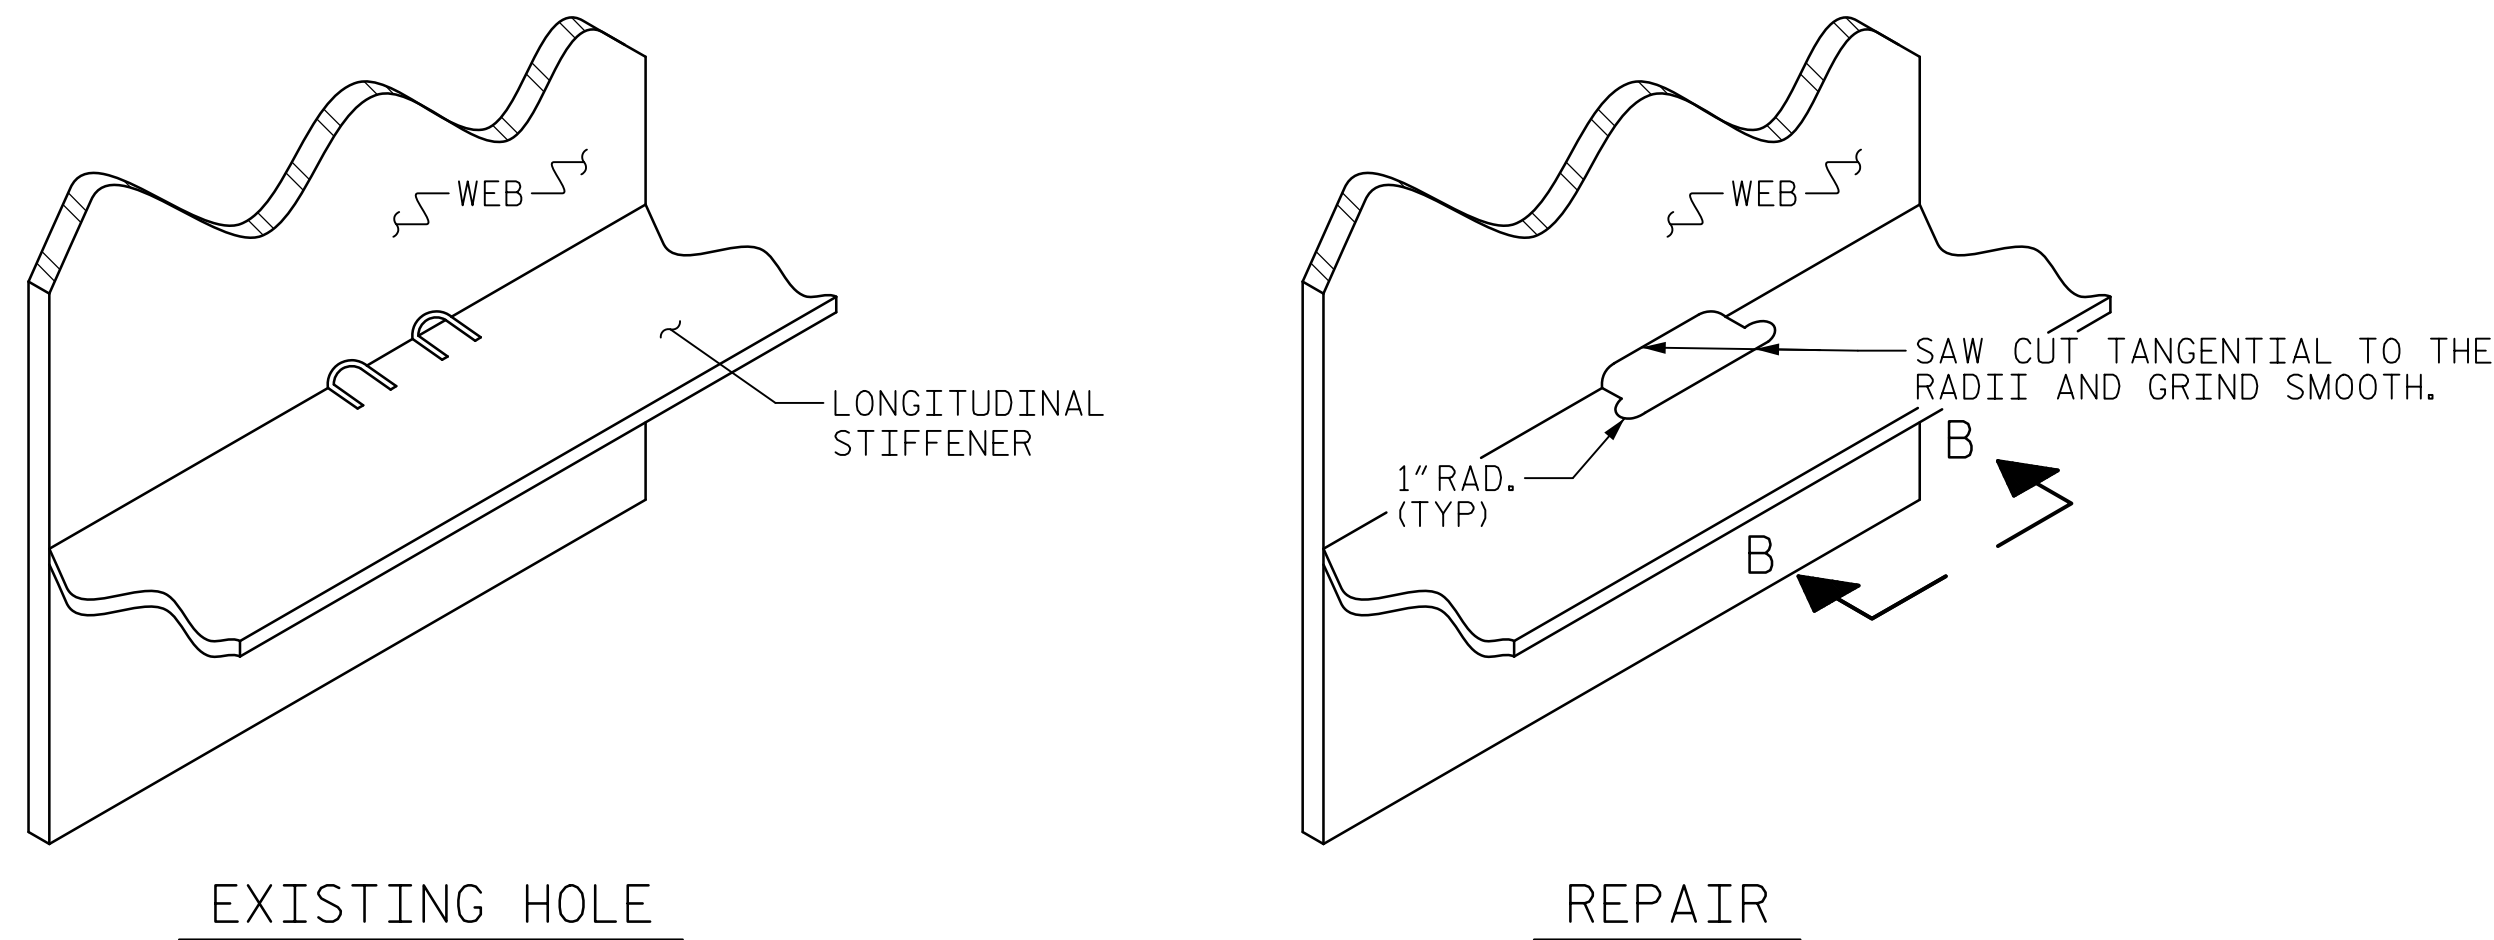
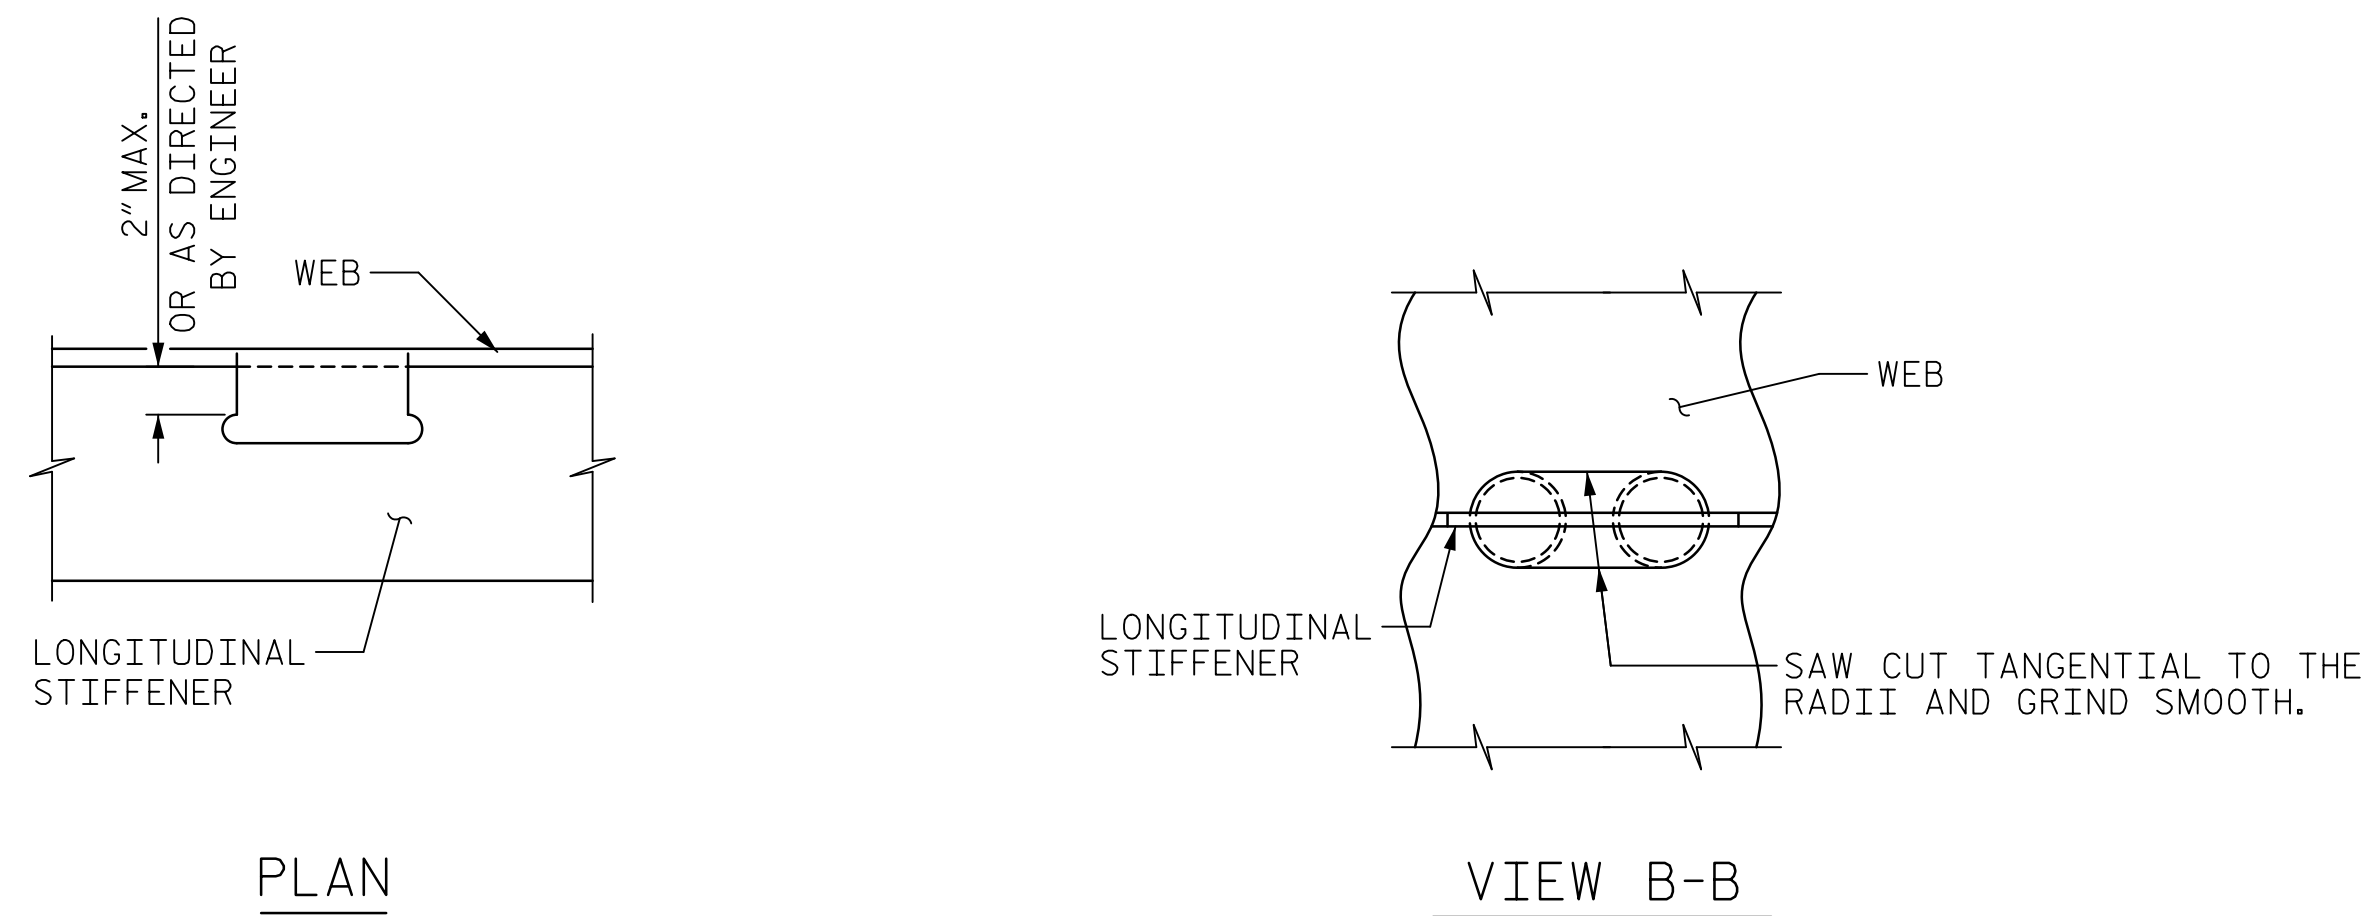
HOLE REPAIR TYPE II

FOR REPRESENTATION ONLY. REPAIR SHALL BE PERFORMED AT EACH LOCATION NOTED. FOR REPAIR LOCATIONS, SEE PHOTO LOCATION LEGEND.

1. DRILL 1" RADIUS AT THE TERMINATION OF THE EXISTING OUTSIDE CUTS IN THE LONGITUDINAL STIFFENER.
2. SAW CUT BETWEEN THE HOLES IN THE WEB AND THE STIFFENER TANGENTIAL TO THE RADII OF THE HOLES.
3. GRIND SMOOTH ADJACENT AREAS OF THE WEB, LONGITUDINAL STIFFENER, AND WELDS.

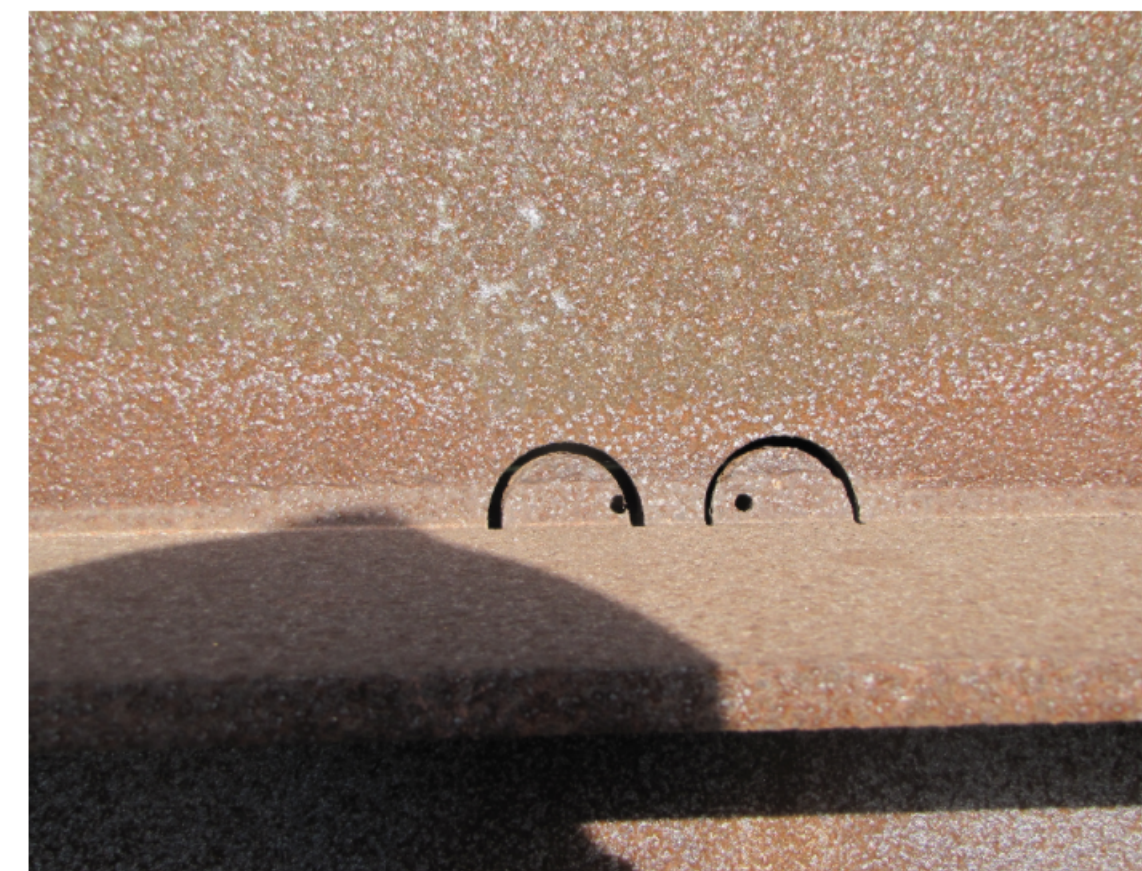
- HR-II-1 GIRDER 1, SPAN B, IN WEB AT BOTTOM LONGITUDINAL STIFFENER, 3'-4" WEST OF PANEL POINT 10: (2) 2" Ø HOLES AT APPROXIMATELY 3" SPACING
- HR-II-2 GIRDER 3, SPAN C, IN WEB AT BOTTOM LONGITUDINAL STIFFENER, 5'-10" WEST OF PANEL POINT 15: (2) 2" Ø HOLES AT APPROXIMATELY 4" SPACING
- HR-II-3 GIRDER 3, SPAN C, IN WEB AT BOTTOM LONGITUDINAL STIFFENER, 8'-9" WEST OF PANEL POINT 15: (2) 2" Ø HOLES AT APPROXIMATELY 4" SPACING
