STATE OF NORTH CAROLINA  
DEPARTMENT OF TRANSPORTATION  
RALEIGH

REHABILITATION

STRUCTURAL STEEL  
REPAIRS

**HOLE REPAIRS TYPE III**  
FOR REPRESENTATION ONLY

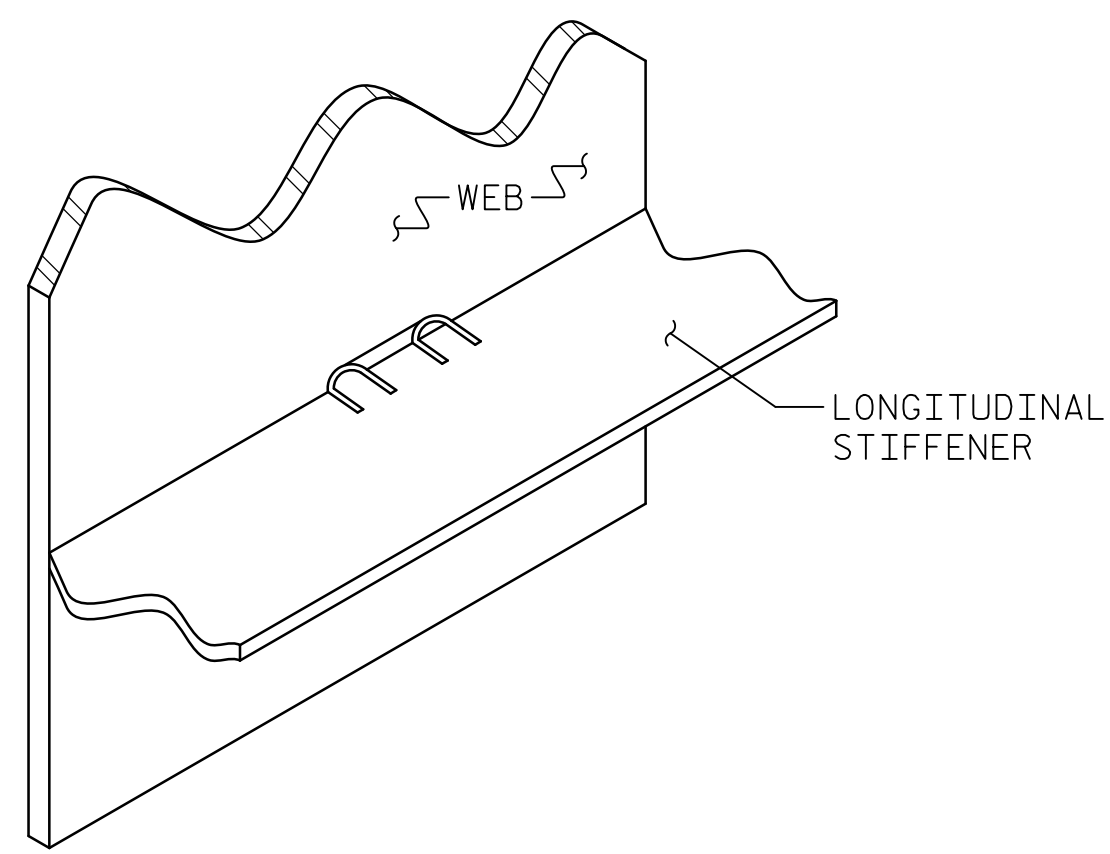
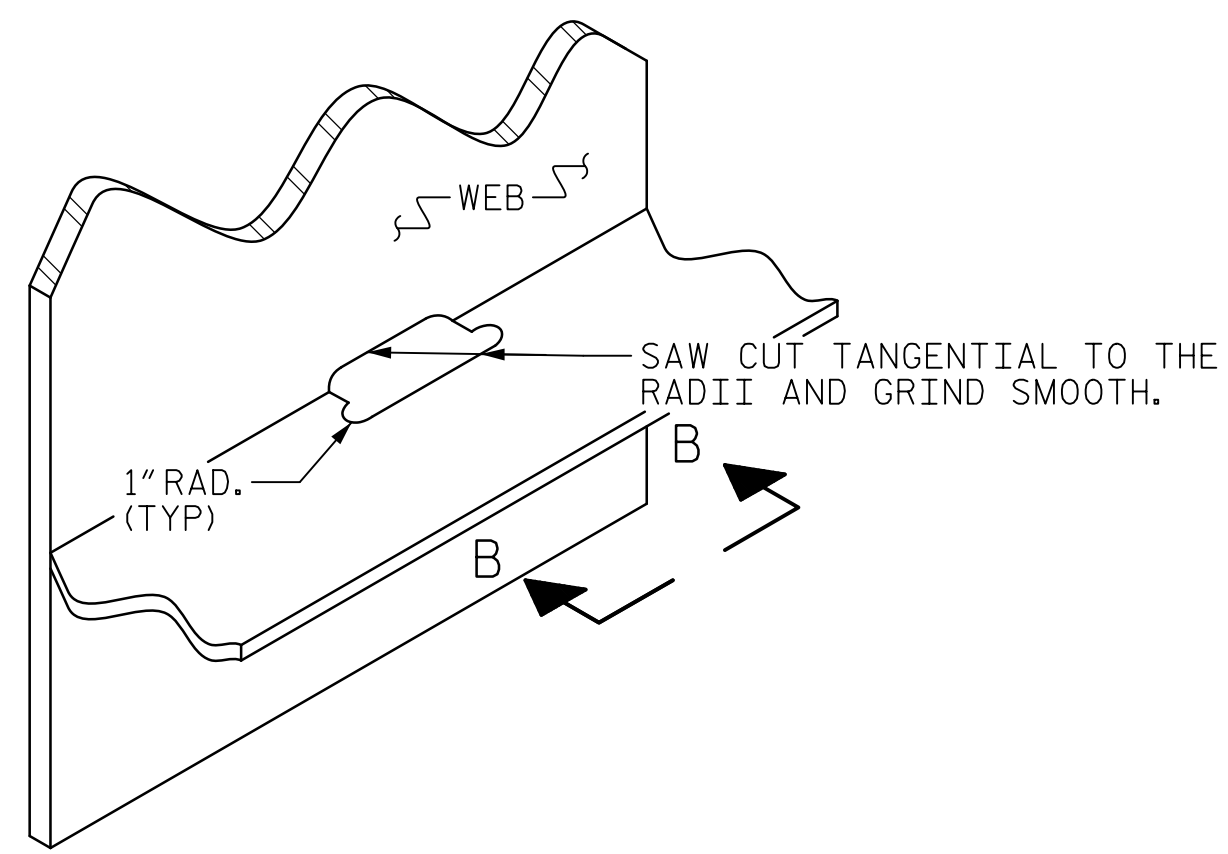
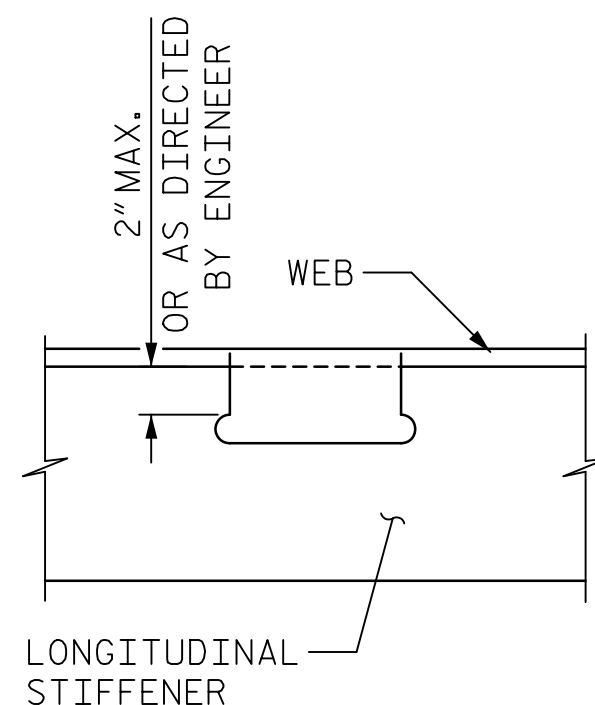
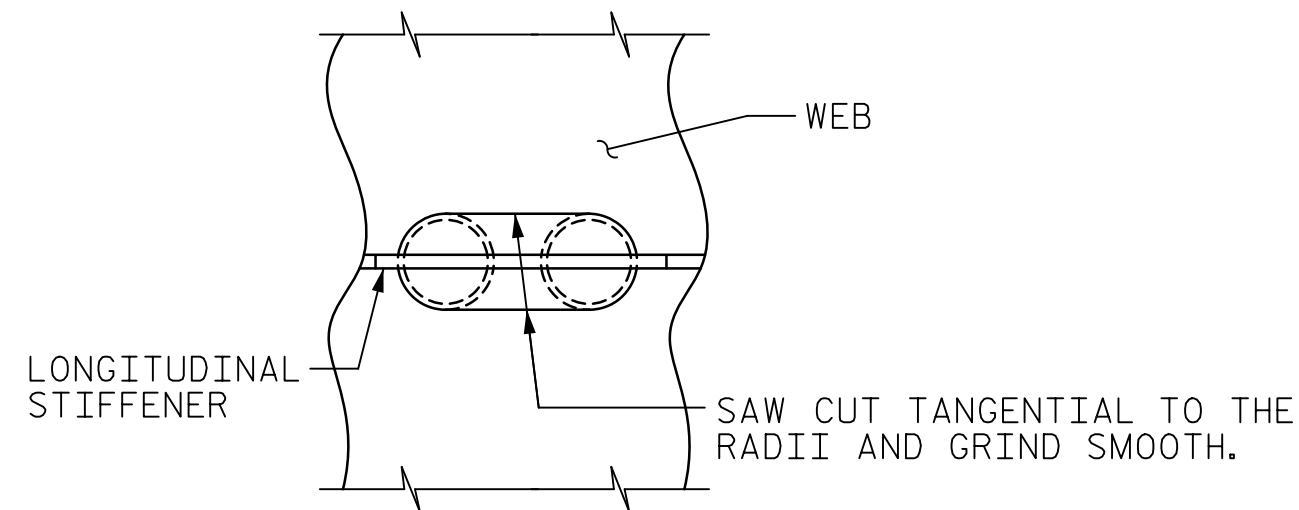
**HOLE REPAIR TYPE III**

EXISTING HOLE

1. DRILL 1" RADIUS AT THE TERMINATION OF THE EXISTING OUTSIDE CUTS IN THE LONGITUDINAL STIFFENER.
2. SAW CUT BETWEEN THE HOLES IN THE WEB AND THE STIFFENER TANGENTIAL TO THE RADII OF THE HOLES.
3. GRIND SMOOTH ADJACENT AREAS OF THE WEB, LONGITUDINAL STIFFENER, AND WELDS.

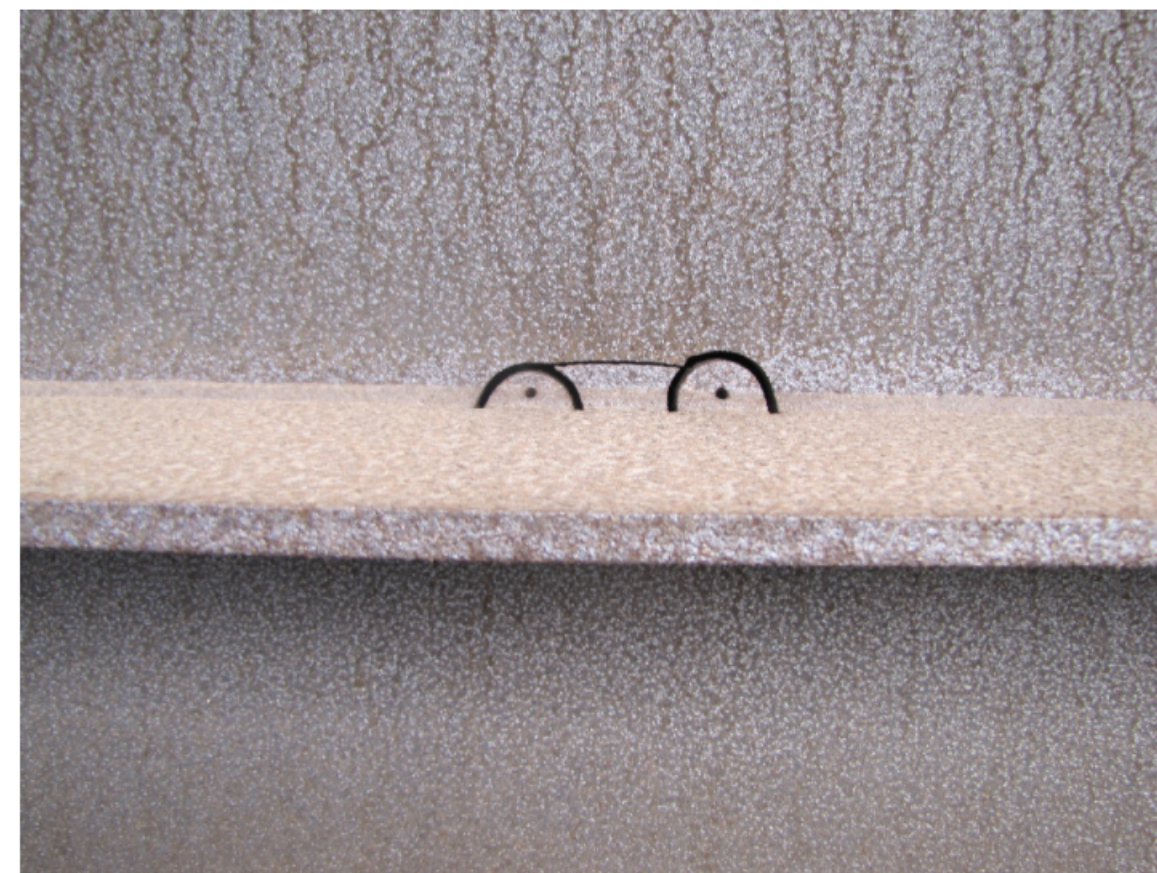
HR-III-1 GIRDER 1, SPAN C, IN WEB AT BOTTOM LONGITUDINAL STIFFENER, 6'-1" WEST OF PANEL POINT 16: (2) 2" Ø HOLES AT APPROXIMATELY 3" SPACING CONNECTED BY SAW CUT
