PROJECT NO. 15BPR.20
HENDERSON COUNTY
 STATION: 35+30.22 -L-

REHABILITATION

STRUCTURAL STEEL
 REPAIRS

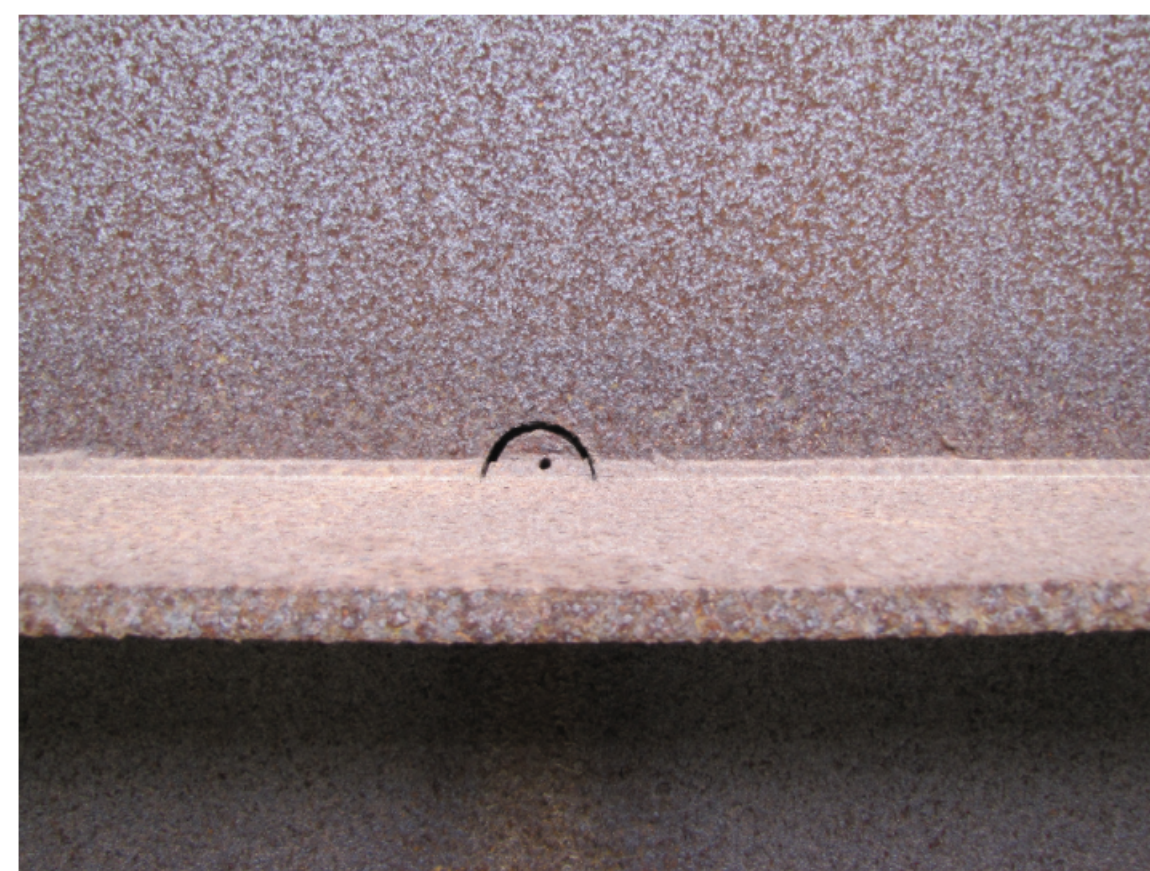
- HR-I-1 GIRDER 2, SPAN B, IN WEB, 15'-6" WEST OF PANEL POINT 8, AT BOTTOM LONGITUDINAL STIFFENER; 2IN DIAMETER HOLE.
- HR-I-2 GIRDER 1, SPAN C, NORTH FACE, 12'-0" WEST OF PANEL POINT 16 IN WEB, AT BOTTOM LONGITUDINAL STIFFENER; 2IN DIAMETER HOLE.

1. DRILL 1" RADIUS HOLES AT THE TERMINATION OF THE EXISTING CUTS IN THE LONGITUDINAL STIFFENER.
2. SAW CUT BETWEEN HOLES TANGENTIAL TO THE RADIUS OF THE HOLE.
3. GRIND SMOOTH ADJACENT AREAS OF THE WEB, LONGITUDINAL STIFFENER, AND WELDS.

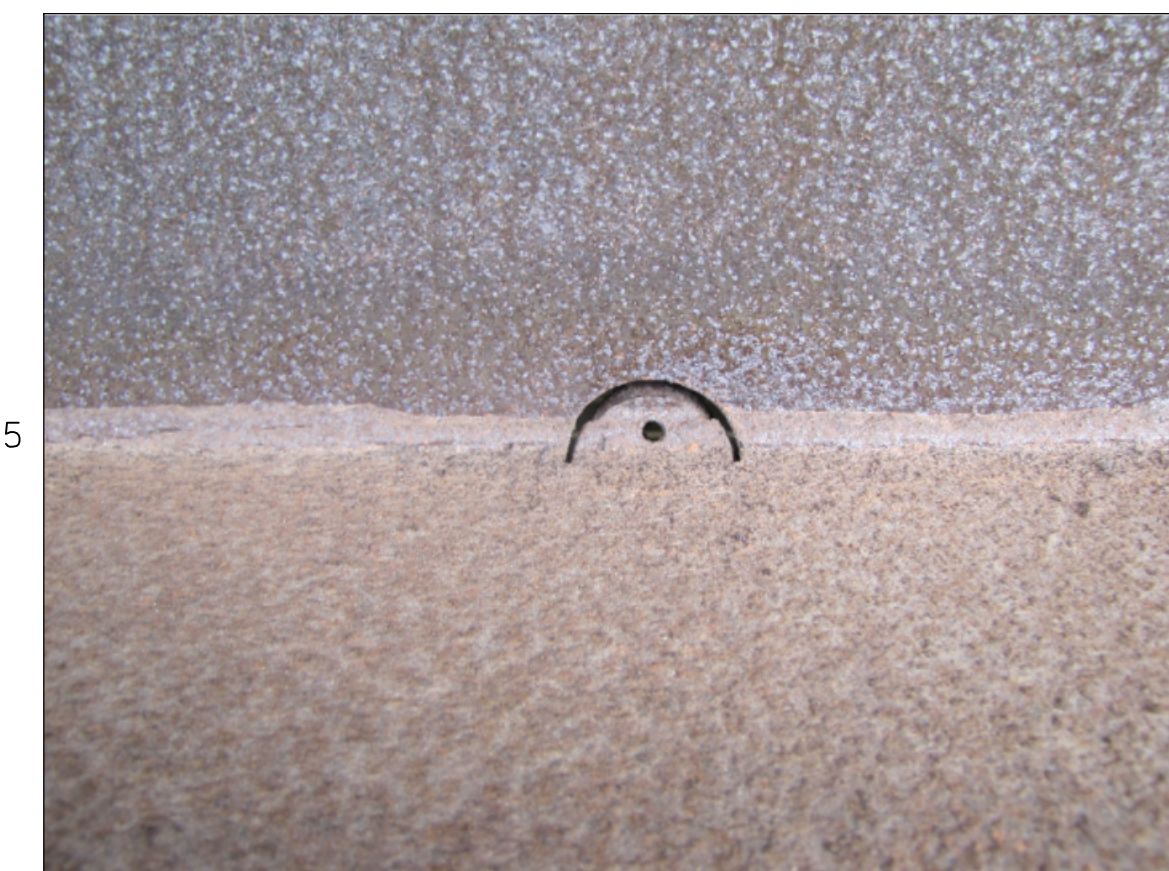
- HR-I-5 GIRDER 1, SPAN C, IN WEB AT TOP LONGITUDINAL STIFFENER, 9'-9" WEST OF PANEL POINT 22; 2IN DIAMETER HOLE.
- HR-I-6 GIRDER 1, SPAN C, IN WEB AT TOP LONGITUDINAL STIFFENER, 11'-5" WEST OF PANEL POINT 22; 2IN DIAMETER HOLE.

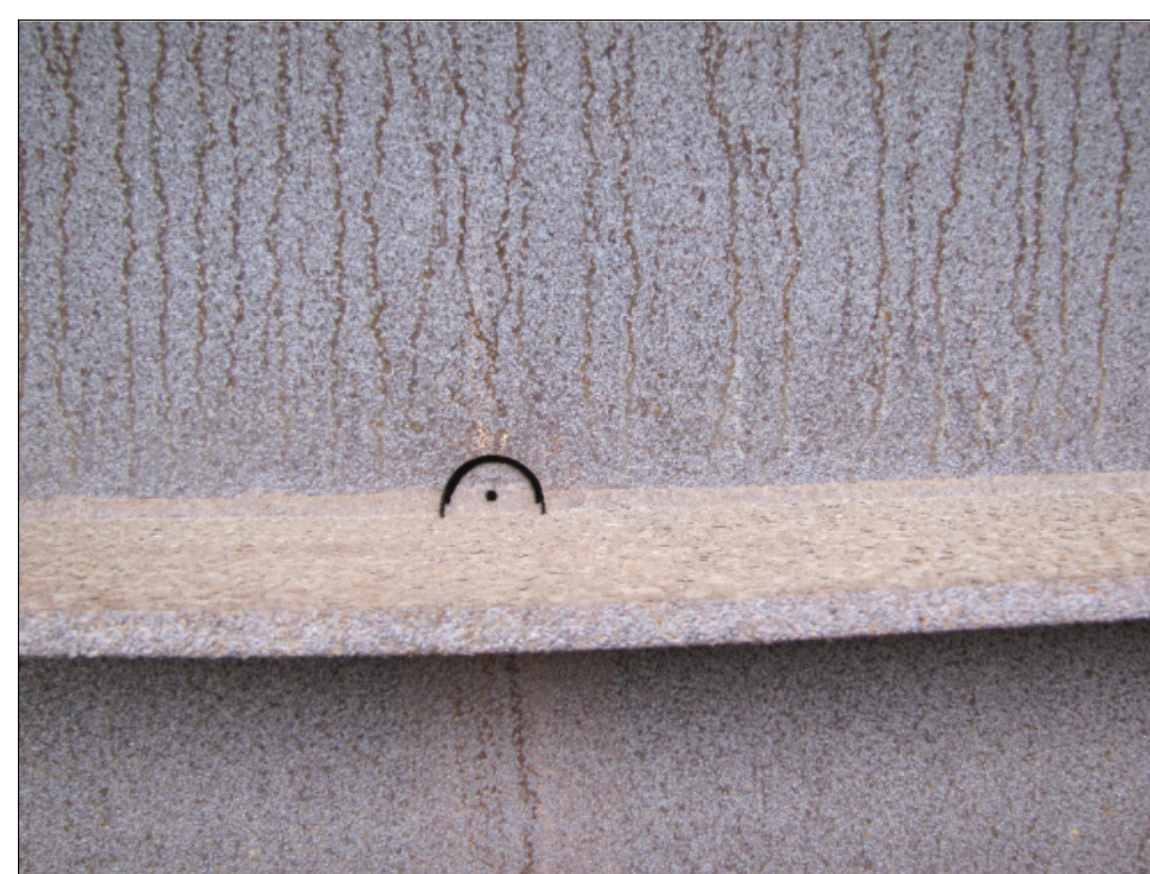
- HR-I-3 GIRDER 2, SPAN C, AT TOP LONGITUDINAL STIFFENER, 13'-8" WEST OF PANEL POINT 21; 2IN DIAMETER HOLE.
- HR-I-4 GIRDER 1, SPAN C, IN WEB AT TOP LONGITUDINAL STIFFENER, 9'-4" WEST OF PANEL POINT 22; 2IN DIAMETER HOLE.

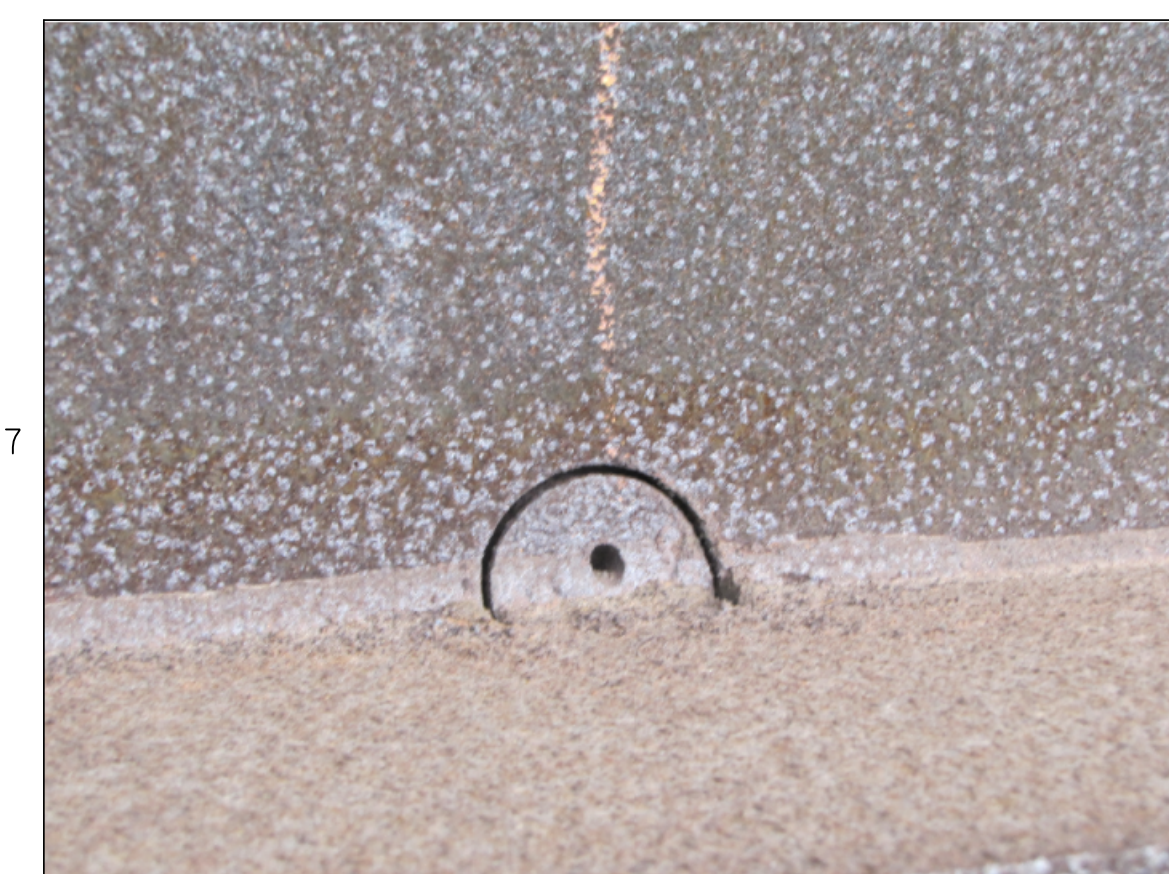
- HR-I-7 GIRDER 1, SPAN C, IN WEB AT TOP LONGITUDINAL STIFFENER, 12'-1" WEST OF PANEL POINT 22; 2" DIAMETER HOLE.
- HR-I-8 GIRDER 1, SPAN C, IN WEB, 6'-0" WEST OF PANEL POINT 22 AT BOTTOM LONGITUDINAL STIFFENER; 2IN DIAMETER HOLE.

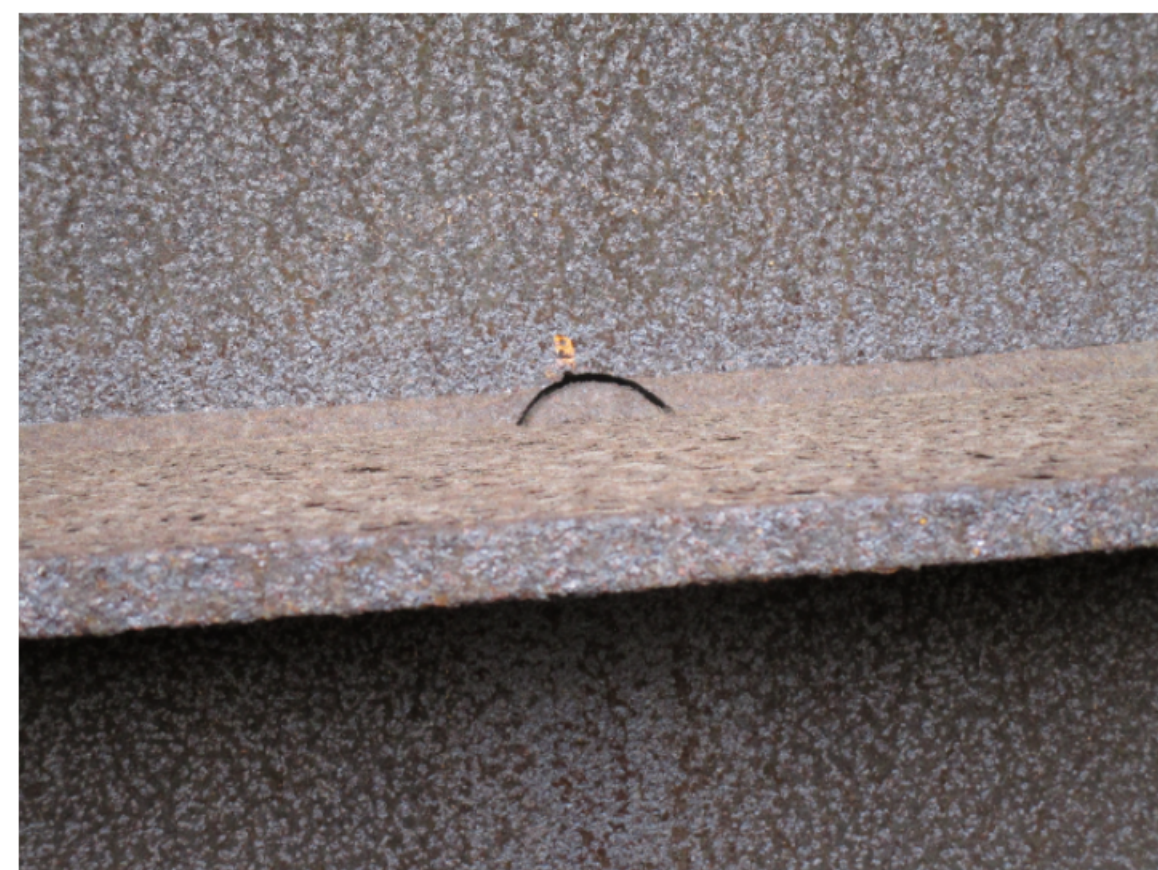
- HR-I-11 GIRDER 3, SPAN C, IN WEB AT BOTTOM LONGITUDINAL STIFFENER, 8'-4" WEST OF PANEL POINT 15; 2" DIAMETER HOLE.
- HR-I-12 GIRDER 3, SPAN C, IN WEB AT TOP LONGITUDINAL STIFFENER, 8'-3" WEST OF PANEL POINT 15; 2" DIAMETER HOLE.

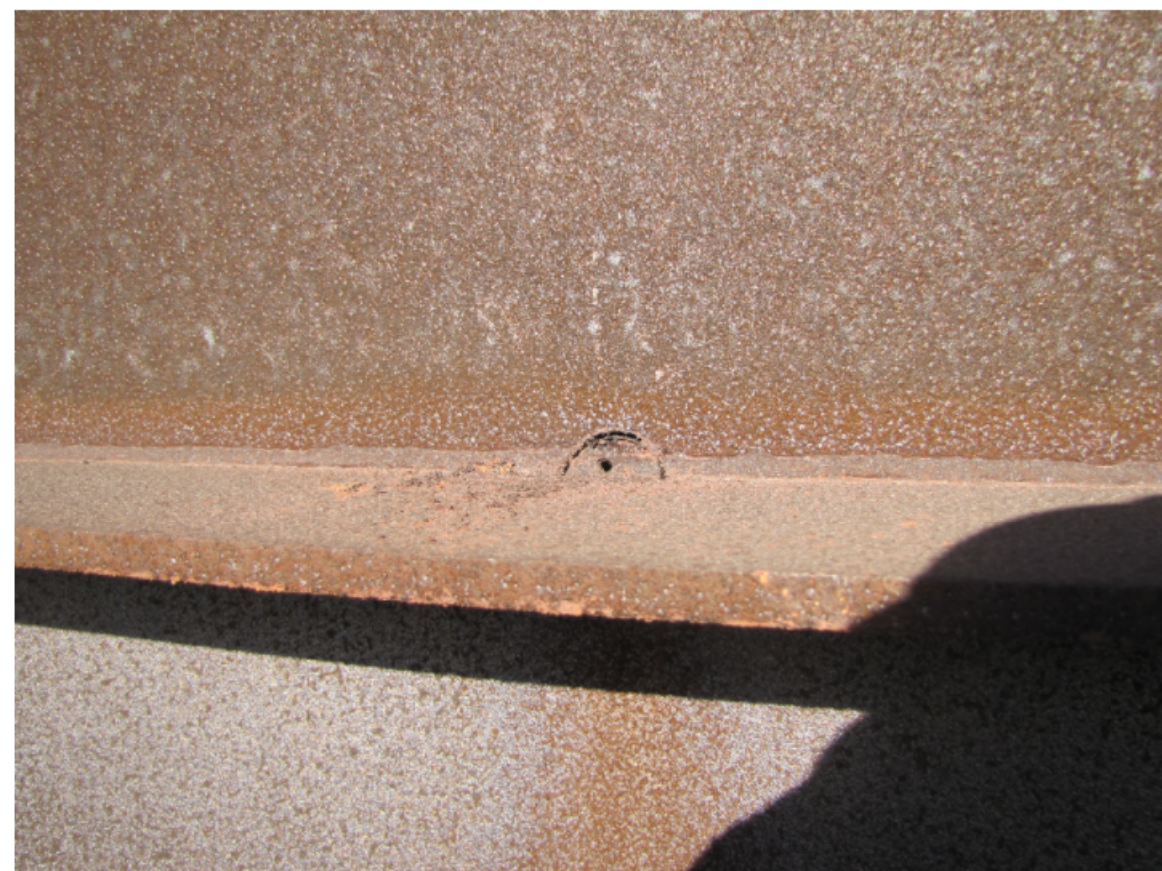
- HR-I-9 GIRDER 1, SPAN C, ON WEB AT BOTTOM LONGITUDINAL STIFFENER 20'-1" WEST OF PANEL POINT 22; 2IN DIAMETER HOLE.
- HR-I-10 GIRDER 2, SPAN D, 10'-8" WEST OF PANEL POINT 30 AT BOTTOM LONGITUDINAL STIFFENER; 2IN DIAMETER HOLE.

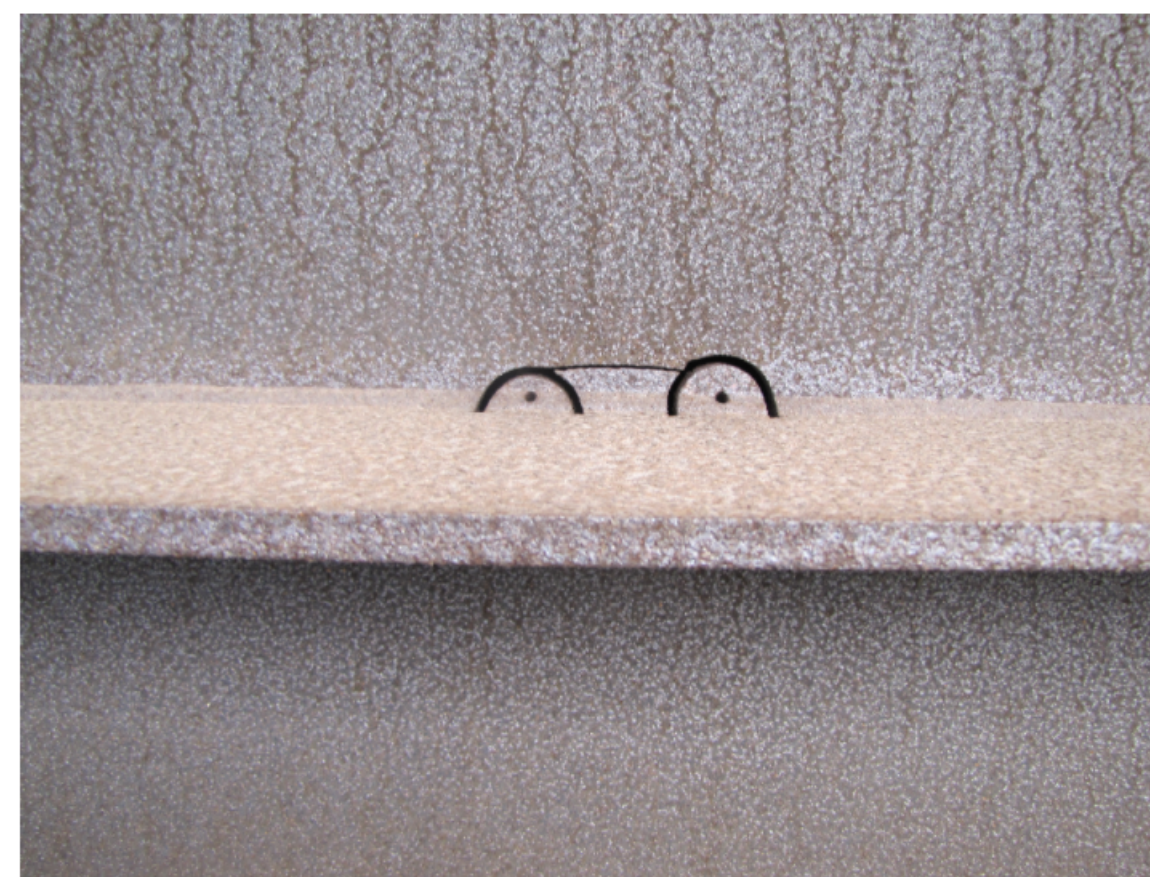
HR-III-1 GIRDER 1, SPAN C, IN WEB AT BOTTOM LONGITUDINAL STIFFENER, 6'-1" WEST OF PANEL POINT 16: (2) 2" Ø HOLES AT APPROXIMATELY 3" SPACING CONNECTED BY SAW CUT

1. DRILL 1" RADIUS AT THE TERMINATION OF THE EXISTING OUTSIDE CUTS IN THE LONGITUDINAL STIFFENER.
2. SAW CUT BETWEEN THE HOLES IN THE WEB AND THE STIFFENER TANGENTIAL TO THE RADII OF THE HOLES.
3. GRIND SMOOTH ADJACENT AREAS OF THE WEB, LONGITUDINAL STIFFENER, AND WELDS.
