NC DEPARTMENT OF TRANSPORTATION  
 DIVISION OF HIGHWAYS  
 STRUCTURE MANAGEMENT UNIT

ATTENTION: **FRACTURE CRITICAL**, Priority Action Request, Changes to Structure Data; inspected South to North - I26 runs West to East

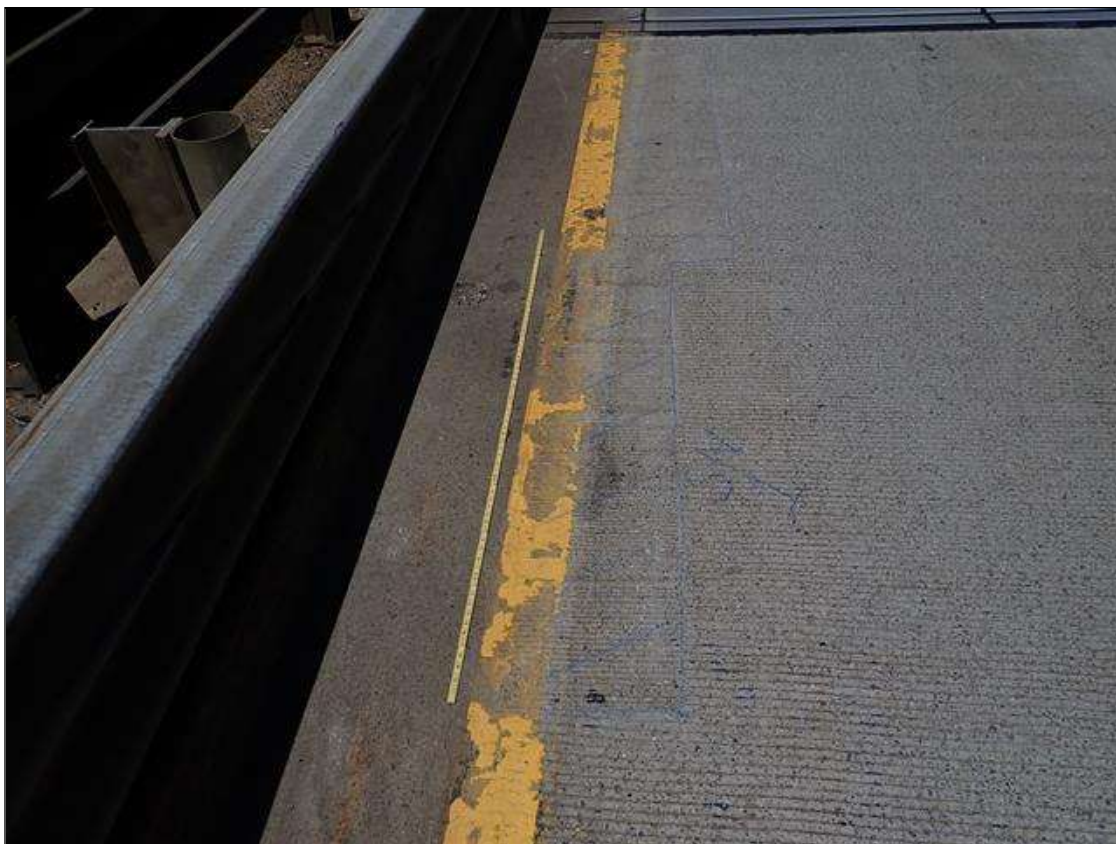
Span 1 Deck: left lane at far end adjacent to yellow line, sound repair [12ft x 1.5ft]

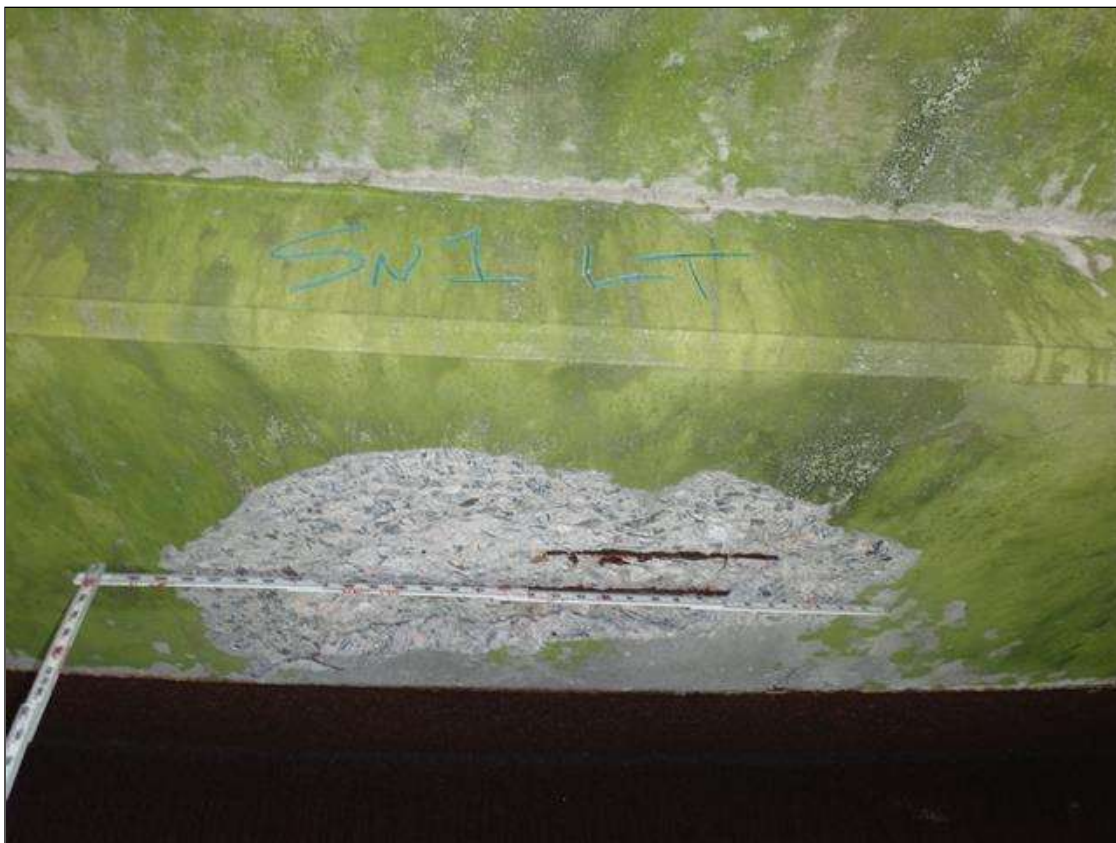
Span 1 Deck: along underside of both overhangs, multiple spalls [up to 29in x 29in x 2in deep] with exposed rusted reinforcing [loss up to 1/16in]

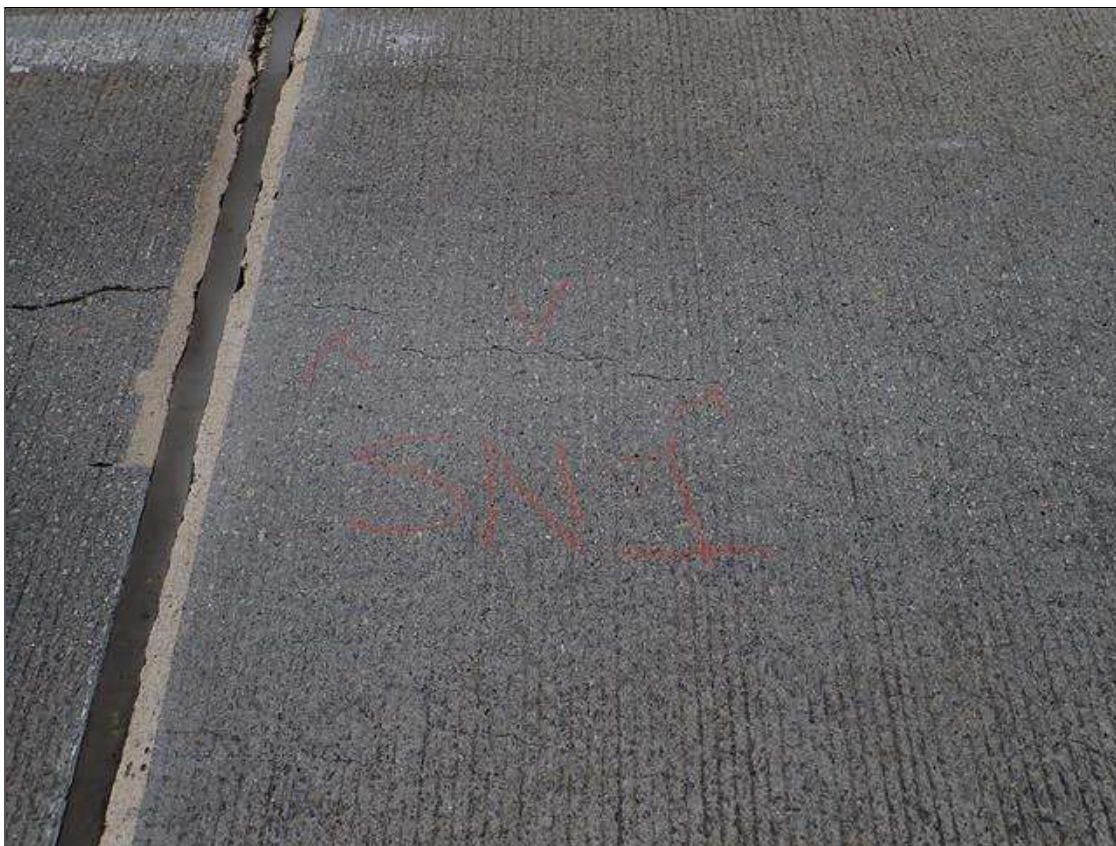
Span 1 Deck: underside of East overhang at End Bent 1, spall [18in x 9in x 1in deep] with exposed rusted reinforcing [no loss]

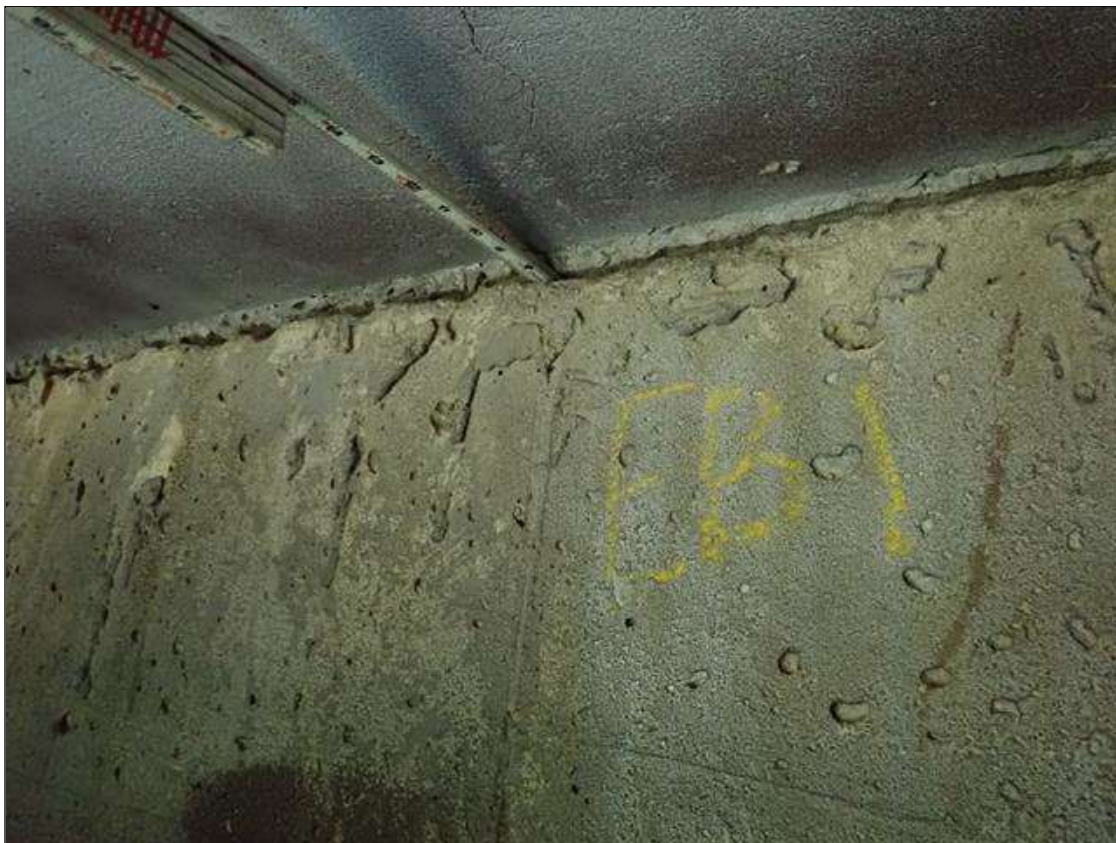
Span 1 Deck: between underside of deck and backwall, gap [up to 3/8in x full length]

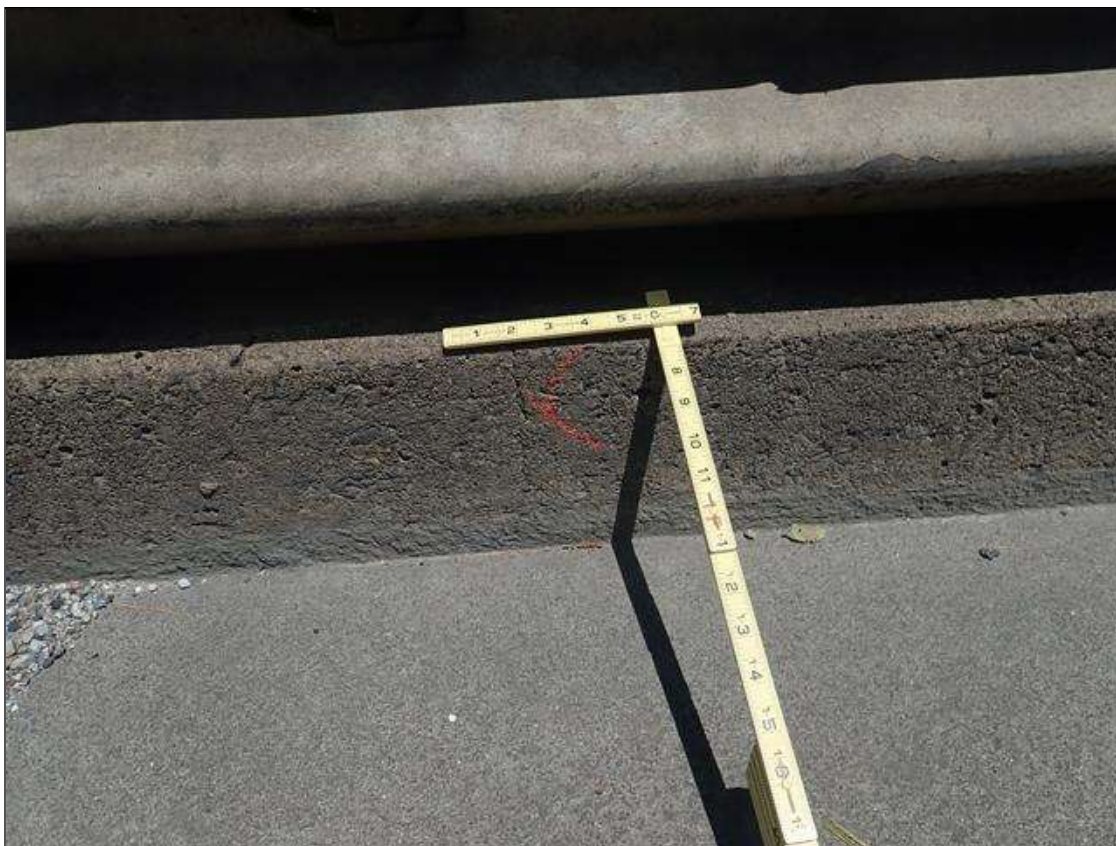
Span 1 Left Bridge Rail: along curb, multiple vertical cracks [full height x up to 0.03in]

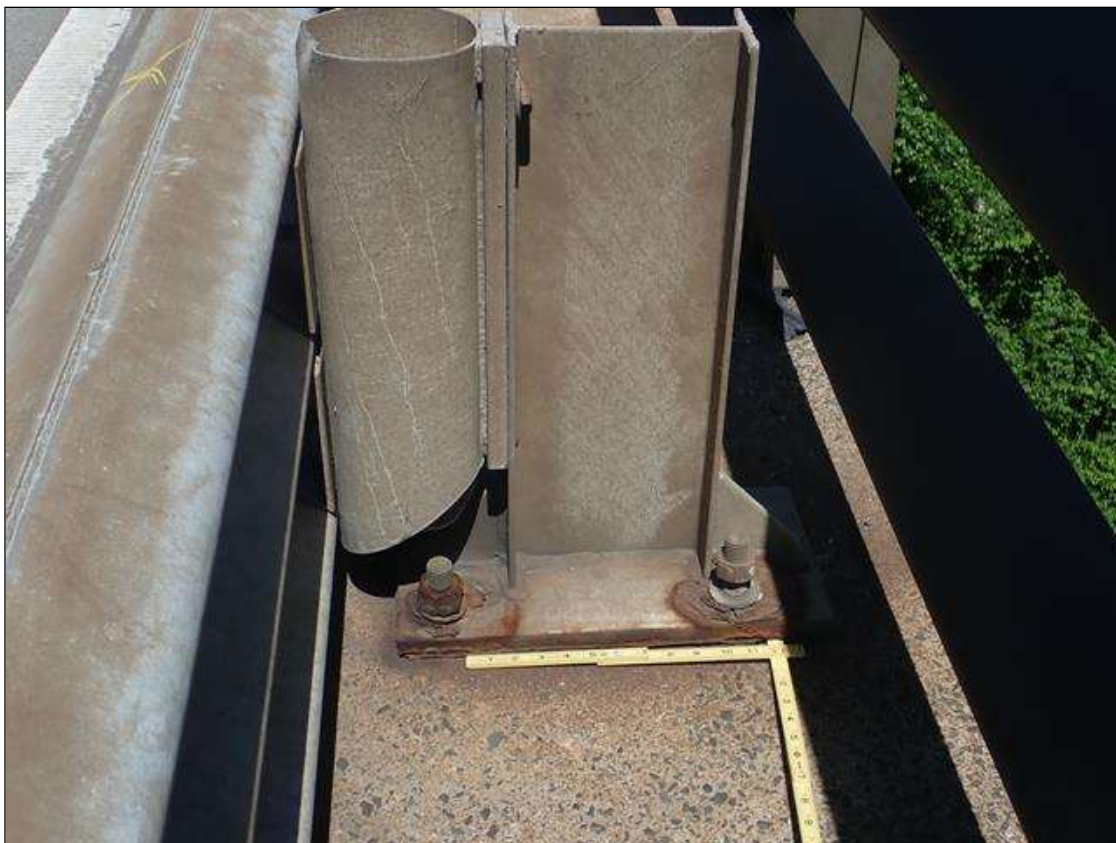
Span 1 Right Bridge Rail: along length of thrie beam at base of posts, active surface corrosion and some with pack rust

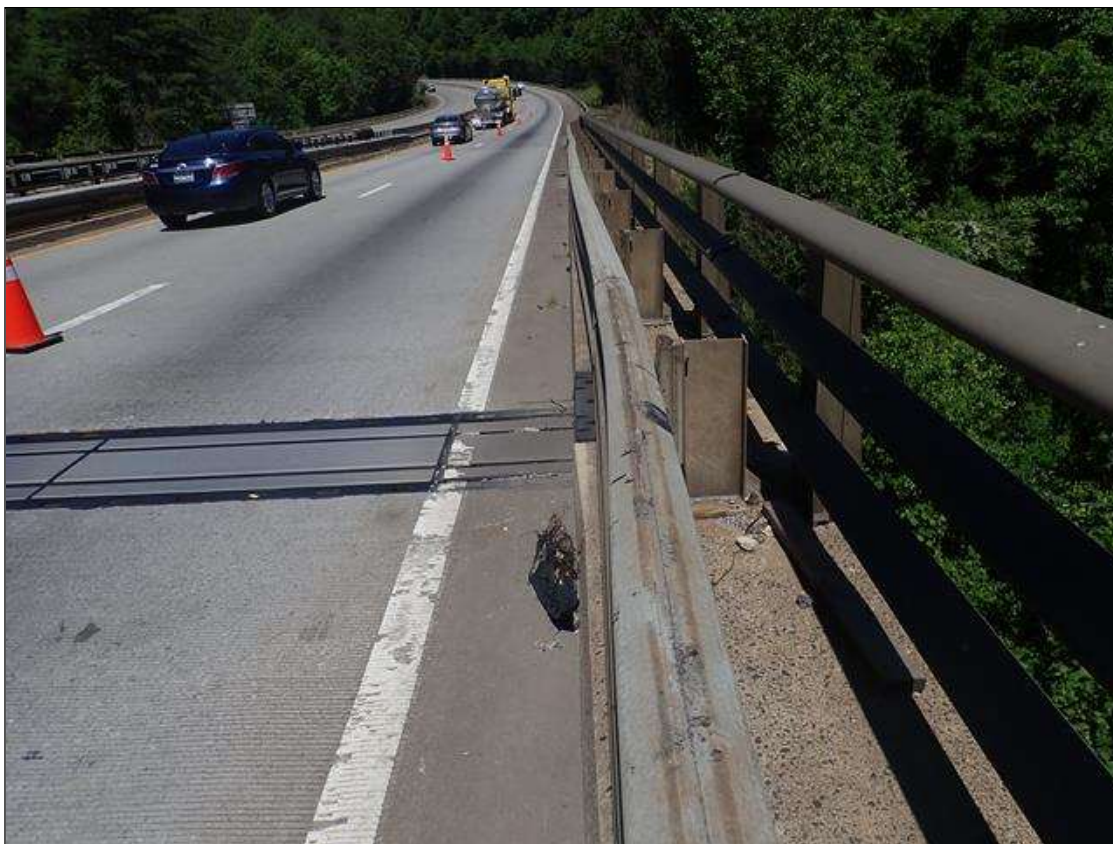
Span 4 Left Bridge Rail: thrie beam at joint 3, impact damage with deflection [45ft x up to 6in deflection]

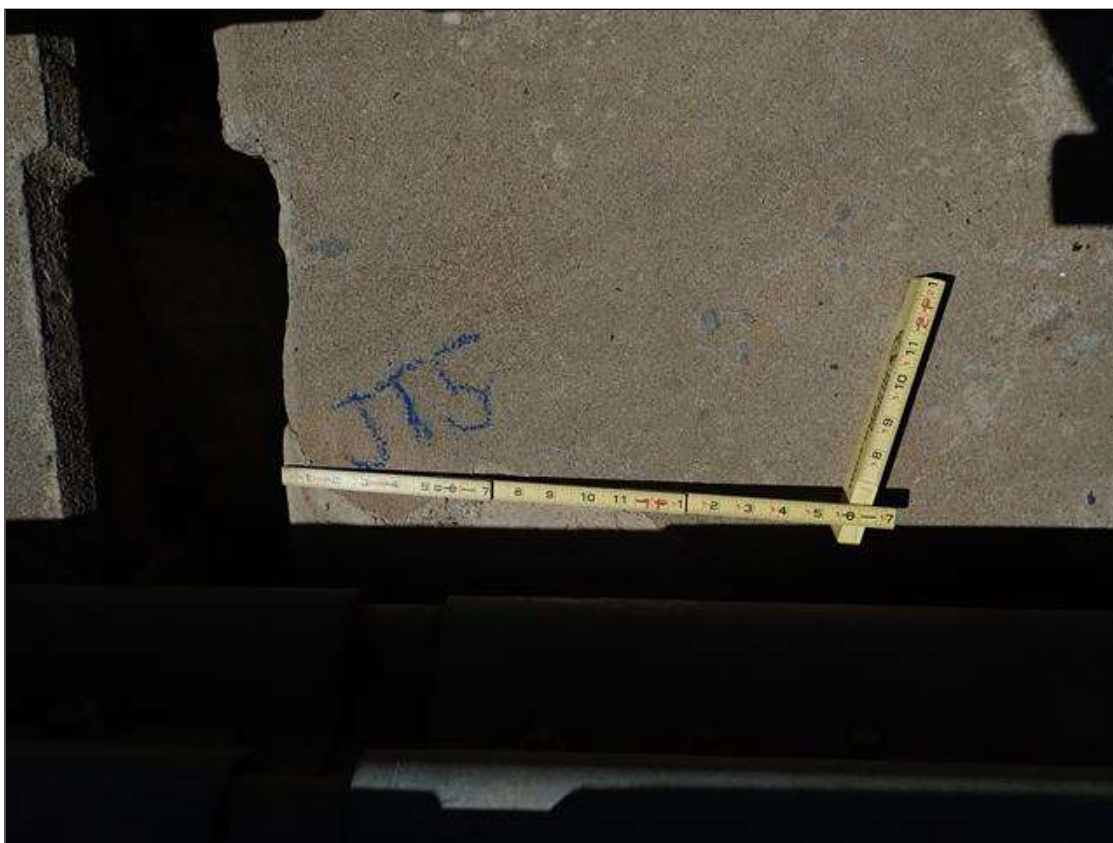
Span 5 Left Bridge Rail: curb adjacent to joint 5, sound patches [up to 14in x up to 12in x up to 9in]

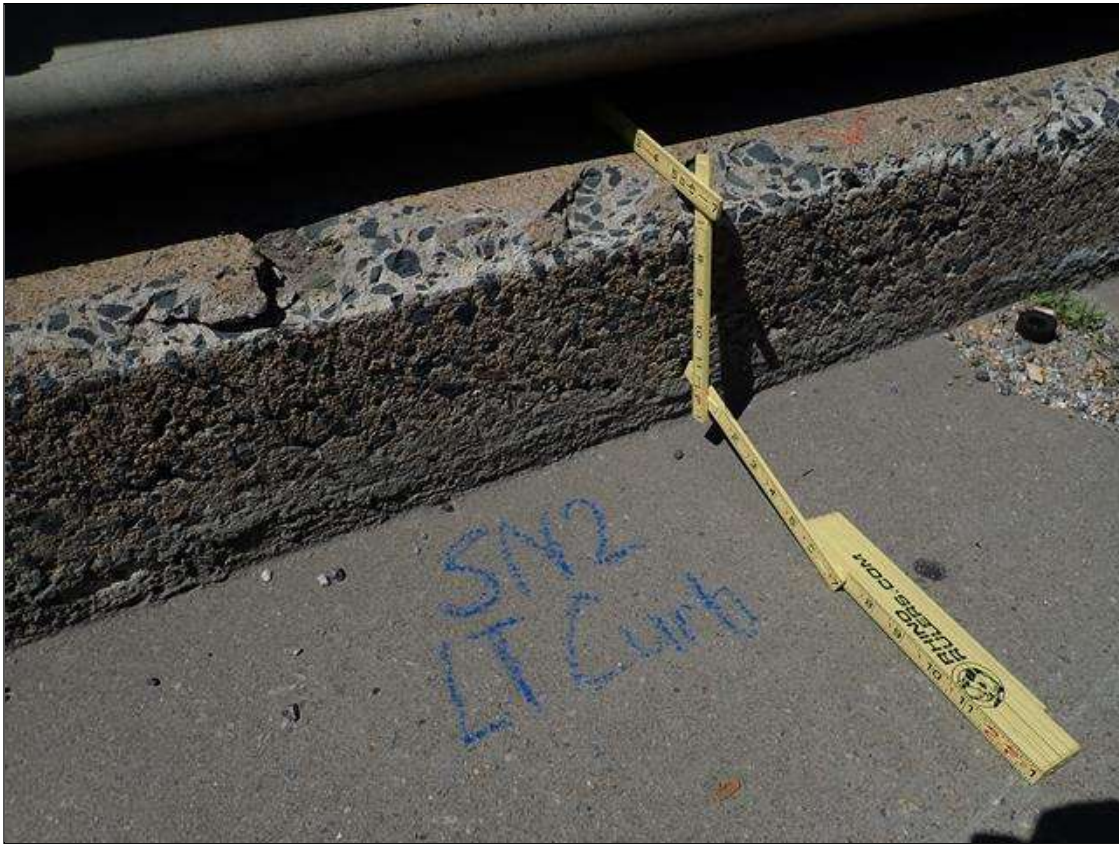
Span 2 Left Bridge Rail: left curb 15ft from joint 5, impact damage [30ft] with spalls [up to 2ft x 5in x 1in deep]

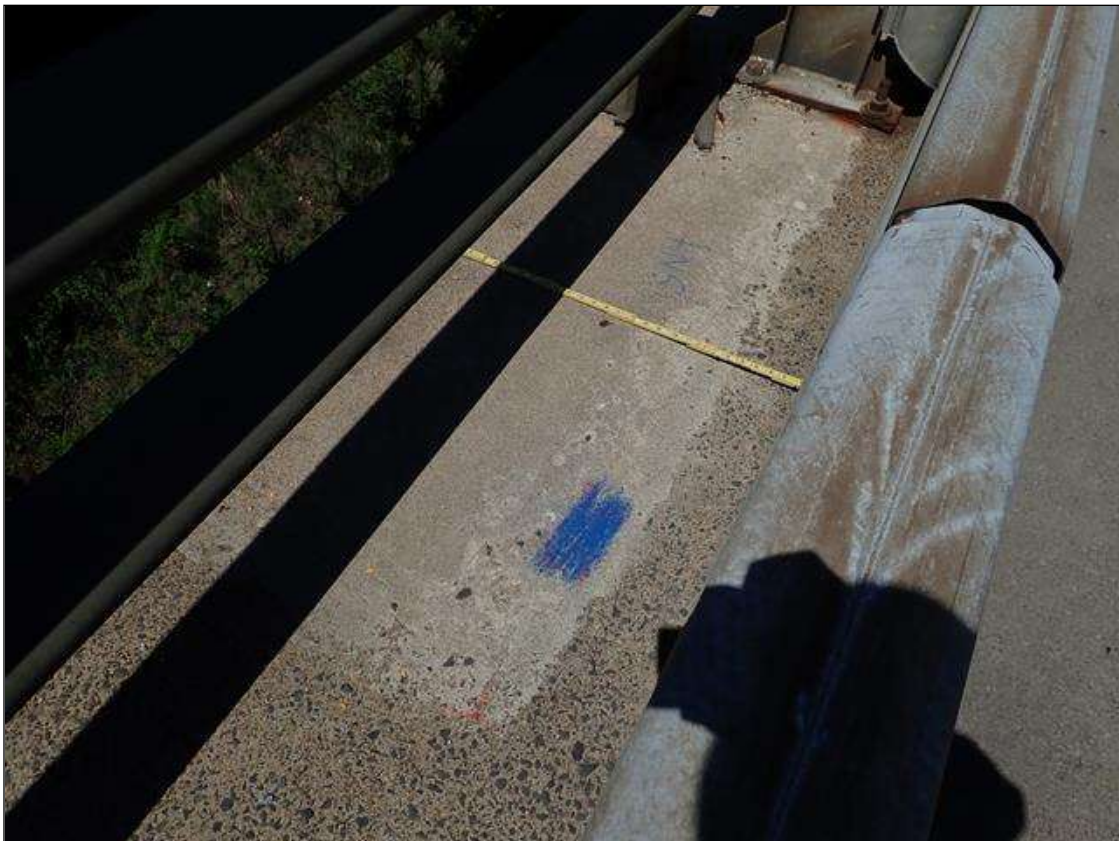
Span 4 Left Bridge Rail: curb at midspan, sound patch [8ft x 2.5in]

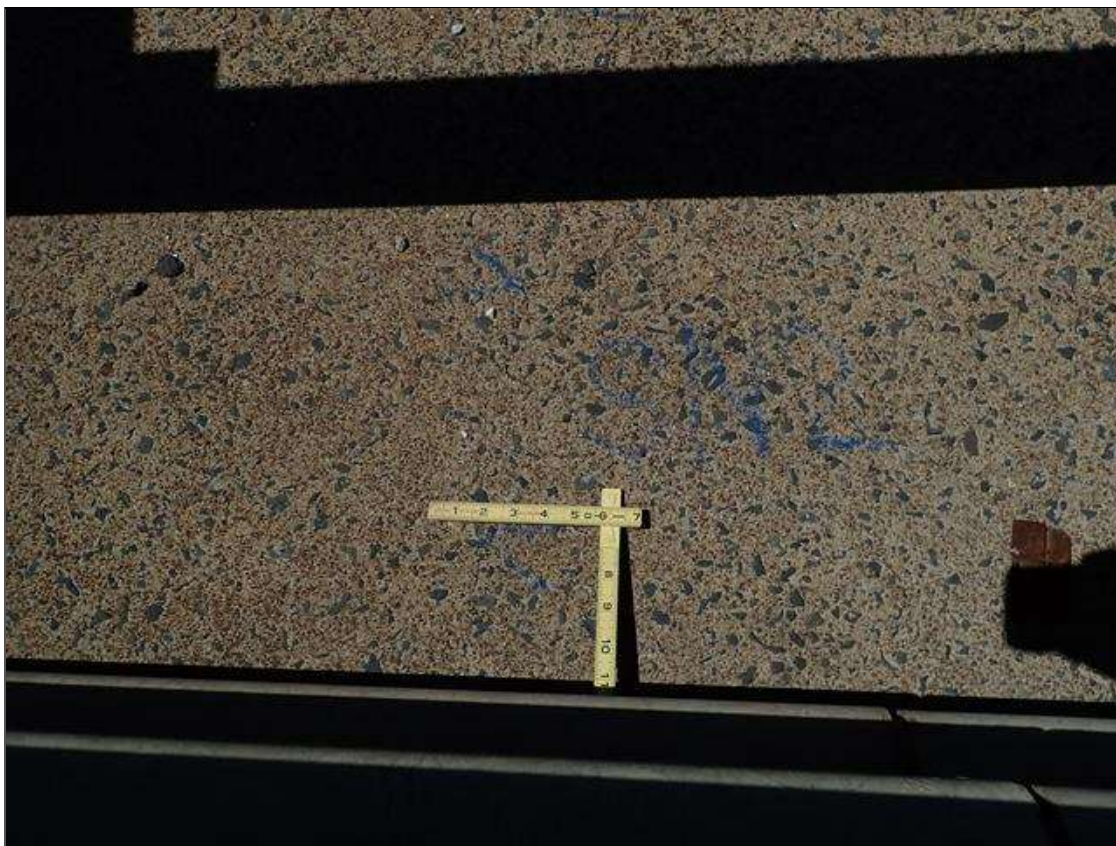
Span 3 Left Bridge Rail: 50ft from bent 3 at curb, transverse crack [full width x 0.012in]

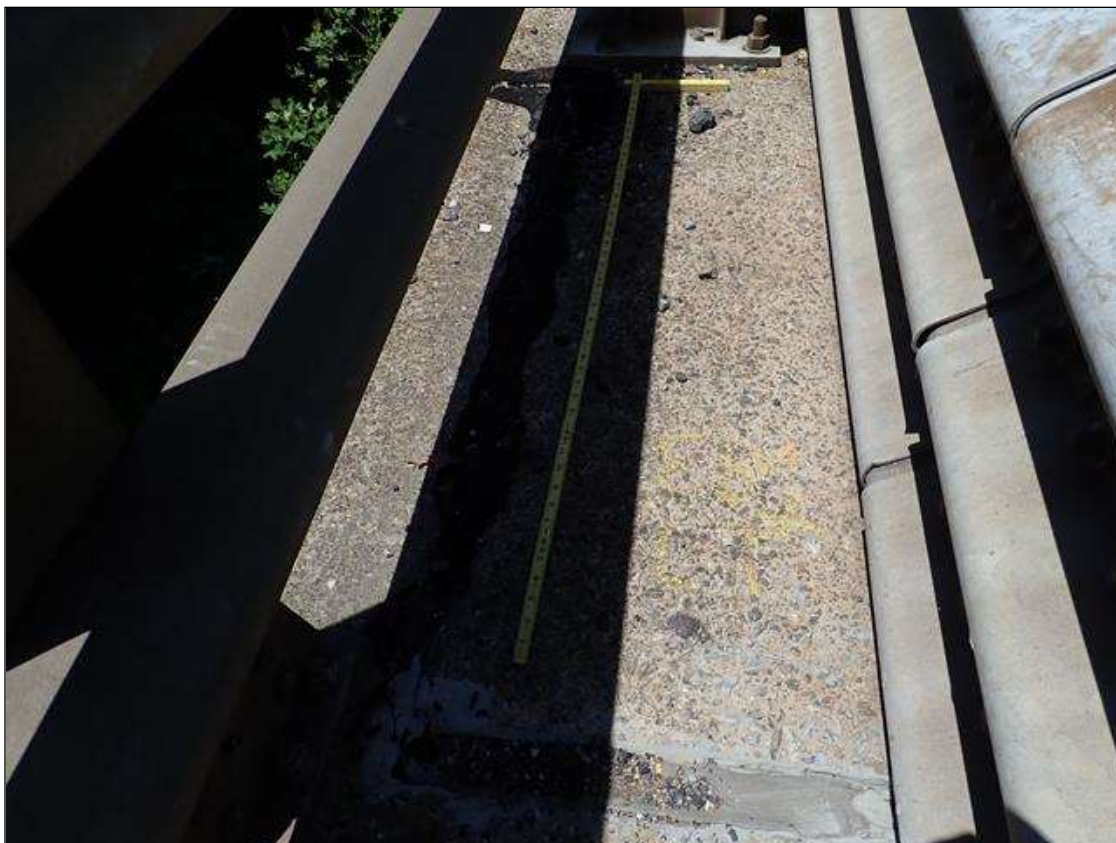
Span 1 Left Bridge Rail: over end bent along joint between wingwall and curb, loss of seal adhesion [up to 4ft] similar at all corners

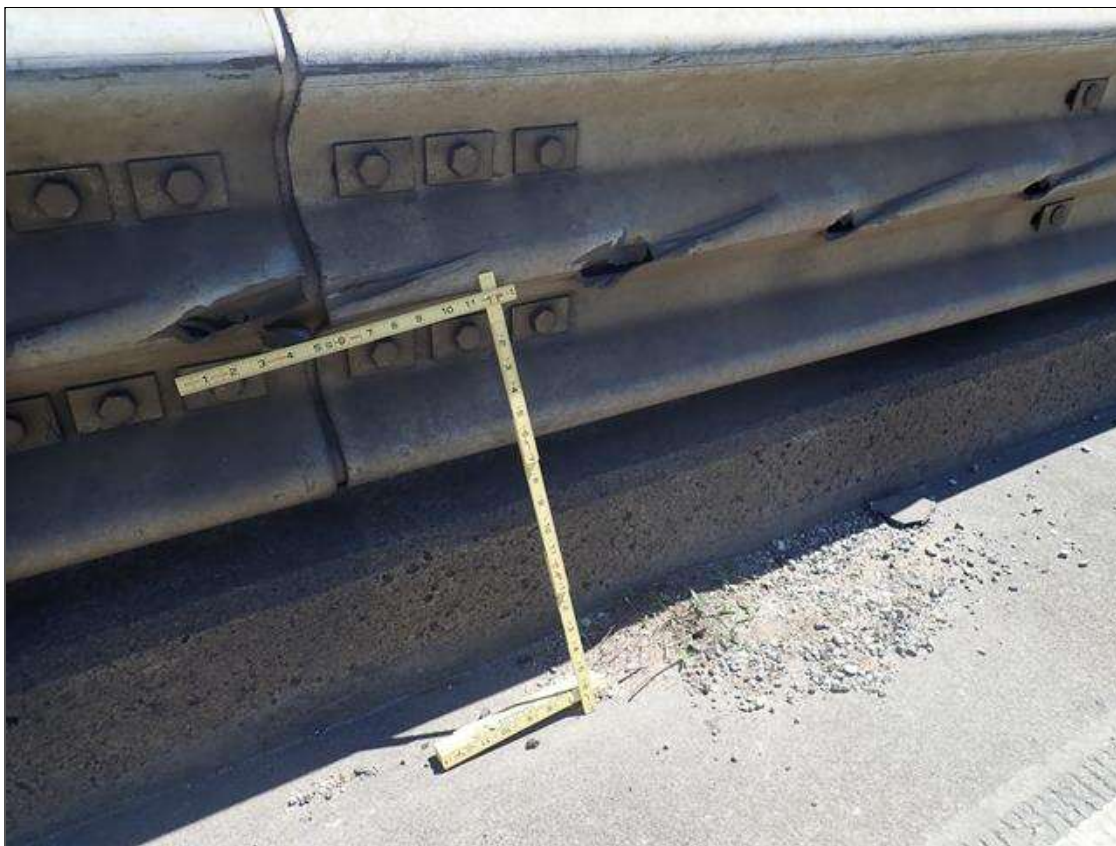
Span 1 Left Bridge Rail: along length of thrie beam, impact damage [full length] with gouges and rips

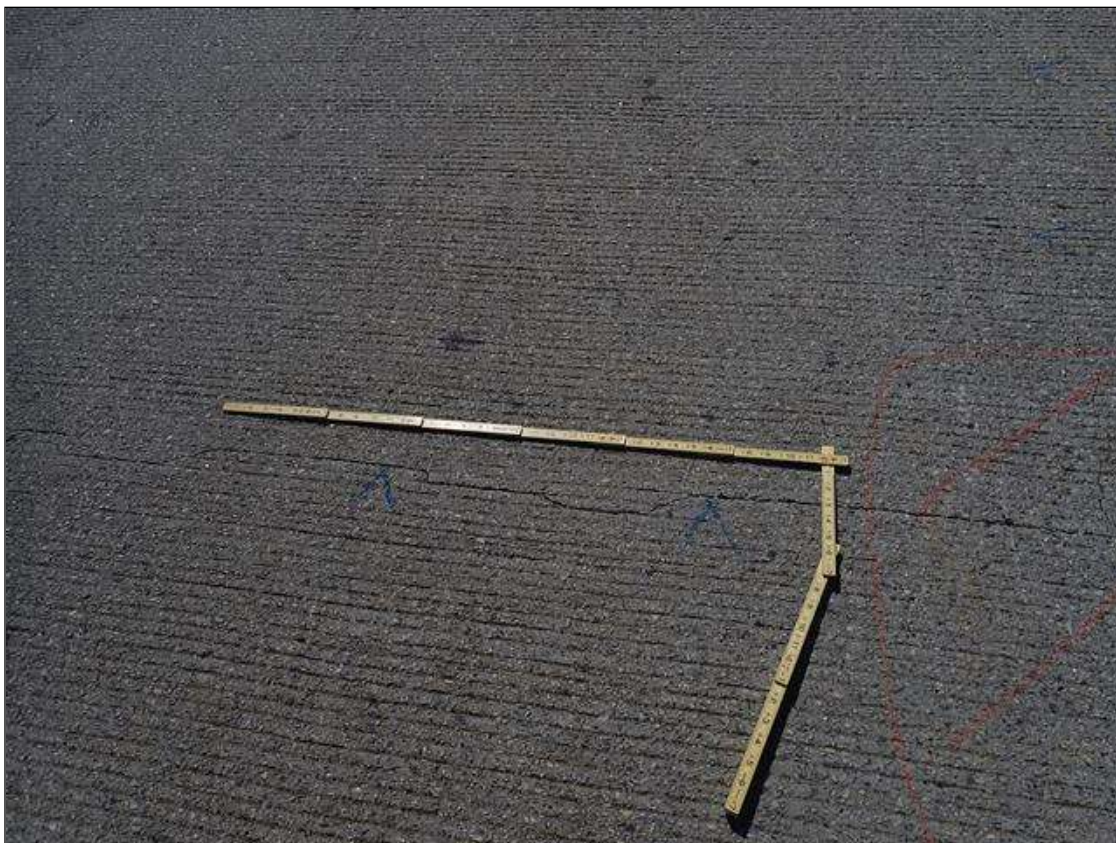
Span 2 Deck: throughout span, multiple transverse cracks [up to full width x 1/16in]

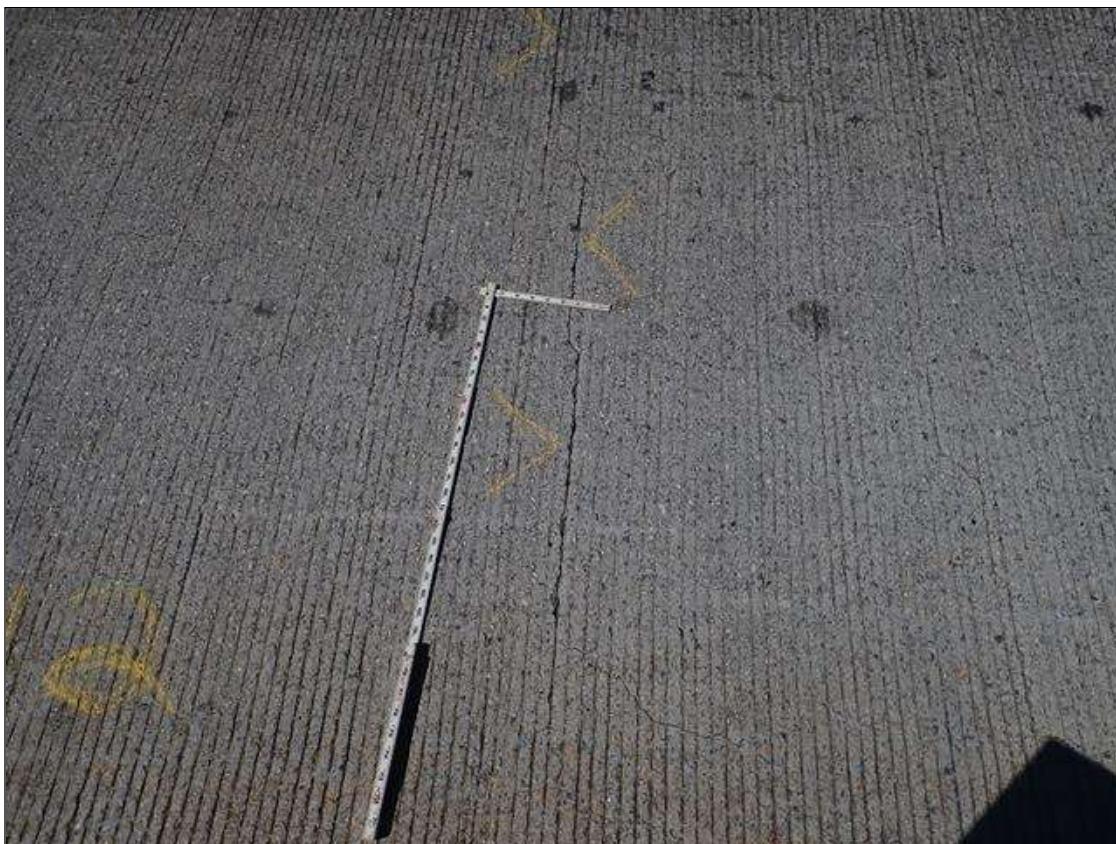
Span 2 Deck: throughout span, multiple transverse cracks [up to full width x 1/16in]

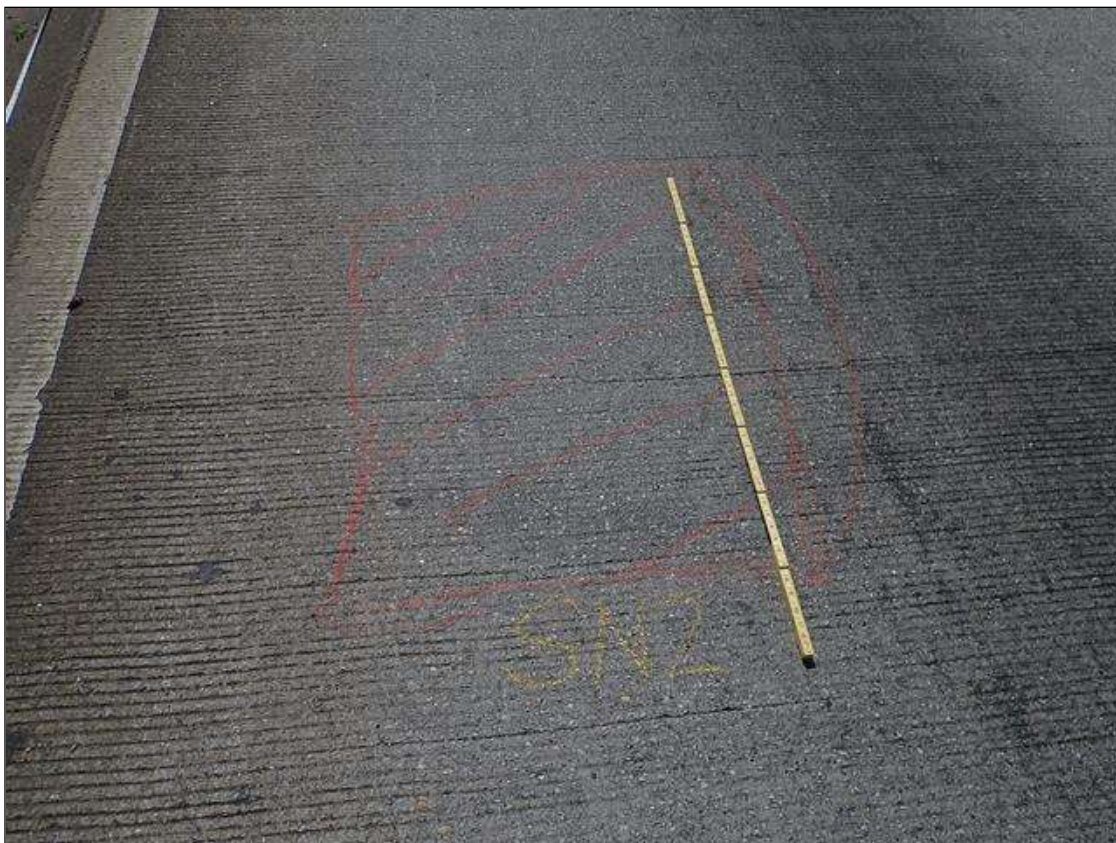
Span 2 Deck: throughout span at random locations, multiple delaminations [up to 7ft x 4ft]

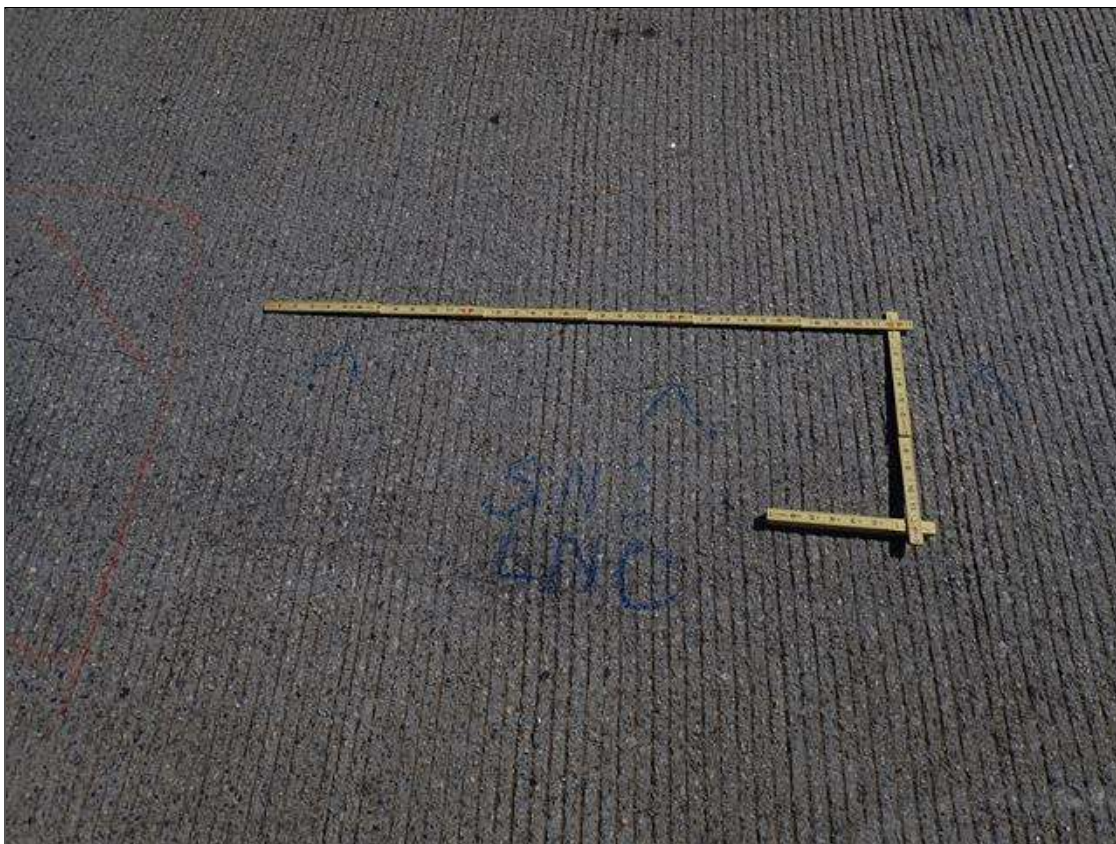
Span 2 Deck: throughout span, multiple longitudinal cracks [up to 30ft x 0.03in]

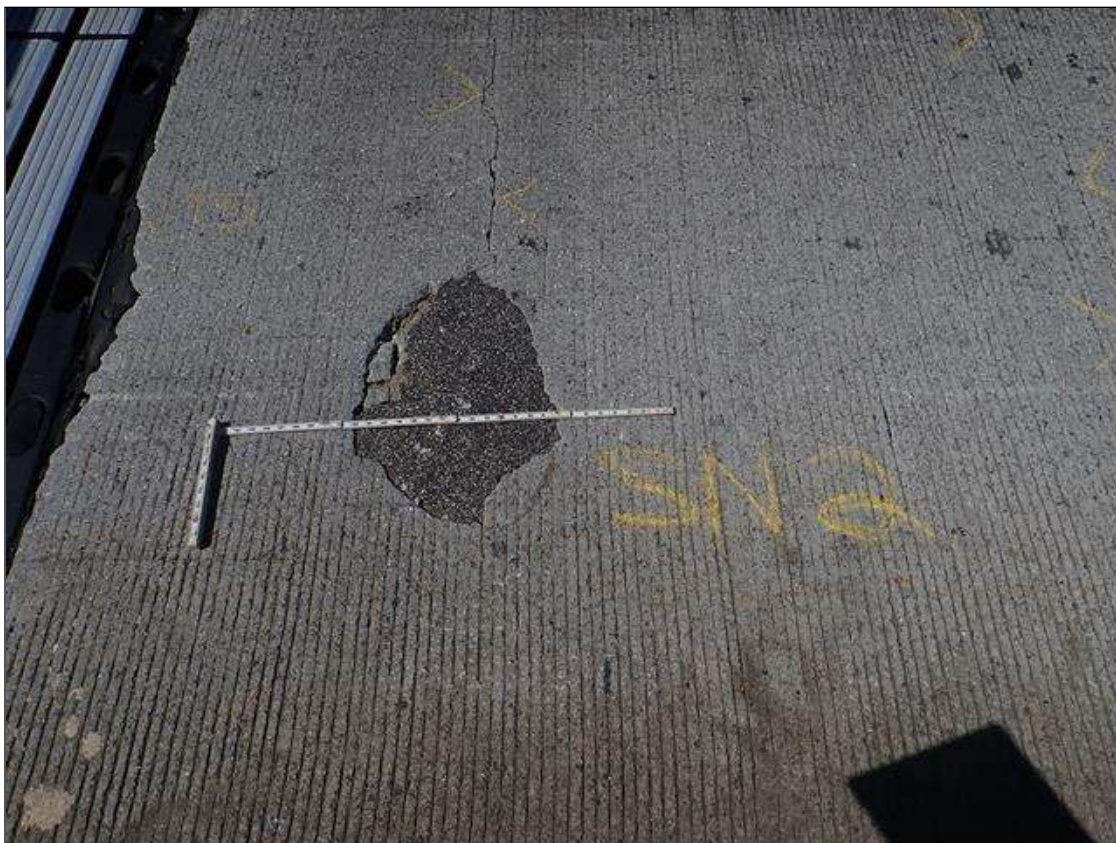
Span 2 Deck: right travel lane 3ft from joint 2, patch [14in x 20in] with edge spalling [up to 12in x 3in x 1in deep]

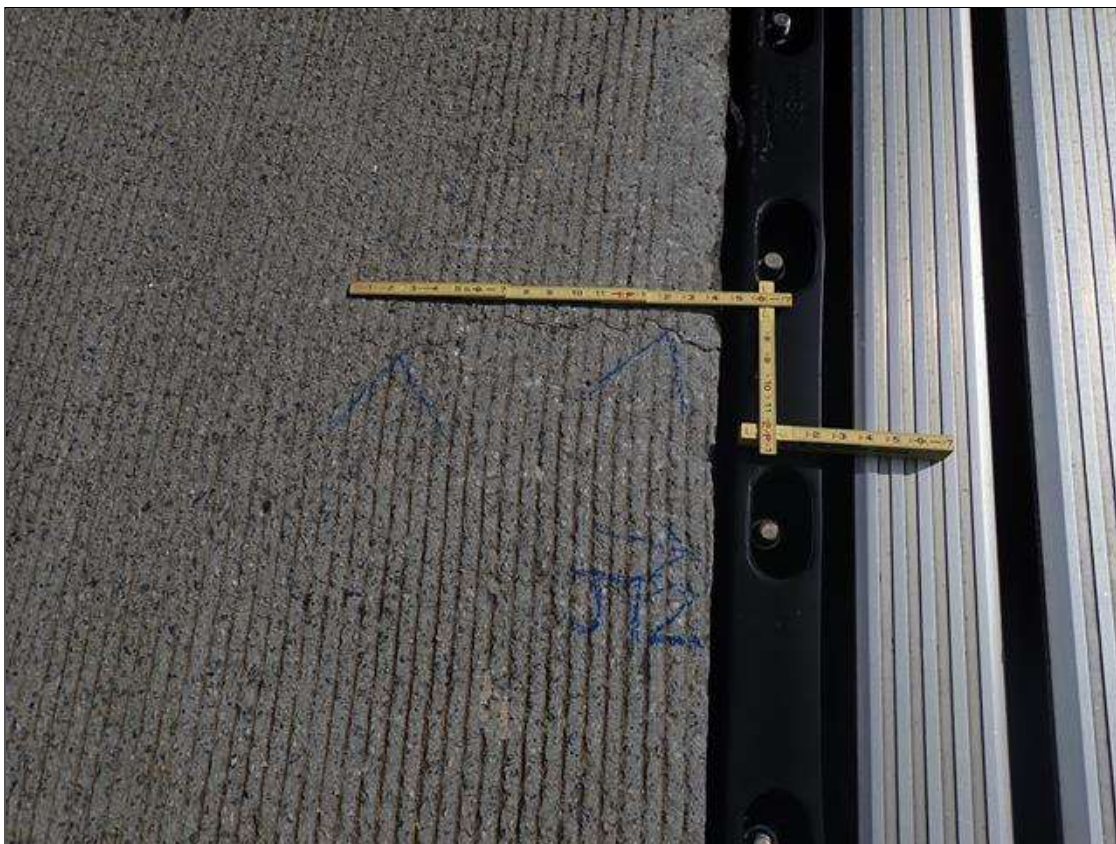
Span 2 Deck: left travel lane in right wheel path extending from joint 2, longitudinal crack [14in x 0.05in], extends down into joint

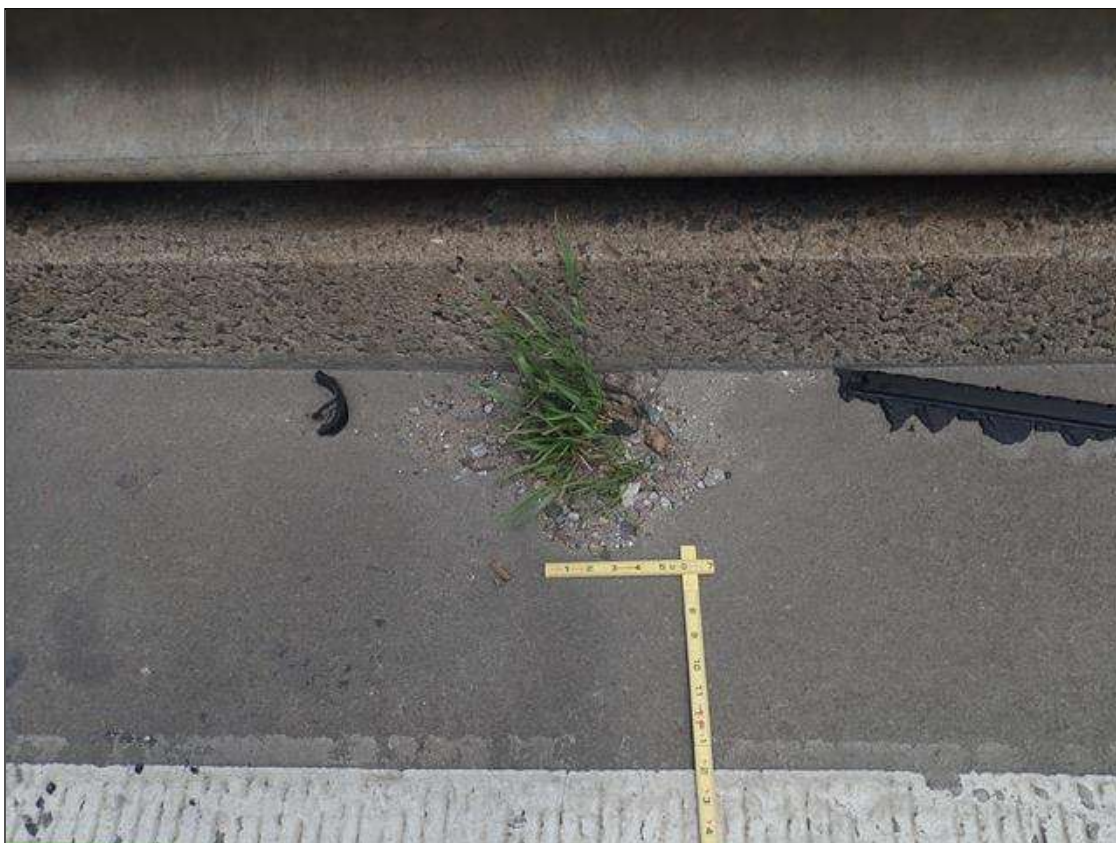
Drainage System: along length of structure, debris accumulation fully blocking drains

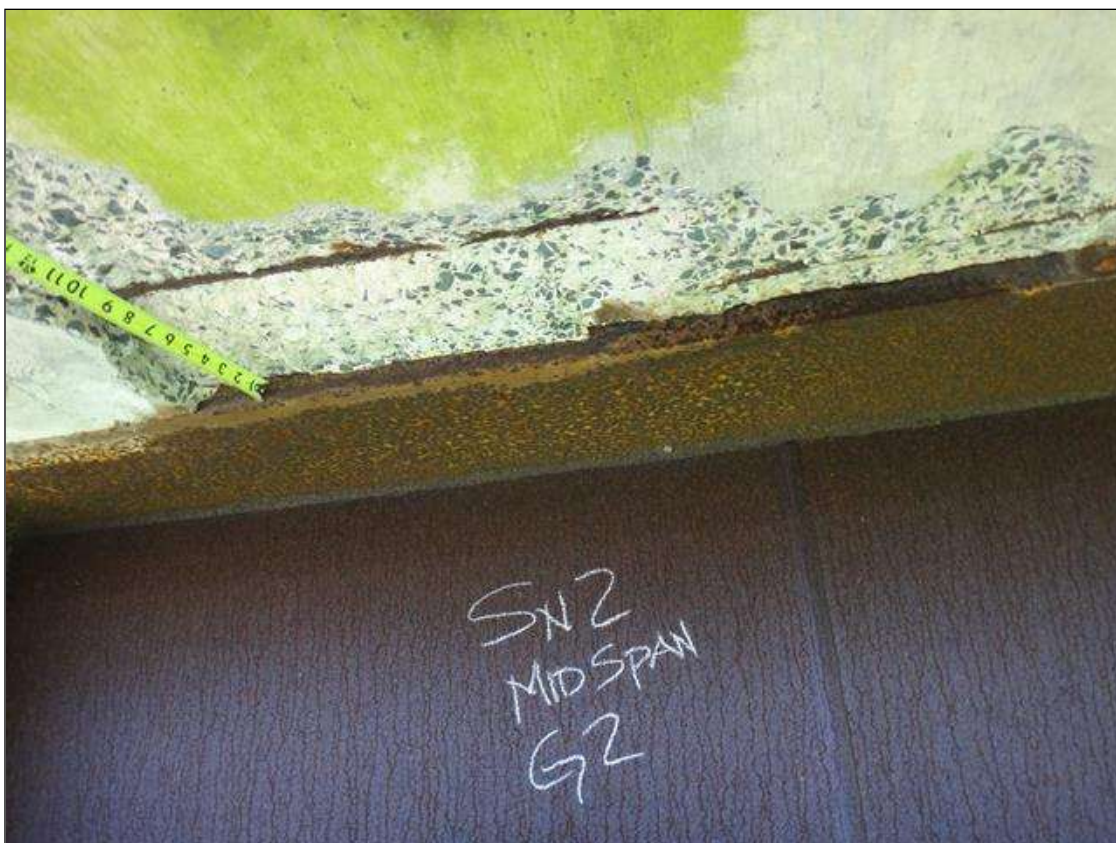
Span 2 Deck: underside West overhang at midspan, spall [45in x 18in x 1-1/2in deep] with exposed rusted rebar

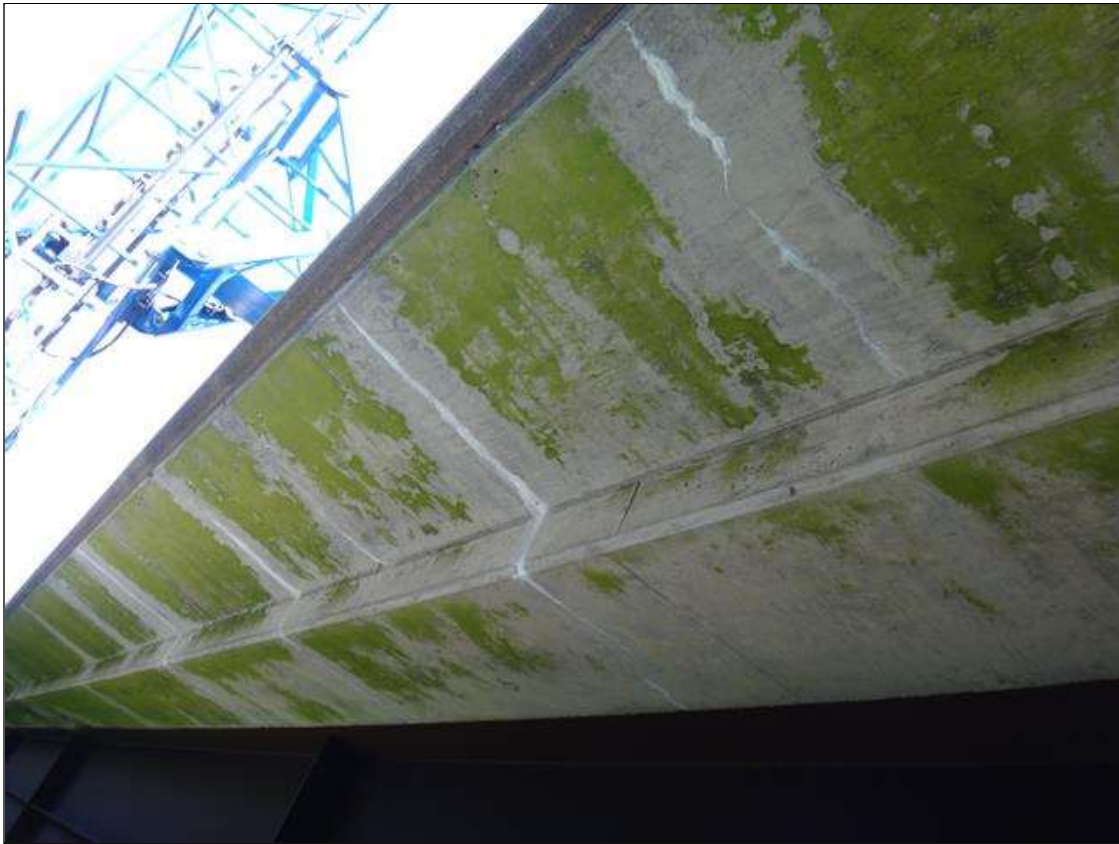
Span 2 Deck: underside East overhang scattered throughout, multiple transverse cracks [full width x hairline] with efflorescence, West overhang similar

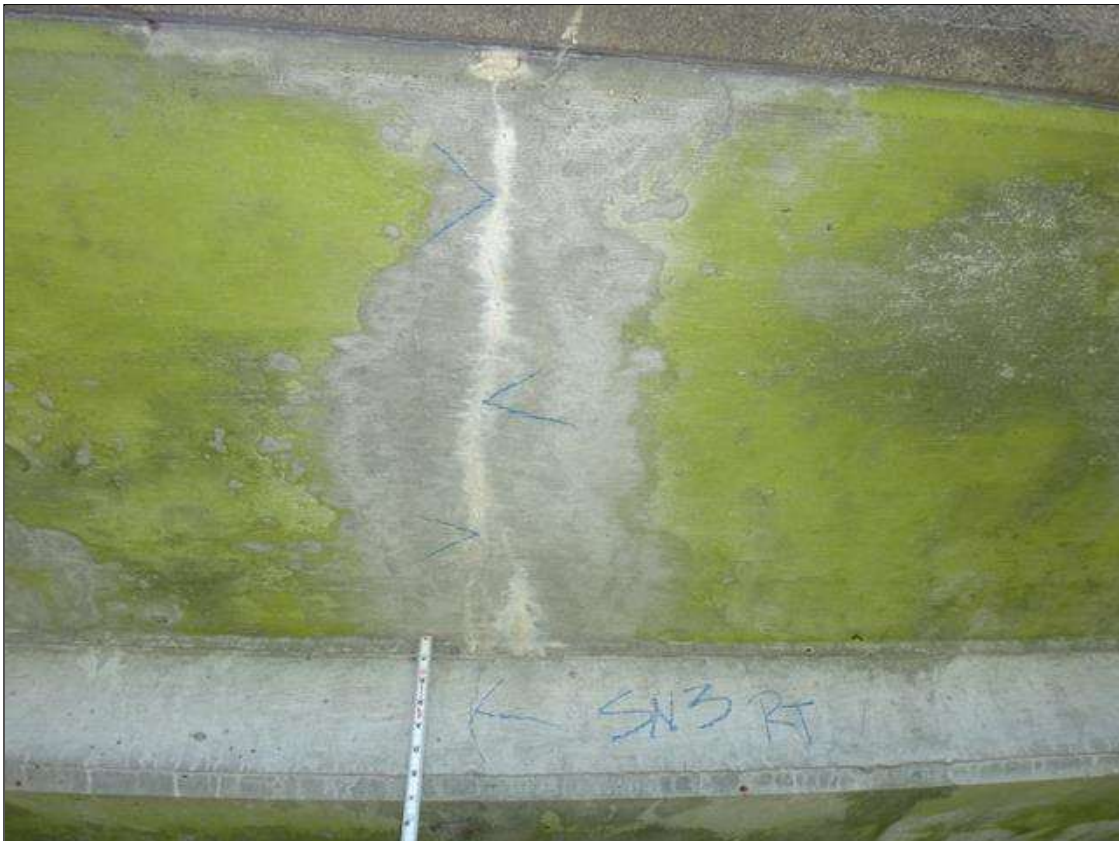
Span 2 Deck: underside East overhang scattered throughout, multiple transverse cracks [full width x hairline] with efflorescence, West overhang similar

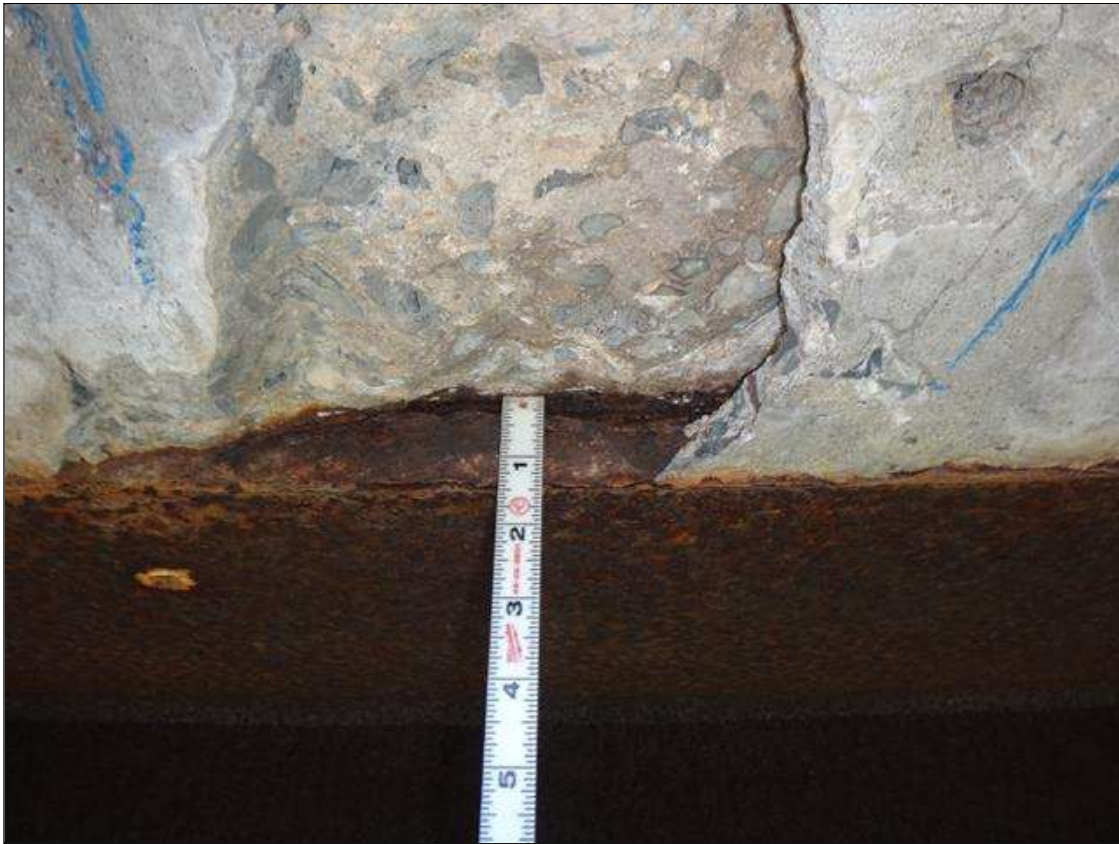
Span 3 Deck: underside left overhang at web stiffener 21, spall/delamination [7ft-10in x 13in x 1-1/4in deep] with pack rust between top flange and deck [1/4in]
