NC DEPARTMENT OF TRANSPORTATION  
 DIVISION OF HIGHWAYS  
 STRUCTURE MANAGEMENT UNIT

ATTENTION: **FRACTURE CRITICAL**, Priority Action Request, Changes to Structure Data; inspected South to North - I26 runs West to East

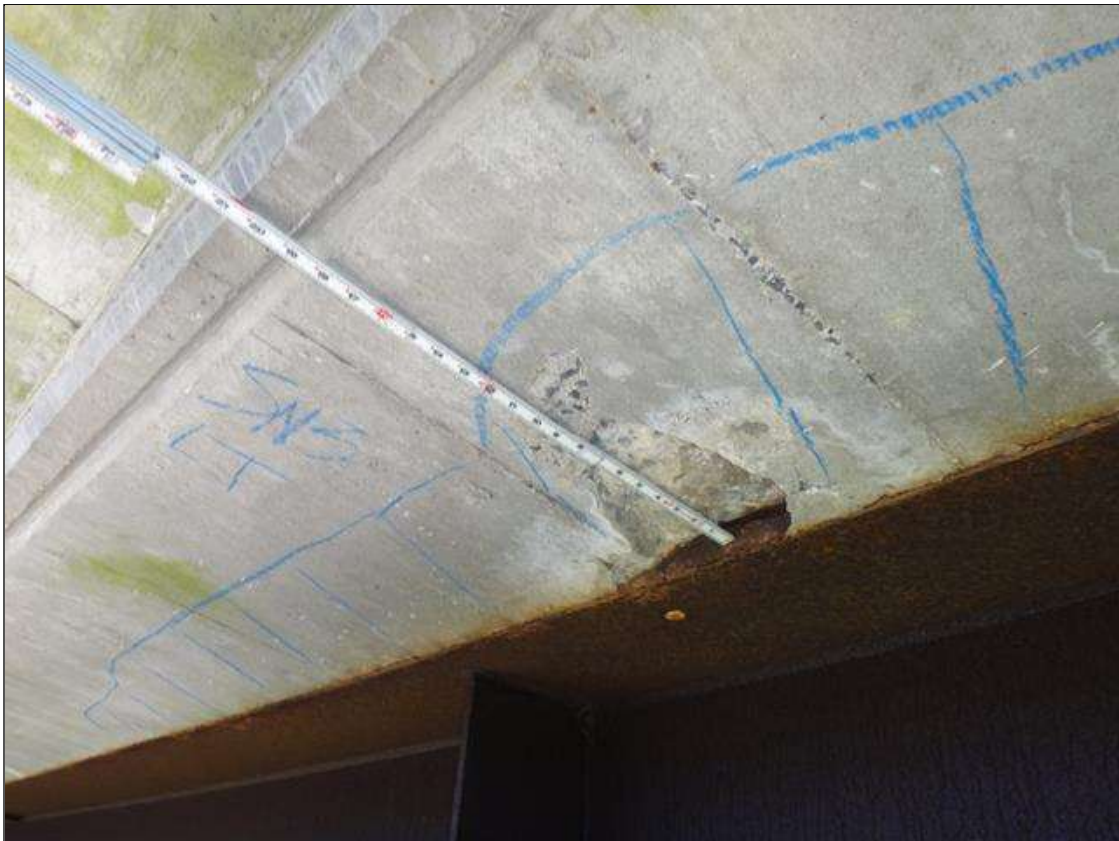
Span 3 Deck: underside left overhang at web stiffener 21, spall/delamination [7ft-10in x 13in x 1-1/4in deep] with pack rust between top flange and deck [1/4in]

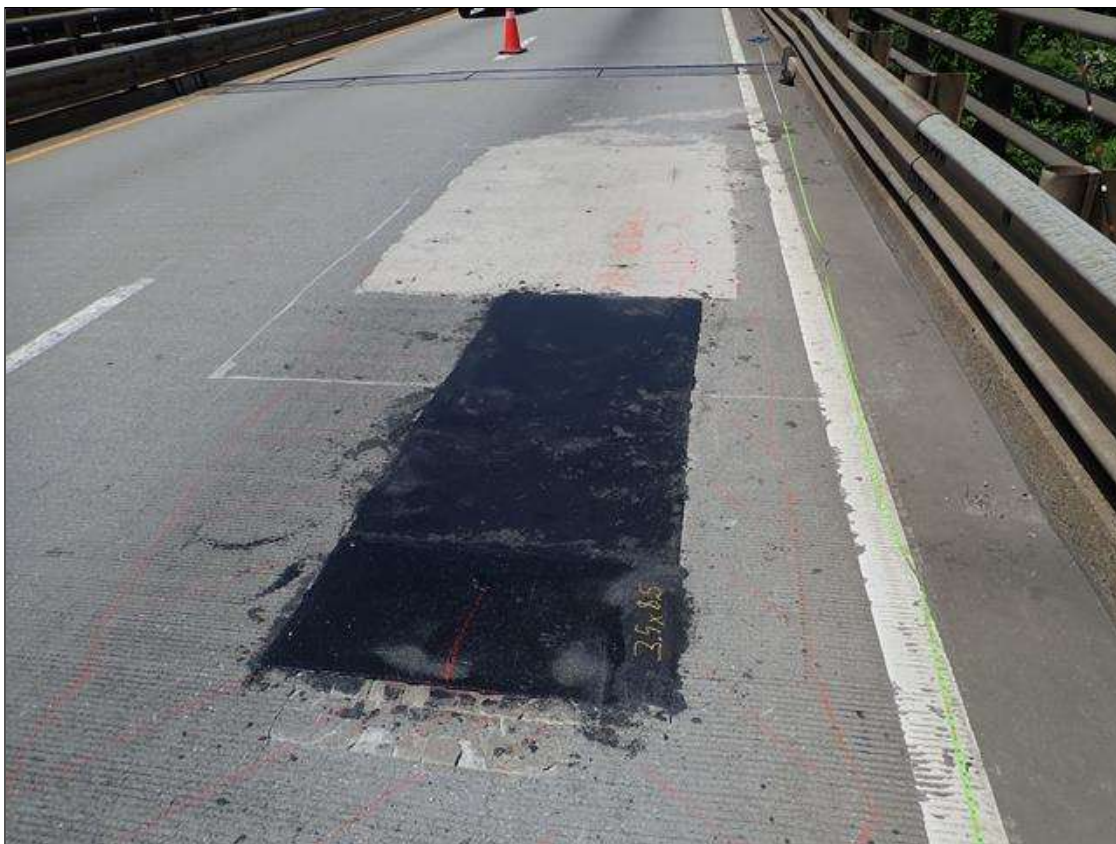
Span 4 Deck: right travel lane at far end, multiple sound patches/repairs [up to 7ft x 12ft]

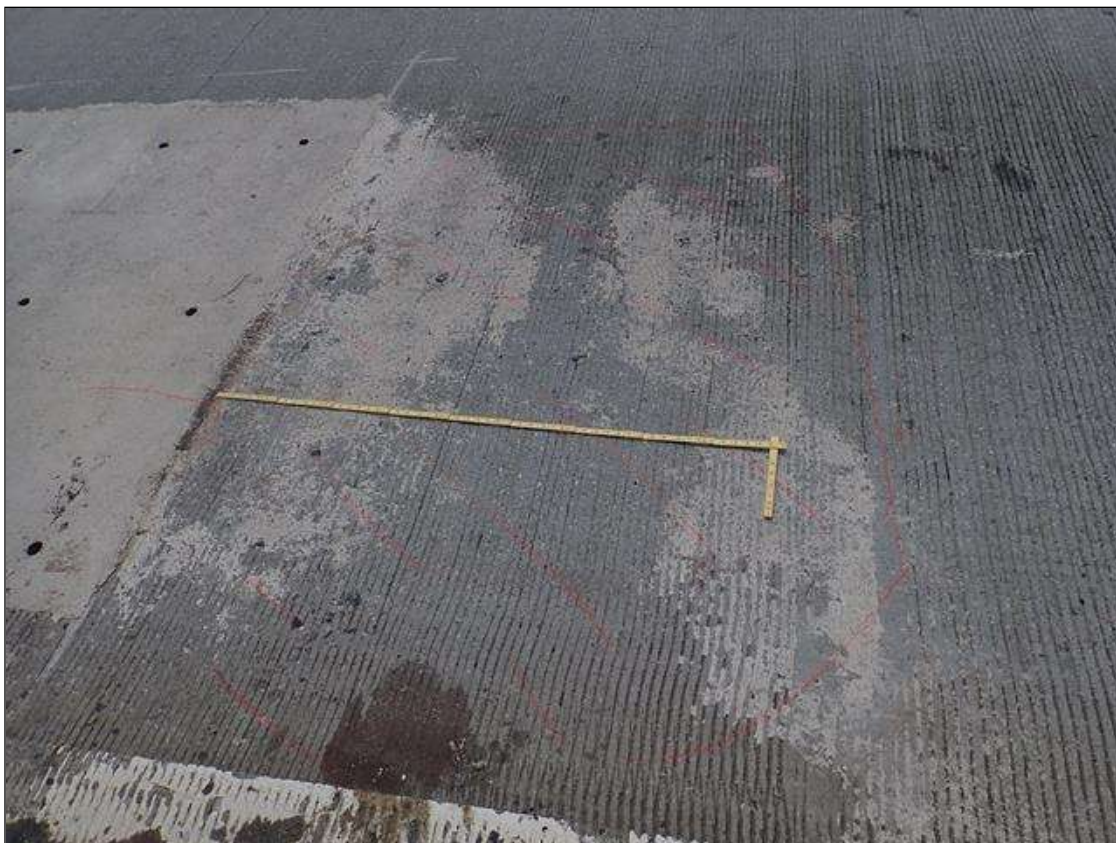
Span 4 Deck: adjacent to repairs at far end, multiple delaminations [up to 5.5ft x 7ft]

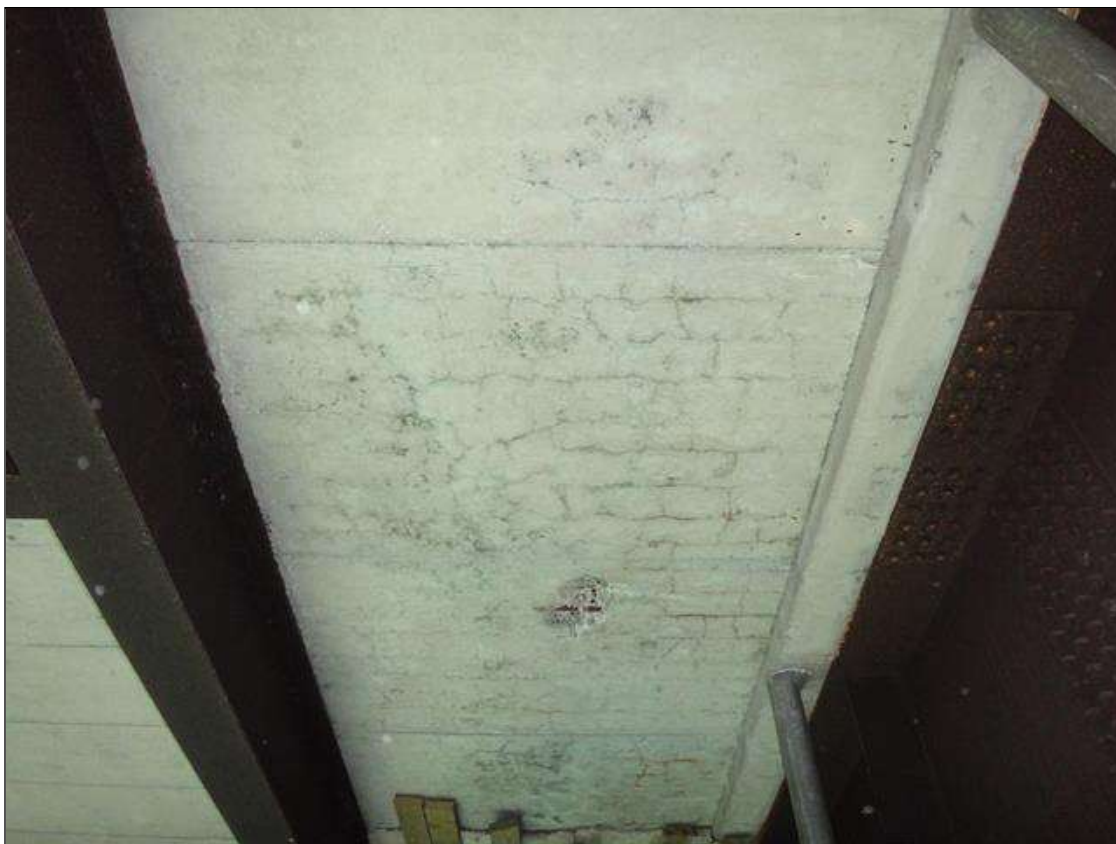
Span 4 Deck: underside of deck at far end, multiple transverse and longitudinal cracks [up to 8ft x 0.03in] with efflorescence and rust stain

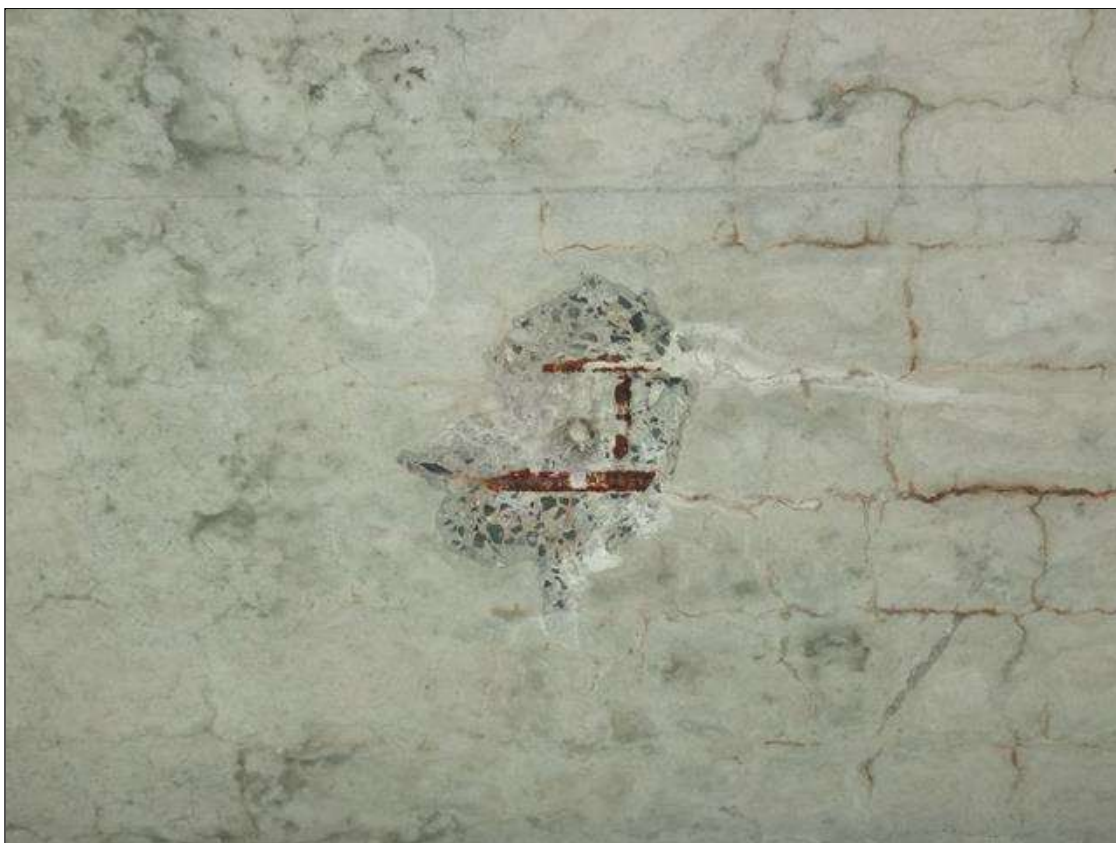
Span 4 Deck: [PAR] underside of deck at far end, spall [12in x 12in x 3in deep] with exposed transverse and longitudinal rebar [loss < 1/16in]

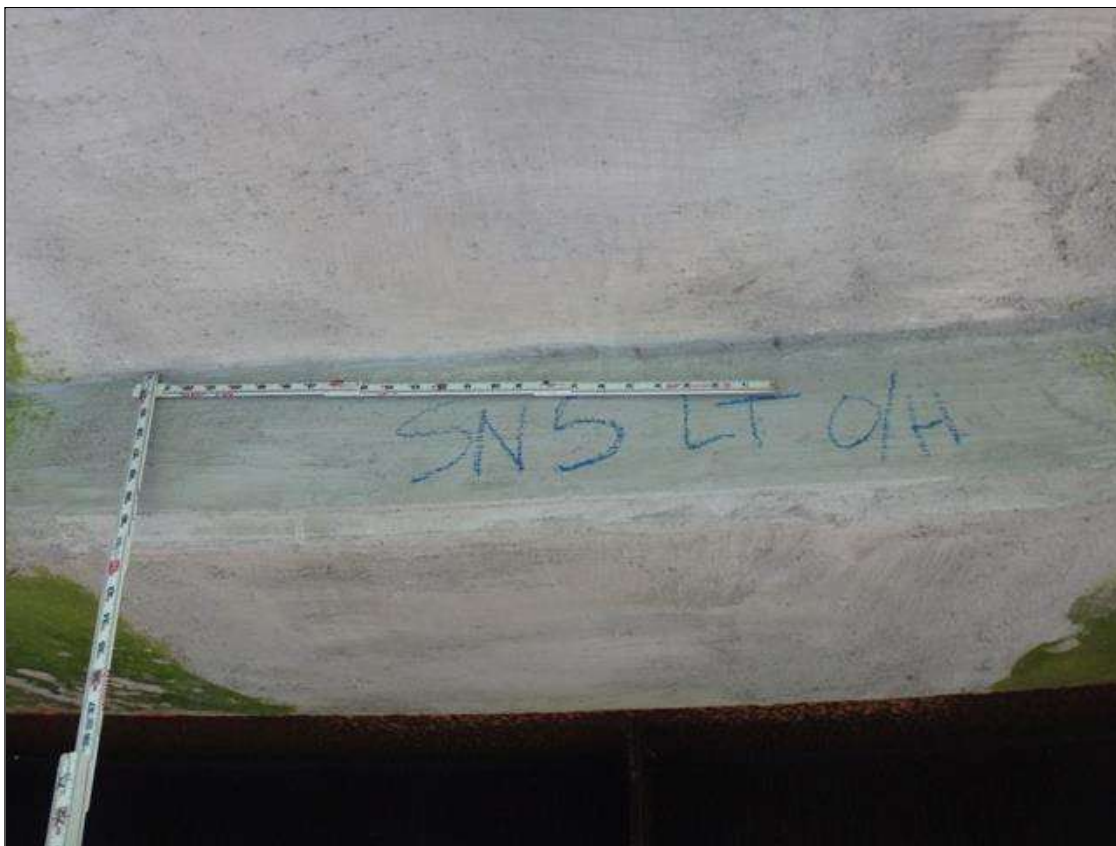
Span 5 Deck: underside West overhang at midspan, sound patch [43in x full width]

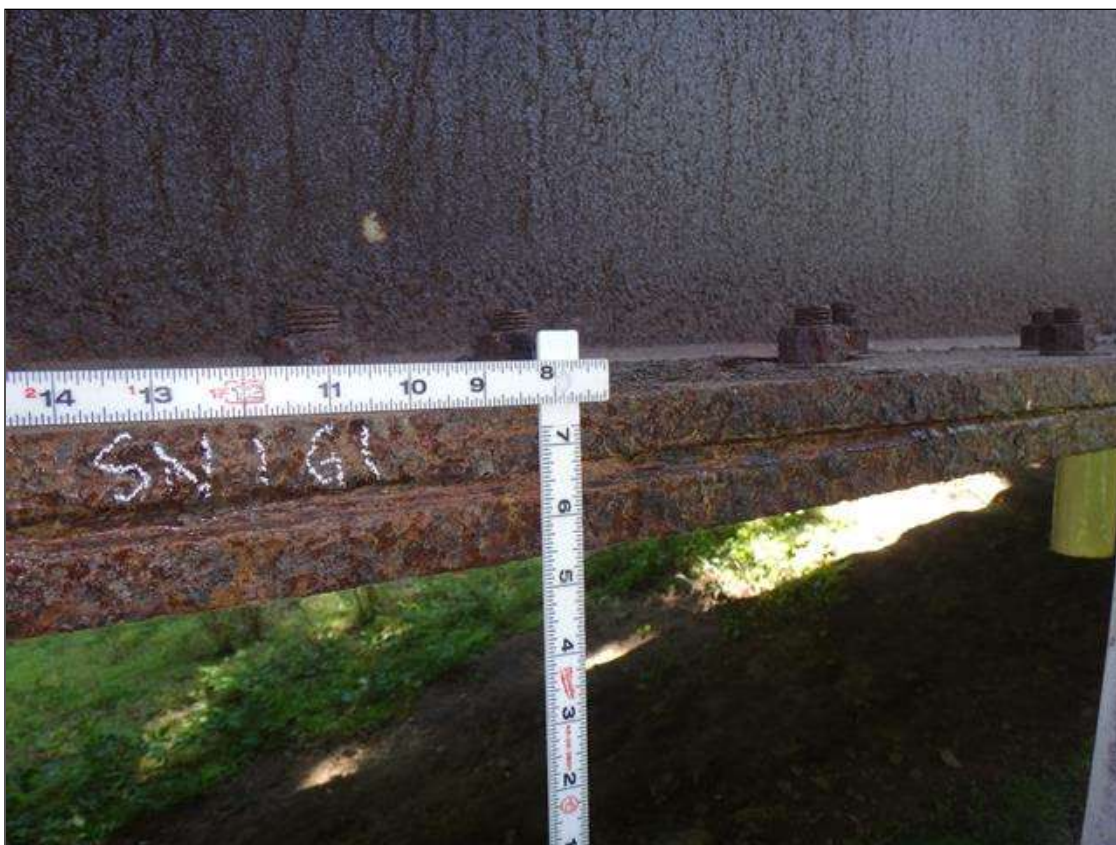
Span 1 Beam 1: along length of bottom flange and cover plate, pack rust [up to 7/16in]

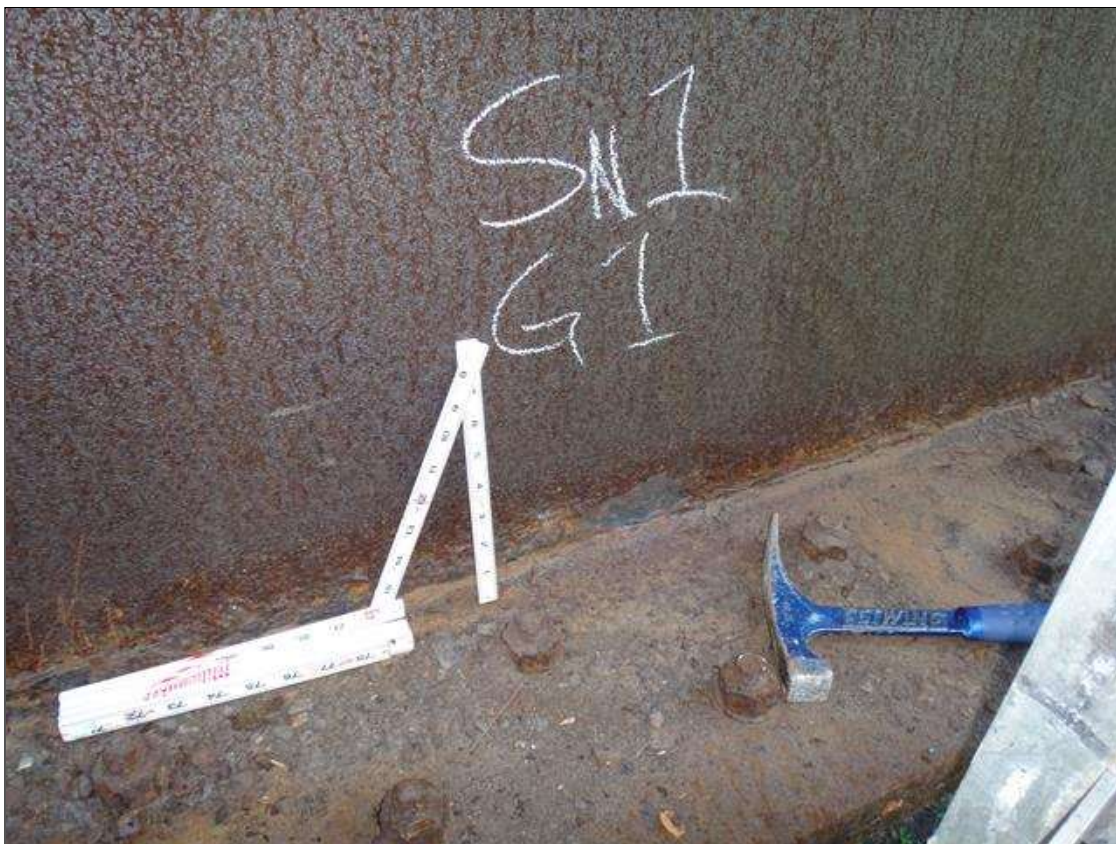
Span 1 Beam 1: along length of exterior face at lower web and web stiffener, active corrosion with section loss [up to 3in high x 1/16in loss]

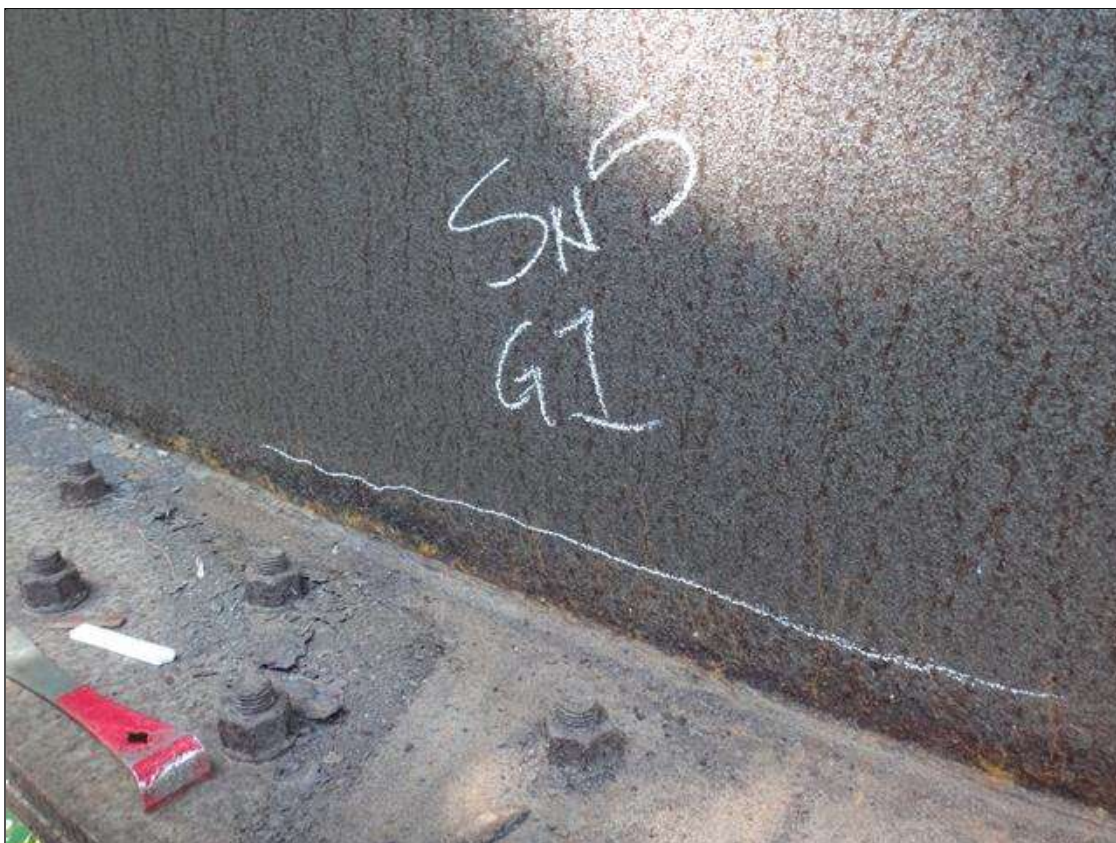
Span 1 Beam 2: lower web along length of exterior face, active corrosion with section loss [85ft x up to 2-1/2in x up to 3/32in deep]

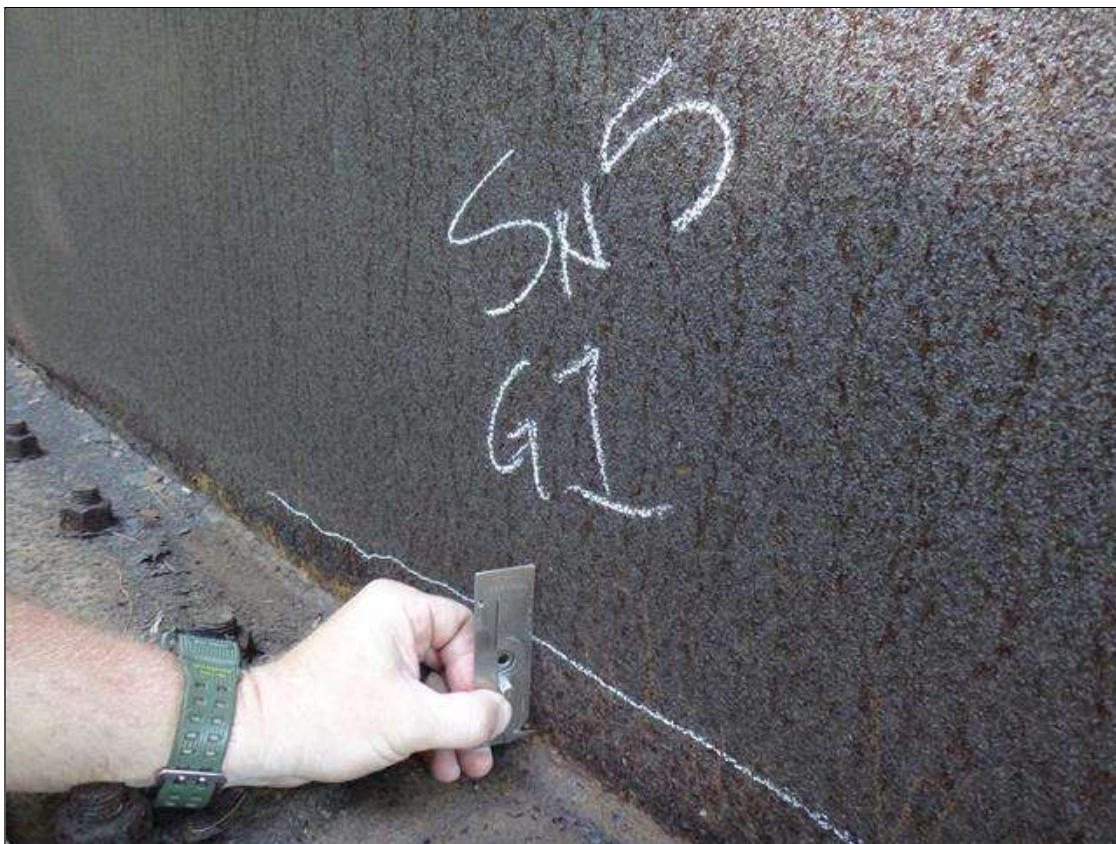
Span 1 Beam 2: lower web along length of exterior face, active corrosion with section loss [85ft x up to 2-1/2in x up to 3/32in deep]

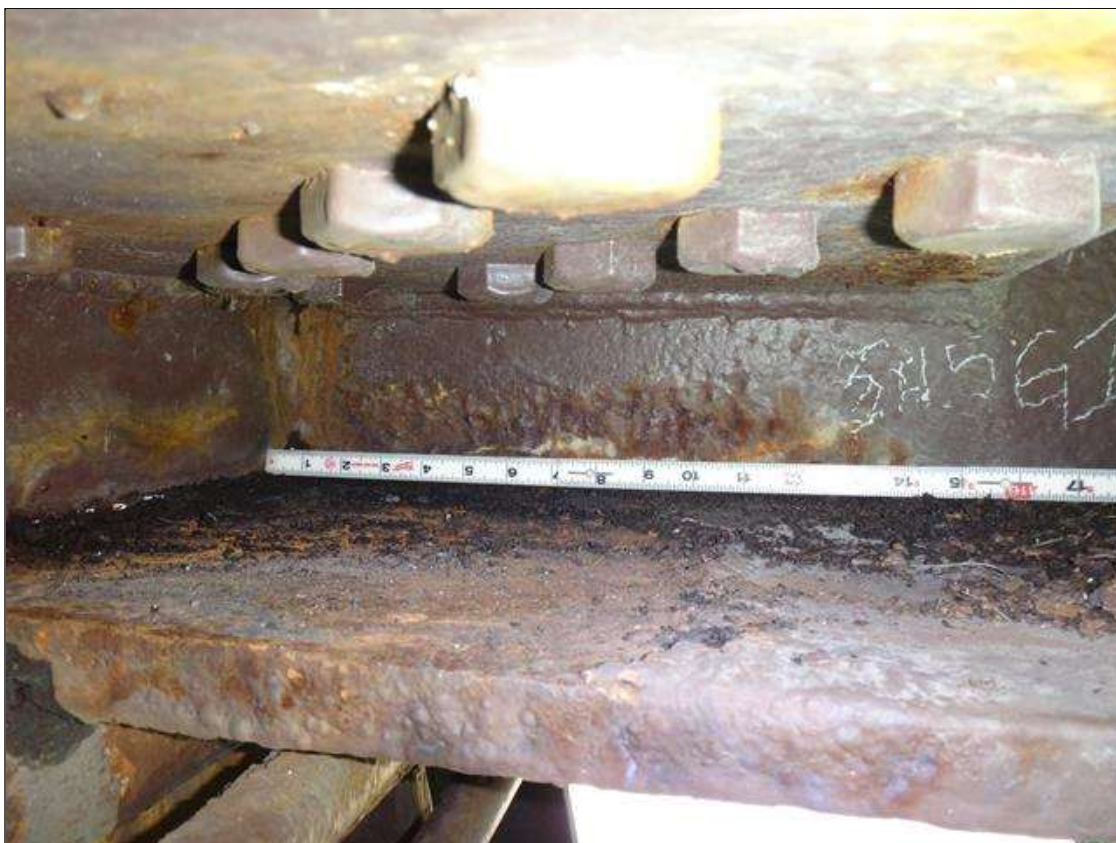
Span 1 Beam 2: [PAR] at bent 1, arrested metal loss, lower web [18in x 3in - avg rem 1/4in]; bottom flange [18in x 12in - avg rem 7/8in]

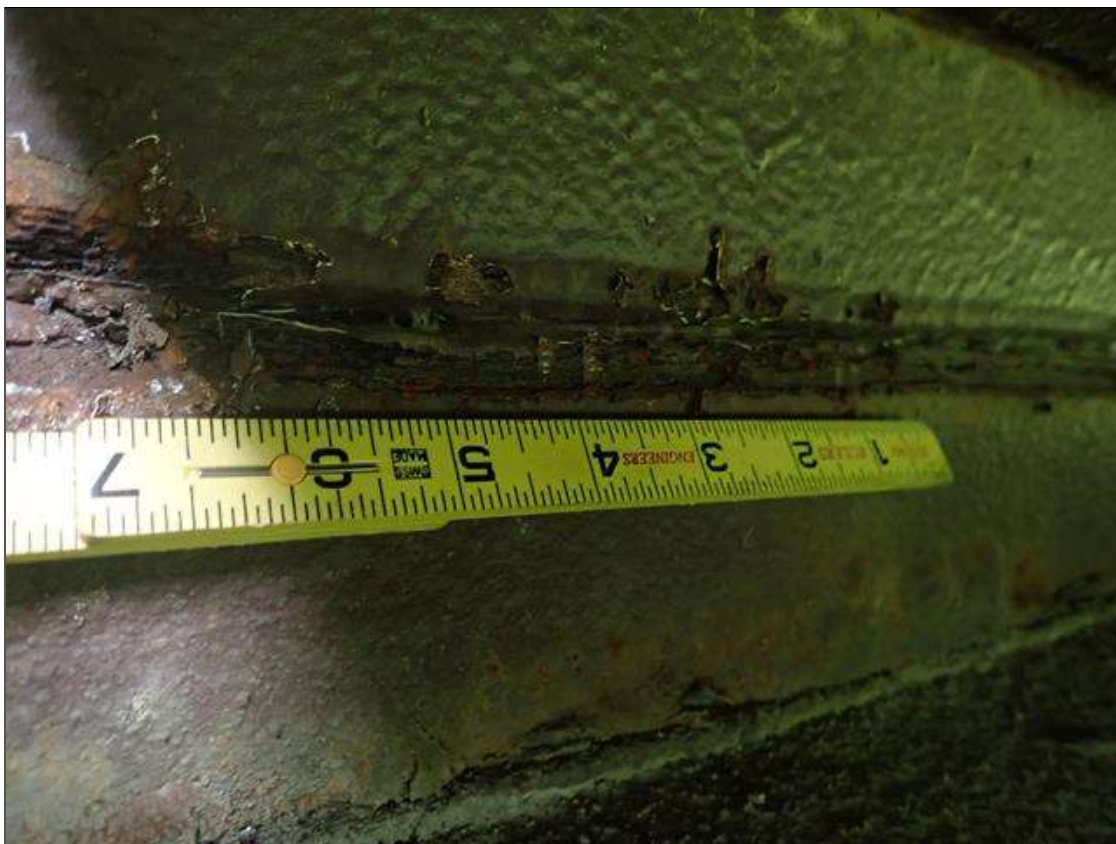
Span 1 Beam 2 Near Bearing: active corrosion with section loss [loss up to 1/8in] with pack rust [1/2in]

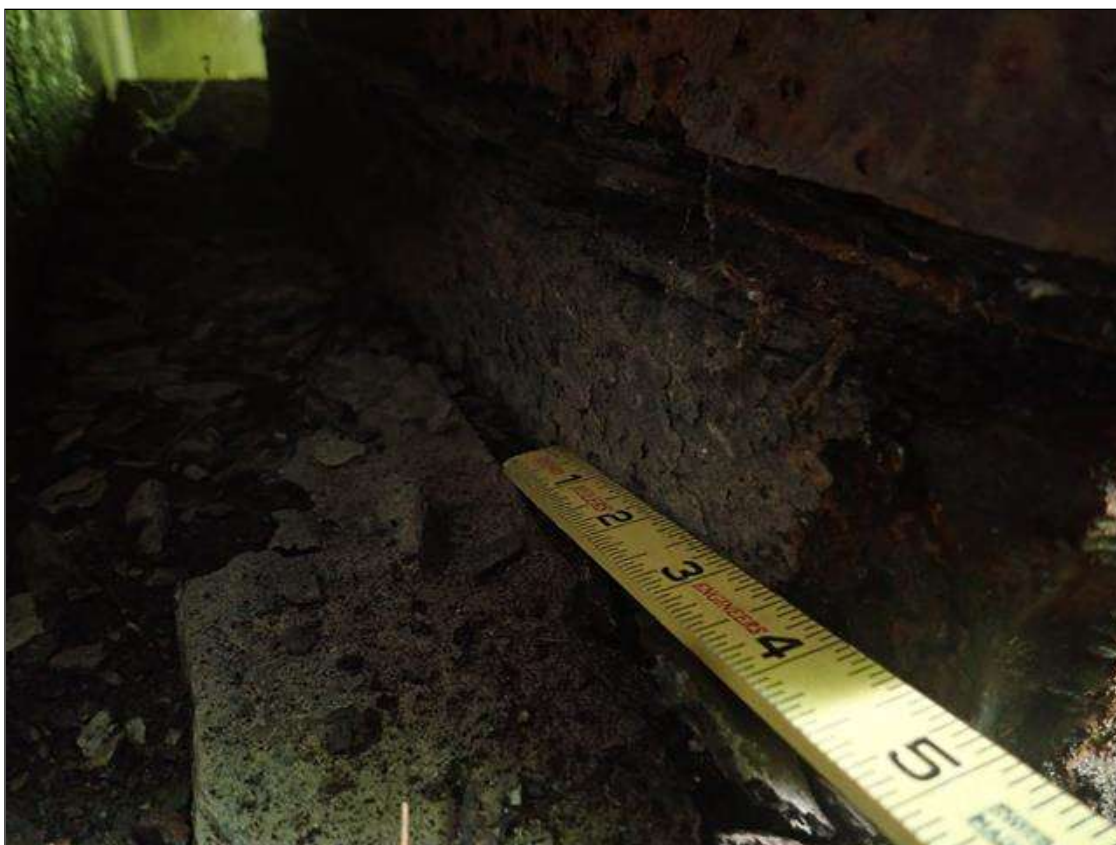
Span 1 Beam 2 Near Bearing: active corrosion with section loss [loss up to 1/8in] with pack rust [1/2in]

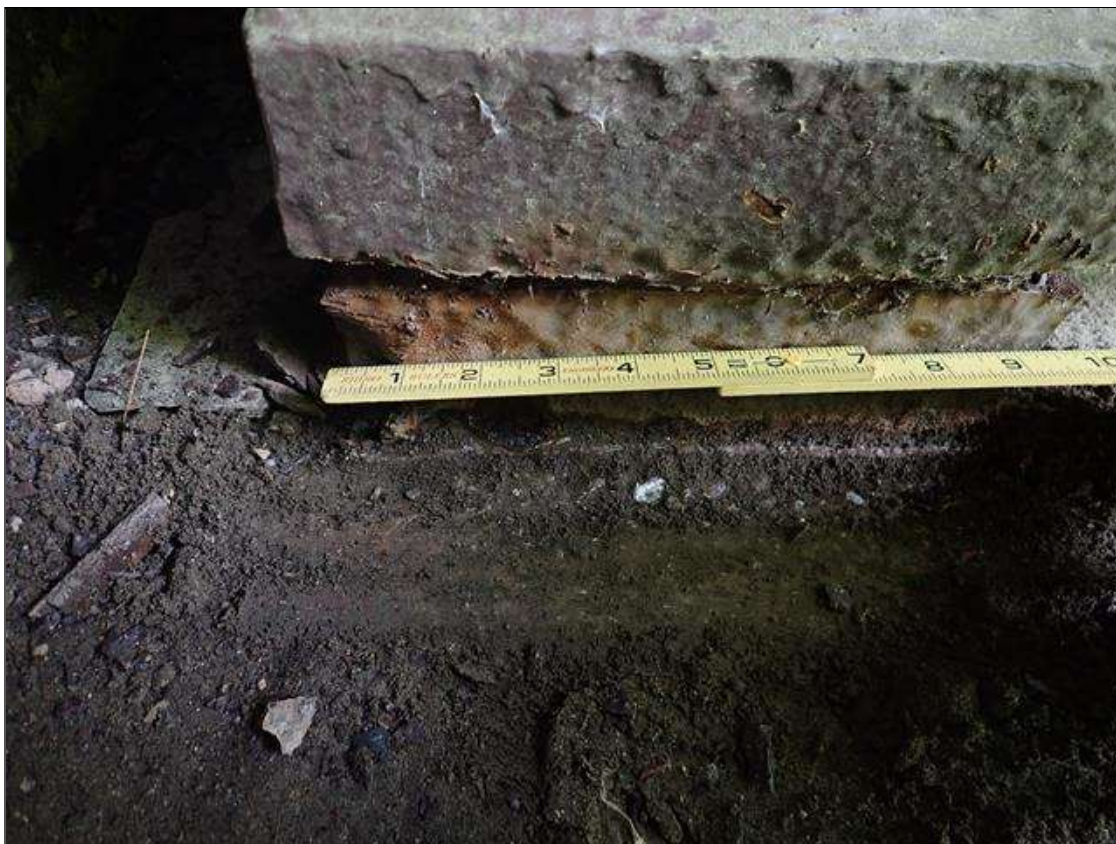
Span 1 Beam 2 Near Bearing: active corrosion with section loss [loss up to 1/8in] with pack rust [1/2in]

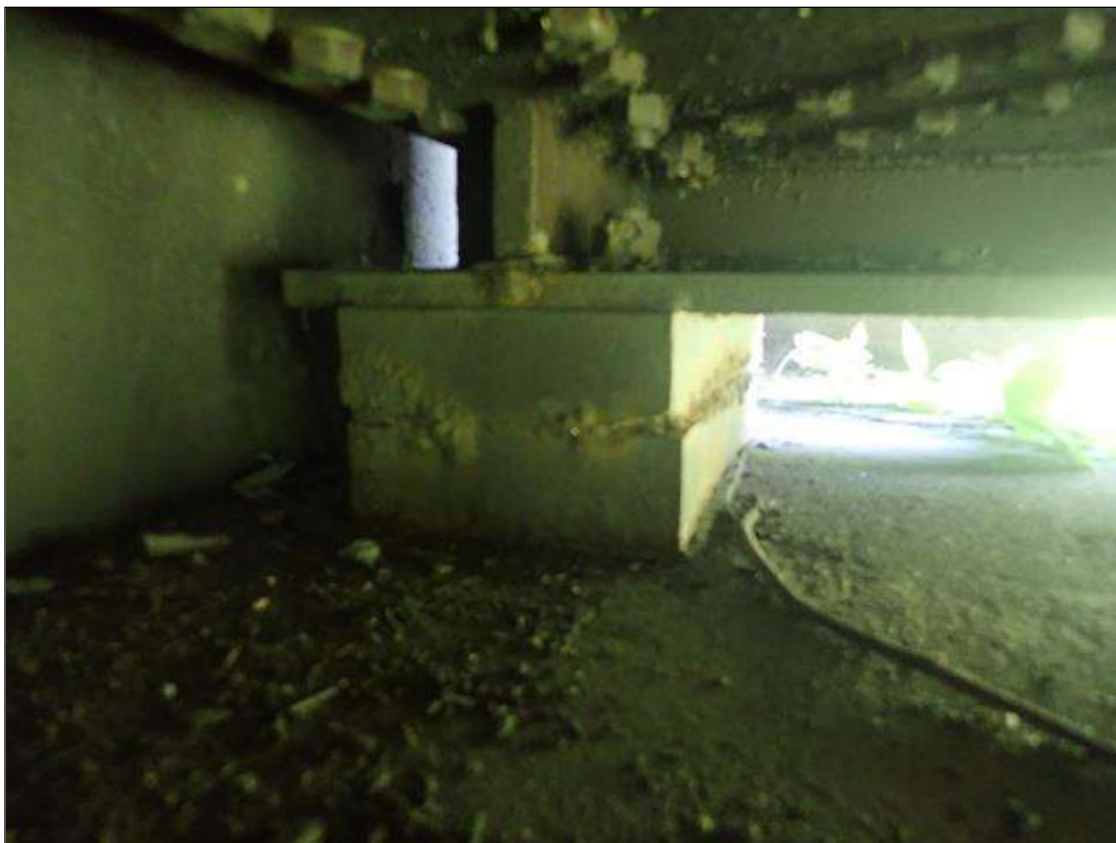
Span 5 Beam 2 Far Bearing: pack rust [up to 1/16in]

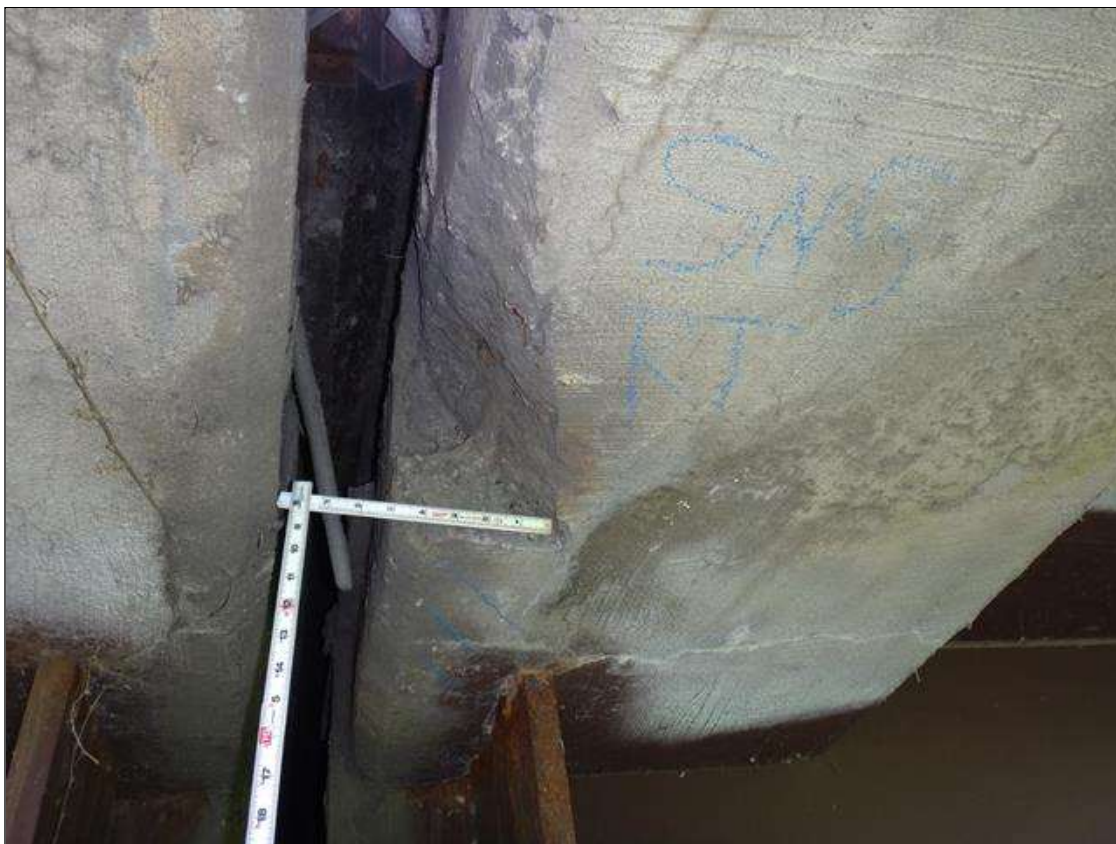
Span 5 Deck: underside East overhang at bent 4, spall [36in x 6in x 8in deep]

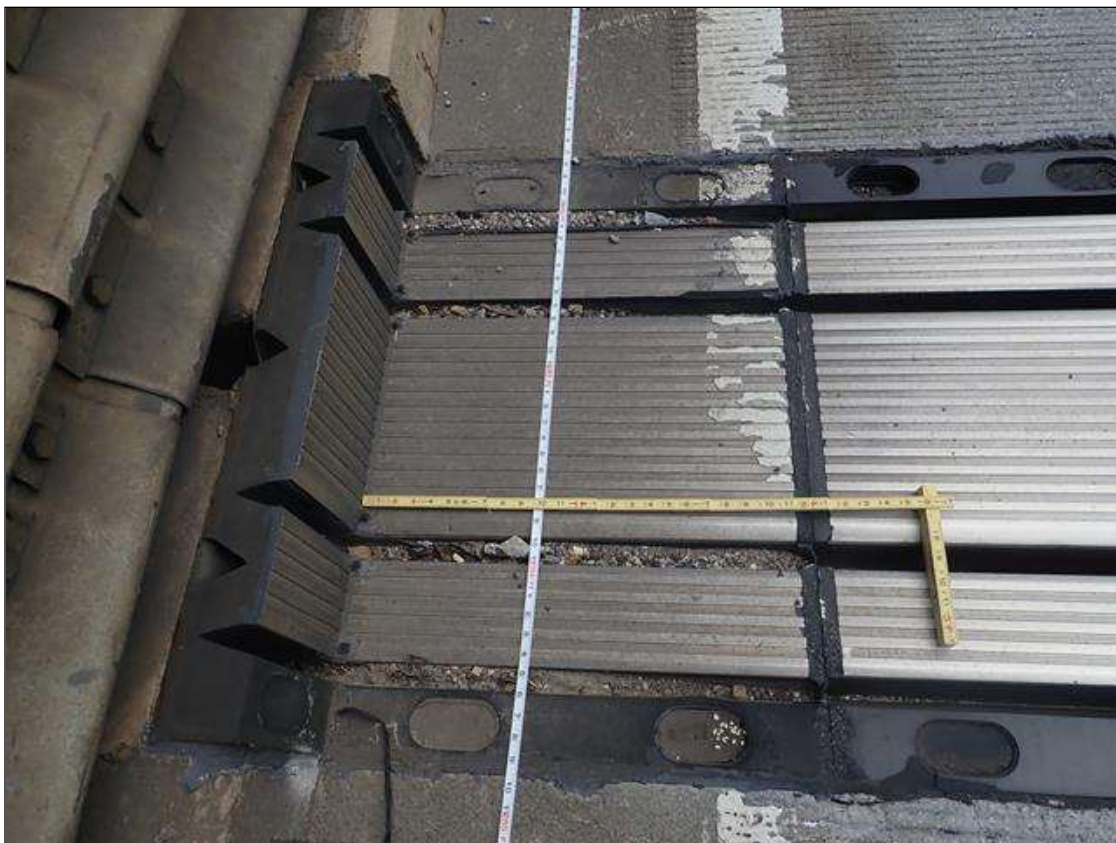
Expansion Joint 5 : at both shoulders, debris accumulation [up to 18in]

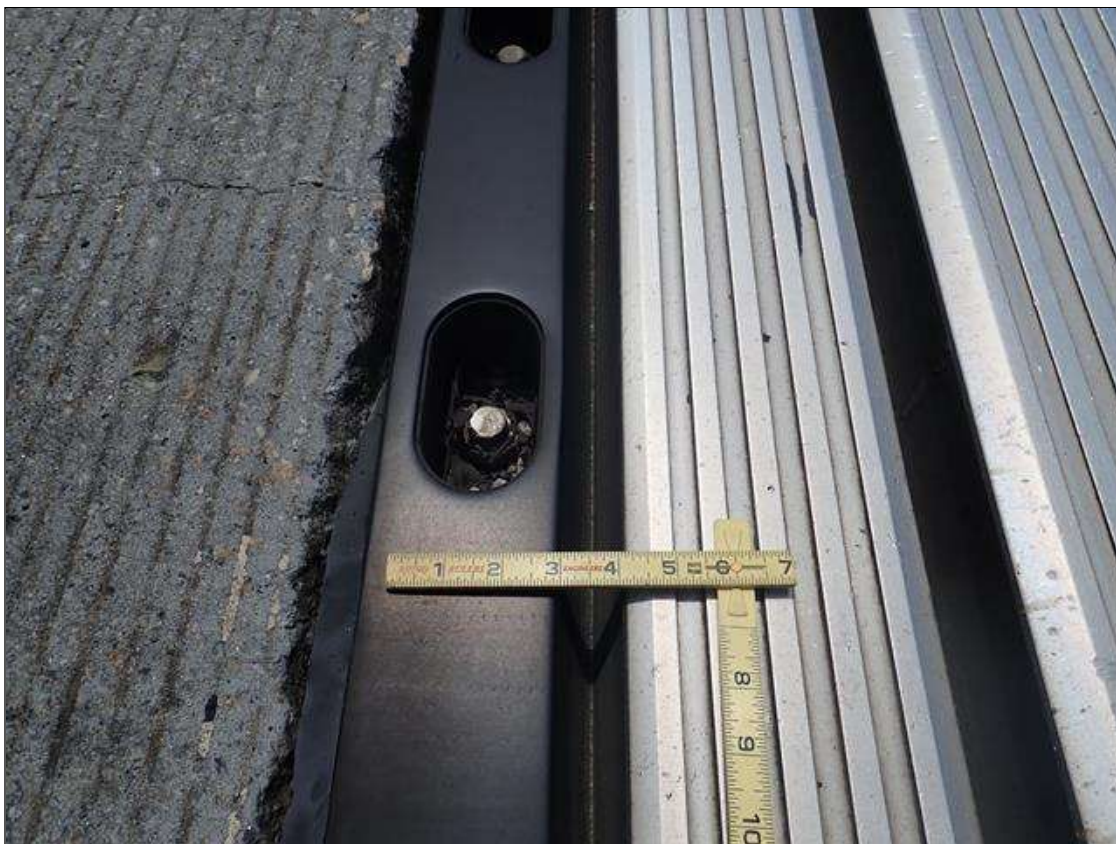
Expansion Joint 5 : both sides of joint, missing plug covers [up to full length]

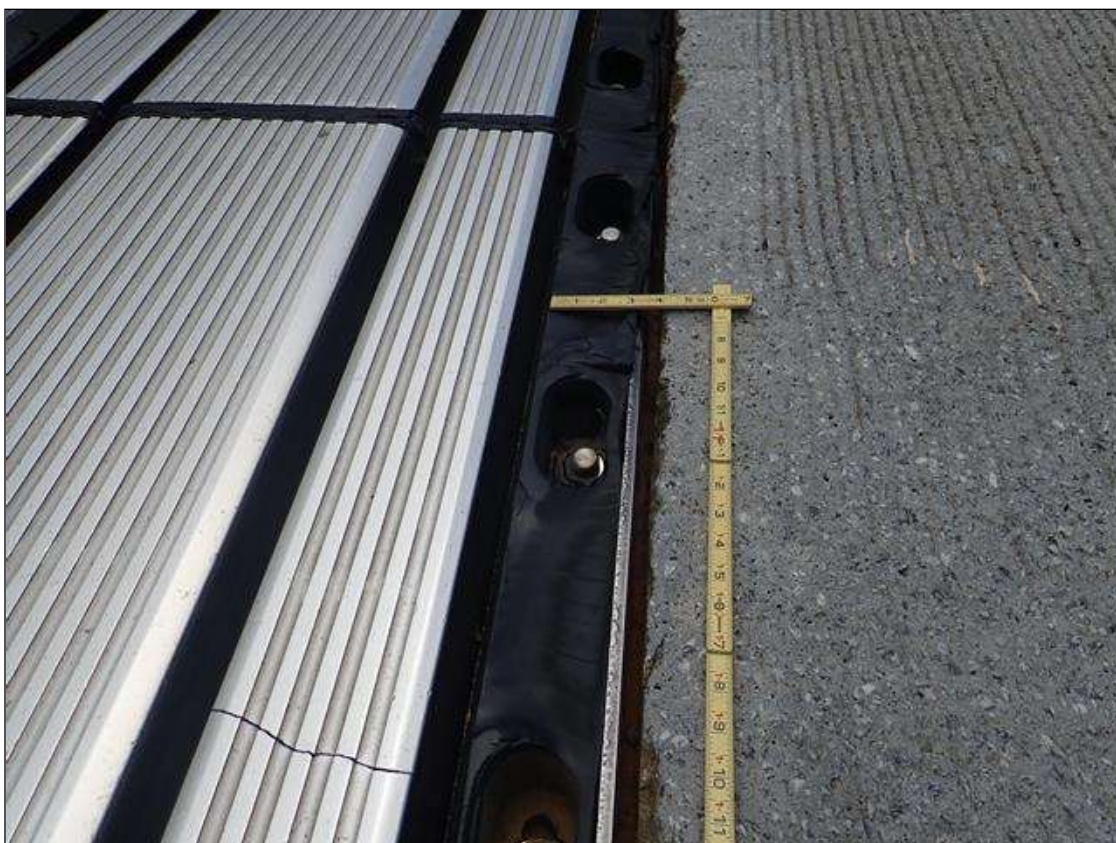
Expansion Joint 5 : along far edge, rubber missing and separated from metal

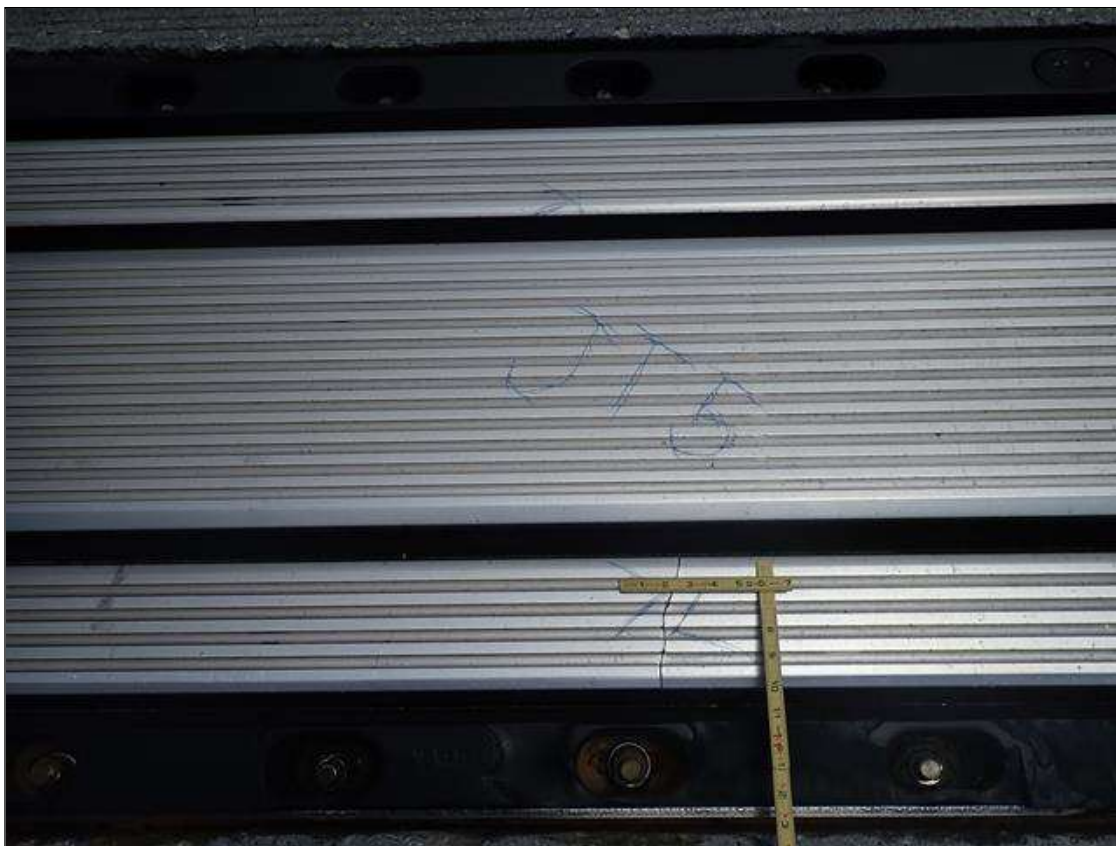
Expansion Joint 5 : [PAR] right travel lane left wheel path in aluminum, two [2] cracks [up to 5in x up to 1/16in]

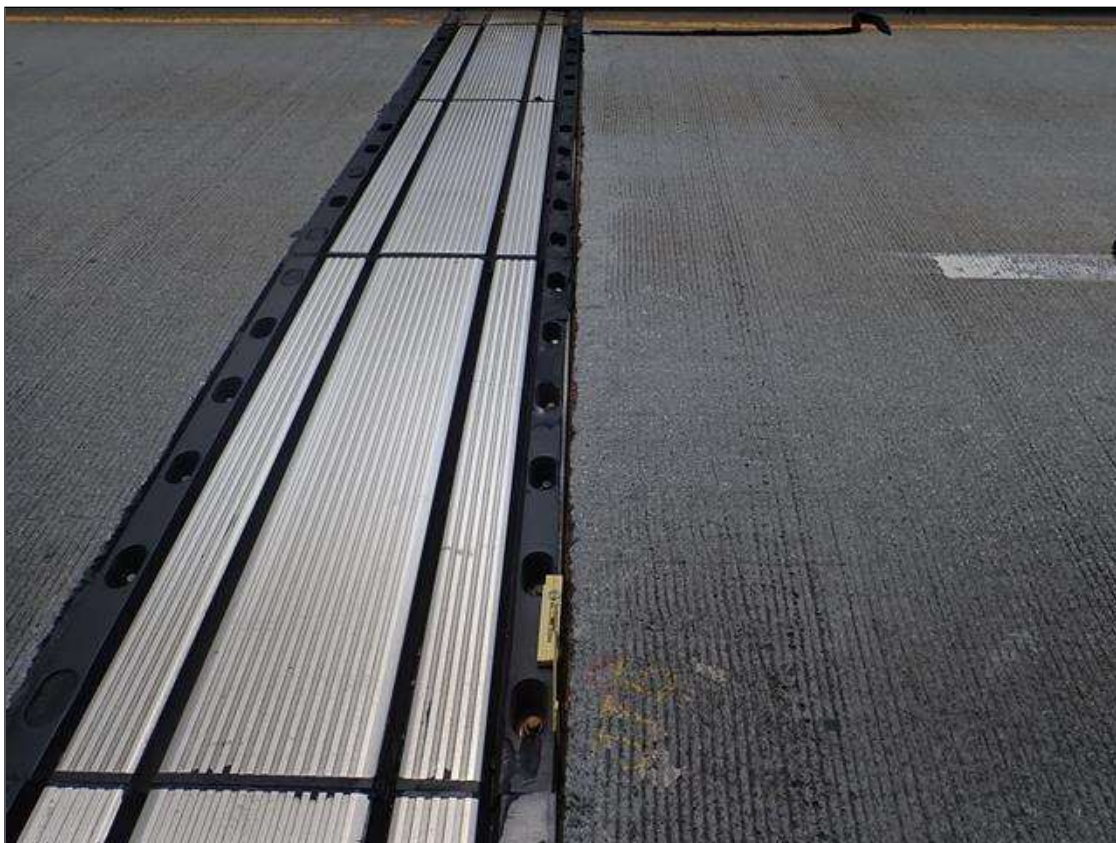
Expansion Joint 5 : along length of joint, missing joint sealant material [up to 20ft] with vertical movement from live load and adjacent edge spalling [up to 12in x 1.5in]

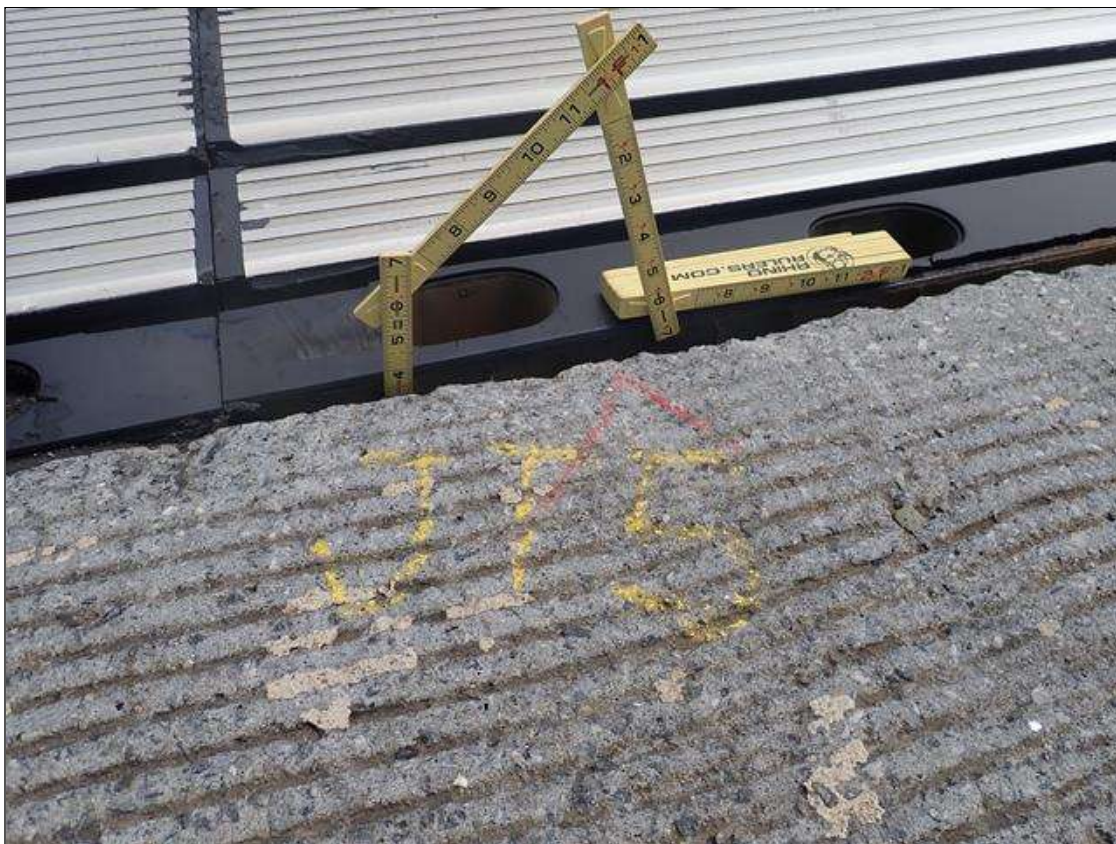
Expansion Joint 5 : along length of joint, missing joint sealant material [up to 20ft] with vertical movement from live load and adjacent edge spalling [up to 12in x 1.5in]

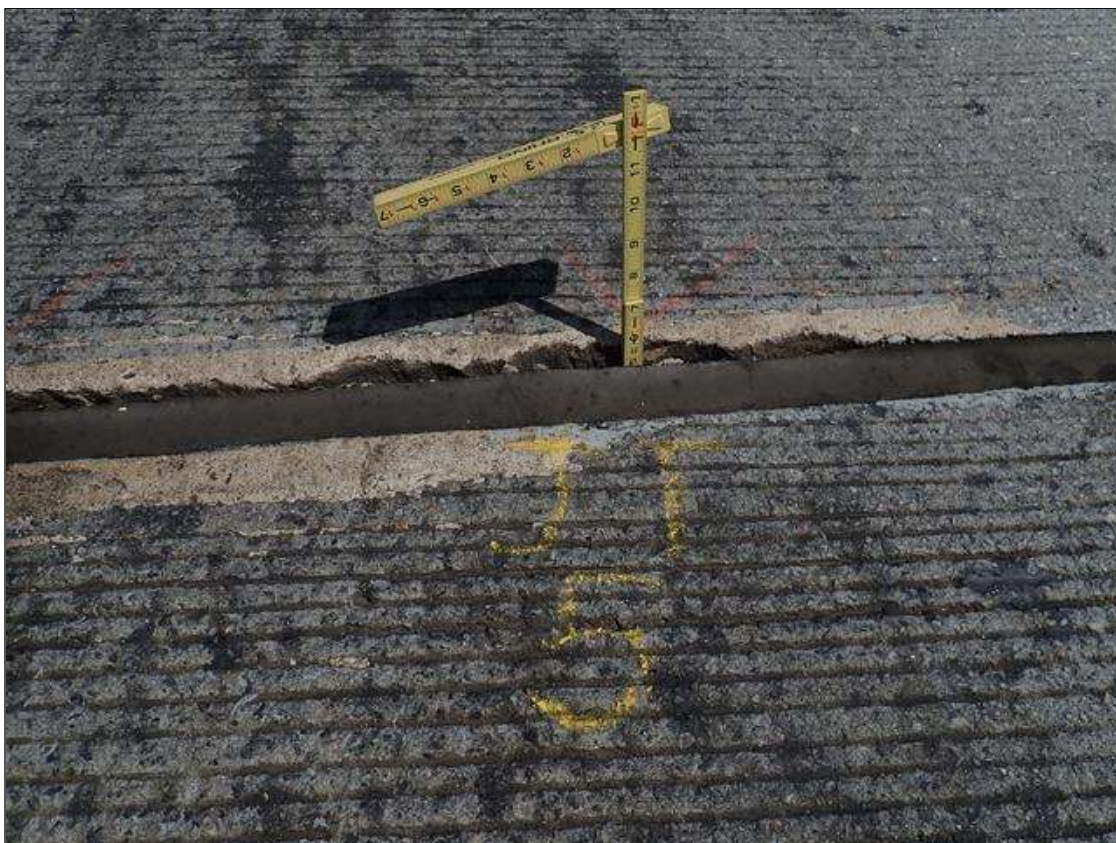
Expansion Joint 6 : along joint, areas of seal adhesion failure [up to 2.5ft x up to full depth]

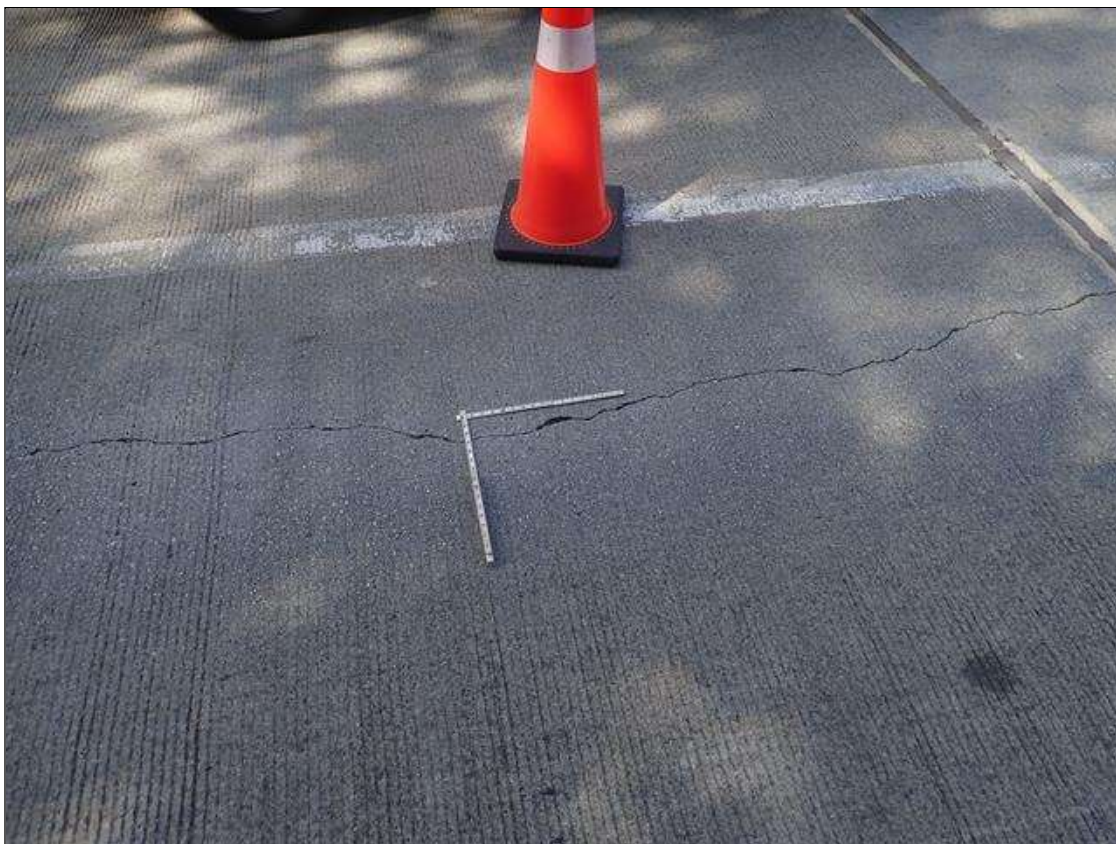
Approach 1: Northbound right lane at center, longitudinal crack [full length x 1/8in]
