NC DEPARTMENT OF TRANSPORTATION  
 DIVISION OF HIGHWAYS  
 STRUCTURE MANAGEMENT UNIT

ATTENTION: **FRACTURE CRITICAL**, Priority Action Request, Changes to Structure Data; inspected South to North - I26 runs West to East

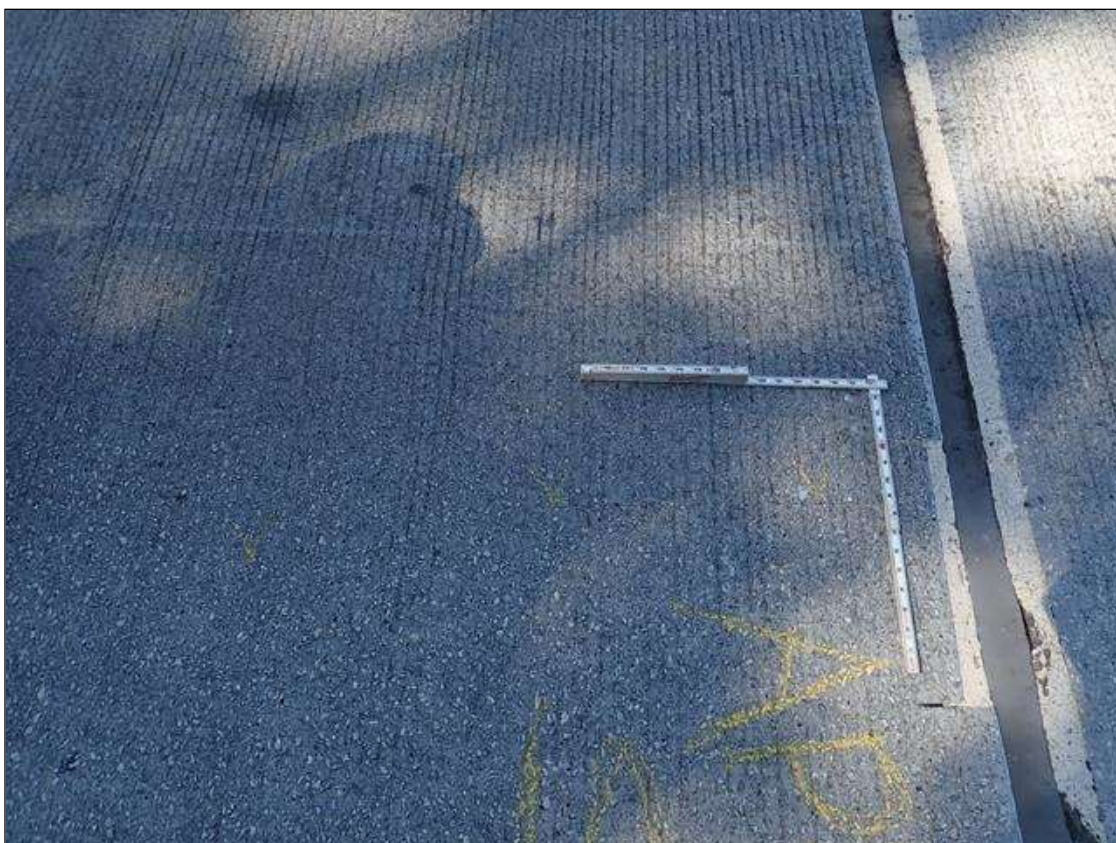
Approach 1: in right travel lane extending from joint, longitudinal crack [3ft x 0.02in]

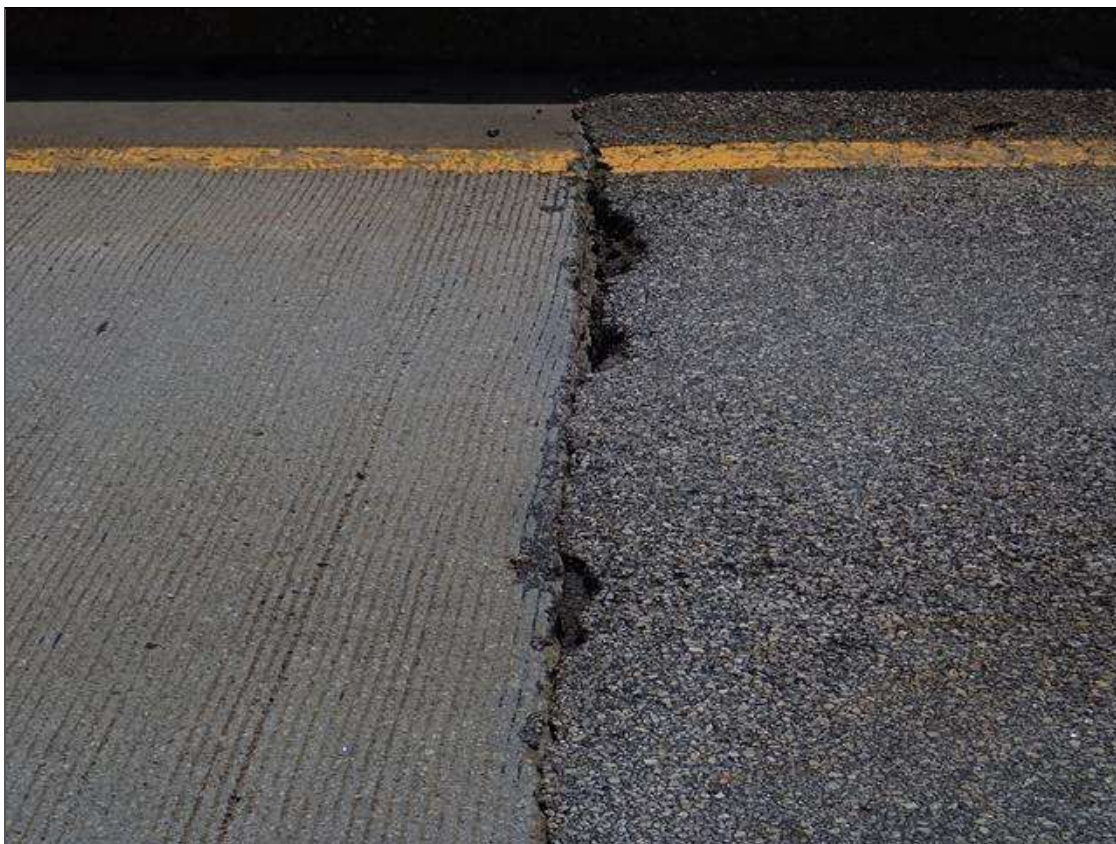
Approach 2: along far edge of slab, multiple edge spalls [up to 6in x 1in x 2in deep] with adjacent potholes [up to 3ft x 5in x 5in deep]

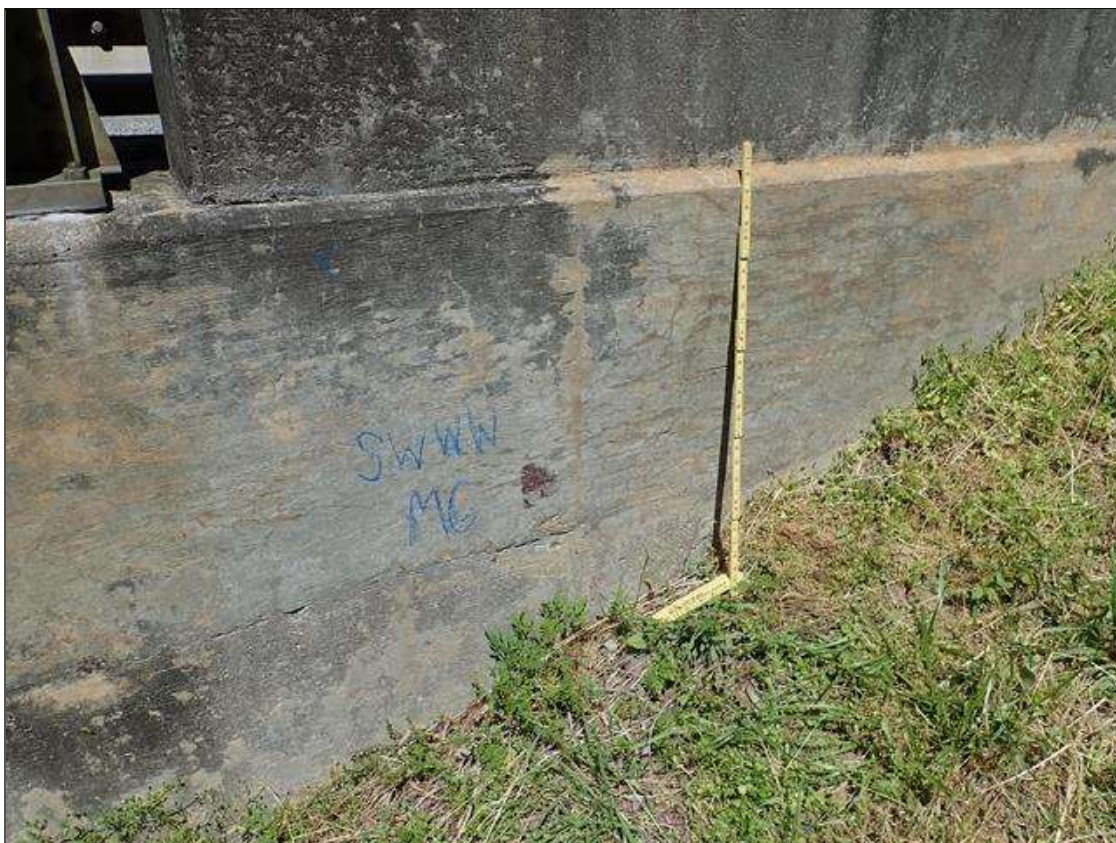
Southwest wingwall: left side at near end, hairline map cracking with efflorescence [8ft x 2ft]

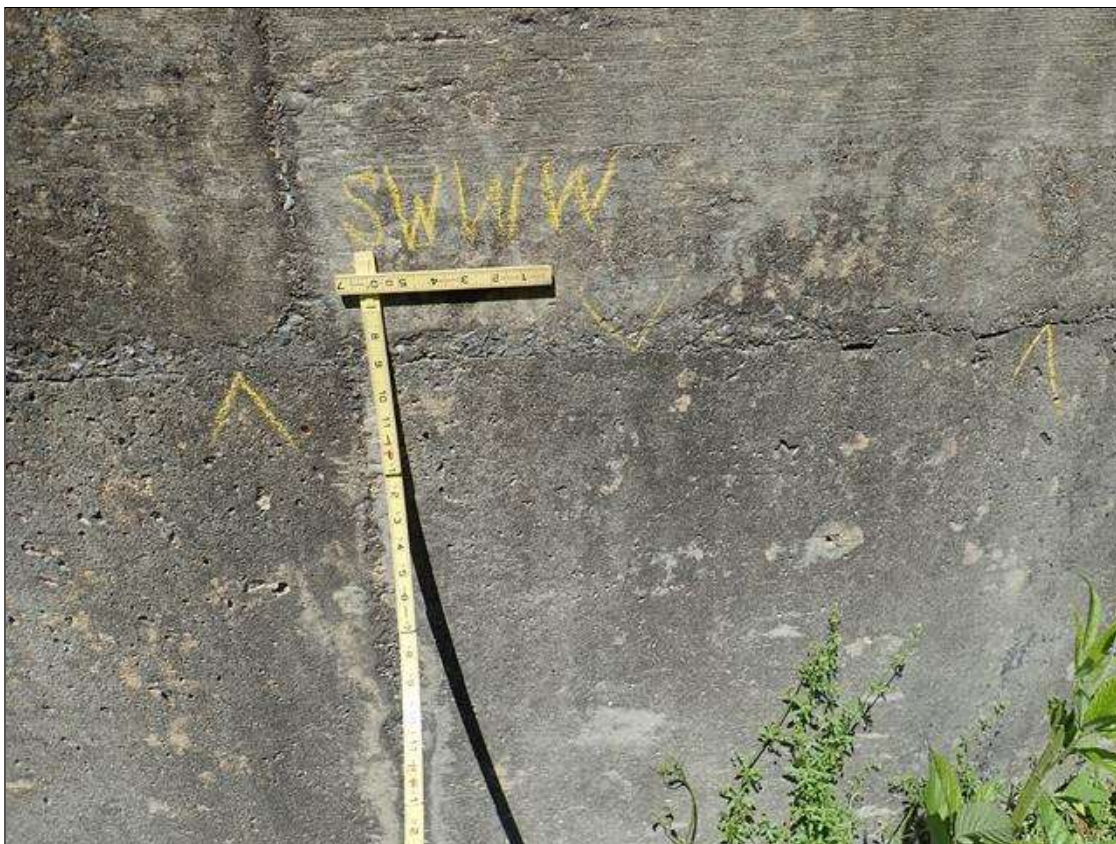
Southwest wingwall: left side 2ft below top edge, horizontal crack [18.5ft x 0.012in]

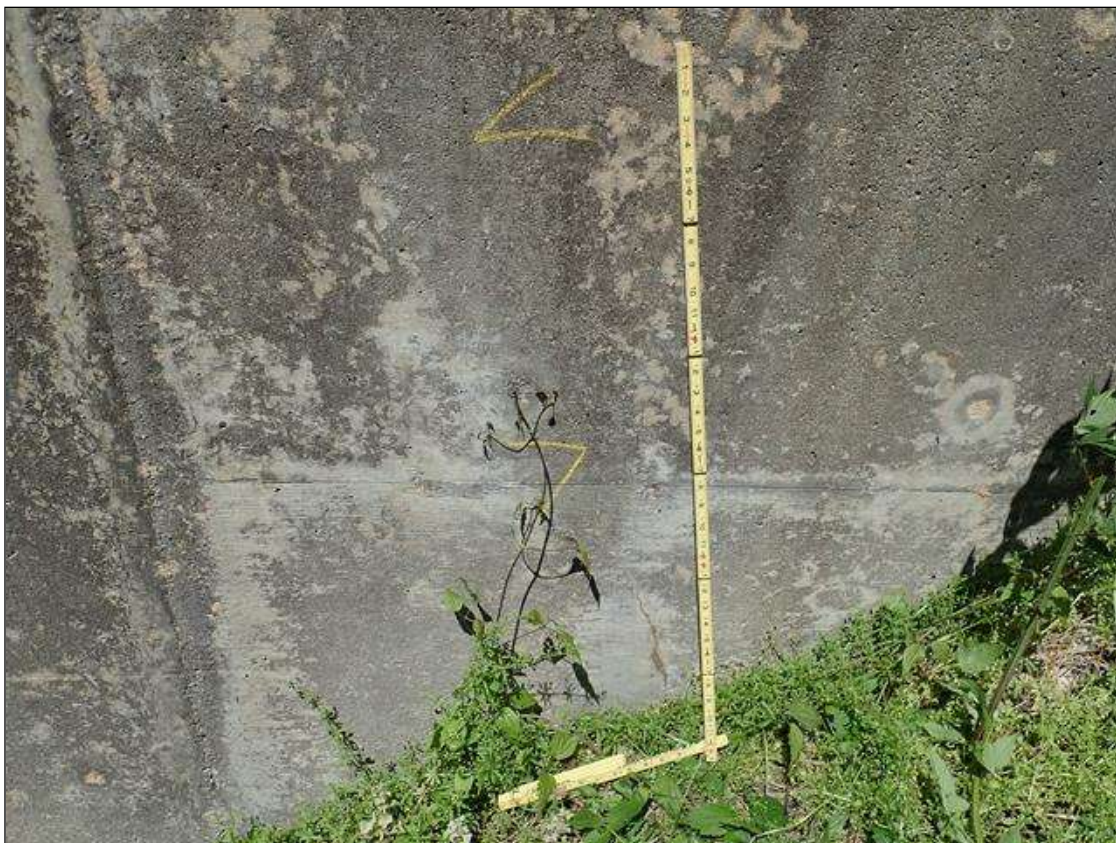
Southwest wingwall: left side 9ft from far end, vertical crack [5ft x hairline] with efflorescence

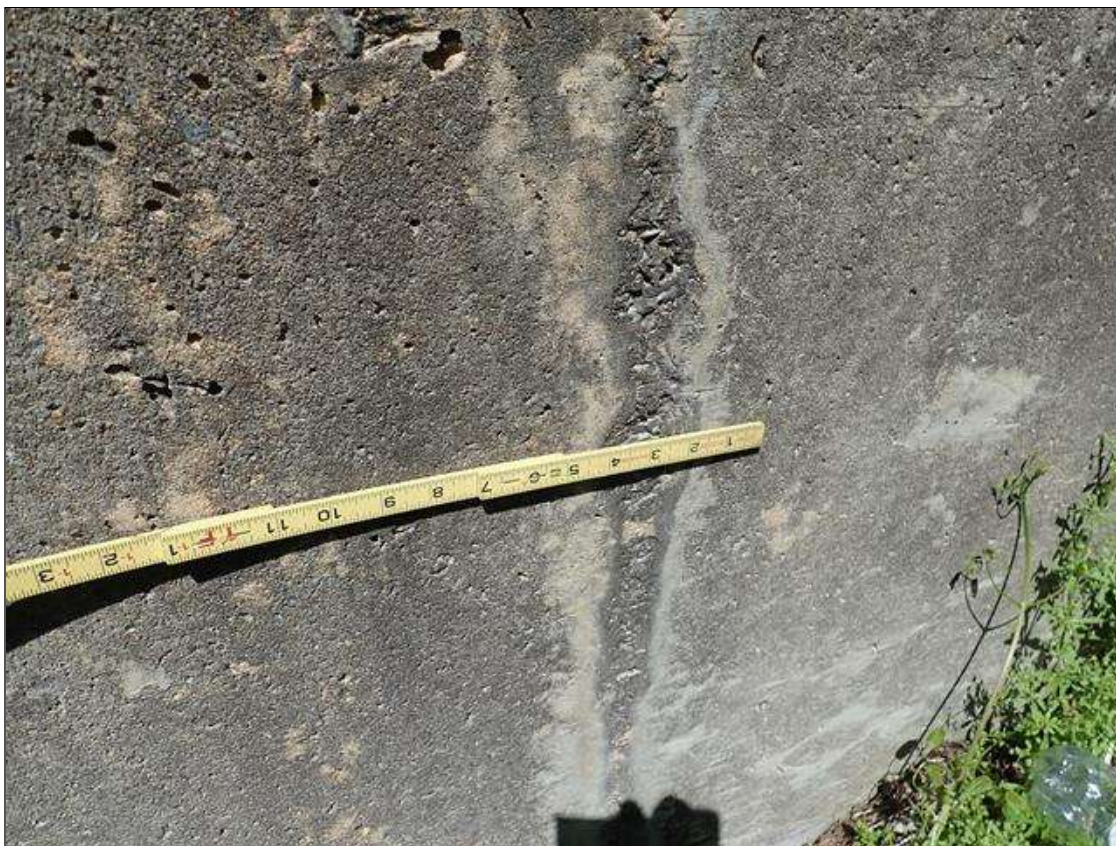
Southwest wingwall: along form lines, exposed coarse aggregate, similar at Southeast wingwall

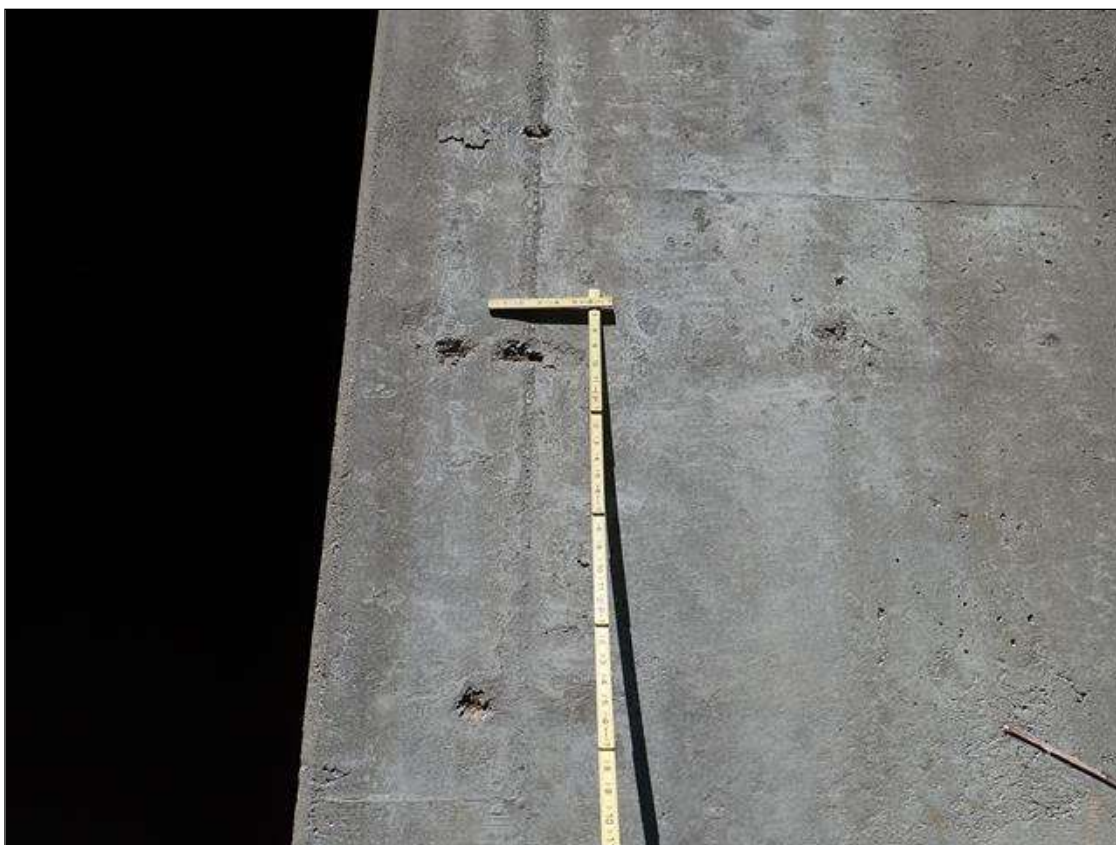
Southwest wingwall: left side at far end, three [3] spalls [up to 5in x 2in x 1/4in deep] with exposed rusted reinforcing [no loss]

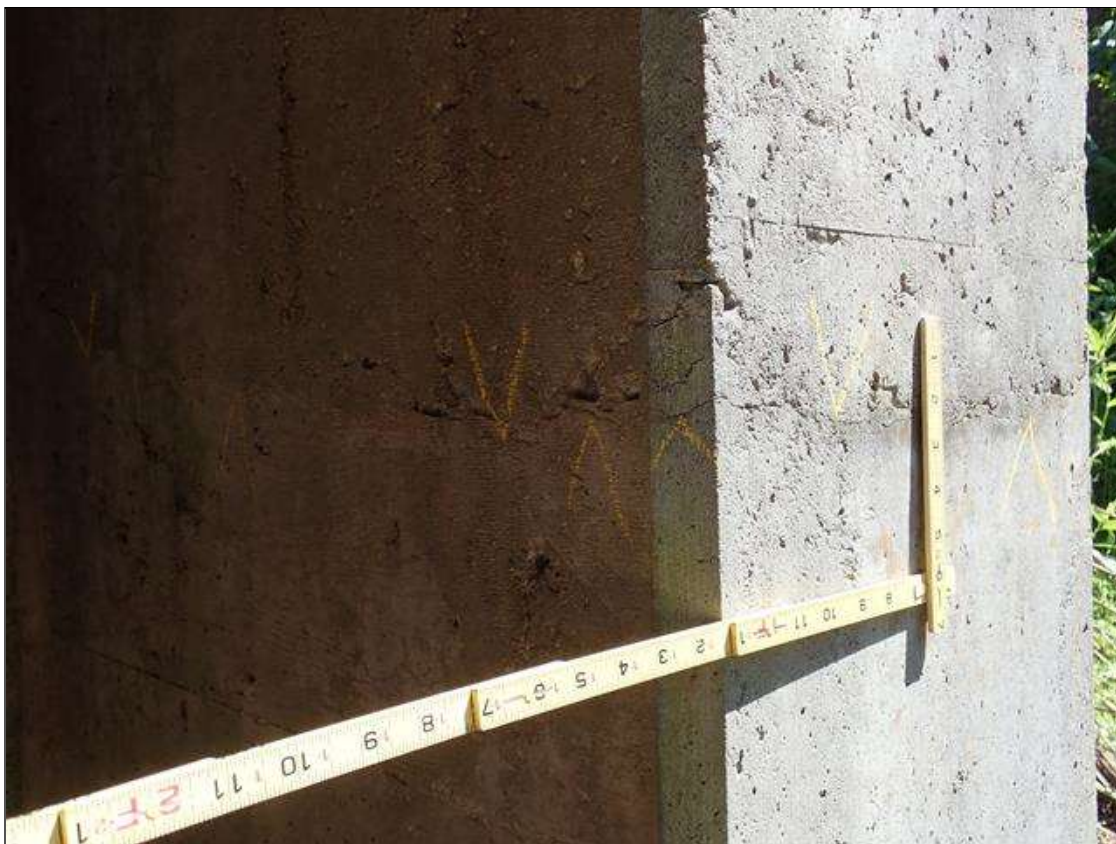
Southwest wingwall: at face of far end and sides, wrap around horizontal crack [4.5ft x up to 0.015in], similar at Southeast wingwall

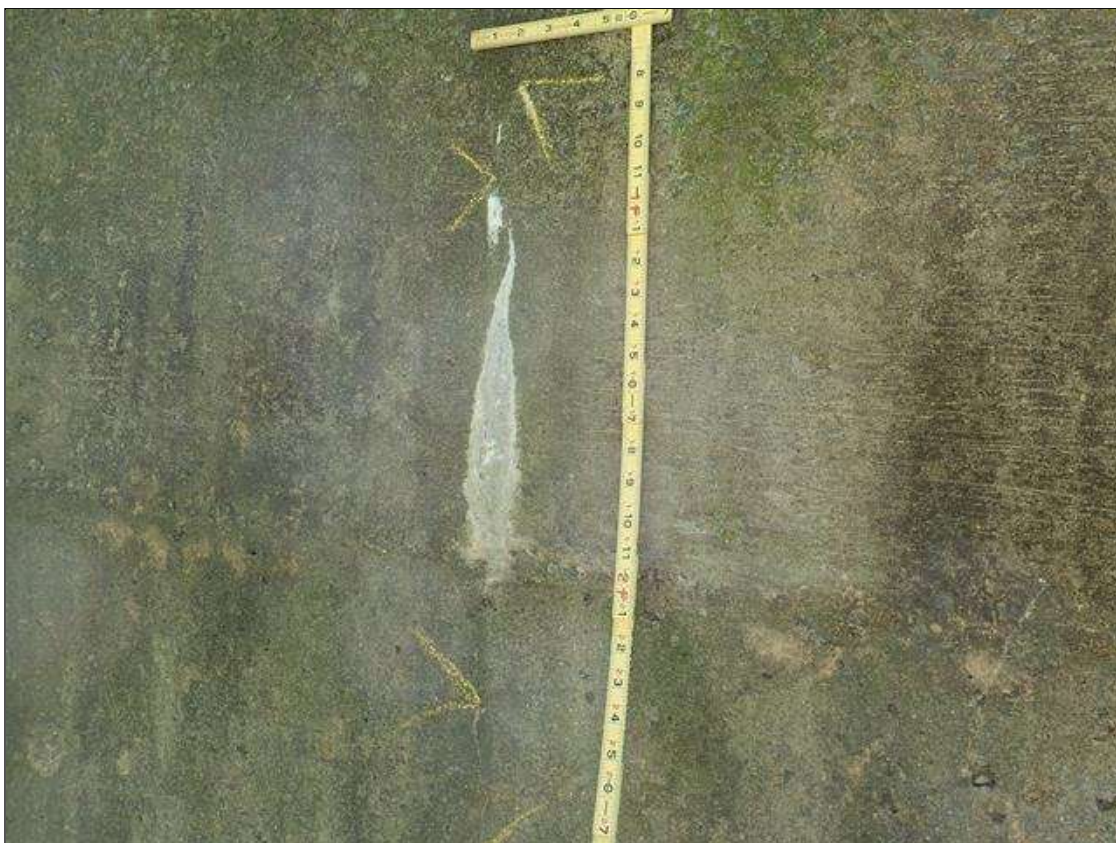
Southeast wingwall: right face at far end and mid length, two [2] vertical cracks [up to 3t x hairline] with efflorescence build-up

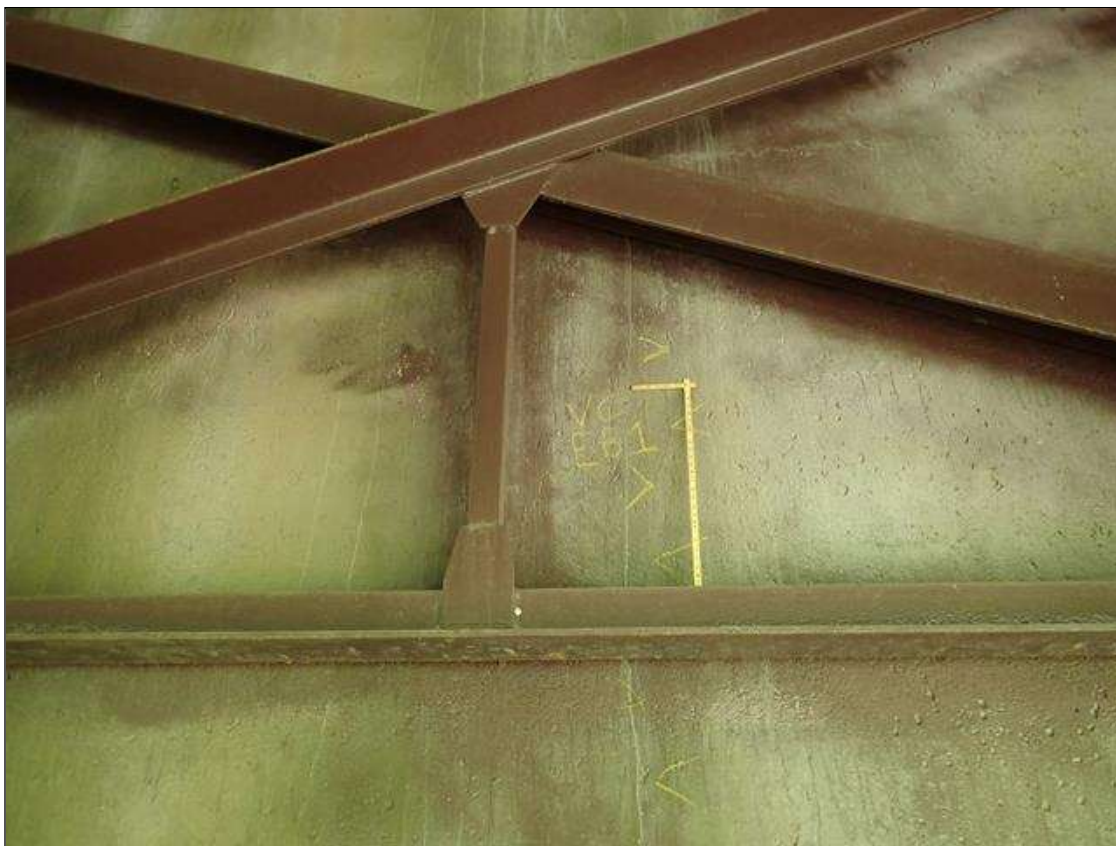
End Bent 1 Abutment/Backwall : at middle of backwall, vertical crack [full height x up to 0.02in]

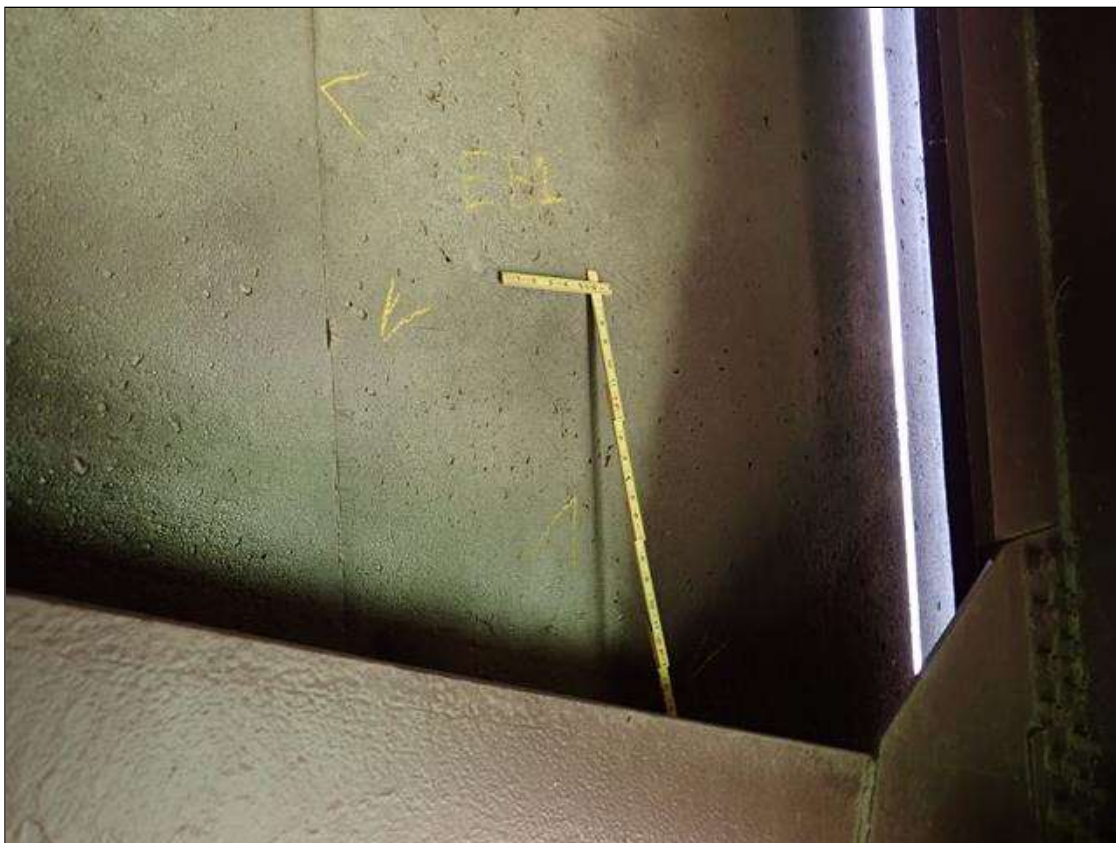
End Bent 1 Abutment/Backwall : left side behind beam 1 bearing, diagonal crack [7ft x up to 0.012in]

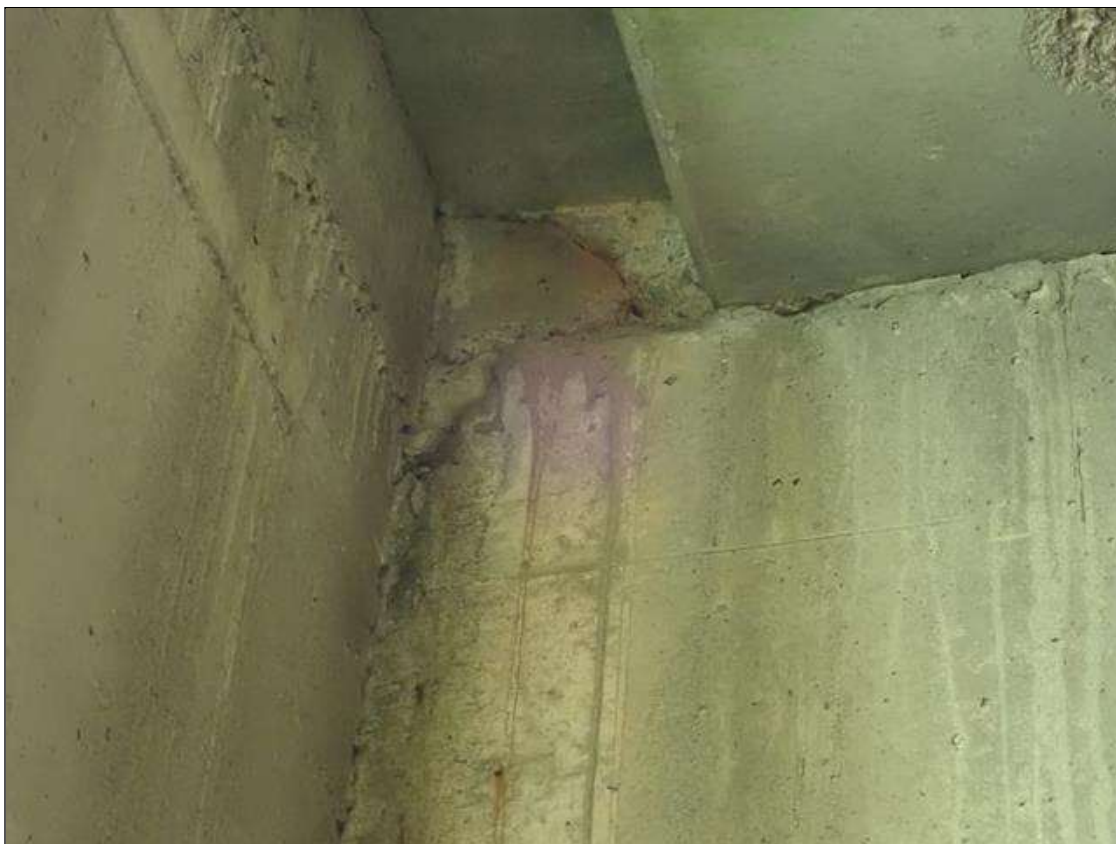
End Bent 1 Abutment/Backwall : top of backwall at right side adjacent to wingwall, spall [9in x 9in x 3in deep], similar at left side

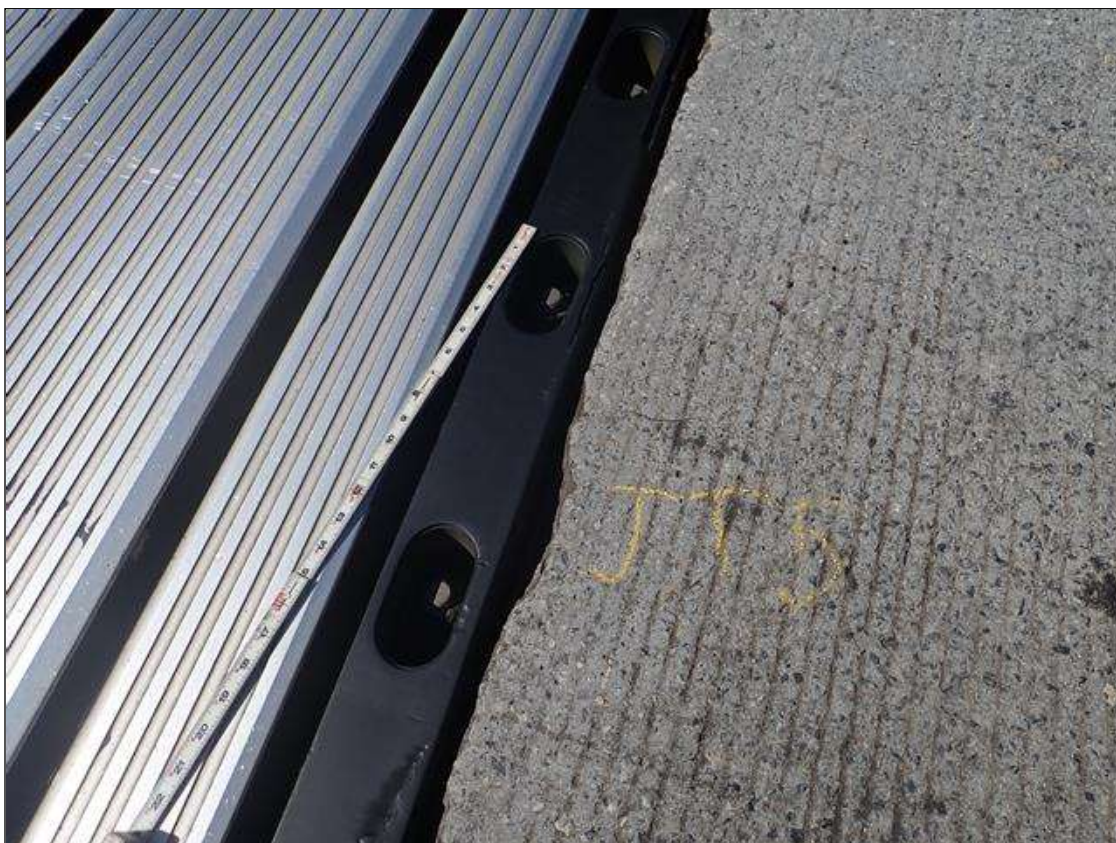
Expansion Joint 2 : at both sides of joint, missing plug covers [up to full length]

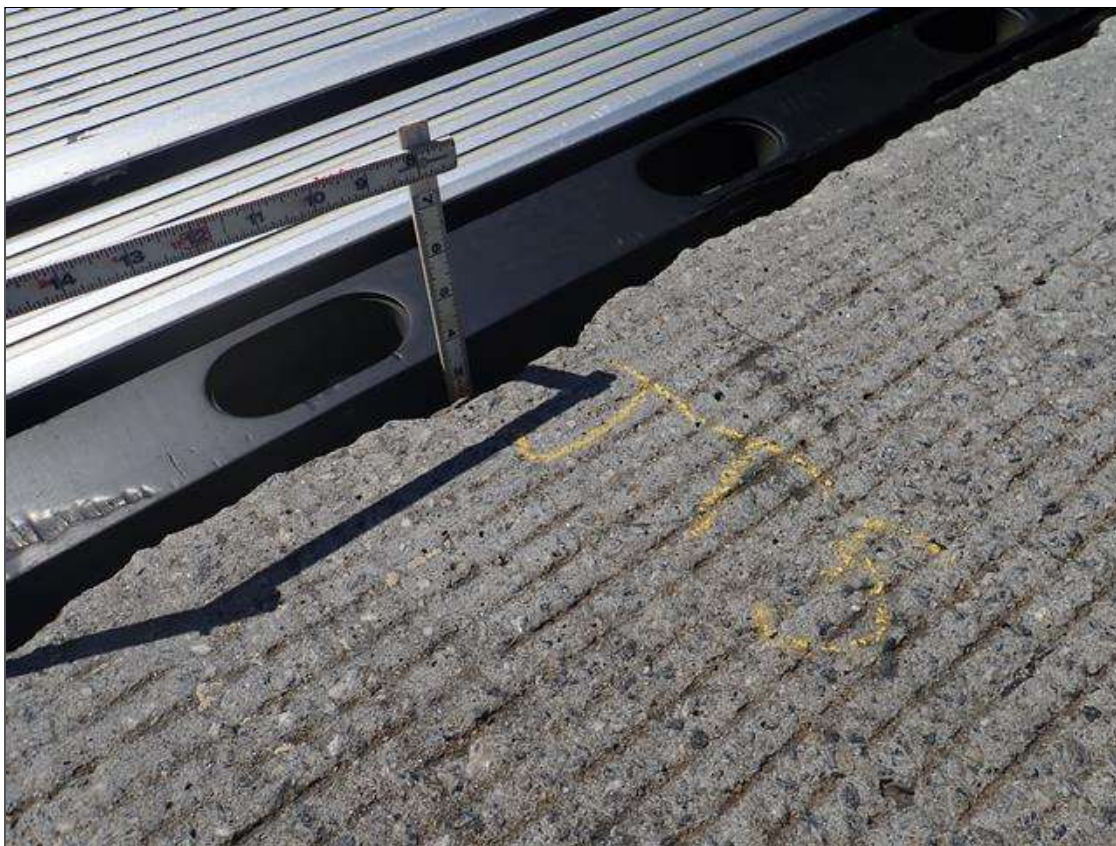
Expansion Joint 2 : along length of joint, missing joint sealant material [up to 28ft]

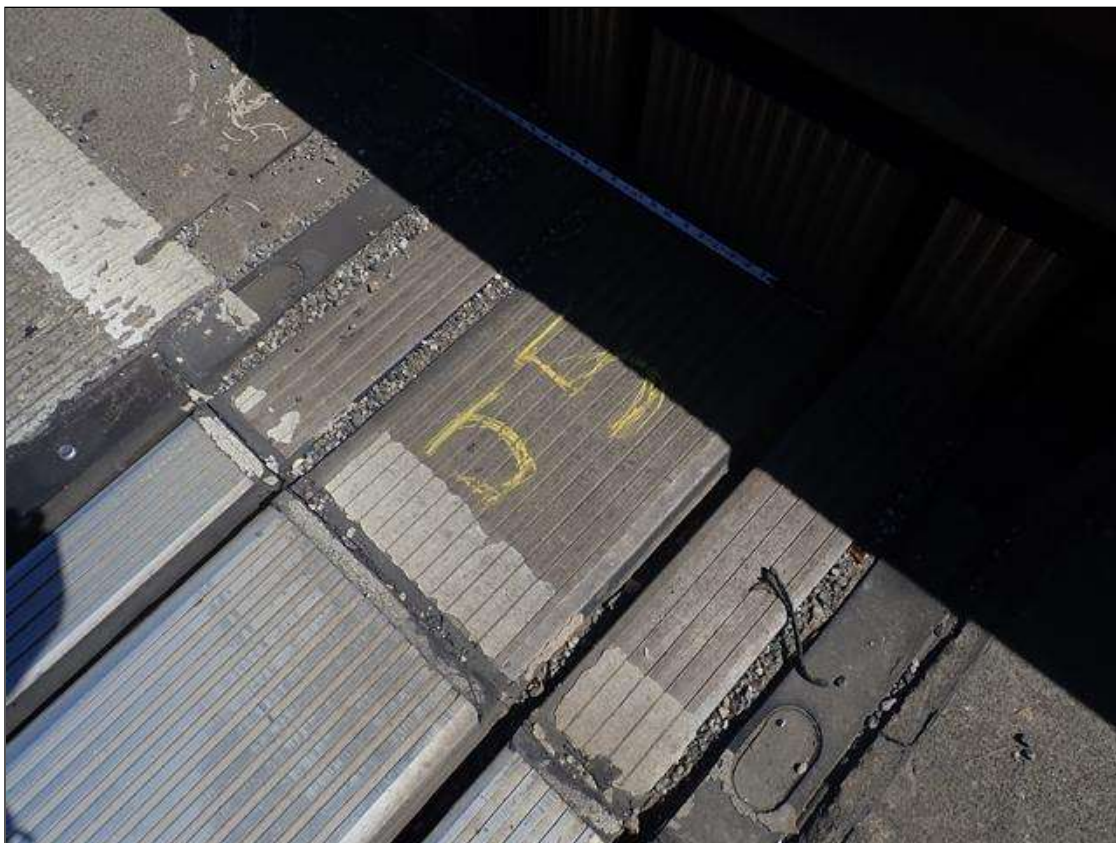
Expansion Joint 2 : at both shoulders, debris accumulation [up to 3ft]

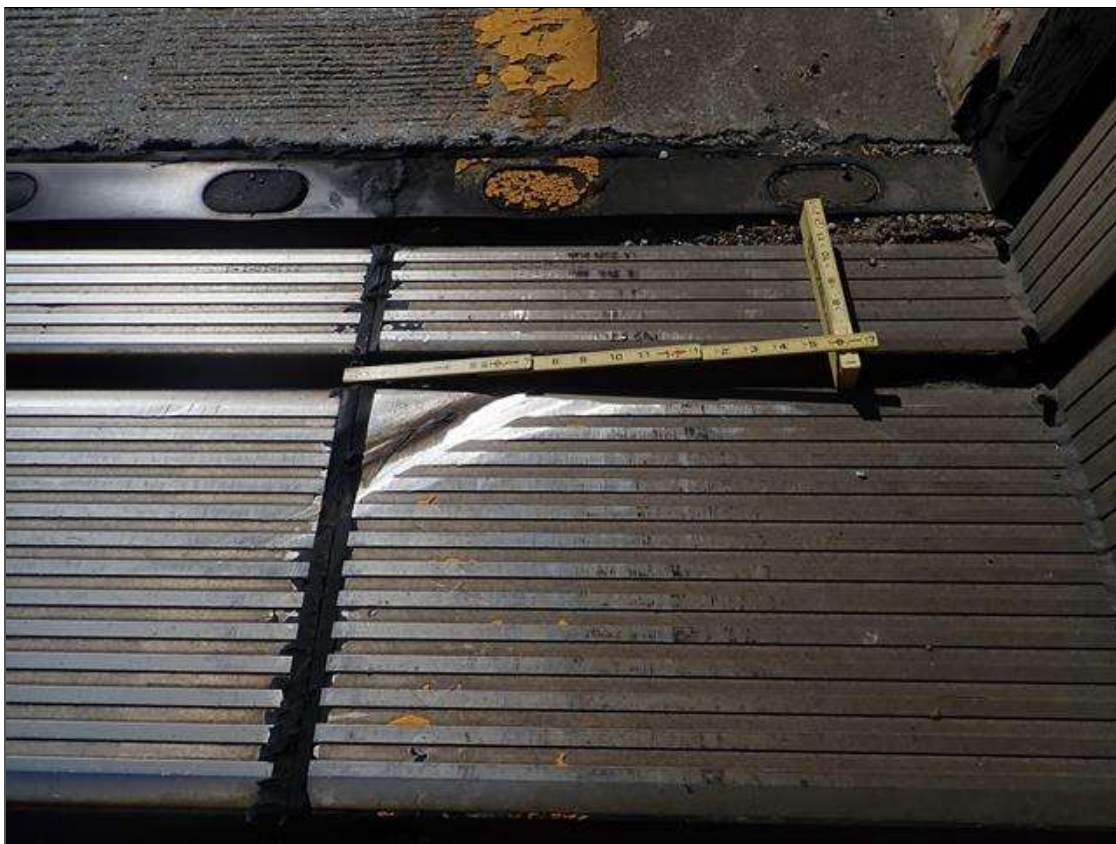
Expansion Joint 2 : in left travel lane at yellow line, damage/gouge [8in x 6in x up to 1/4in deep]

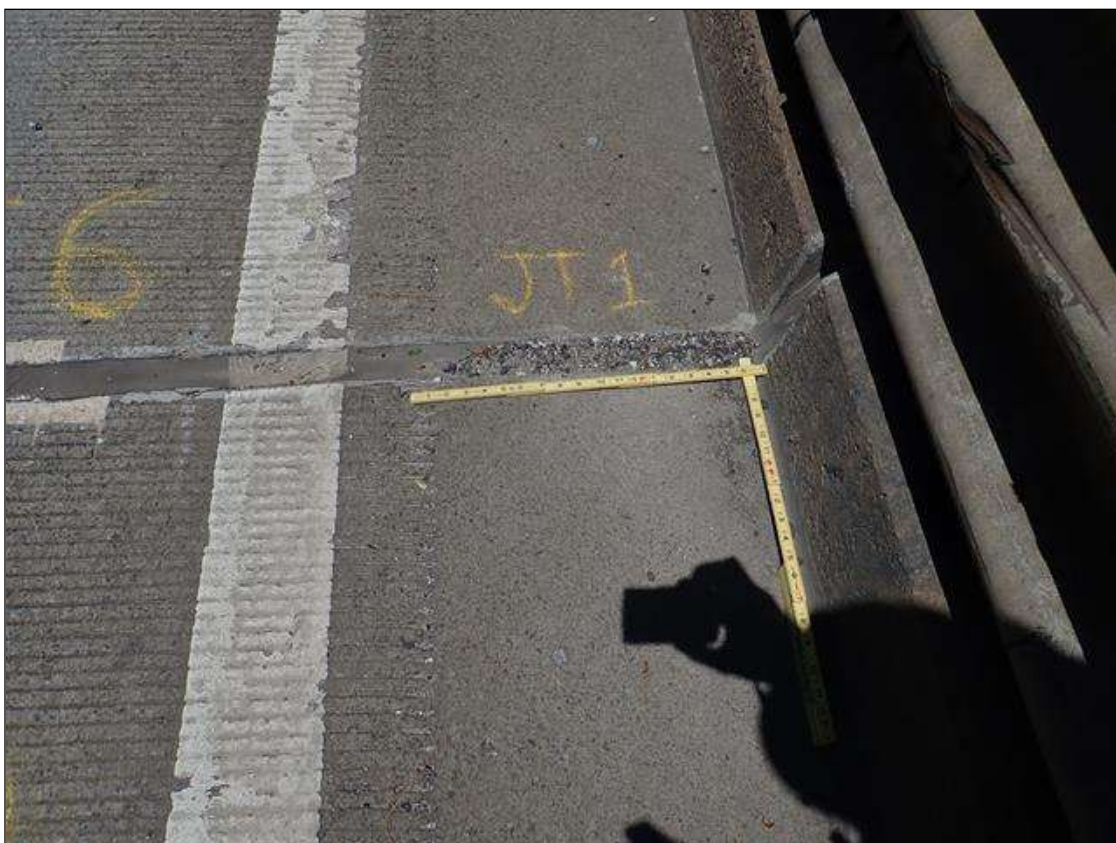
Expansion Joint 1 : at right shoulder, debris accumulation [14in]

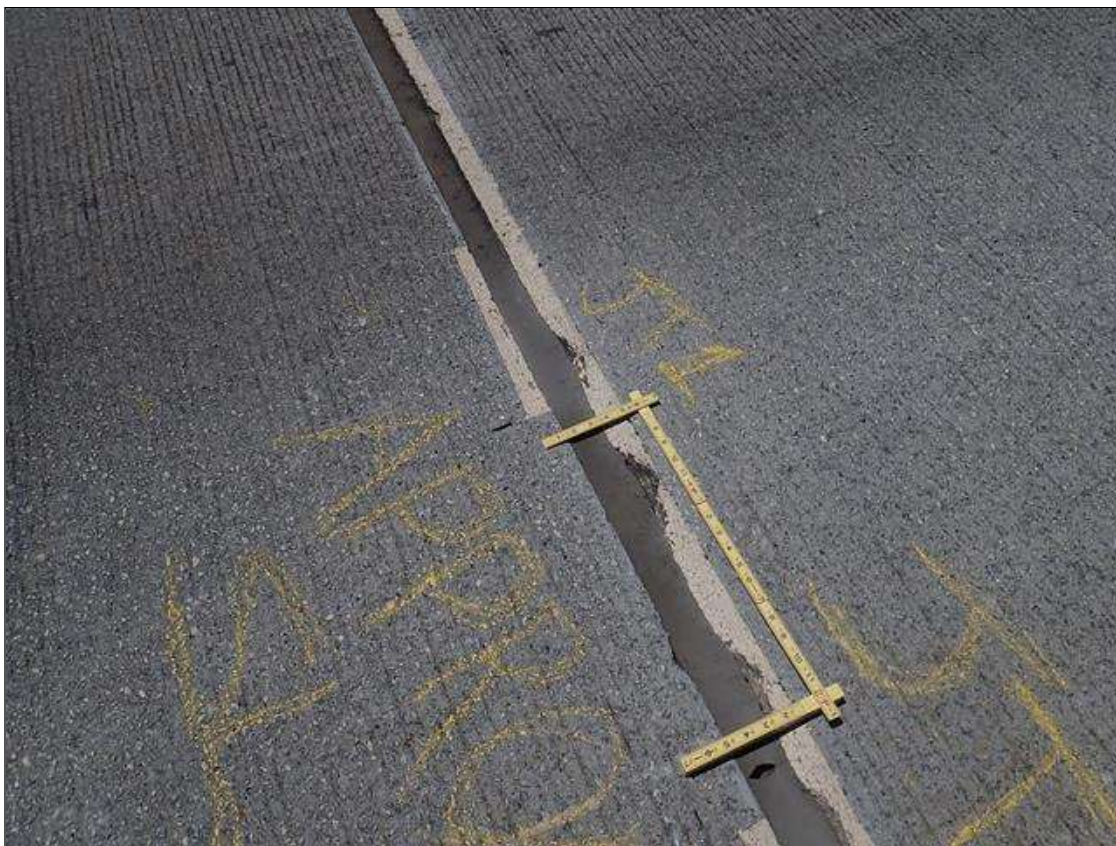
Expansion Joint 1 : at both headers of right lane, multiple edge spalls [up to 6in x 1in x 1in deep] at area of repair

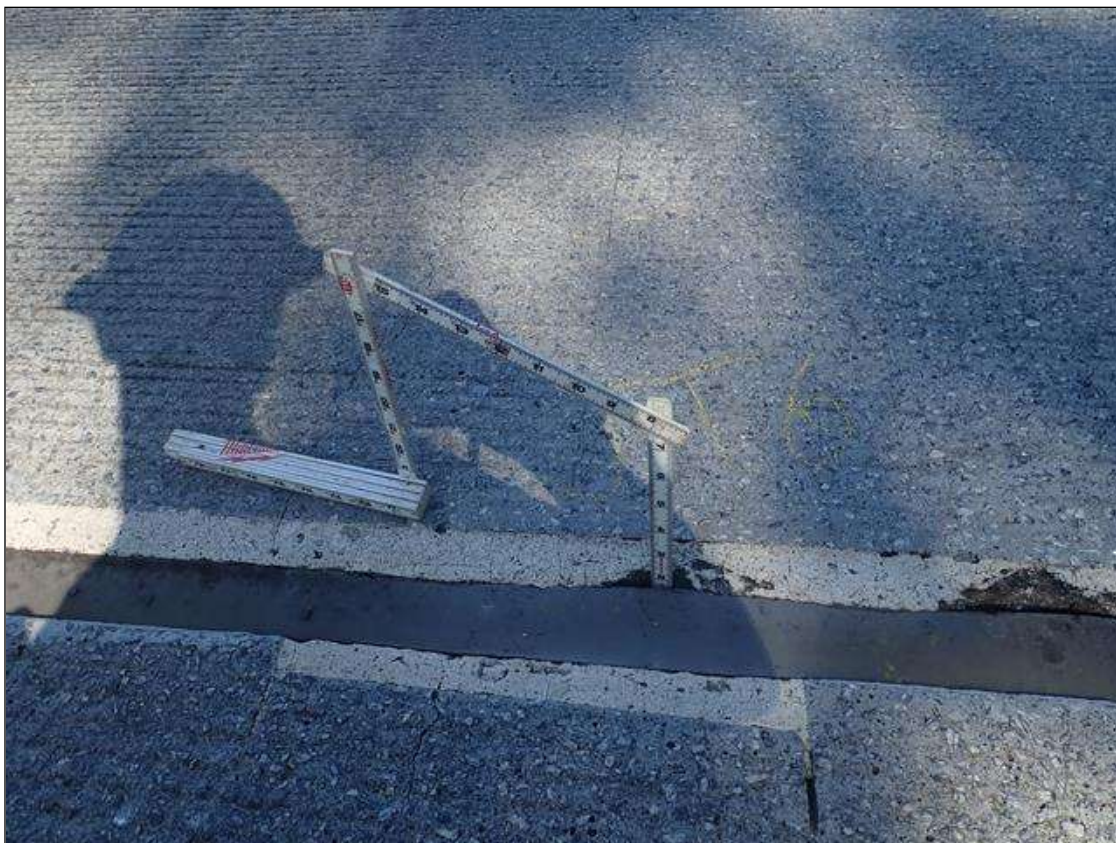
Expansion Joint 1 : along joint in right lane, seal adhesion failure [up to 2in deep]

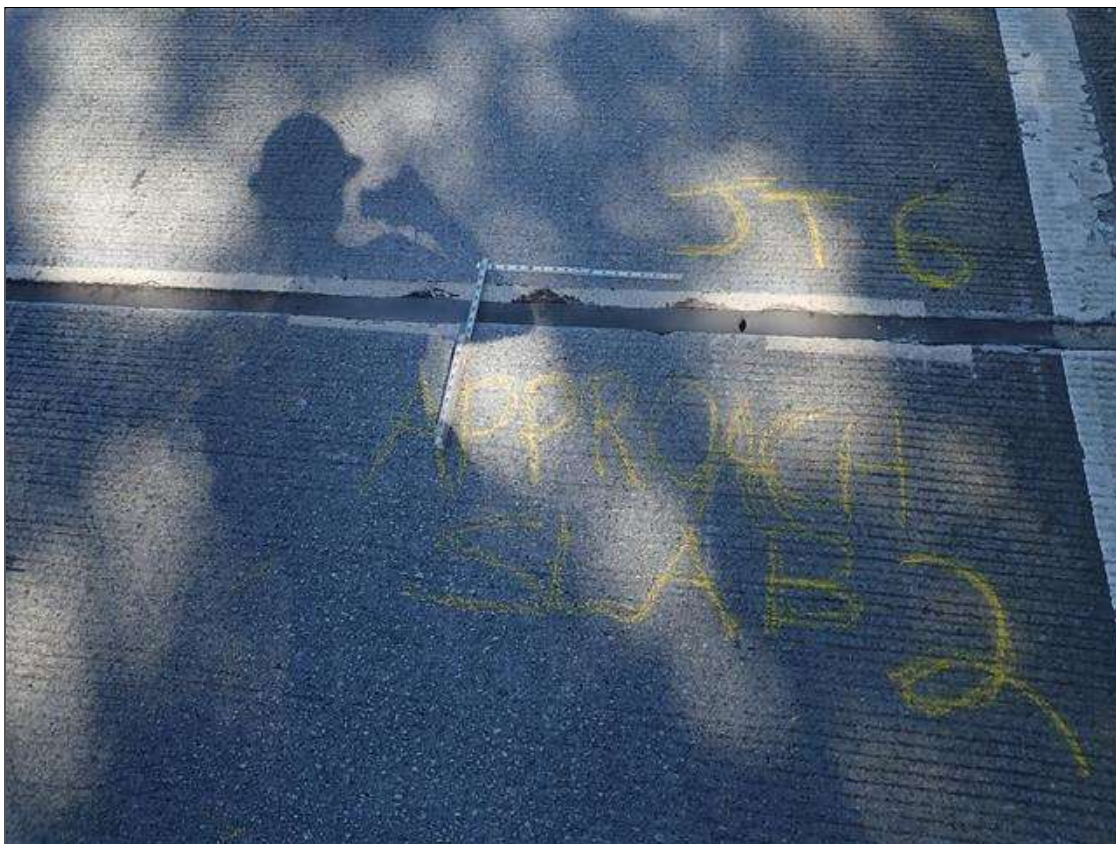
Expansion Joint 1 : at 5ft from East curb, hole in joint material [1-1/2in x 1/2in x 1-3/4in deep]

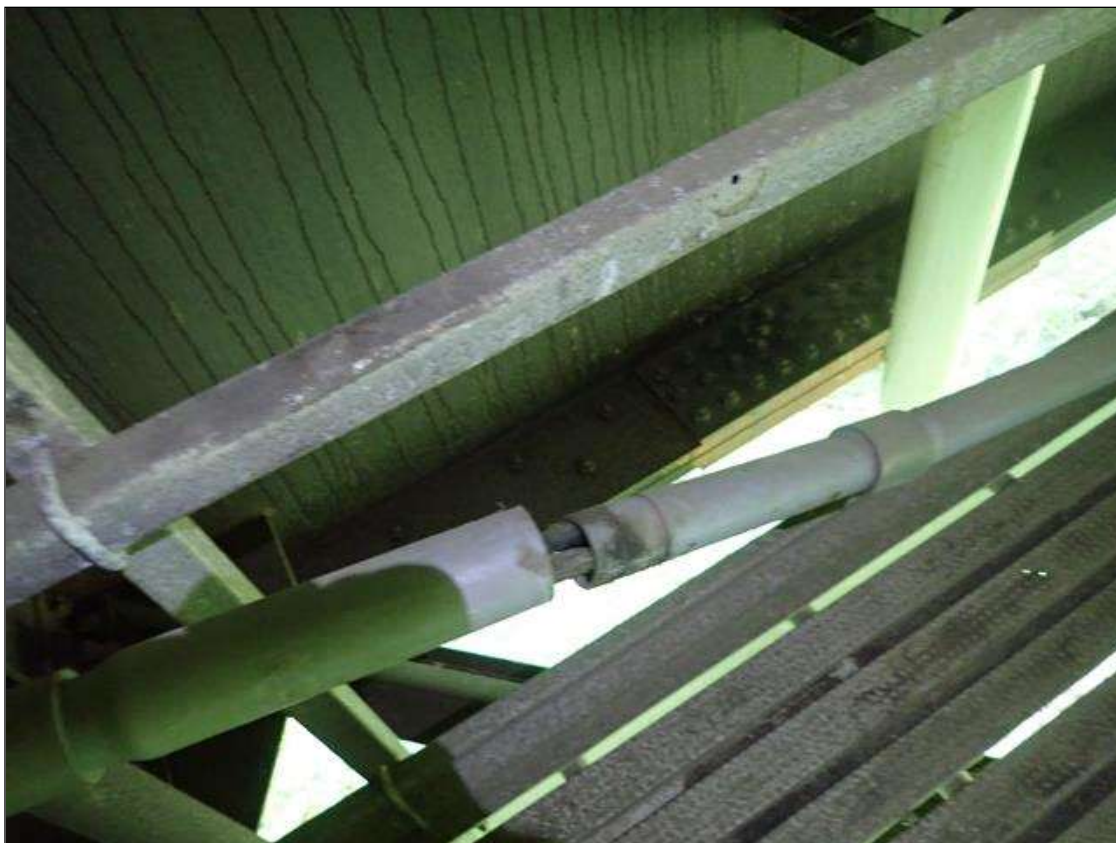
Utilities: span 2 beam 1 between floor beam 3 and 4, attached utility broken and detached

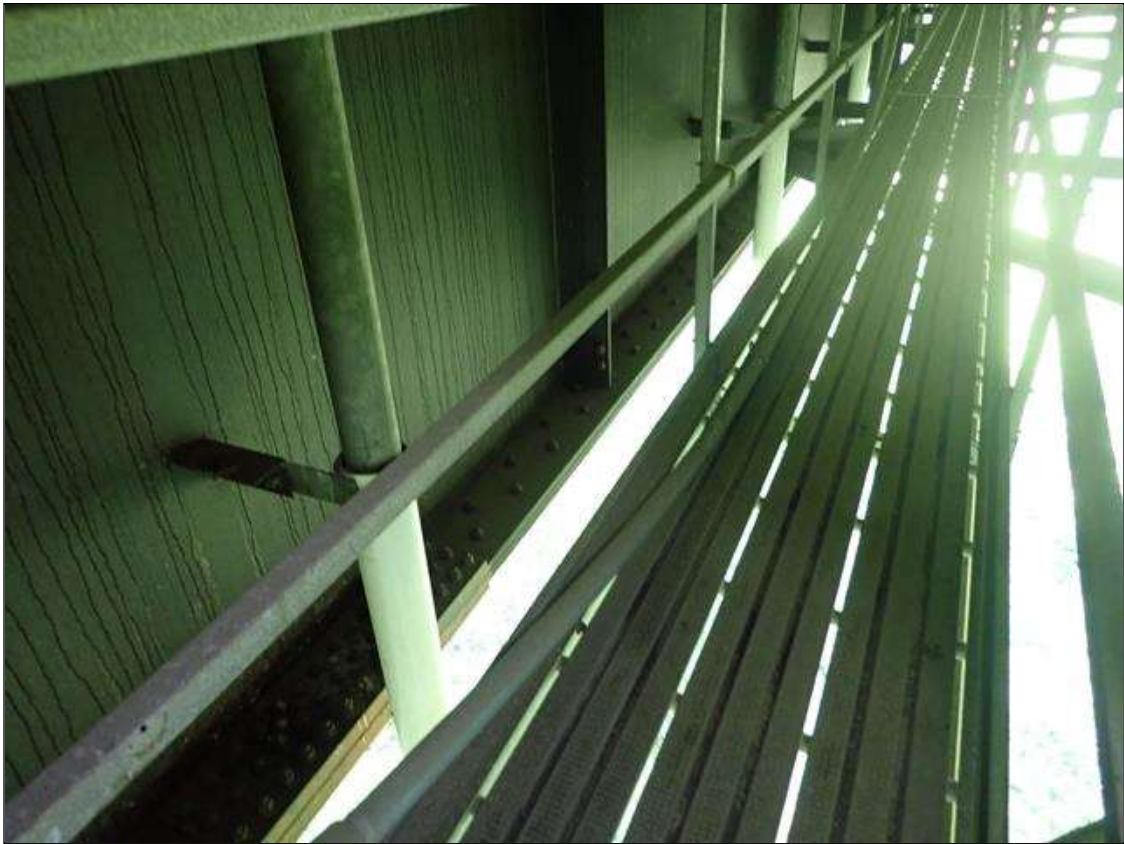
Utilities: span 2 beam 1 between floor beam 3 and 4, attached utility broken and detached

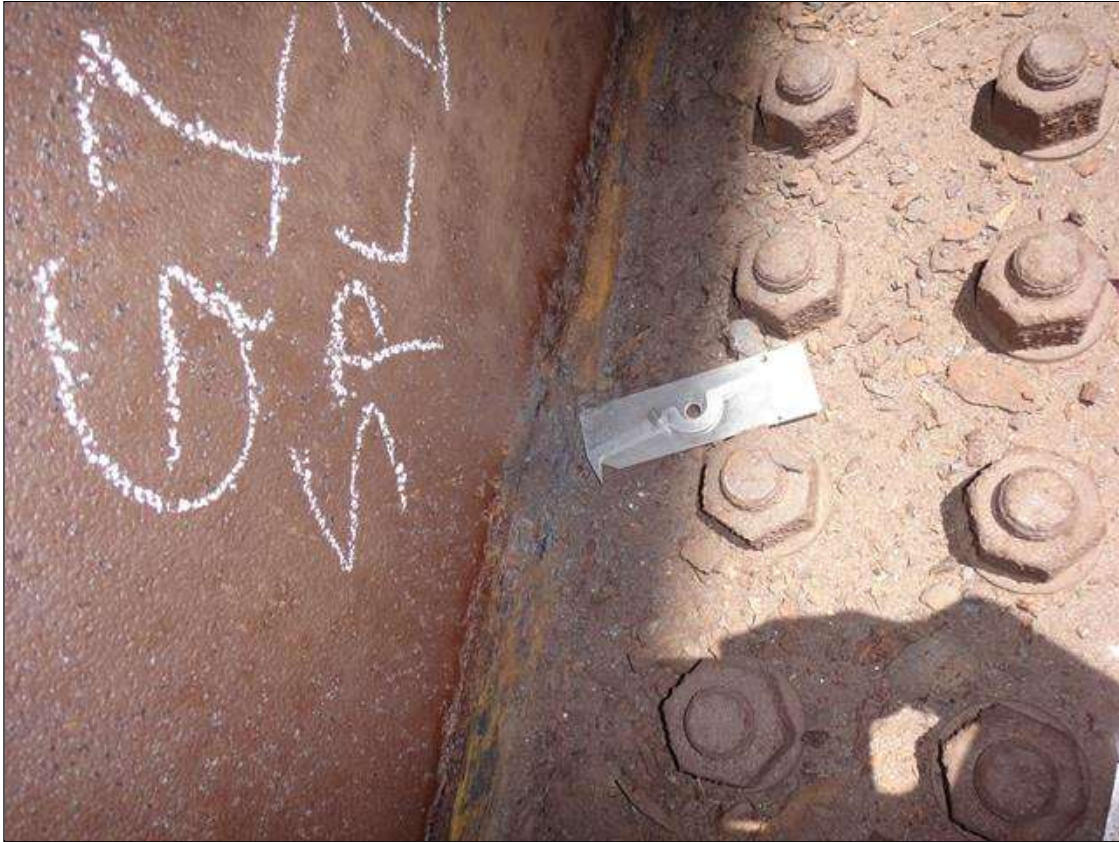
Span 2 Beam 1: span 3, lower web and splice plate both faces at splice plate 11, active corrosion with section loss, web [6.5ft x 3in - avg rem 1/2in] with areas of 3/16in loss [avg rem 3/8in]; plate [full width x 1-1/2in x 1/16in loss], and lower bolts [10% loss]
