NC DEPARTMENT OF TRANSPORTATION  
 DIVISION OF HIGHWAYS  
 STRUCTURE MANAGEMENT UNIT

ATTENTION: **FRACTURE CRITICAL**, Priority Action Request, Changes to Structure Data; inspected South to North - I26 runs West to East

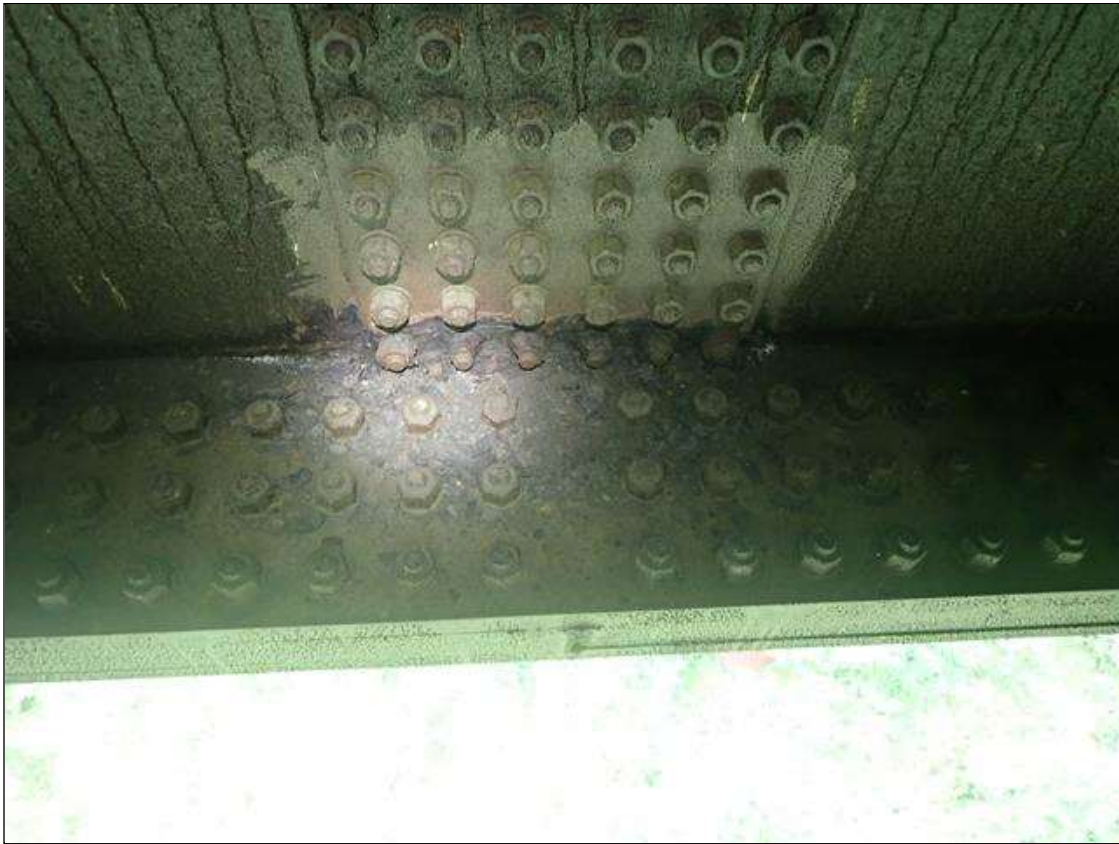
Span 2 Beam 1: span 3, lower web and splice plate both faces at splice plate 11, active corrosion with section loss, web [6.5ft x 3in - avg rem 1/2in] with areas of 3/16in loss [avg rem 3/8in]; plate [full width x 1-1/2in x 1/16in loss], and lower bolts [10% loss]

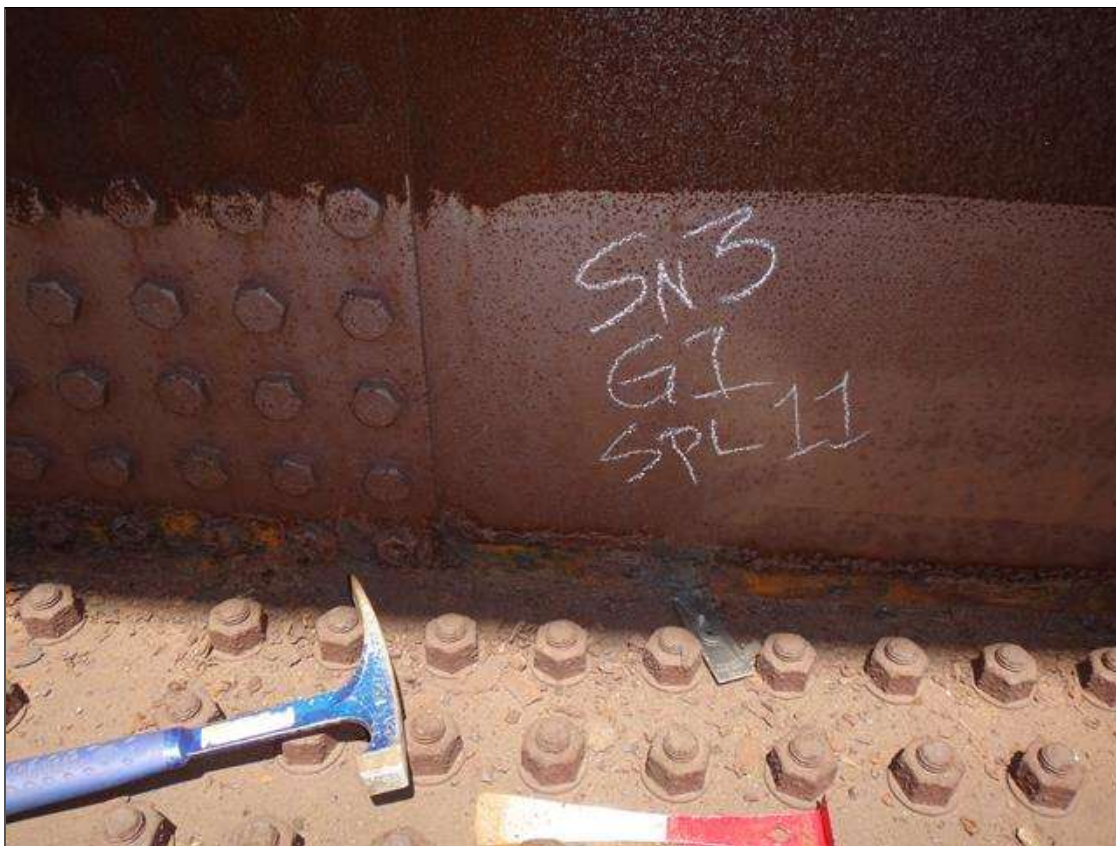
Span 2 Beam 1: span 3, lower web and splice plate both faces at splice plate 11, active corrosion with section loss, web [6.5ft x 3in - avg rem 1/2in] with areas of 3/16in loss [avg rem 3/8in]; plate [full width x 1-1/2in x 1/16in loss], and lower bolts [10% loss]

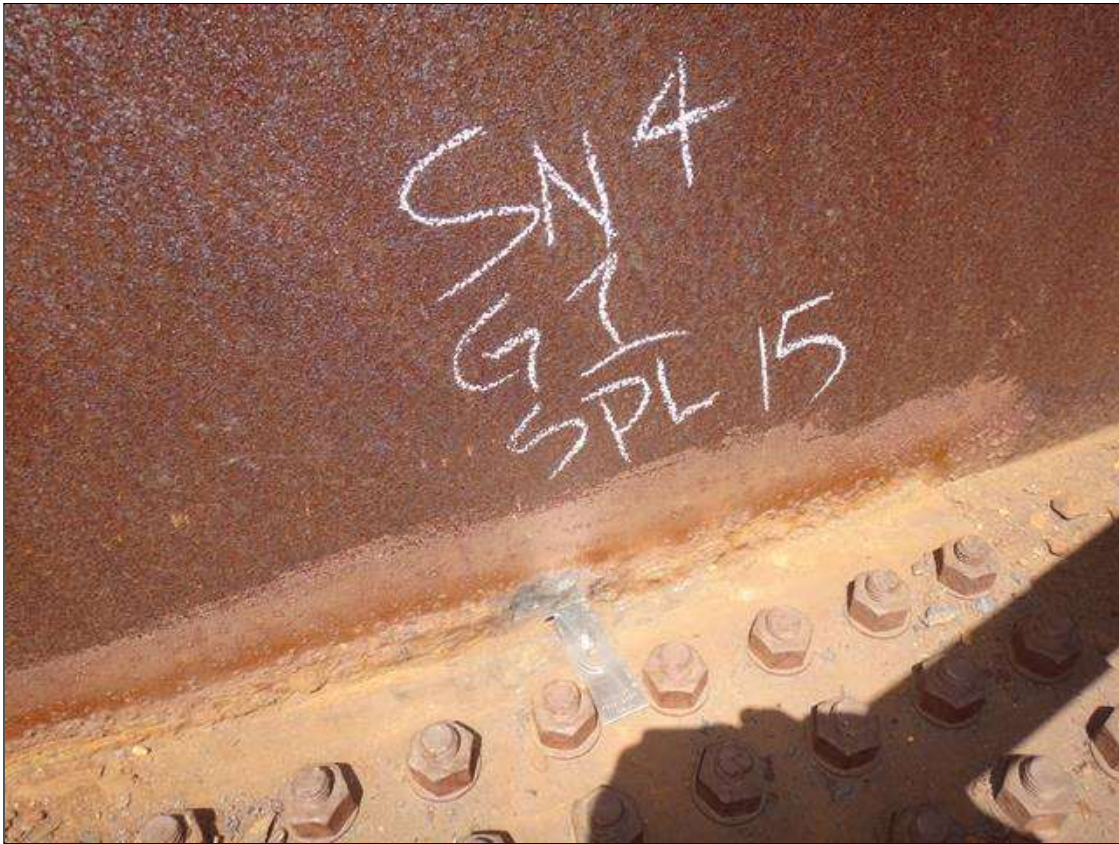
Span 2 Beam 1: span 4, lower web and splice plate exterior face at splice plate 16, active corrosion with section loss, web [4ft x 2in - avg rem 7/16in]; top of plate [full width x 1in x 1/16in loss]

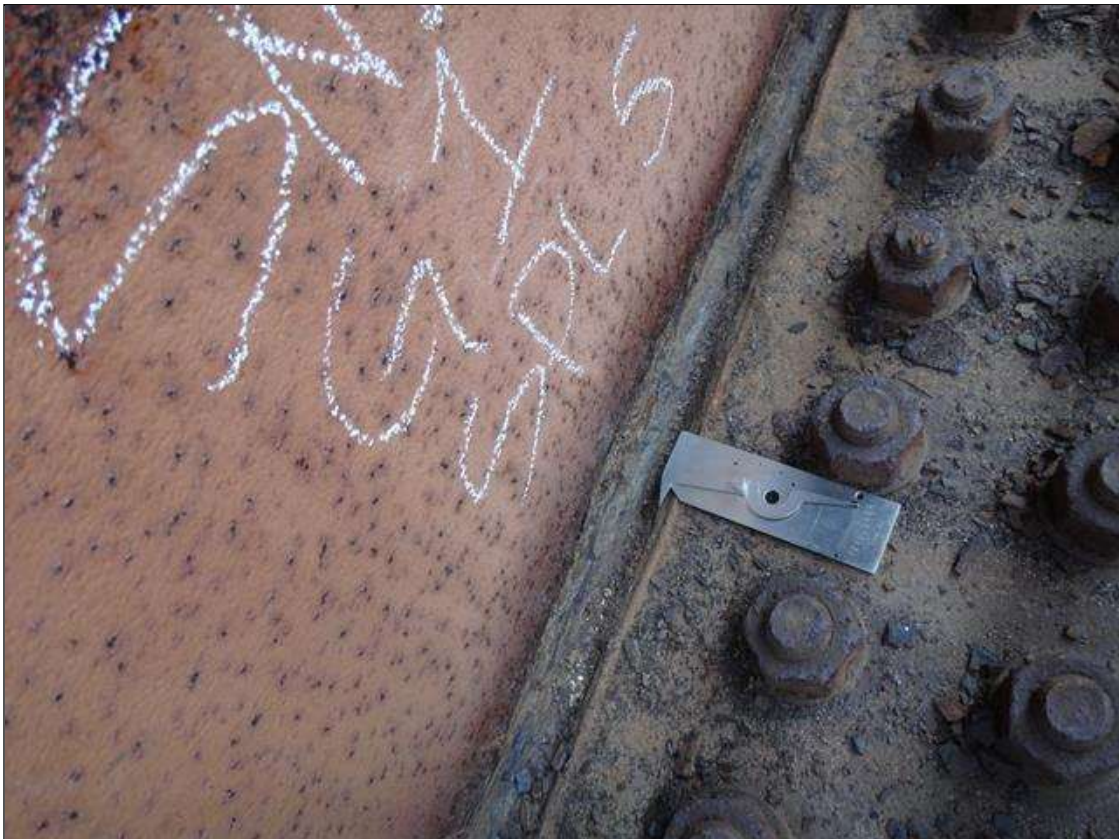
Span 2 Beam 1: [PAR] span 2, exterior and interior of lower web at splice 5, active corrosion with section loss [7ft x 2-1/2in - avg rem 7/16in] with areas of up to 1/4in loss [avg rem 3/8in]

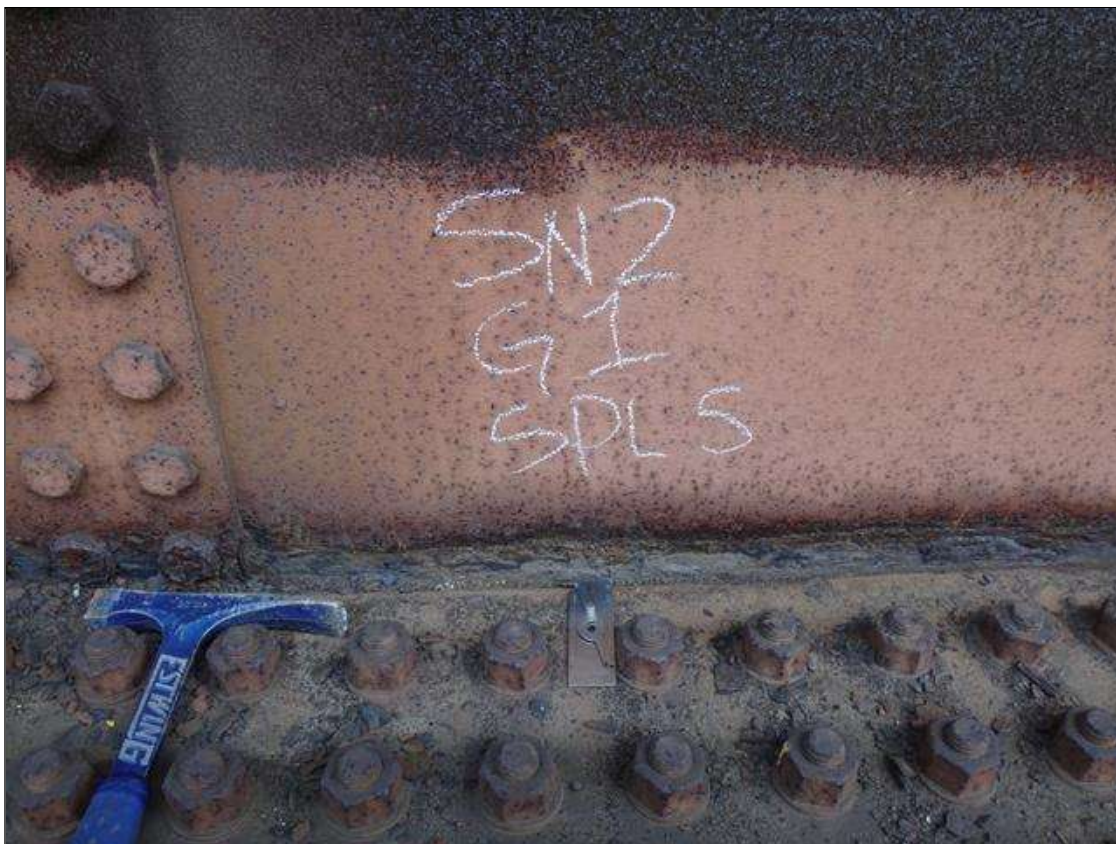
Span 2 Beam 1: [PAR] span 2, exterior and interior of lower web at splice 5, active corrosion with section loss [7ft x 2-1/2in - avg rem 7/16in] with areas of up to 1/4in loss [avg rem 3/8in]

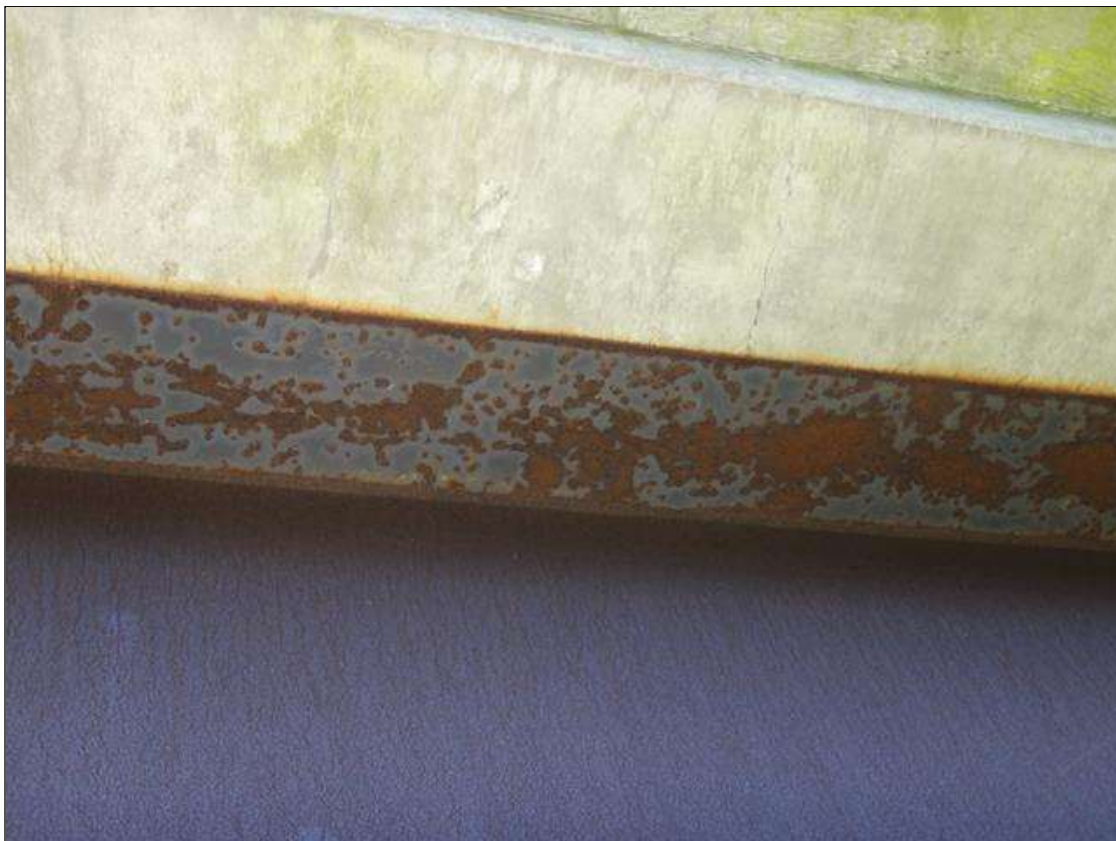
Span 2 Beam 1: underside of top flange over bent 3, underdeveloped patina with exposed steel

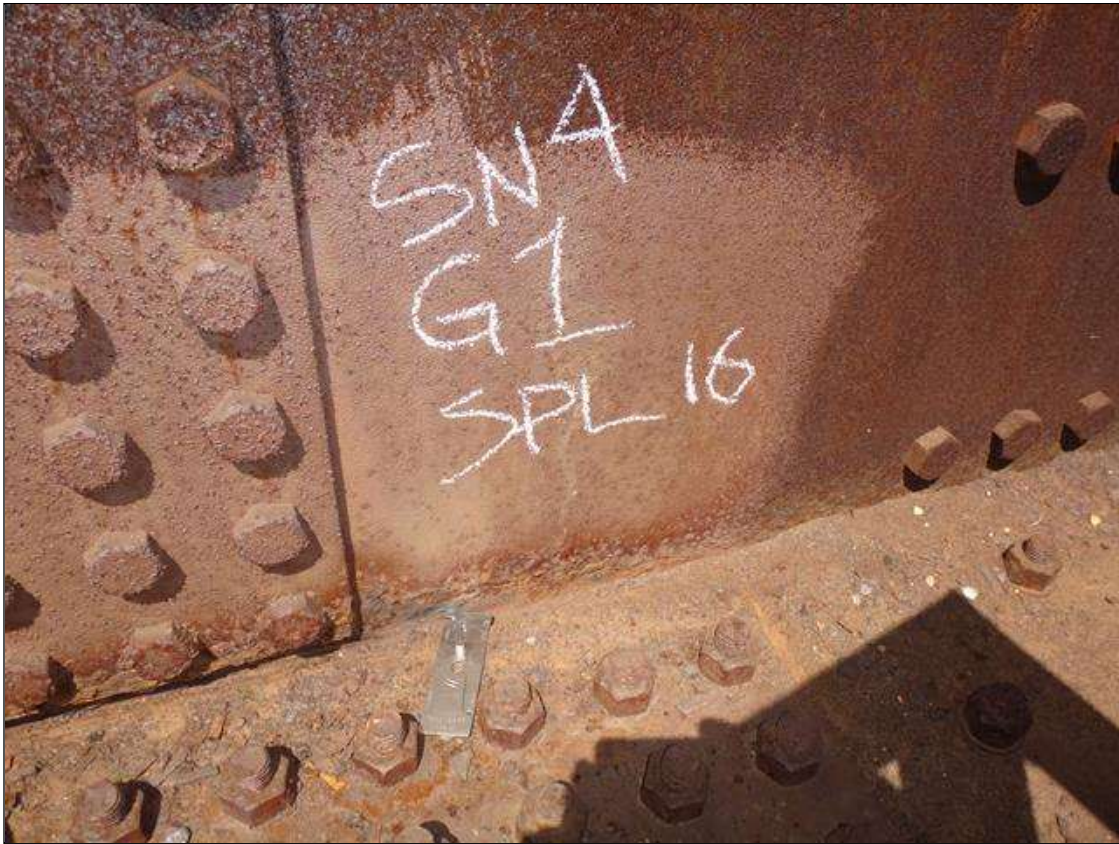
Span 2 Beam 1: [PAR] span 4, interior and exterior face of lower web at splice 16, active corrosion with section loss [4ft x 2in - avg rem 7/16in] with areas of 1/4in loss [avg rem 3/8in]

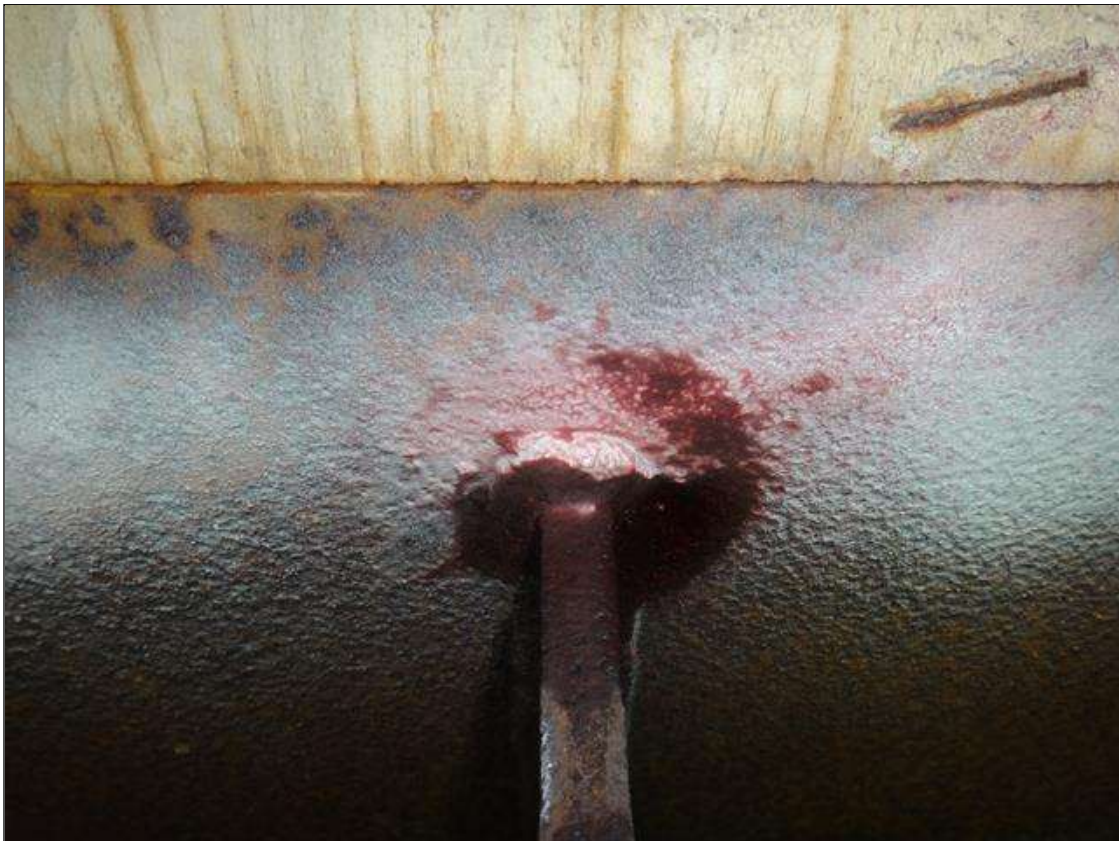
Span 2 Beam 1: exterior face of top flange at web stiffener 20, dye pen test indicates possible 1/8in crack in toe of weld

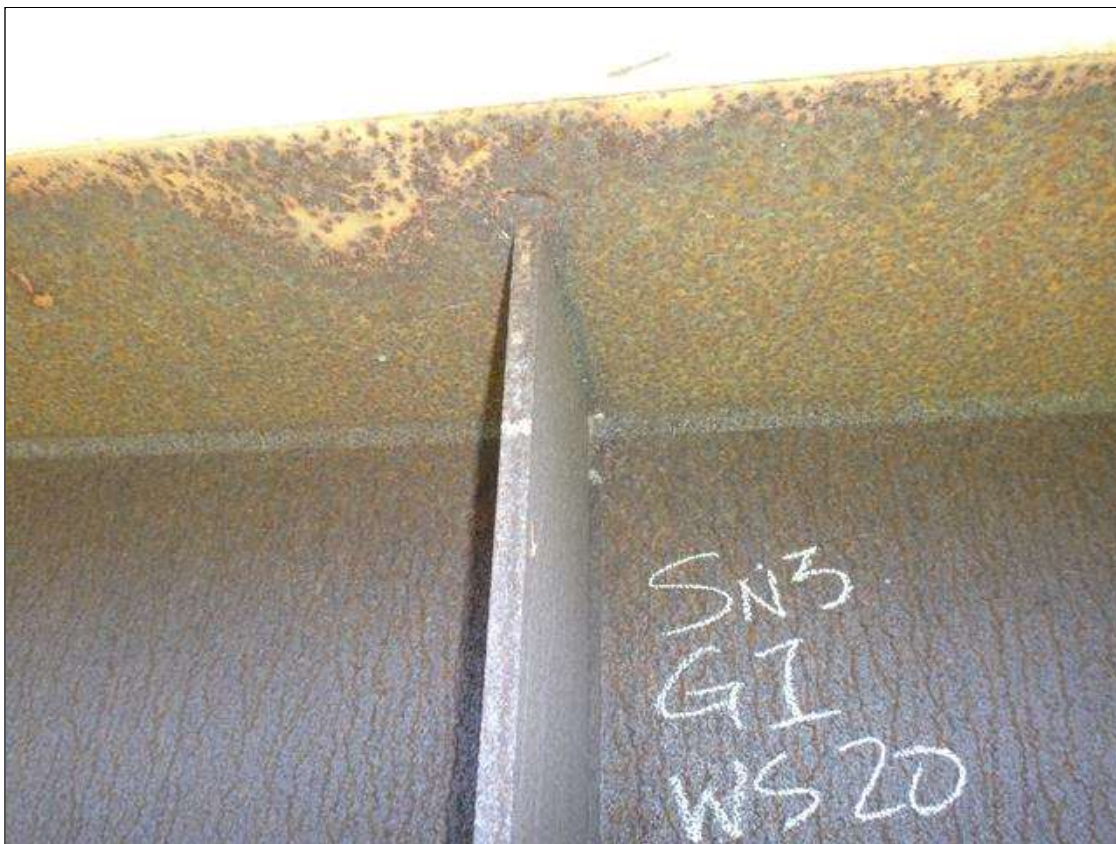
Span 2 Beam 1: exterior face of top flange at web stiffener 20, dye pen test indicates possible 1/8in crack in toe of weld

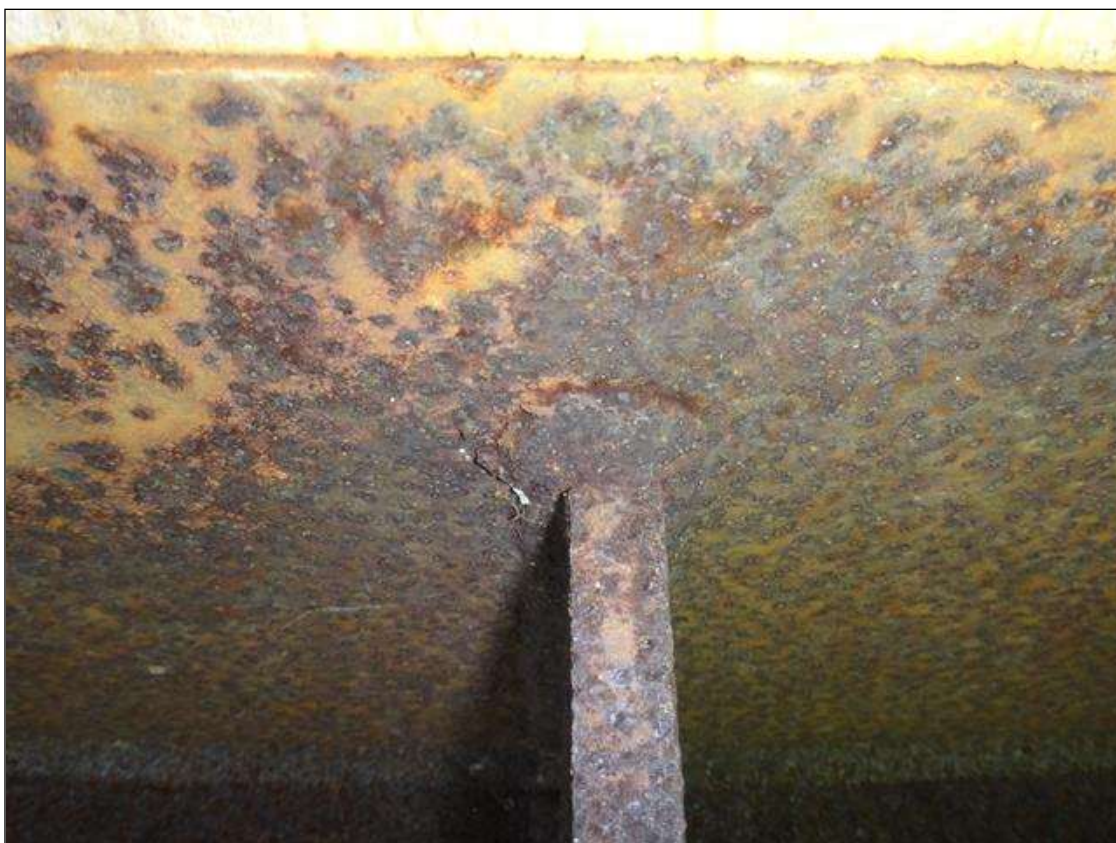
Span 2 Beam 1: exterior face of top flange at web stiffener 20, dye pen test indicates possible 1/8in crack in toe of weld

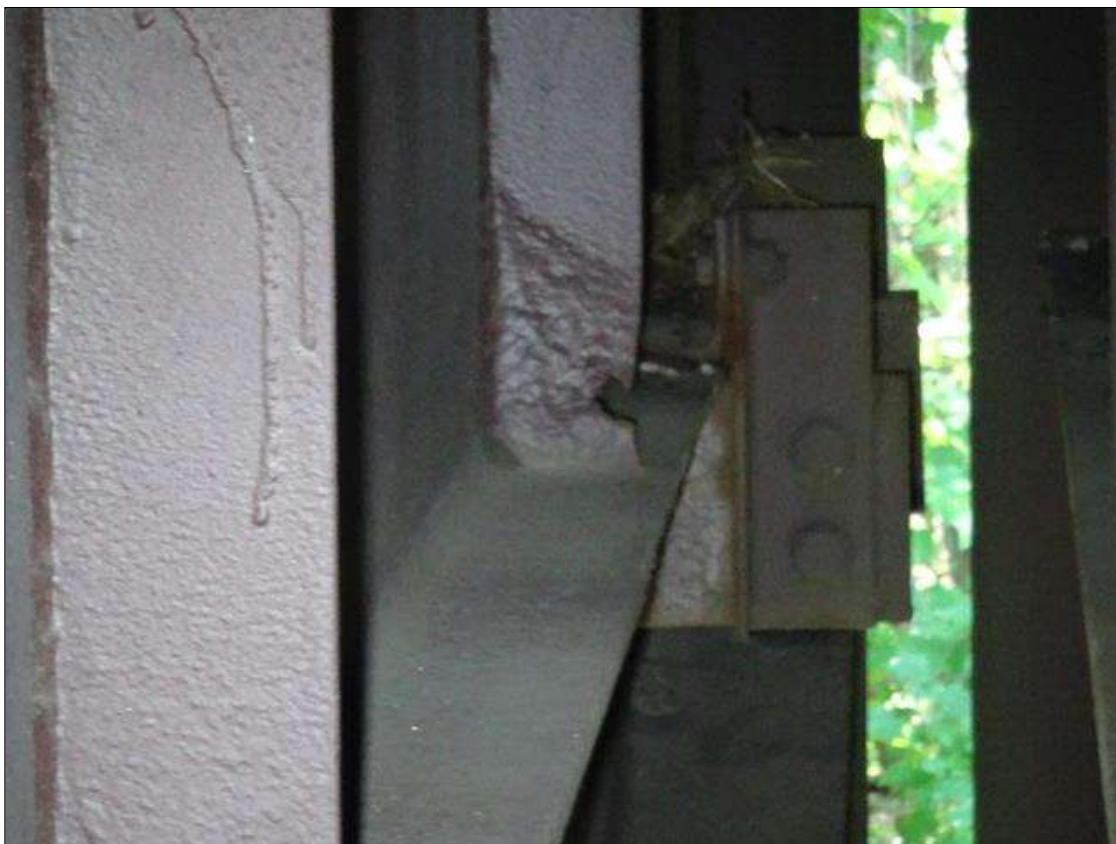
Span 2 Floor Beam 1: first web stiffener from girder 2, painted over pitting [5in x full width x down to knife edge] with corrosion hole [1in diameter]

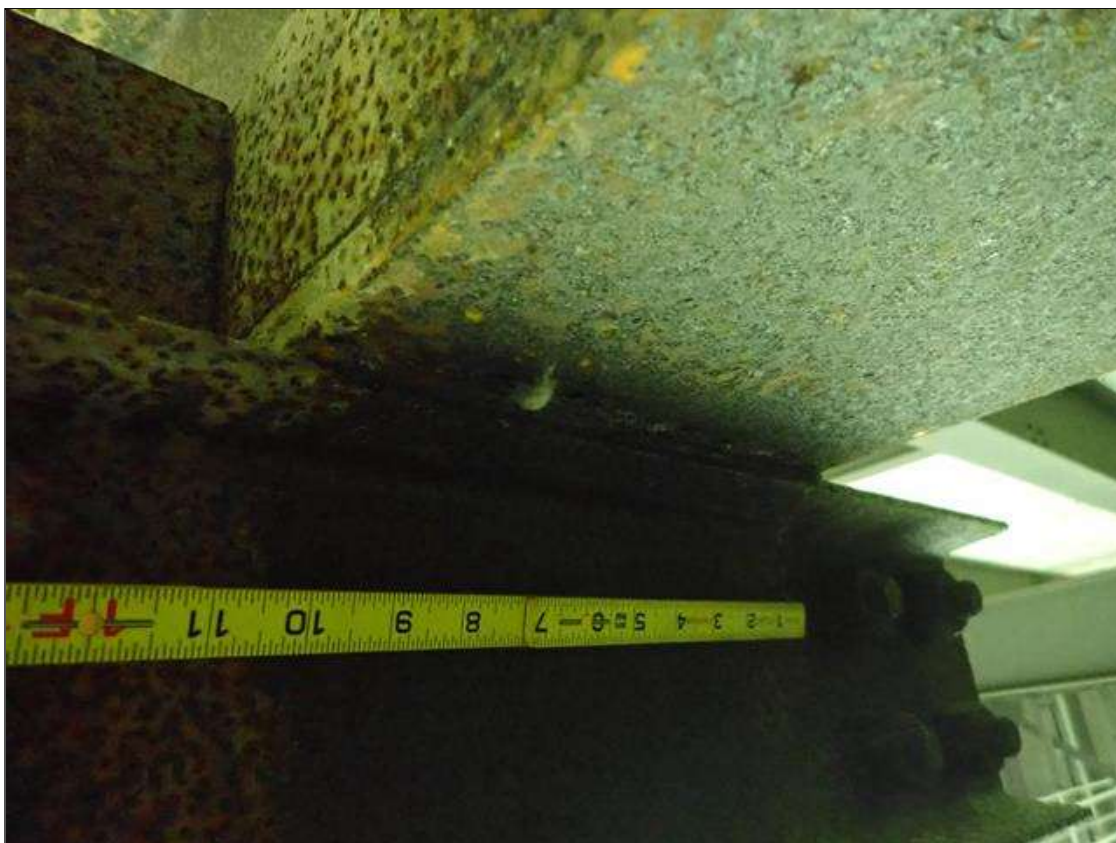
Span 2 Floor Beam 6: underside of bottom flange at catwalk connection, active corrosion with section loss [full width x 1in x up to 1/16in loss]

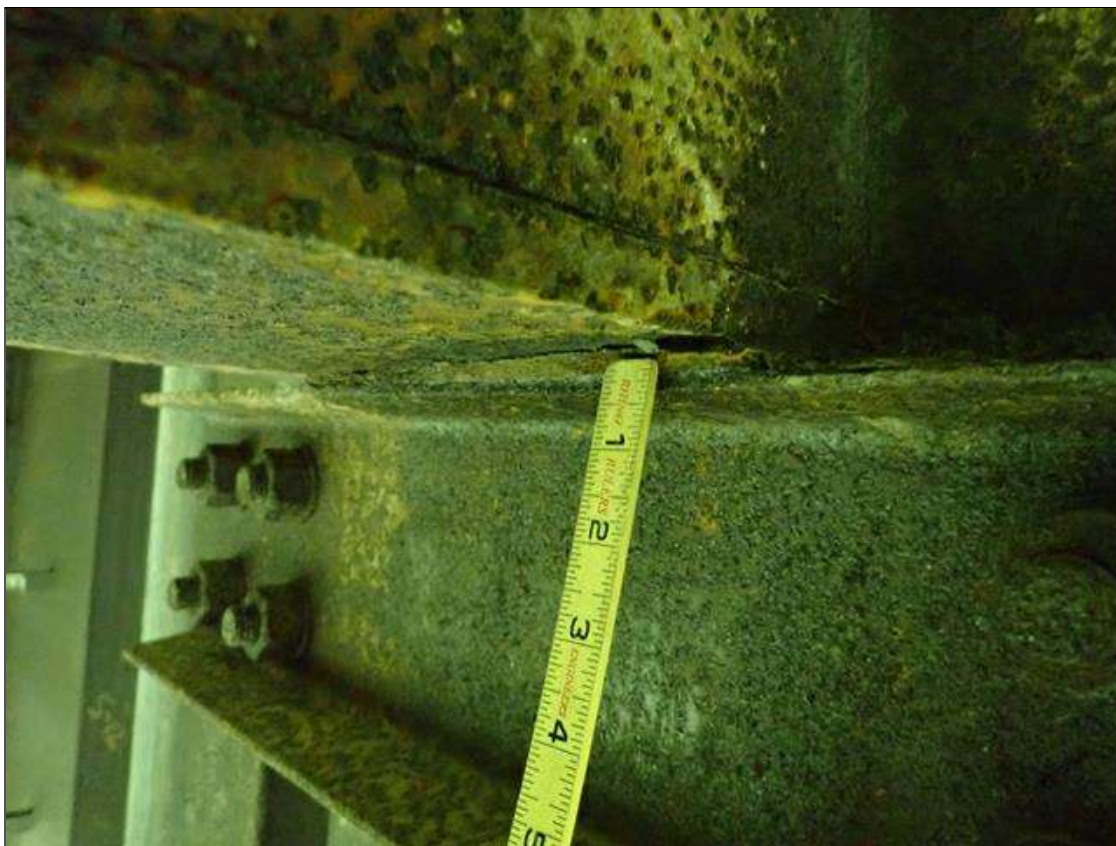
Span 2 Floor Beam 6: between floor beam bottom flange and catwalk hanger at girder 1, pack rust [1/8in] with section loss [up to 1/16in]

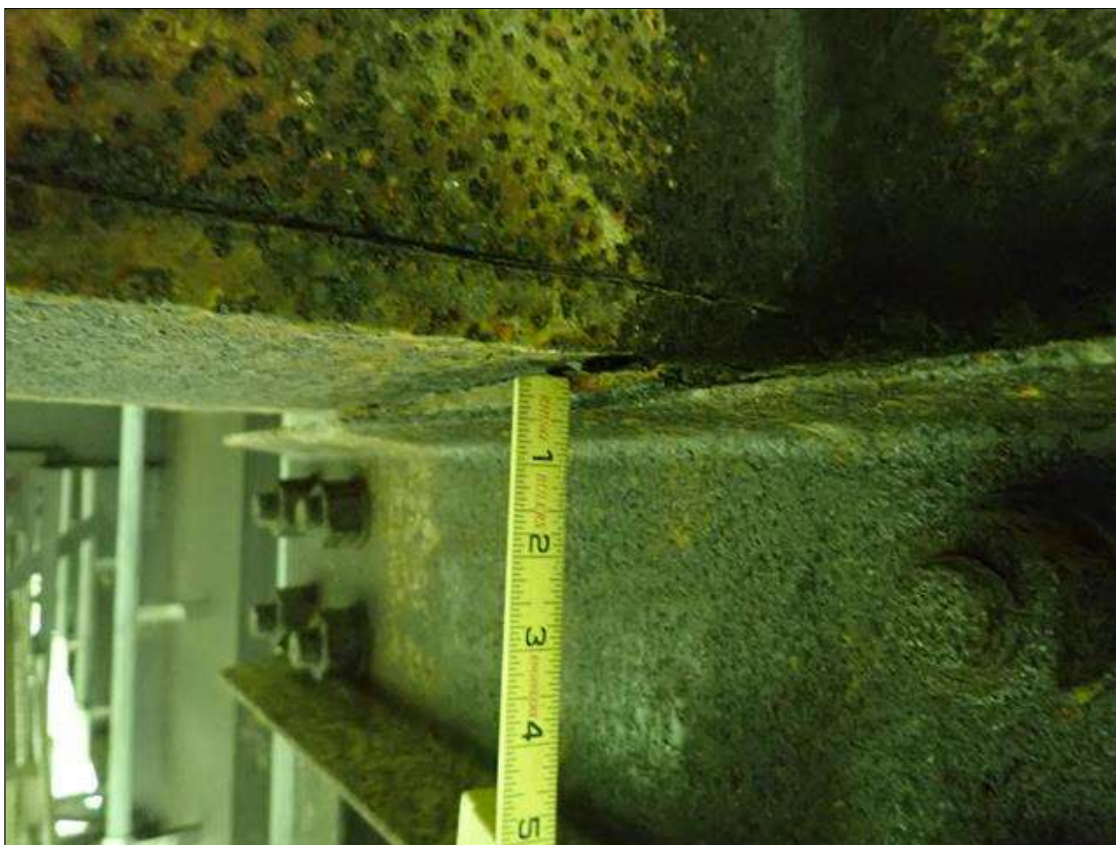
Span 2 Floor Beam 6: between floor beam bottom flange and catwalk hanger at girder 1, pack rust [1/8in] with section loss [up to 1/16in]

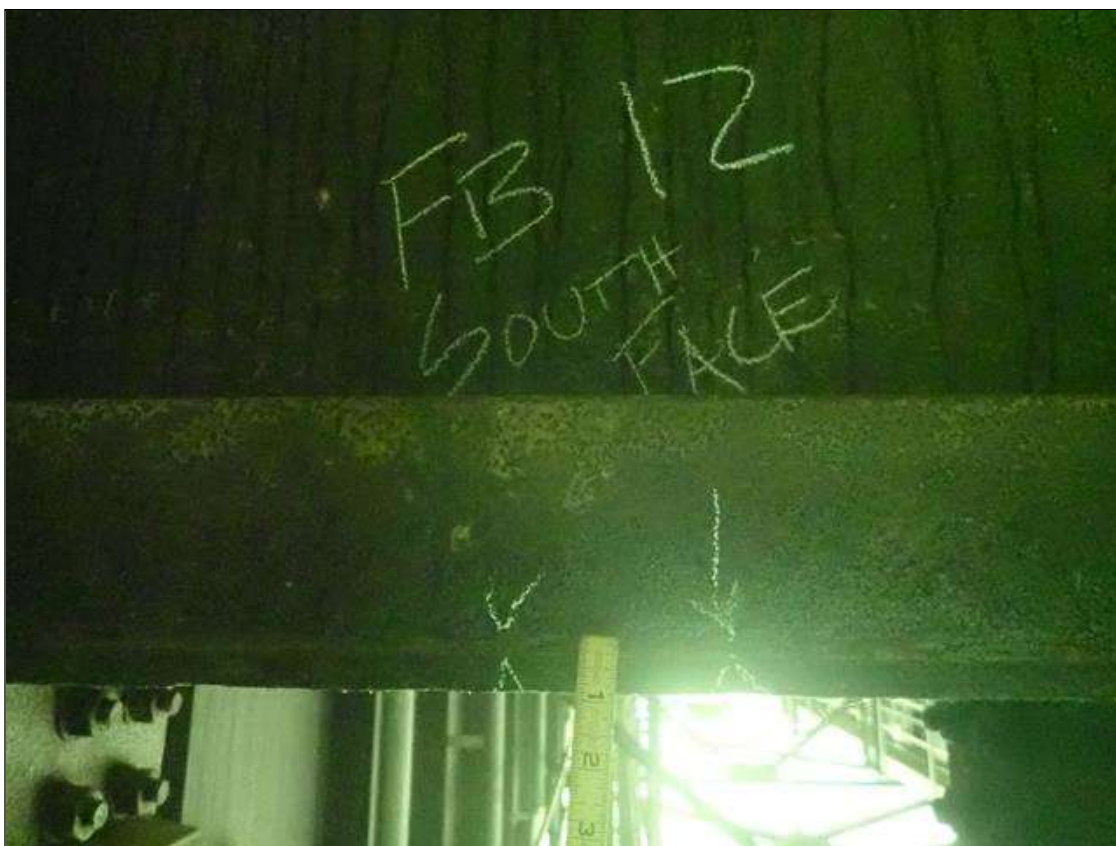
Span 2 Floor Beam 12: between floor beam bottom flange and catwalk hanger at both girders, pack rust [up to 1/4in]

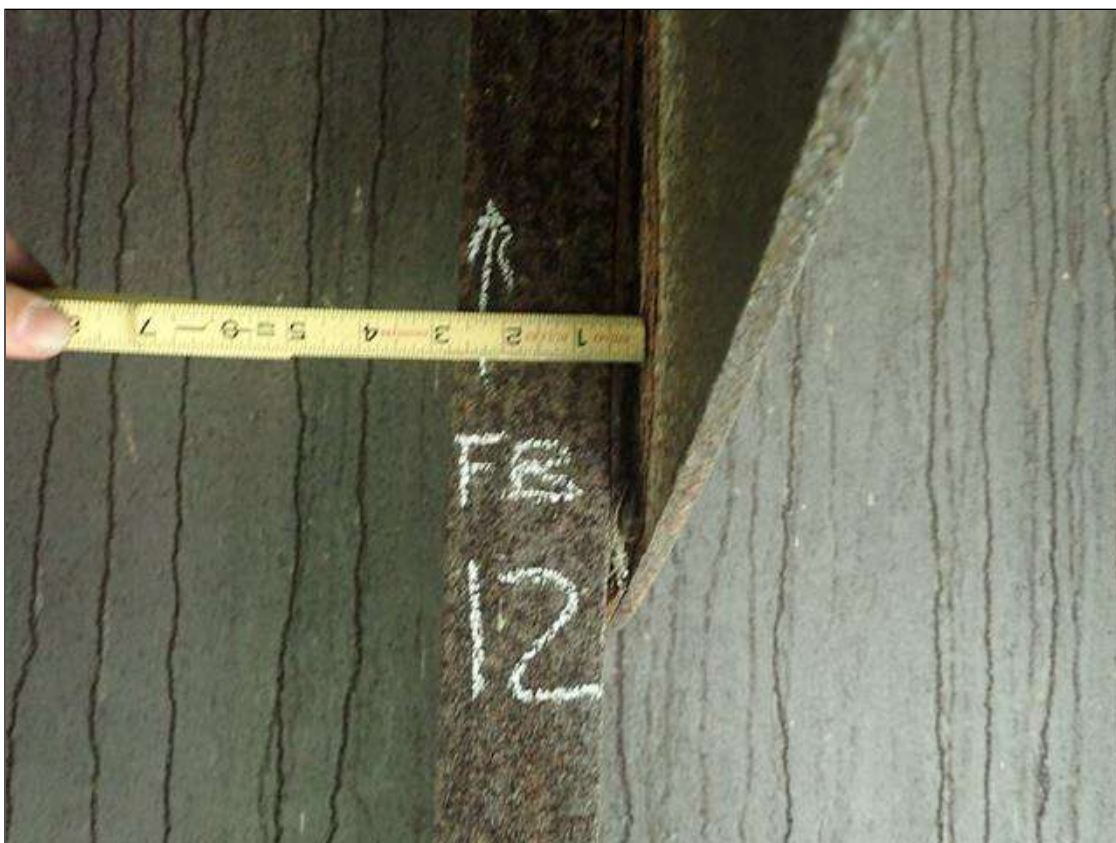
Span 2 Floor Beam 12: between upper gusset plate and web stiffener at both girders, pack rust [up to 1/2in]

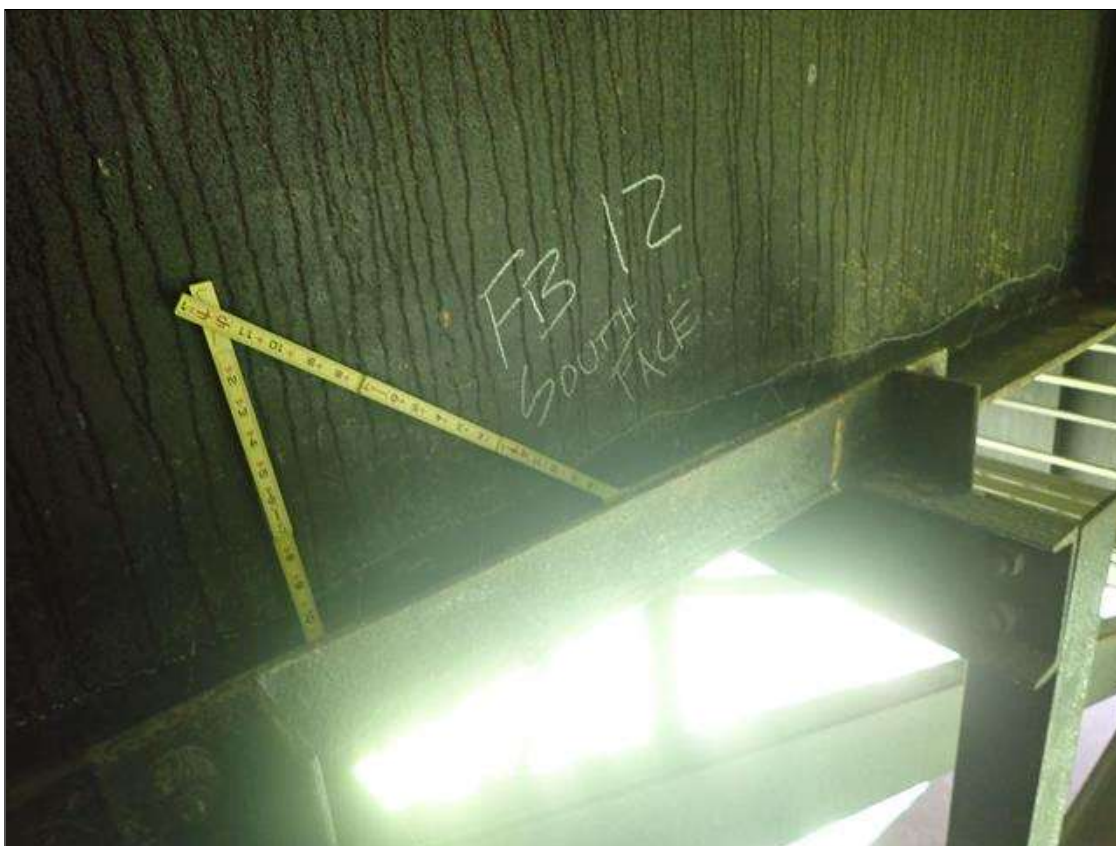
Span 2 Floor Beam 12: [PAR] lower web south face next to girder 1, active corrosion with section loss [7ft x 4in - avg rem 5/16in]

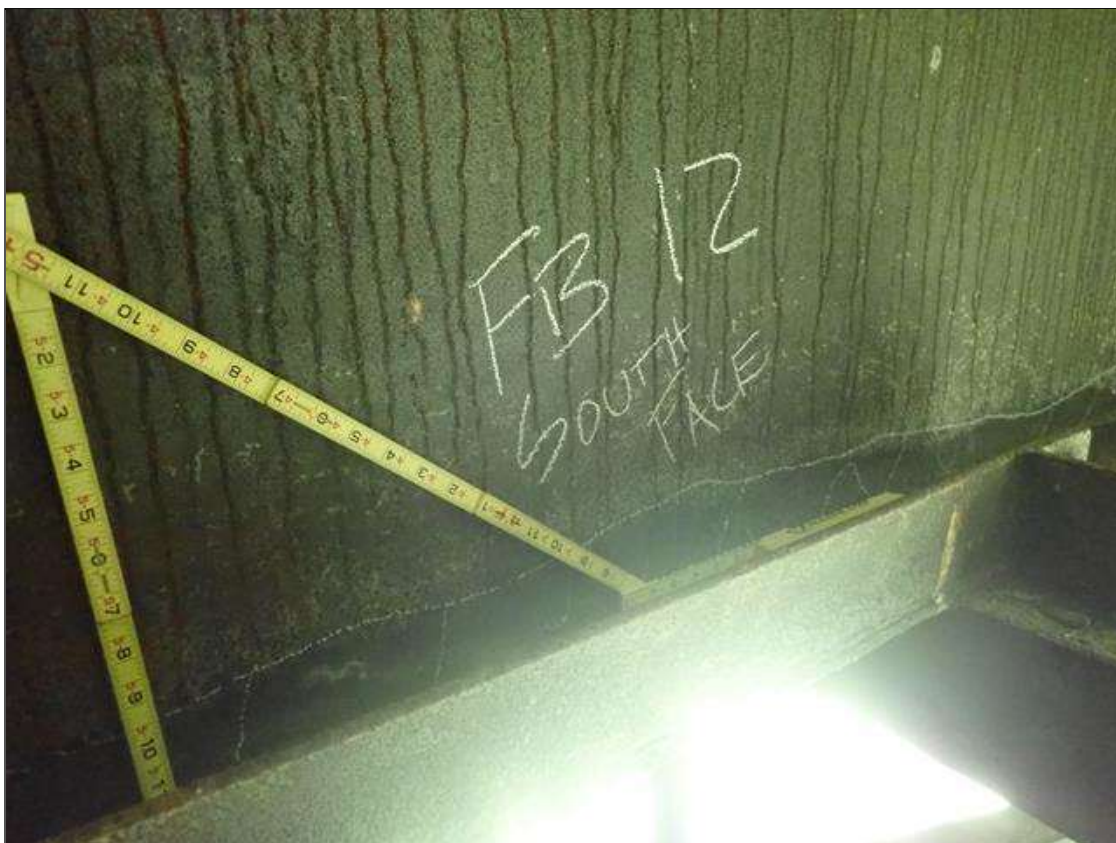
Span 2 Floor Beam 12: [PAR] lower web south face next to girder 1, active corrosion with section loss [7ft x 4in - avg rem 5/16in]

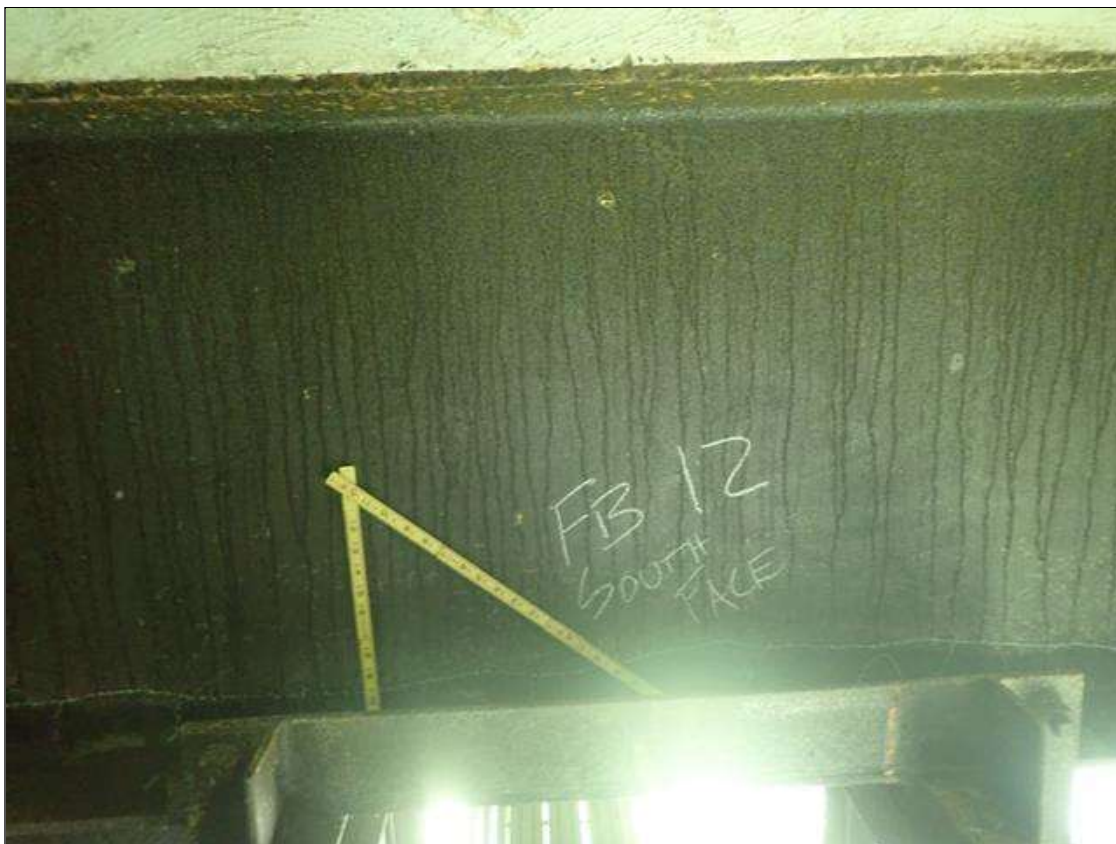
Span 2 Floor Beam 12: [PAR] lower web south face next to girder 1, active corrosion with section loss [7ft x 4in - avg rem 5/16in]

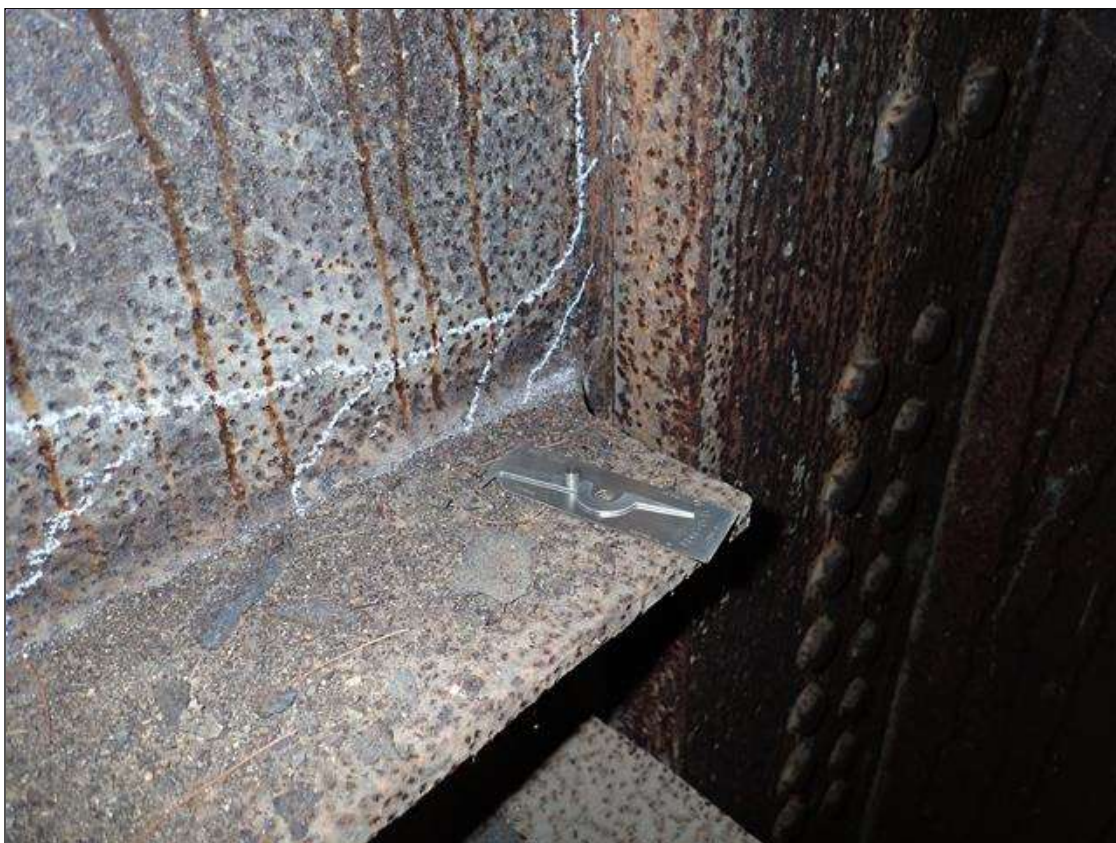
Span 2 Floor Beam 12: lower web South face next to girder 2, active corrosion with section loss [full height x up to 2in - avg rem 3/8in] with pack rust [up to 5/16in]

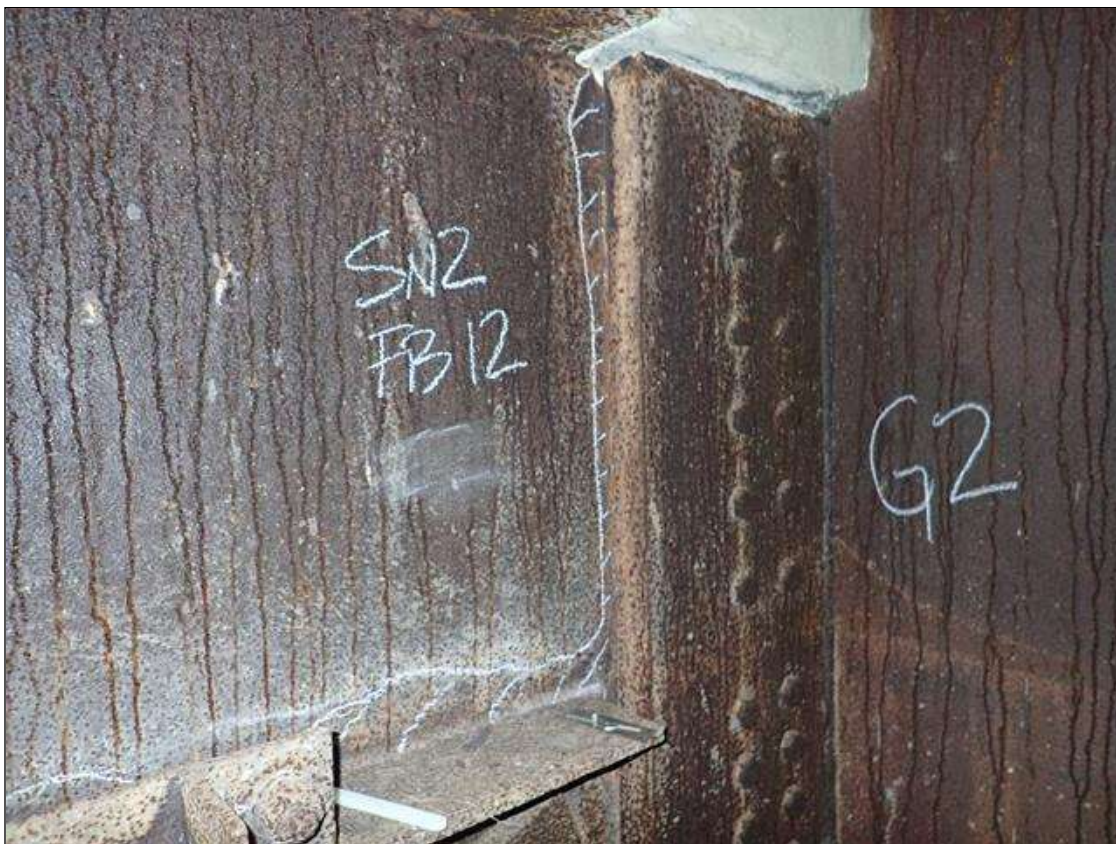
Span 2 Floor Beam 12: lower web South face next to girder 2, active corrosion with section loss [full height x up to 2in - avg rem 3/8in] with pack rust [up to 5/16in]

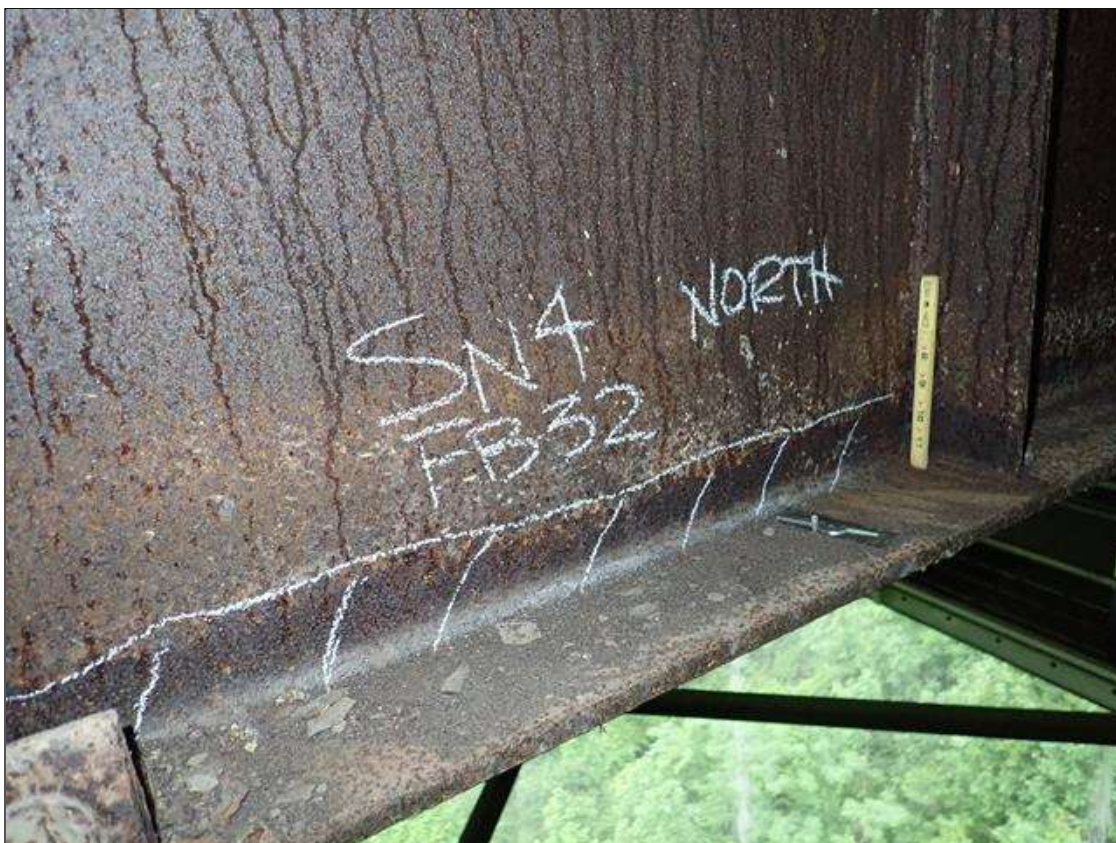
Span 2 Floor Beam 32: lower web North face, active corrosion with section loss [full length x 2in - avg rem 3/8in]

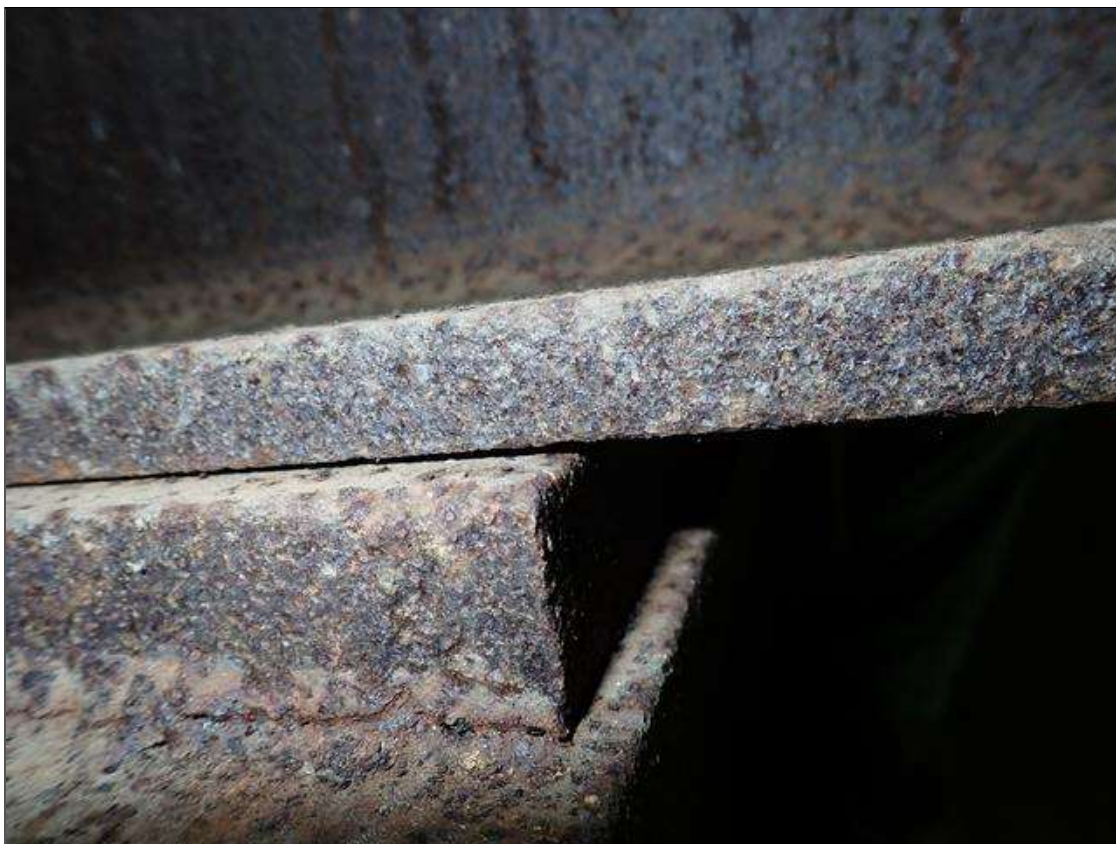
Span 2 Stringer 2: [PAR] at floor beam 33, missing anchor bolts on East face and two cracked tack welds [full length]
