NC DEPARTMENT OF TRANSPORTATION  
 DIVISION OF HIGHWAYS  
 STRUCTURE MANAGEMENT UNIT

ATTENTION: **FRACTURE CRITICAL**, Priority Action Request, Changes to Structure Data; inspected South to North - I26 runs West to East

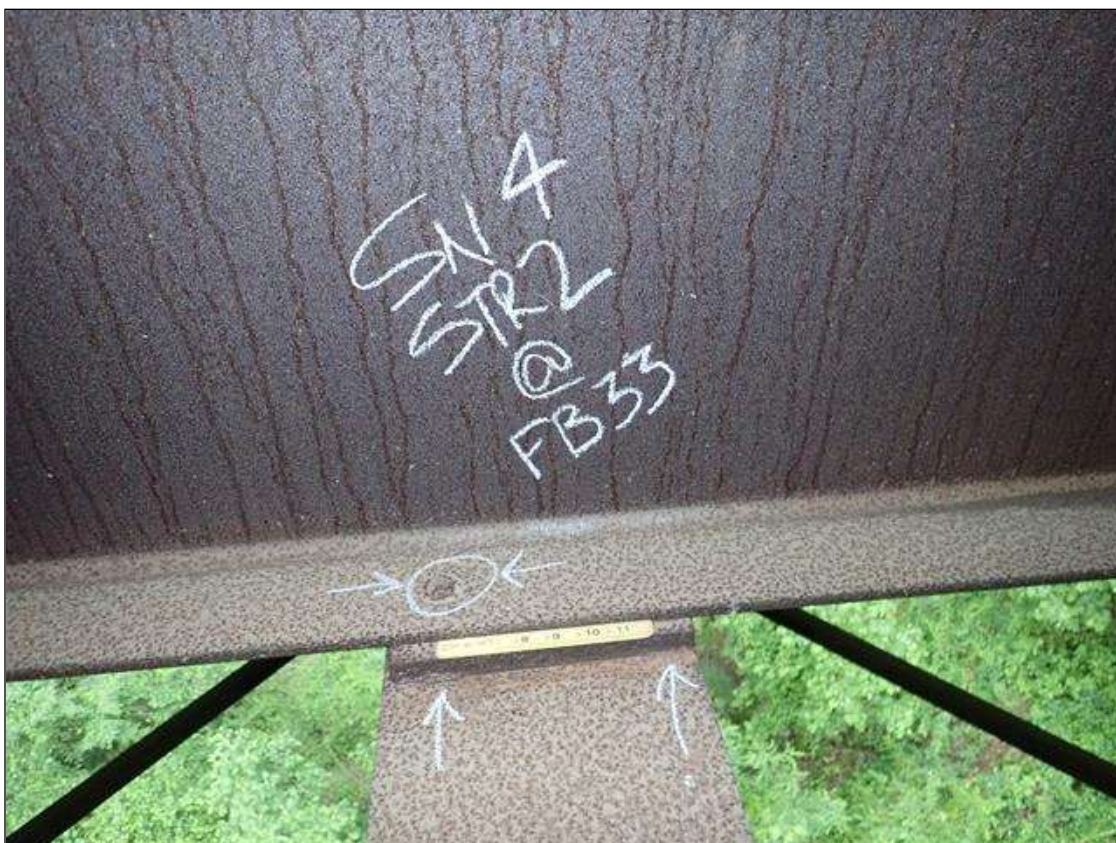
Span 2 Stringer 2: [PAR] at floor beam 33, missing anchor bolts on East face and two cracked tack welds [full length]

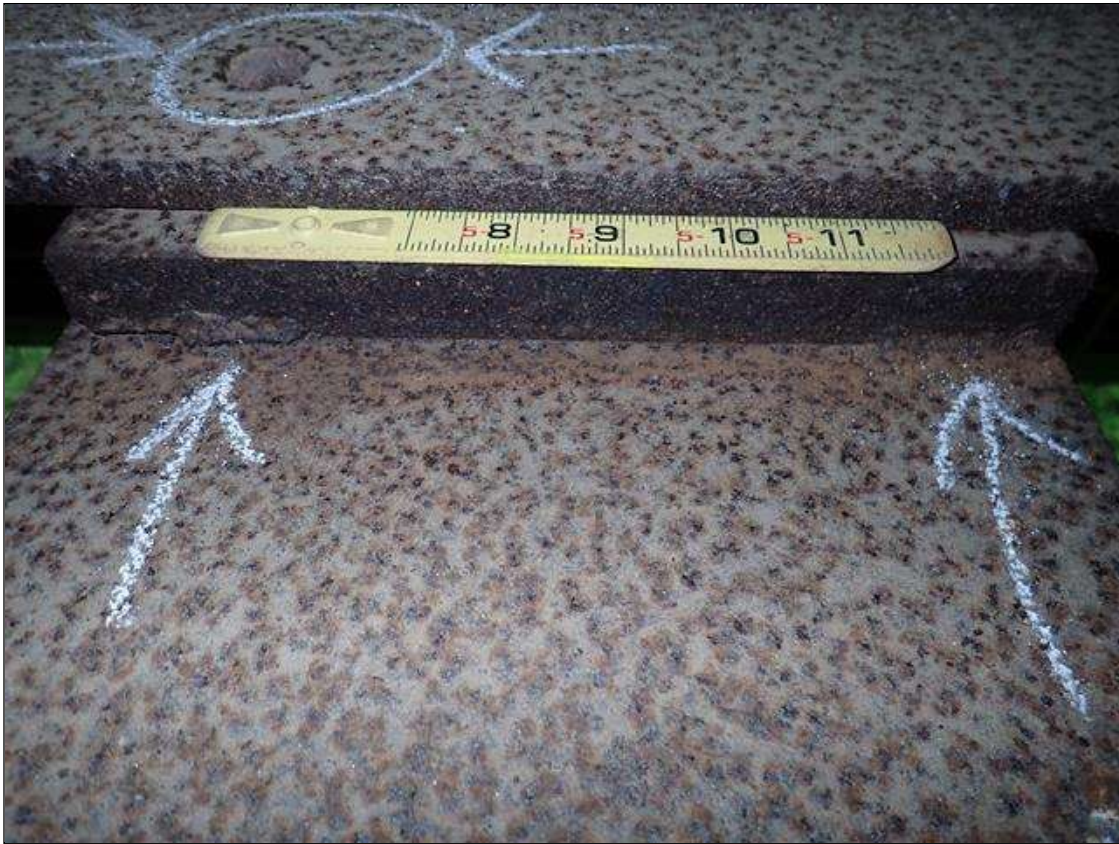
Span 2 Stringer 2: [PAR] at floor beam 33, missing anchor bolts on East face and two cracked tack welds [full length]

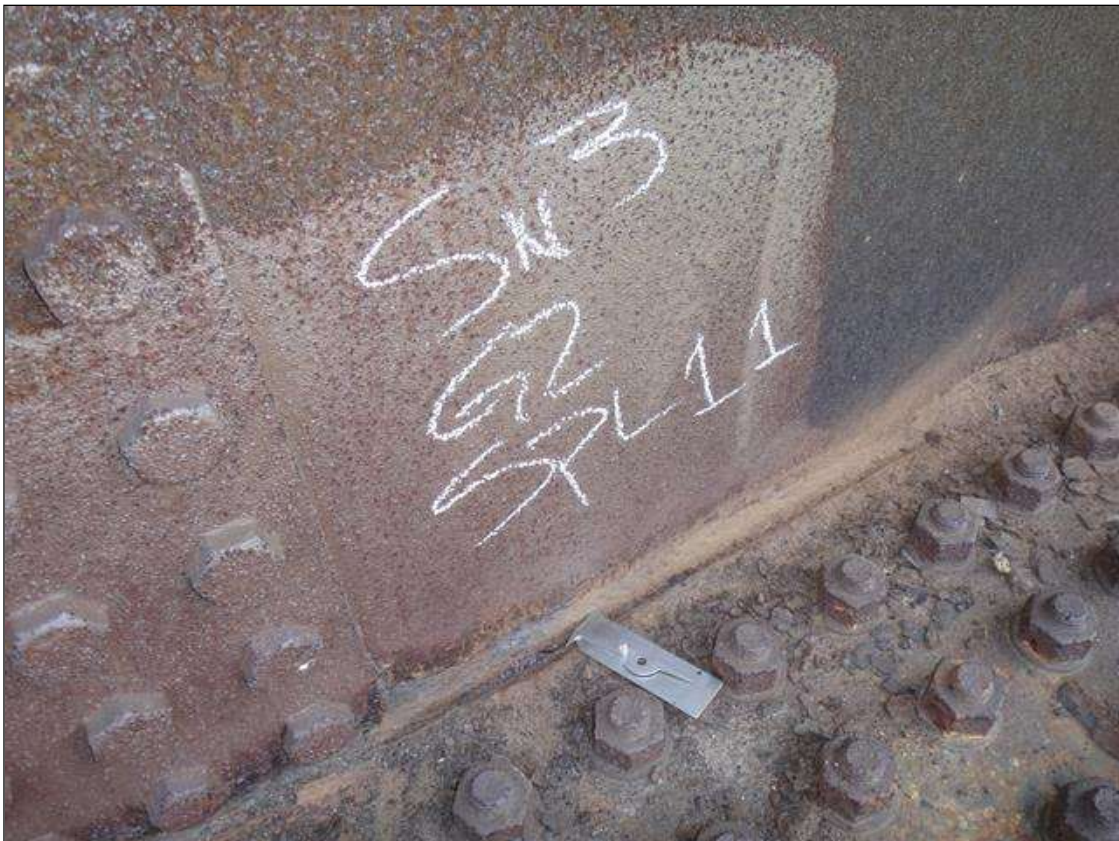
Span 2 Beam 2: span 3, lower web and splice plate exterior face at splice plate 11, active corrosion with section loss, web [7ft-10in x 2in x avg rem 1/2in]; plate [full width x 1-1/2in x 1/16in loss]

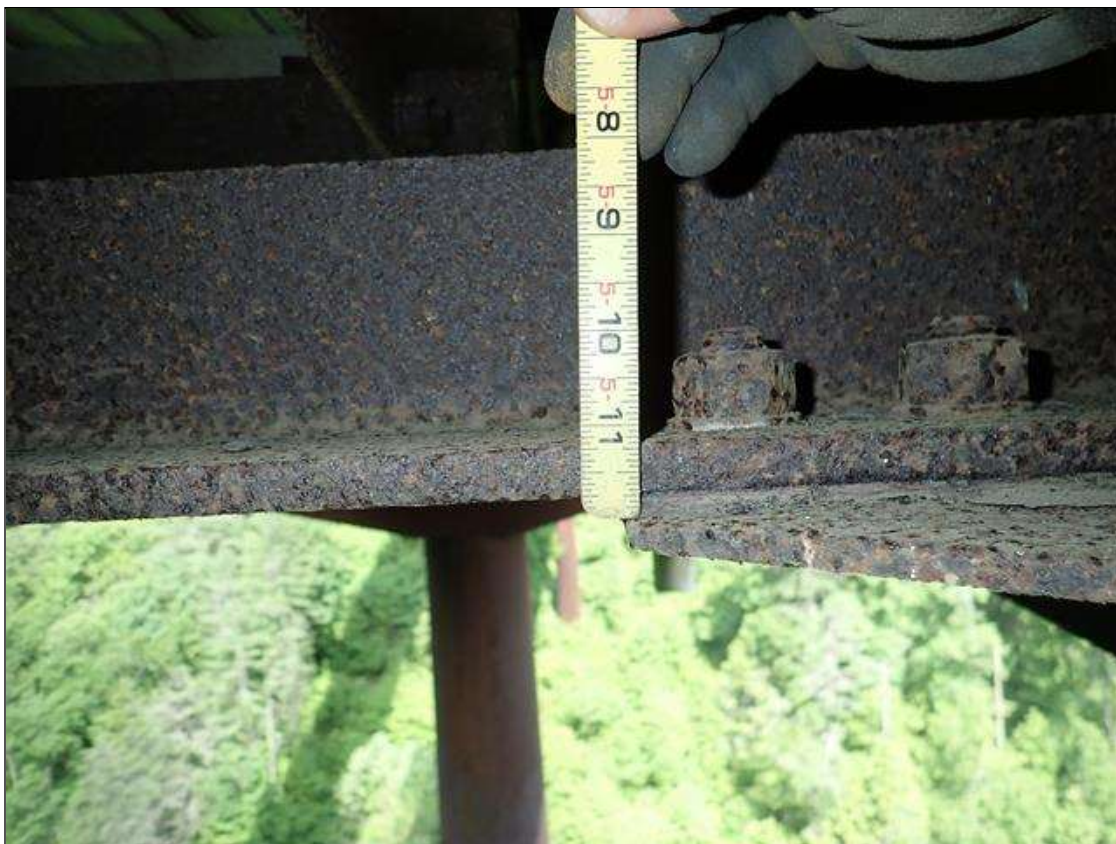
Span 2 Beam 2: span 2, between connection plate and lateral bracing at floor beam 9, pack rust [up to 3/16in]

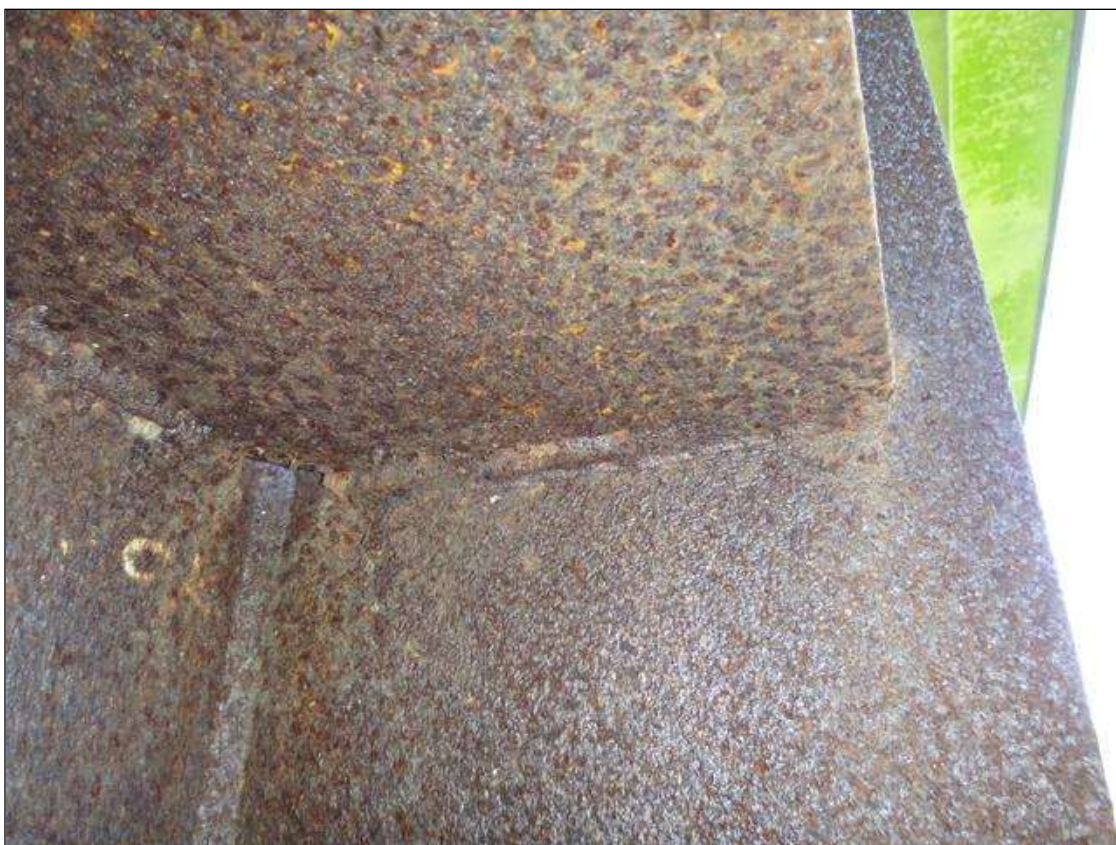
Span 2 Beam 2: poor quality welds found throughout longitudinal and vertical web stiffeners

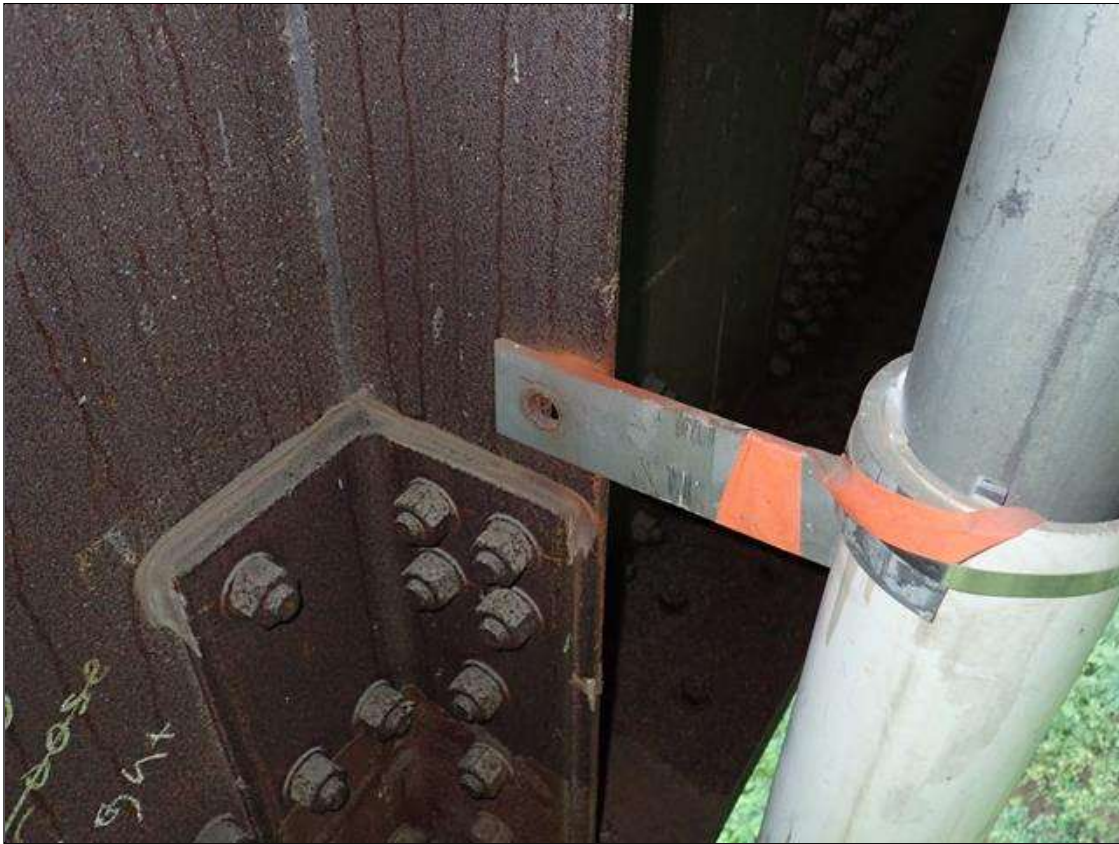
Drainage System: girder 2 downspout South of floor beam 8, lower connection bolt missing

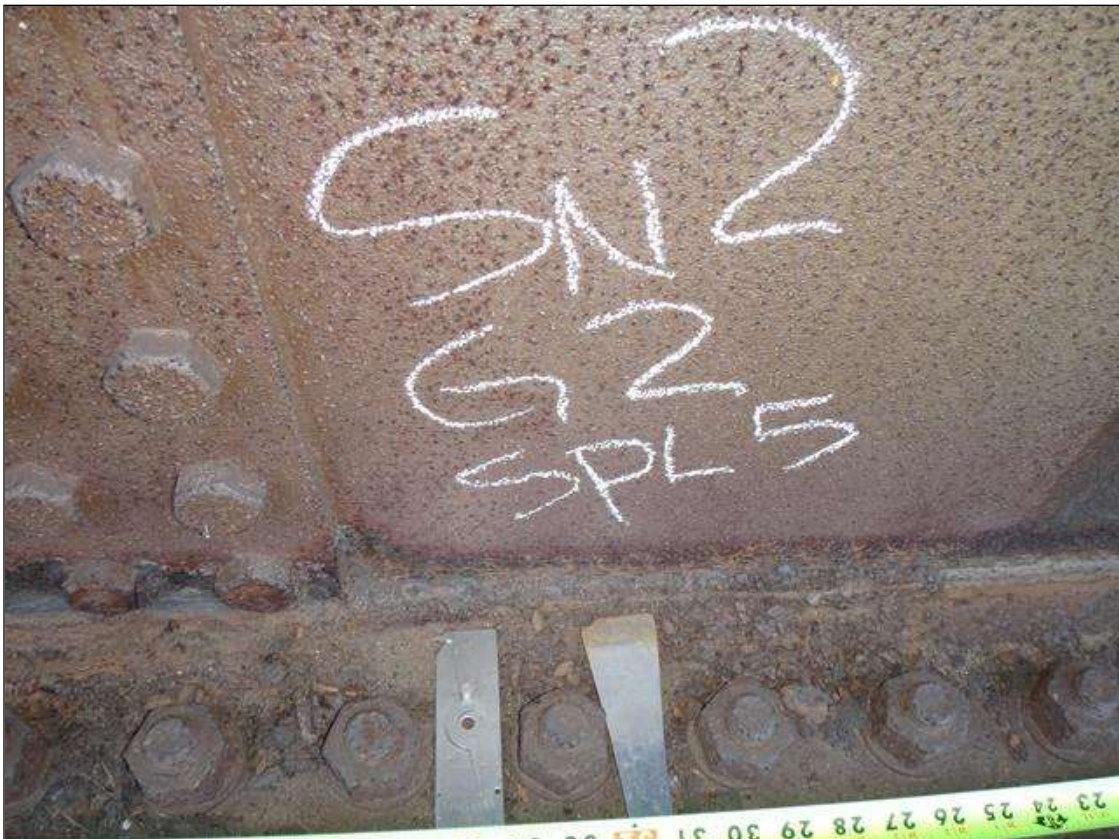
Span 2 Beam 2: [PAR] lower web exterior face at splice 5, active corrosion with section loss [7ft-10in x up to 2-1/2in - avg rem 15/32in]

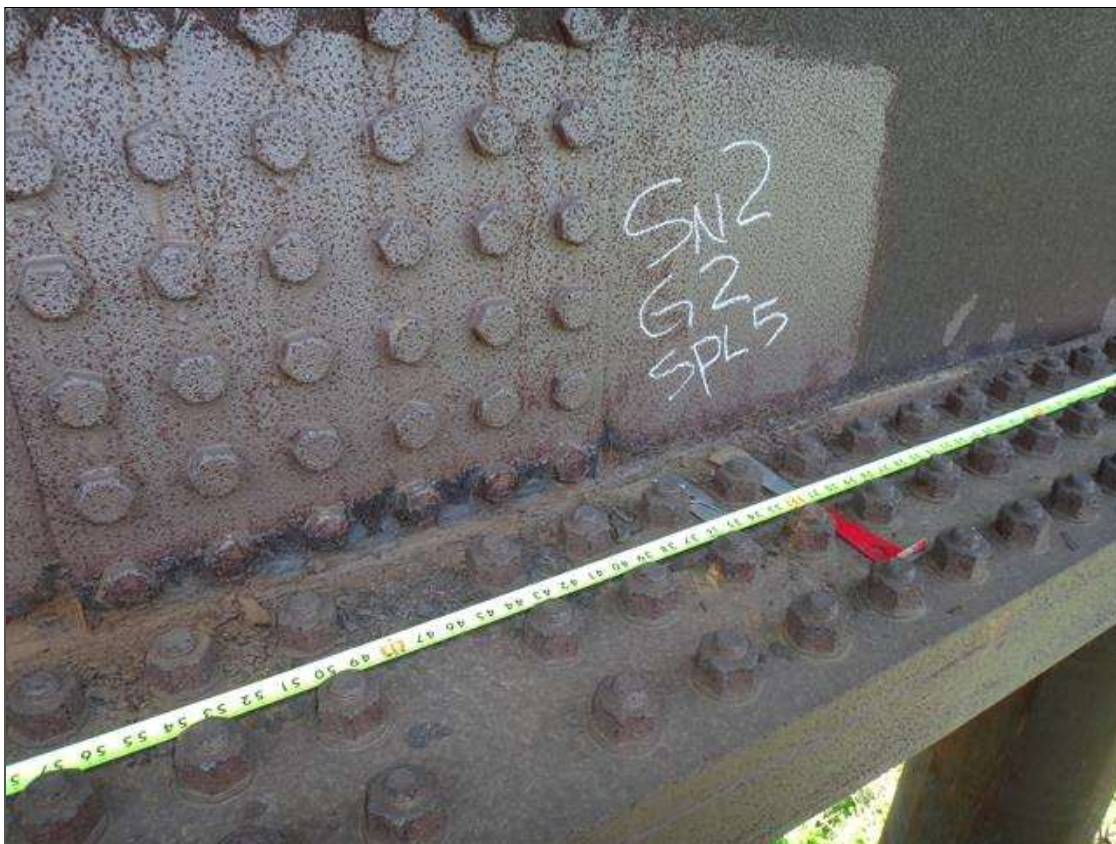
Span 2 Beam 2: [PAR] lower web exterior face at splice 5, active corrosion with section loss [7ft-10in x up to 2-1/2in - avg rem 15/32in]

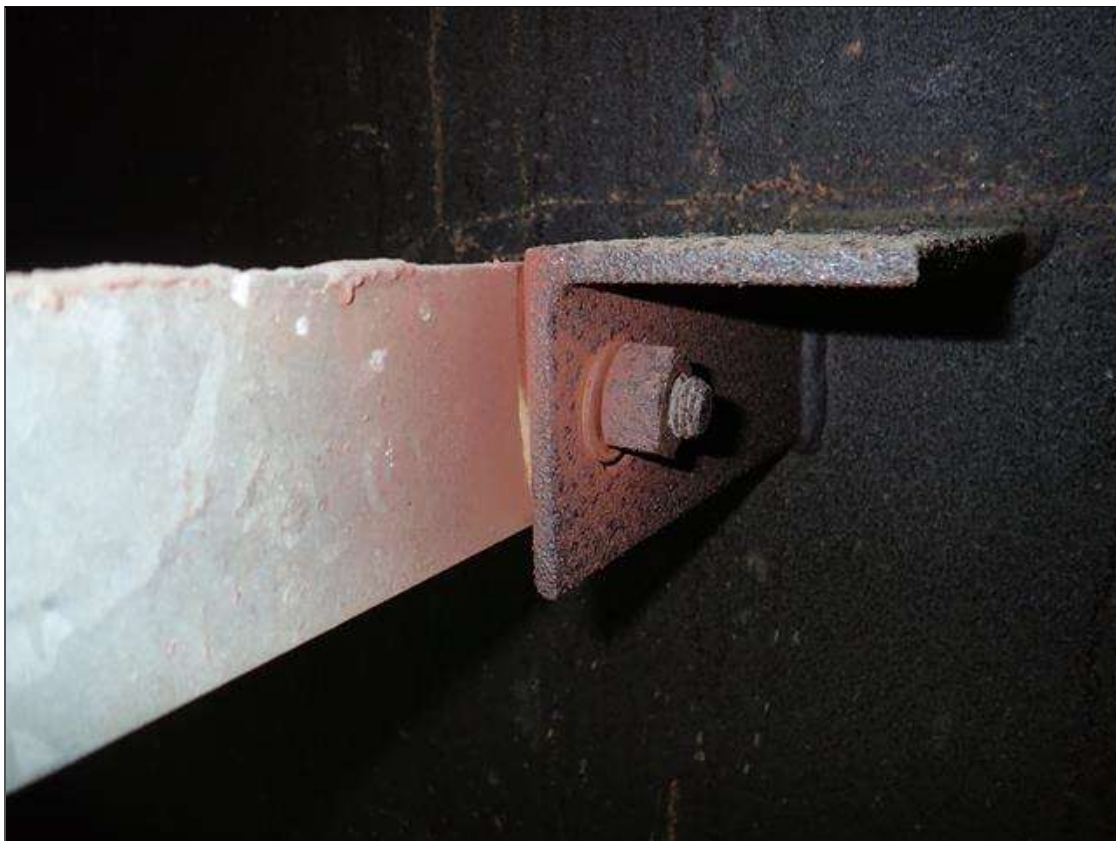
Drainage System: girder 2 downspout South of floor beam 7, loose bottom connection bolt with fretting rust

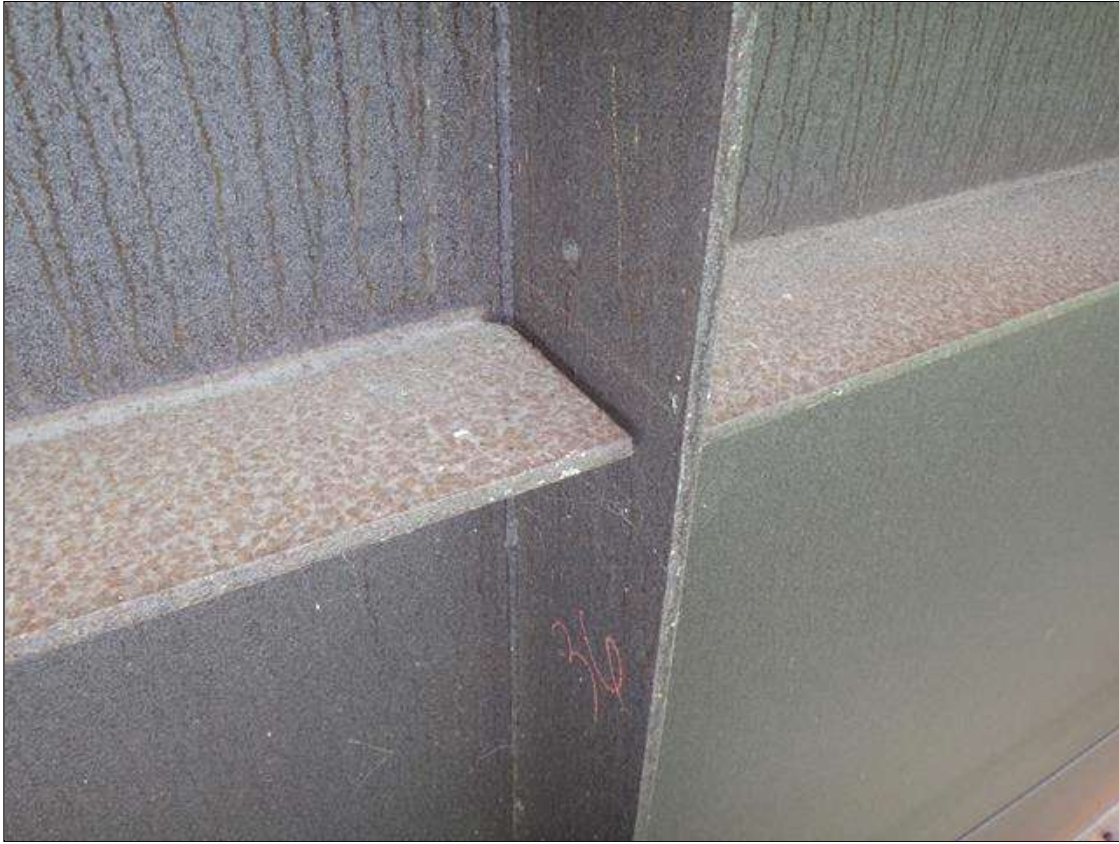
Span 2 Beam 2: span 4, exterior face at web stiffener 36, no weld between horizontal and vertical stiffener [both sides], similar at stiffener 37

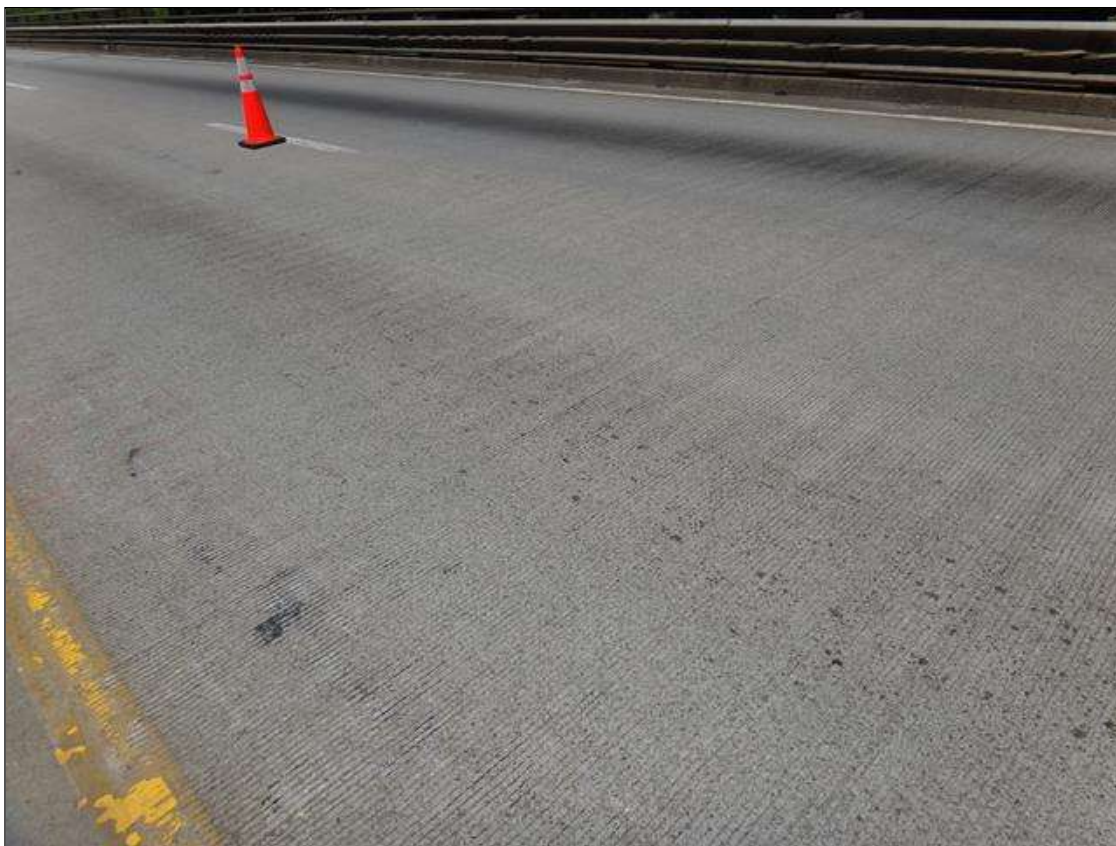
typical wearing surface

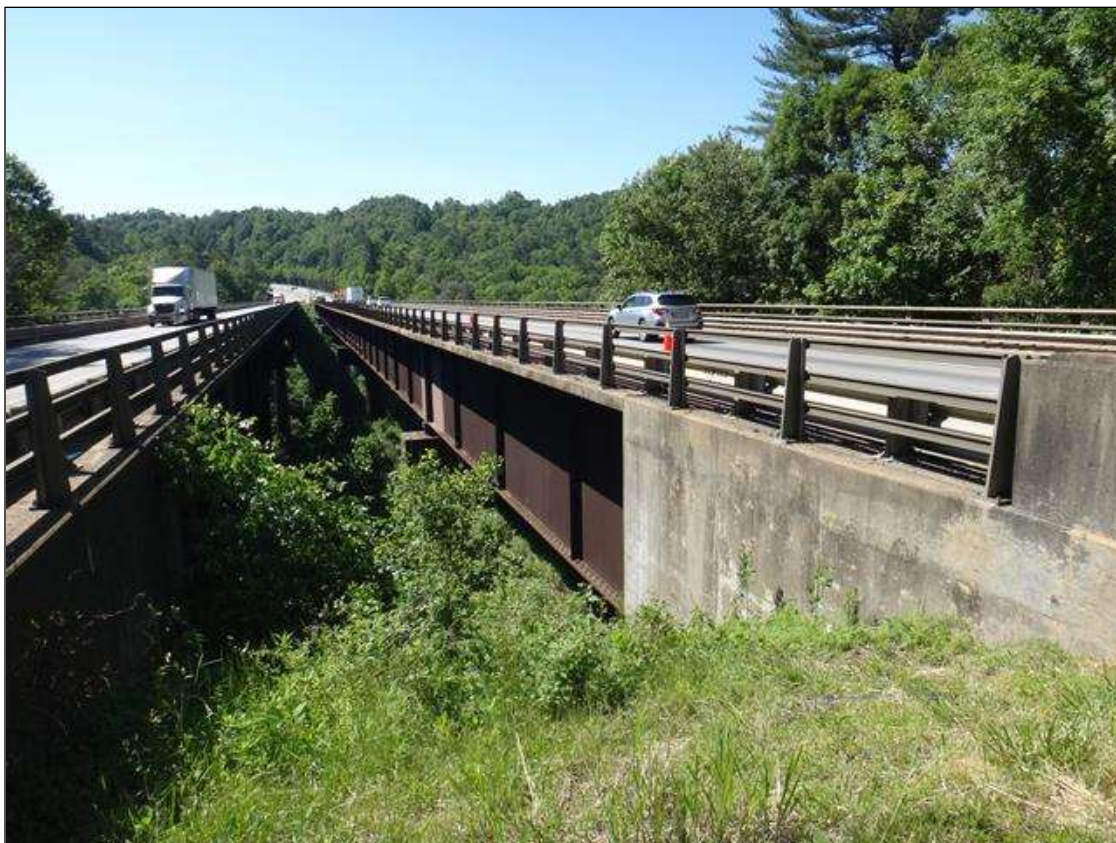
West profile looking East

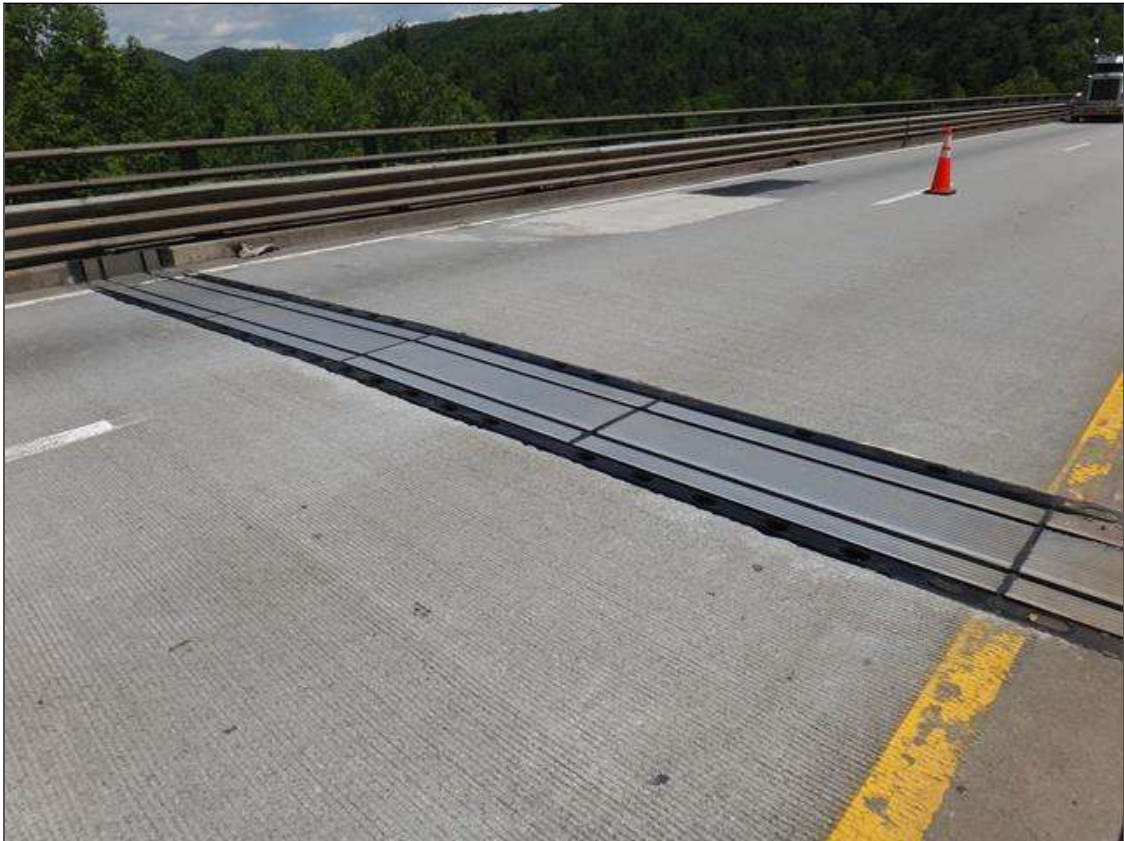
typical joint over interior bent

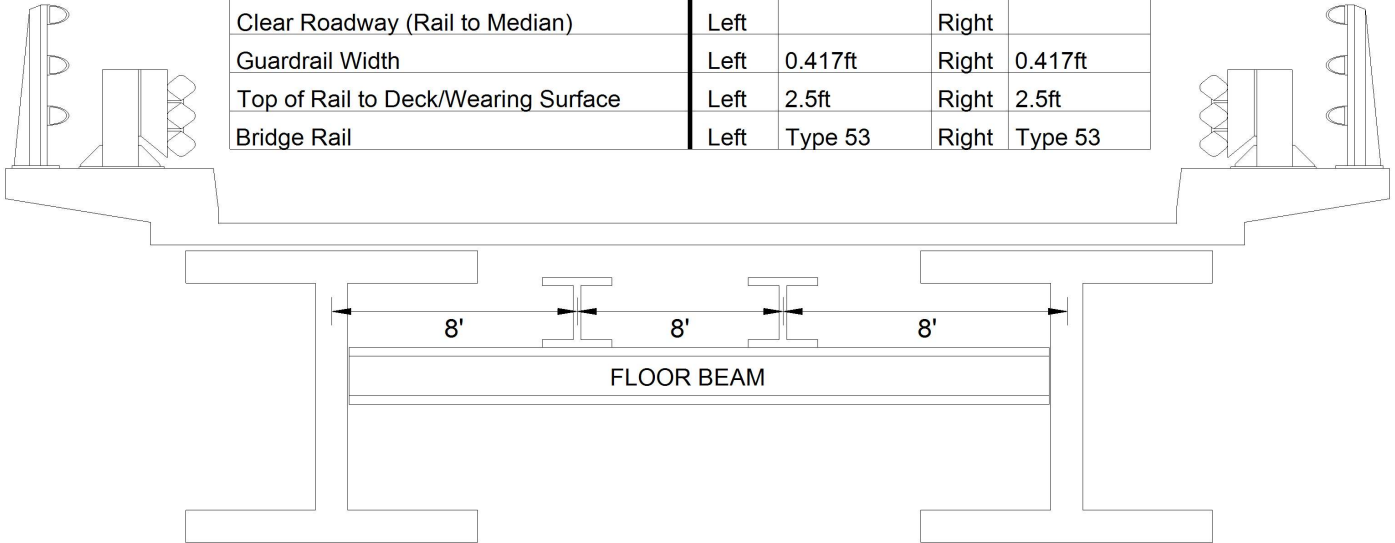
Measurements for Span #	1	ALL SPANS SIMILAR	
Deck Thickness	0.646ft	Left Overhang	5.333ft
Top of Rail to Bottom of Beam	18.46ft	Right Overhang	5.333ft

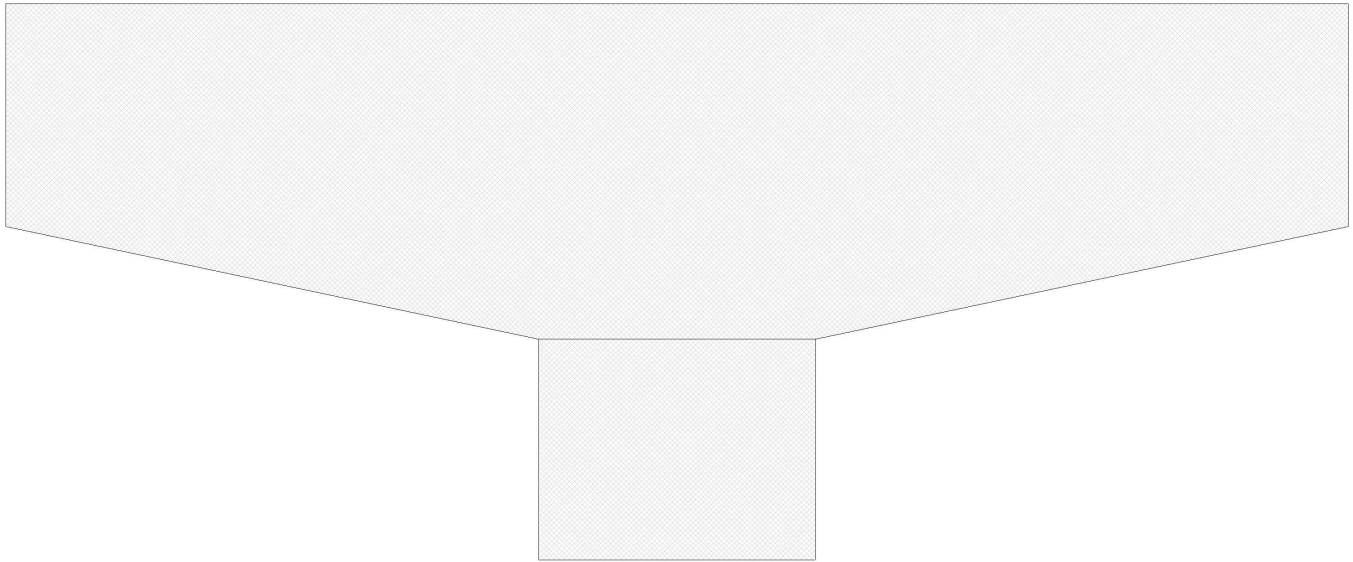
<b>Cap Information</b>			<b>Material</b> Cast-in-Place Concrete							
Length	Width	Height	Left Overhang	Right Overhang	Left Beam to End of Cap.	Right Beam to End of Cap.				
34.000 ft.	7.000 ft.	8.500 ft.	17.000 ft.	17.000 ft.	5.000 ft.	5.000 ft.				
<b>Subcap Information</b>			<b>Material</b>							
Length	Width	Height	Left Overhang	Right Overhang	Left Pile to Splice.					
<b>Sill Information</b>			<b>Material</b>							
Length	Width	Height								
<b>Pile #</b>	<b>Material</b>	<b>Spacing</b>	<b>Width/Dia.</b>	<b>Height</b>	<b>Length</b>	<b>Orientation</b>	<b>Driven?</b>	<b>Replacement?</b>	<b>Removed?</b>	<b>Collar?</b>
1	Concrete		7 ft.			Vertical	No	No	No	No
<b>Bent #: 1</b>		<b>Similar Bents: 2, 3, &amp; 4</b>

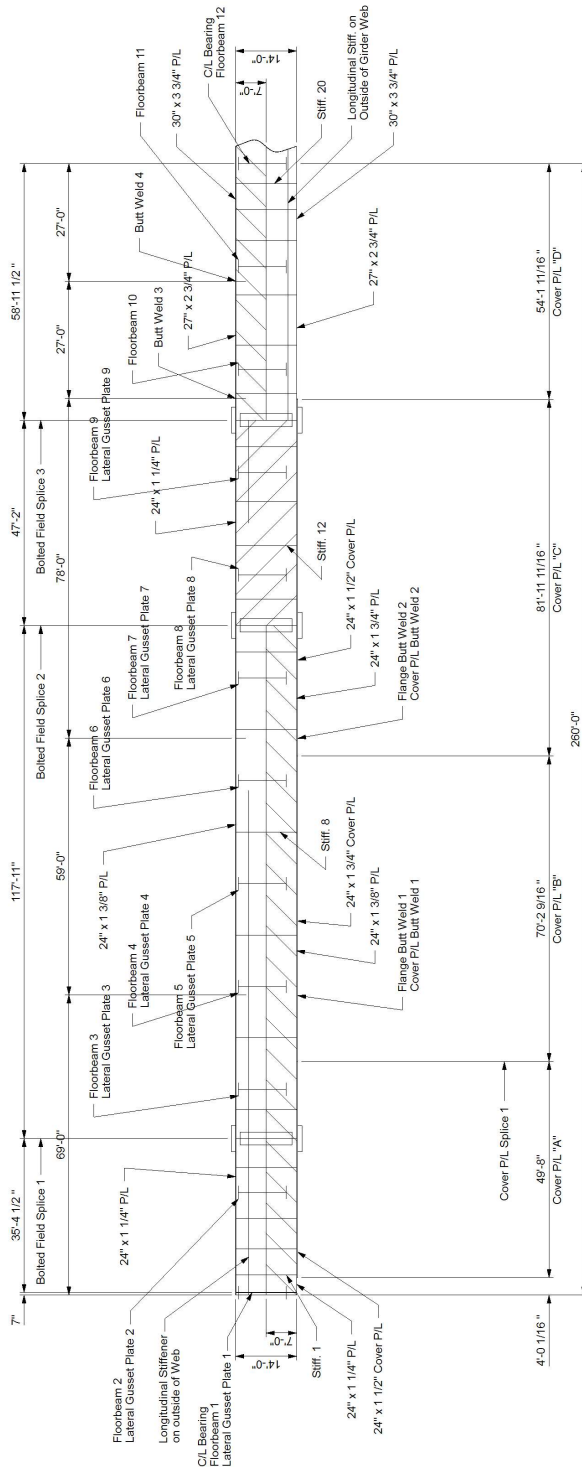
Span "B" Girder Elevation (For Both Girders)

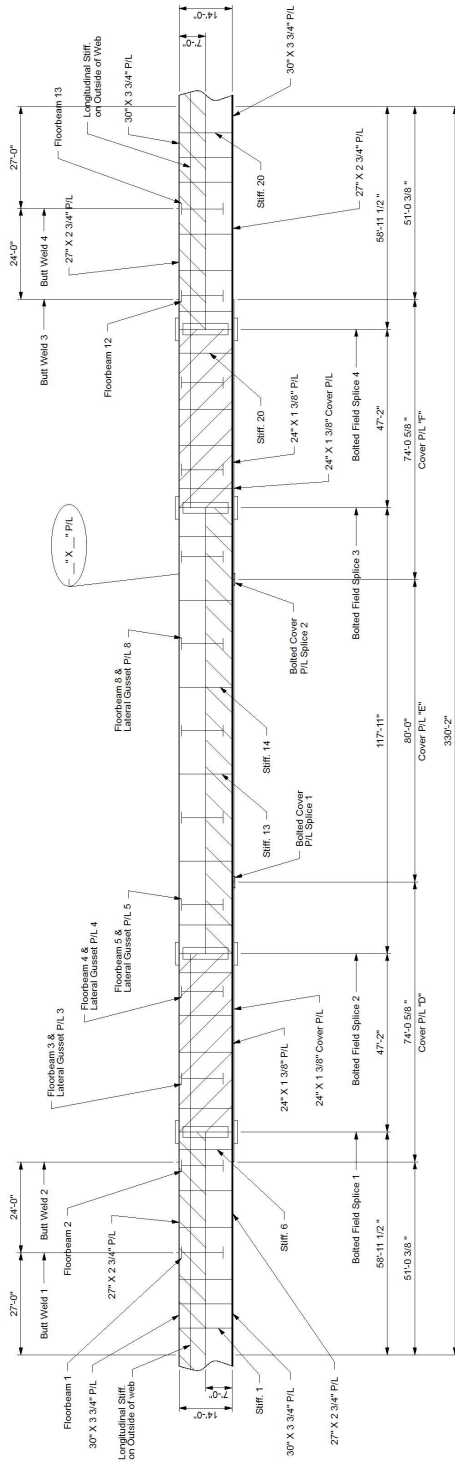
Span "C" Girder Elevation (For Both Girders)

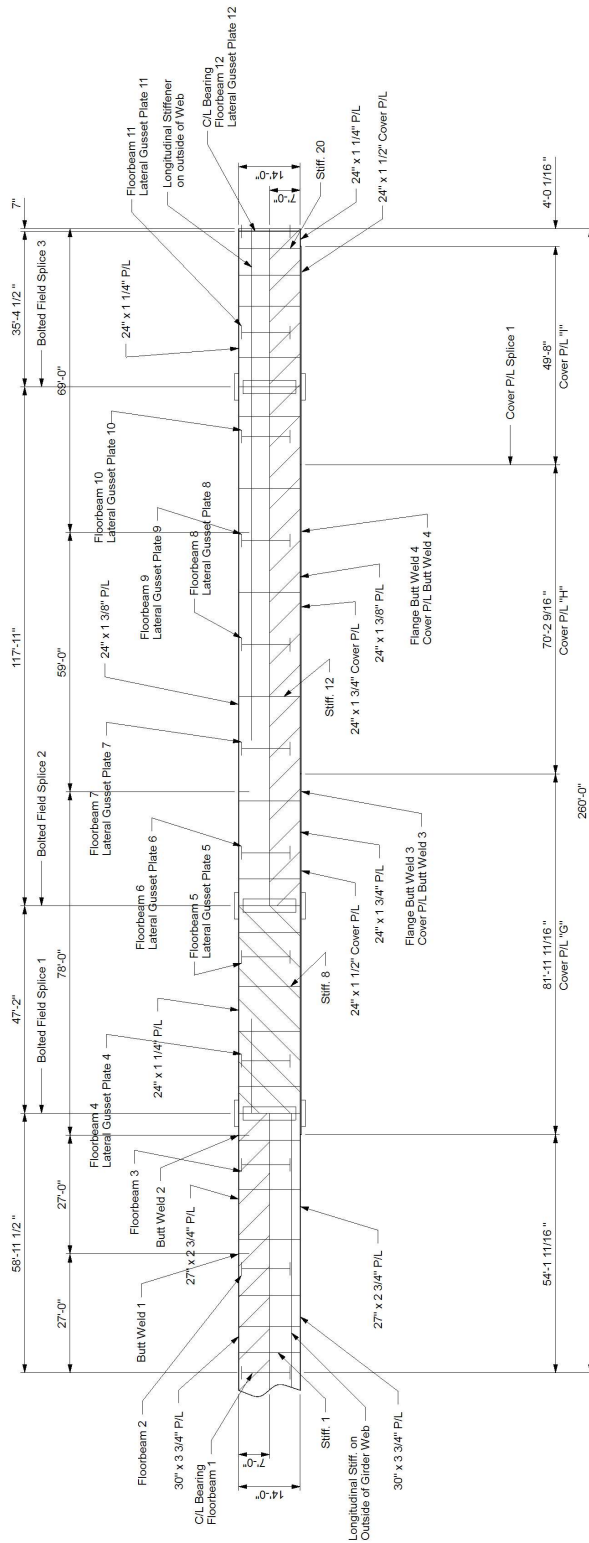
Span "D" Girder Elevation (For Both Girders)

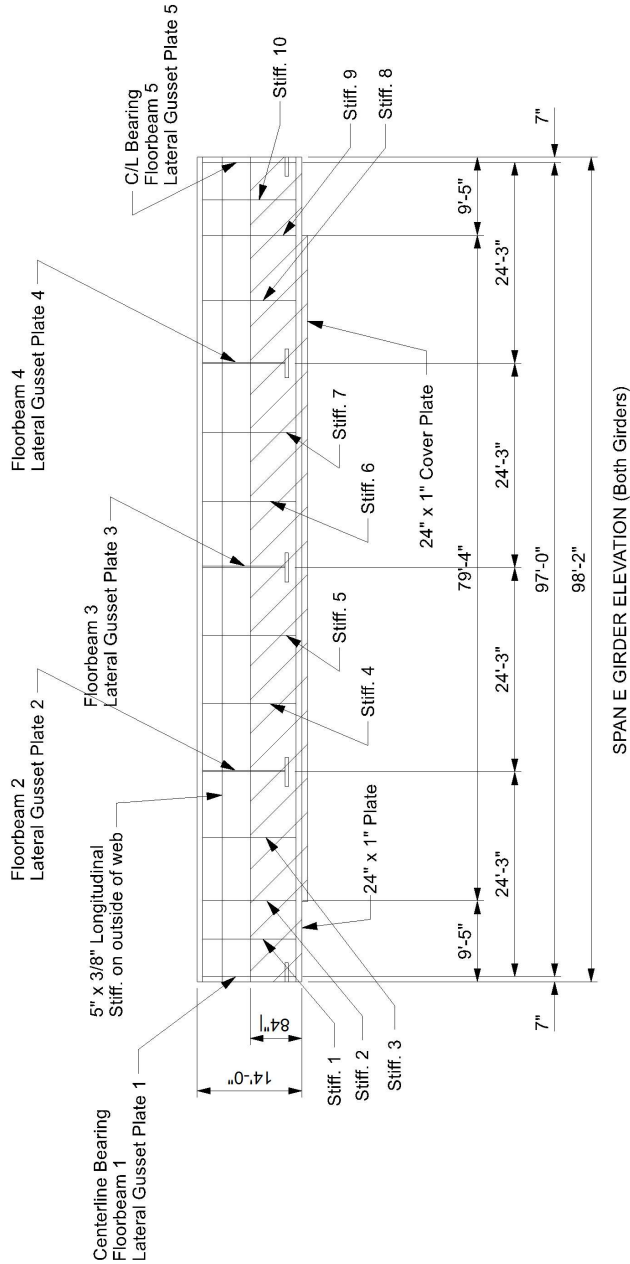
Verified: T. Graham 5/31/2019
