**SOLE PLATE REPAIR**

PROJECT NO. 15BPR.19  
NEW HANOVER COUNTY  
 BRIDGE NO. 640021

STATE OF NORTH CAROLINA  
 DEPARTMENT OF TRANSPORTATION  
 RALEIGH

**RESET BEARINGS  
 DETAILS**

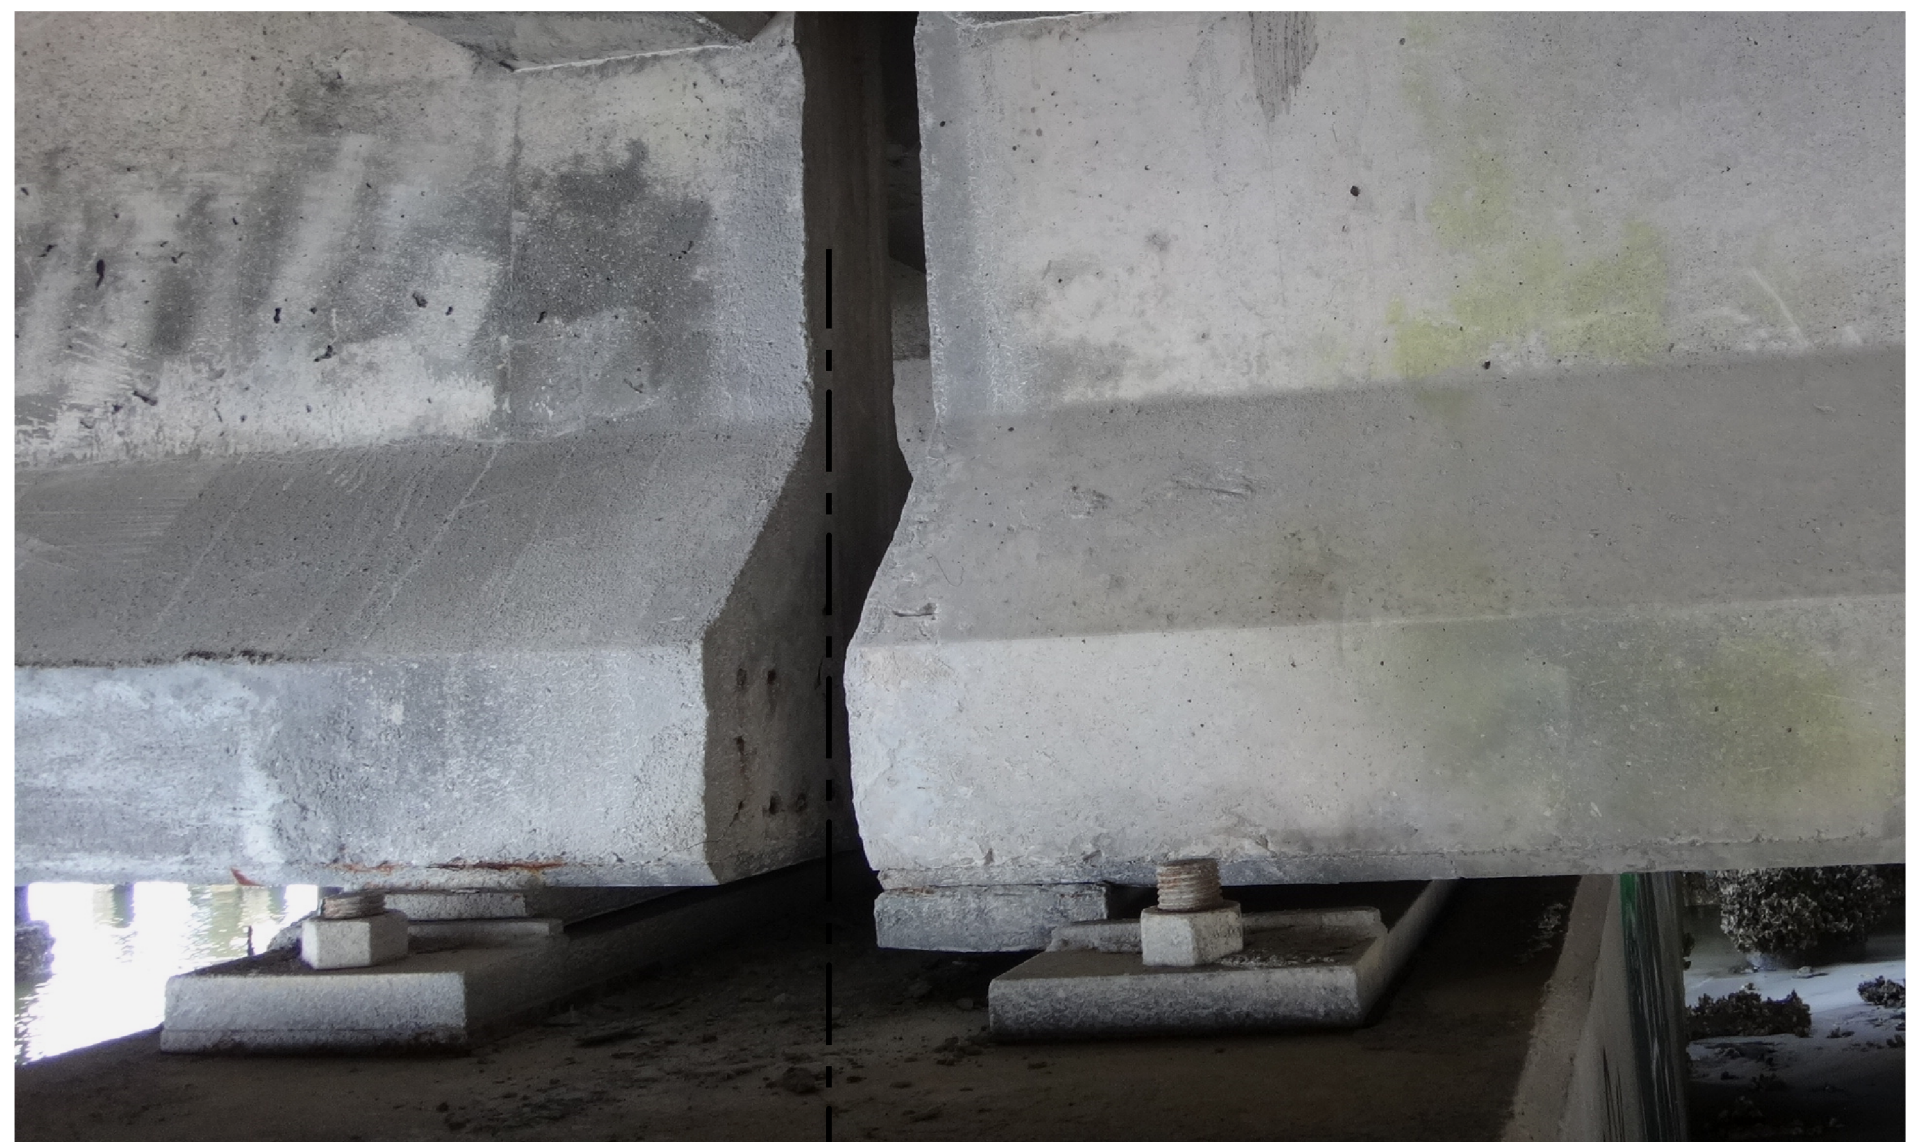
**EXISTING CONDITION**  
SPAN 1 BEAM 4 SOLE PLATE DISPLACEMENT

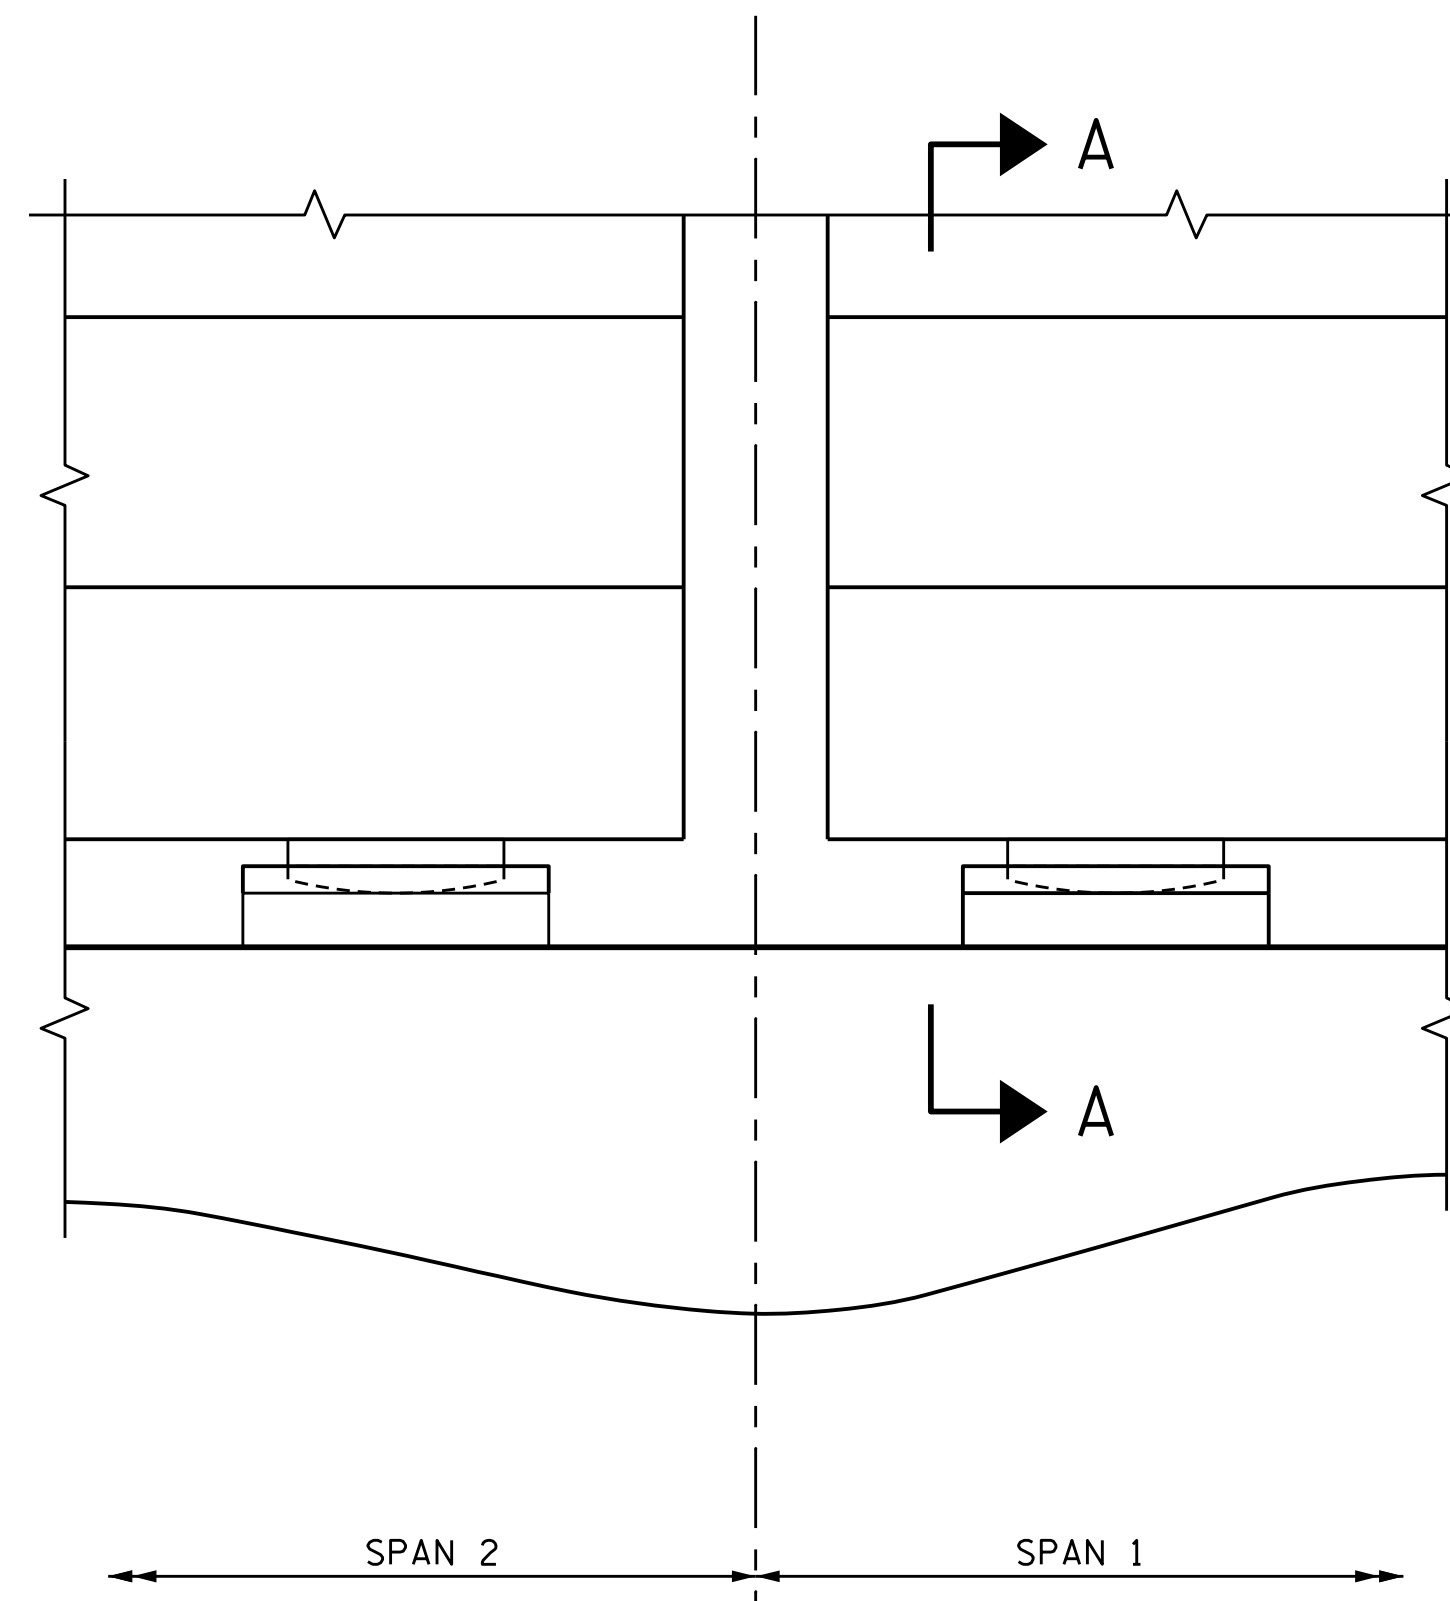
**PROPOSED REPAIR**  
SPAN 1 BEAM 4 SOLE PLATE REPAIRED

**REPAIR SEQUENCE**

- AFTER THE JACKING OF THE GIRDER, PER JACKING PLANS PROVIDED BY OTHERS, GRIND EXISTING WELD TO REMOVE SOLE PLATE FROM EMBEDDED CONNECTOR PLATE.
- PLACE SOLE PLATE IN DESIRED POSITION AND LOCATION.
- CLEAN AND PREP THE AREAS THAT WERE WELDED TO SOLE PLATE SO A CLEAN WELD CAN BE PERFORMED TO REATTACH THE SOLE PLATE TO CONNECTOR PLATE IN THE GIRDER PER DETAIL "A".
- WELD SOLE PLATE TO EMBEDDED PLATE AS INDICATED.
- AFTERWARDS REFER TO THE "CLEANING AND PAINTING EXISTING BEARINGS" SHEET.
- FOR REMOVE AND RESET BEARINGS, SEE SPECIAL PROVISIONS.
- FOR BRIDGE JACKING, SEE SPECIAL PROVISIONS.
