- SHOTCRETE REPAIR					
ERI - EPOXY RESIN INJECTION					
- DEMOLITION (SEE ``CAP DEMOLITION DETAILS'' SHEET)					
PRA		IO F	3-46	526	
project no. <u>B-4626</u> Stanly, Rowan					
STATION: 45+22.65 -EBL-

SHEET 1 OF 2 STATE OF NORTH CAROLINA					
DEPARTMENT OF TRANSPORTATION					
RALEIGH					
SUBSTRUCTURE REPAIR					
SUBSTRUCTURE REPAIR BENT 3 SEAL 020208 SPAN `C' FACE					
GINEER BUILD			т <i>Р</i>		
Ein Bhil h 9/2/2021		REVISIONS			HEET NO.
DOCUMENT NOT CONSIDERED	BY: DATE	NO. BY:	DA	TE:	S1-80
FINAL UNLESS ALL 1 SIGNATURES COMPLETED 2		3 4			total sheets 125

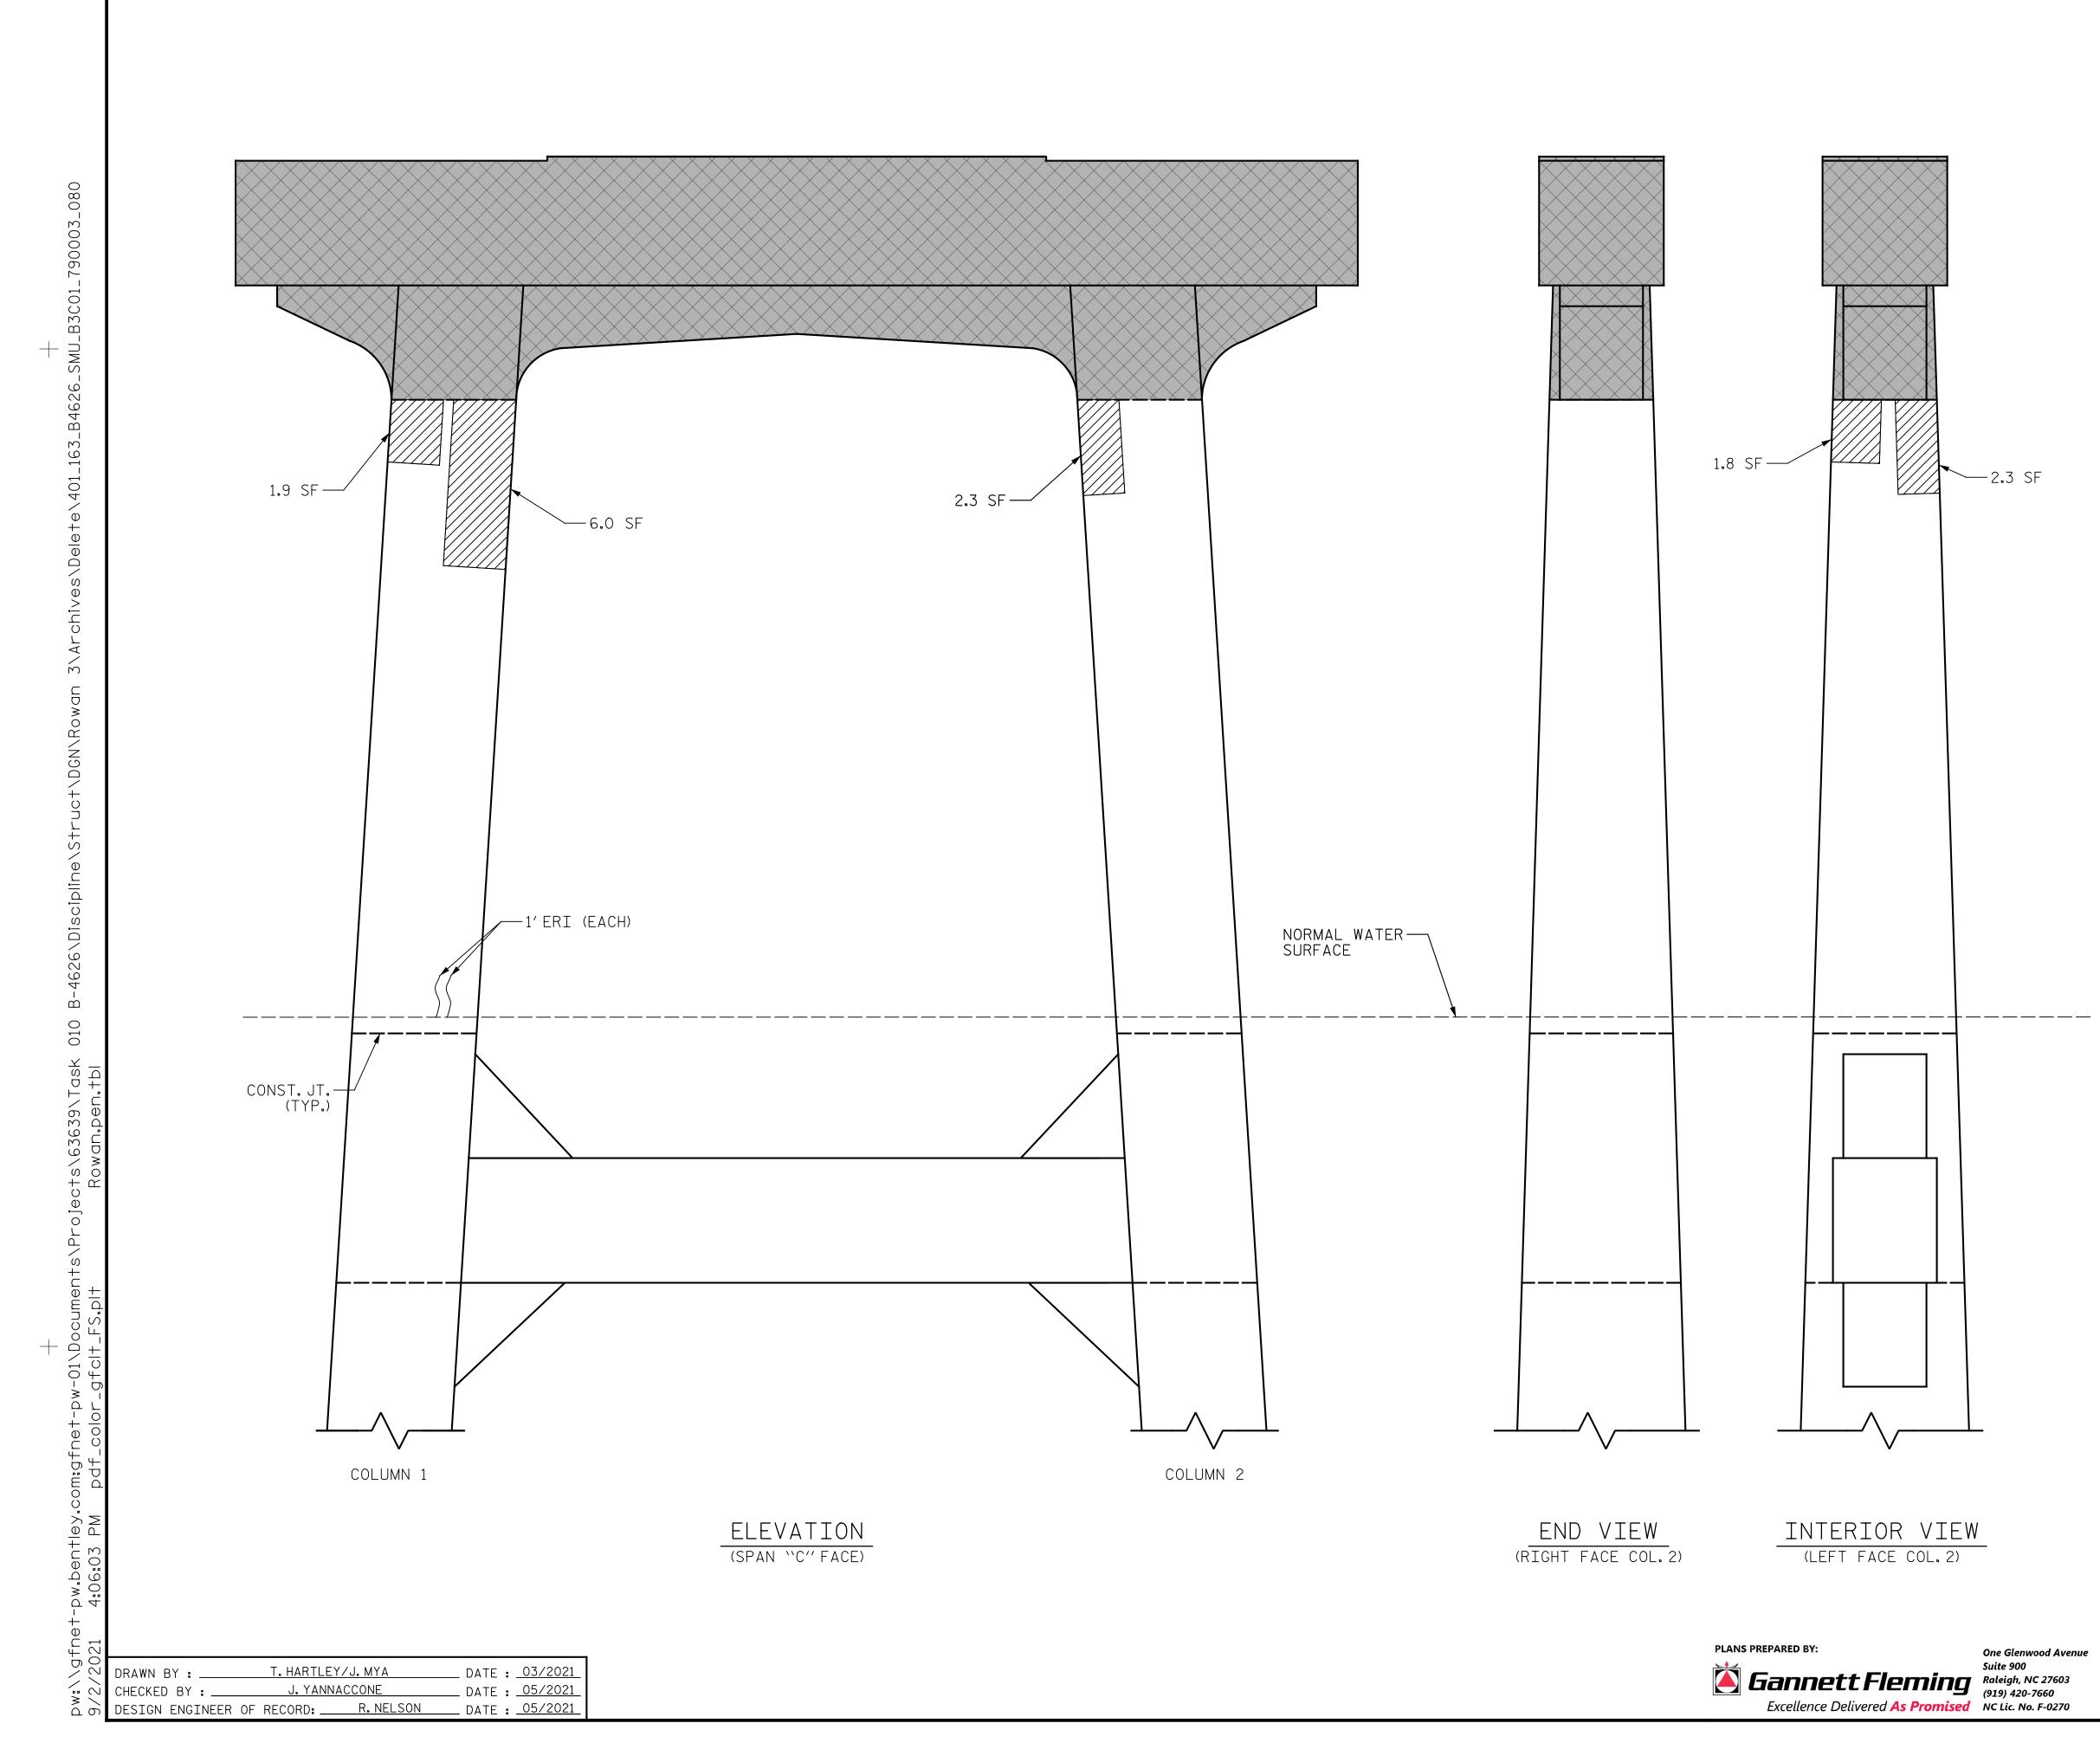
AS-BUILT REPA	IR QI	JANTI	ΤY	ΤΑΒ	LE
BENT 3 REPAIRS	QUANTITIES ESTIMATE ACTUAL				
SHOTCRETE REPAIRS	AREA	VOLUME	AREA SF		- VOLUME CF
COLUMN	26.2	10.5	১r 		
EPOXY RESIN INJECT	ION	LENGTH LF		LENGTH LF	
COLUMN 3.0					
VALUES IN CHART REPRESENT ESTIMATED REPAIR TOTALS AFTER REMOVAL OF UNSOUND CONCRETE, MINIMUM OF 1″BEHIND REBAR AND MINIMUM 2″CLEARANCE TO SAWCUT.FOR REPAIR DETAILS, SEE ``TYPICAL					
CAP AND COLUMN REPAIR DETAILS' SHEET.					
NOTES: REPAIR LOCATIONS AND ESTIMATE OF QUANTITIES ARE BASED ON					
THE BEST INFORMATION AVAILABLE. IF ADDITIONAL REPAIRS NOT SHOWN ON THE DRAWINGS ARE DEEMED NECESSARY BY THE ENGINEER.THE ENGINEER WILL NOTE ON THE DRAWINGS THE					
APPROXIMATE LOCATION AND DESCRIPTION OF THE REPAIRS AND ENTER THE ACTUAL QUANTITIES INTO THE AS-BUILT REPAIR					
QUANTITY TABLE.					
FOR SHOTCRETE REPAIRS, SEE SPECIAL PROVISIONS. FOR EPOXY RESIN INJECTION, SEE SPECIAL PROVISIONS.

WHEN COLUMN REPAIRS ARE INDICATED TO GROUND LINE, EXTEND					
REPAIR MININUM OF 1'BELOW GROUND LINE. For proposed bent cap replacement details,see substructure					
BENT SHEETS.
