UNDERSIDE REPAIR

PROJEC <u>ME</u> BRIDGE	CKLEN		BURC	•	<u>C</u> UNTY	
CDocuSigned by: SHEET 5 OF 6							
DZEE938FAB674CS DZE	STATE OF NORTH CAROLINA DEPARTMENT OF TRANSPORTATION RALEIGH						
	REVISIONS SHEET NO.						
OCUMENT NOT CONSIDERED	NO. BY:	DATE:	NO.	BY:	DATE:	S1-8	
FINAL UNLESS ALL SIGNATURES COMPLETED	1		3			TOTAL SHEETS	
STONATORES COMPLETED	2		ቆ			274

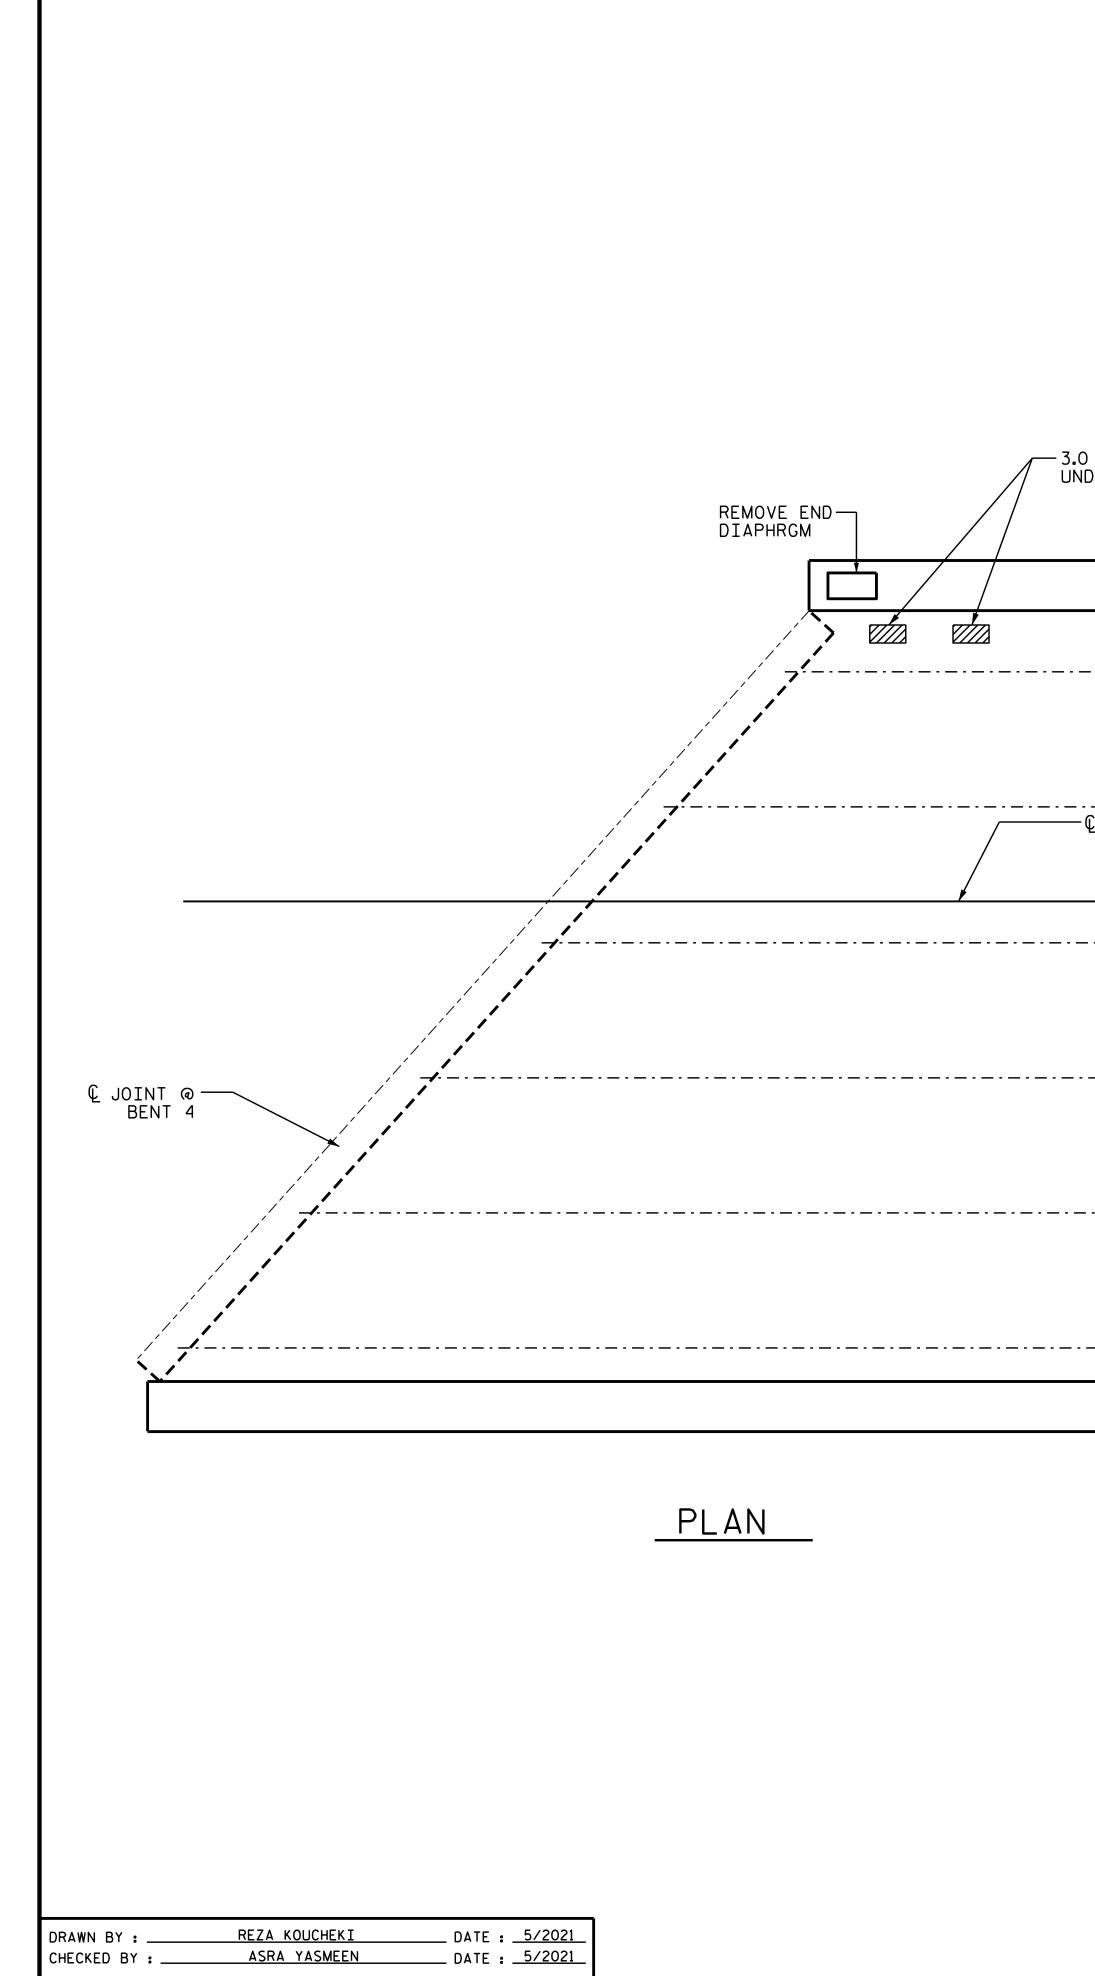
-3.0 SF SHOTCRETE REPAIR UNDERSIDE OF OVERHANG

AS-BUILT REPAIR	QUAN	ITITY	ΤΑΒ	LE					
UNDERSIDE OF DECK REPAIRS									
	ESTIMATE		ACTUAL						
SHOTCRETE REPAIRS	AREA SQ.FT.	VOLUME CU.FT.	AREA SQ.FT.	VOLUME CU.FT.					
UNDERSIDE OF DECK	0.0	0.0							
UNDERSIDE OF OVERHANG	6.0	2.0							
INTERIOR DIAPHRAGMS	0.0	0.0							
	ESTIMATE		ACTUAL						
UNDERSIDE EPOXY RESIN INJECTION	0.0 LIN.FT.

UNDERSIDE OF DECK REPAIR QUANTITIES REPRESENT ESTIMATED VALUES OF DECK REPAIR TOTALS AFTER REMOVAL OF UNSOUND CONCRETE, MINIMUM OF 1"BEHIND REBAR AND MINIMUM OF 2"CLEAR TO SAWCUT. SEE REPAIR DETAILS.

FOR UNDERSIDE OF DECK AND DIAPHRAGM REPAIRS, SEE ``OVERHANG, DIAPHRAGM AND BRIDGE RAIL REPAIR DETAILS'' SHEET.
