PROJECT NO. I-5746C
MECKLENBURG COUNTY
 BRIDGE NO. 590138

DECK UNDERSIDE REPAIR

NO.	REVISIONS			SHEET NO.
	BY:	DATE:	DATE:	
1				S3-08 TOTAL SHEETS 274
2

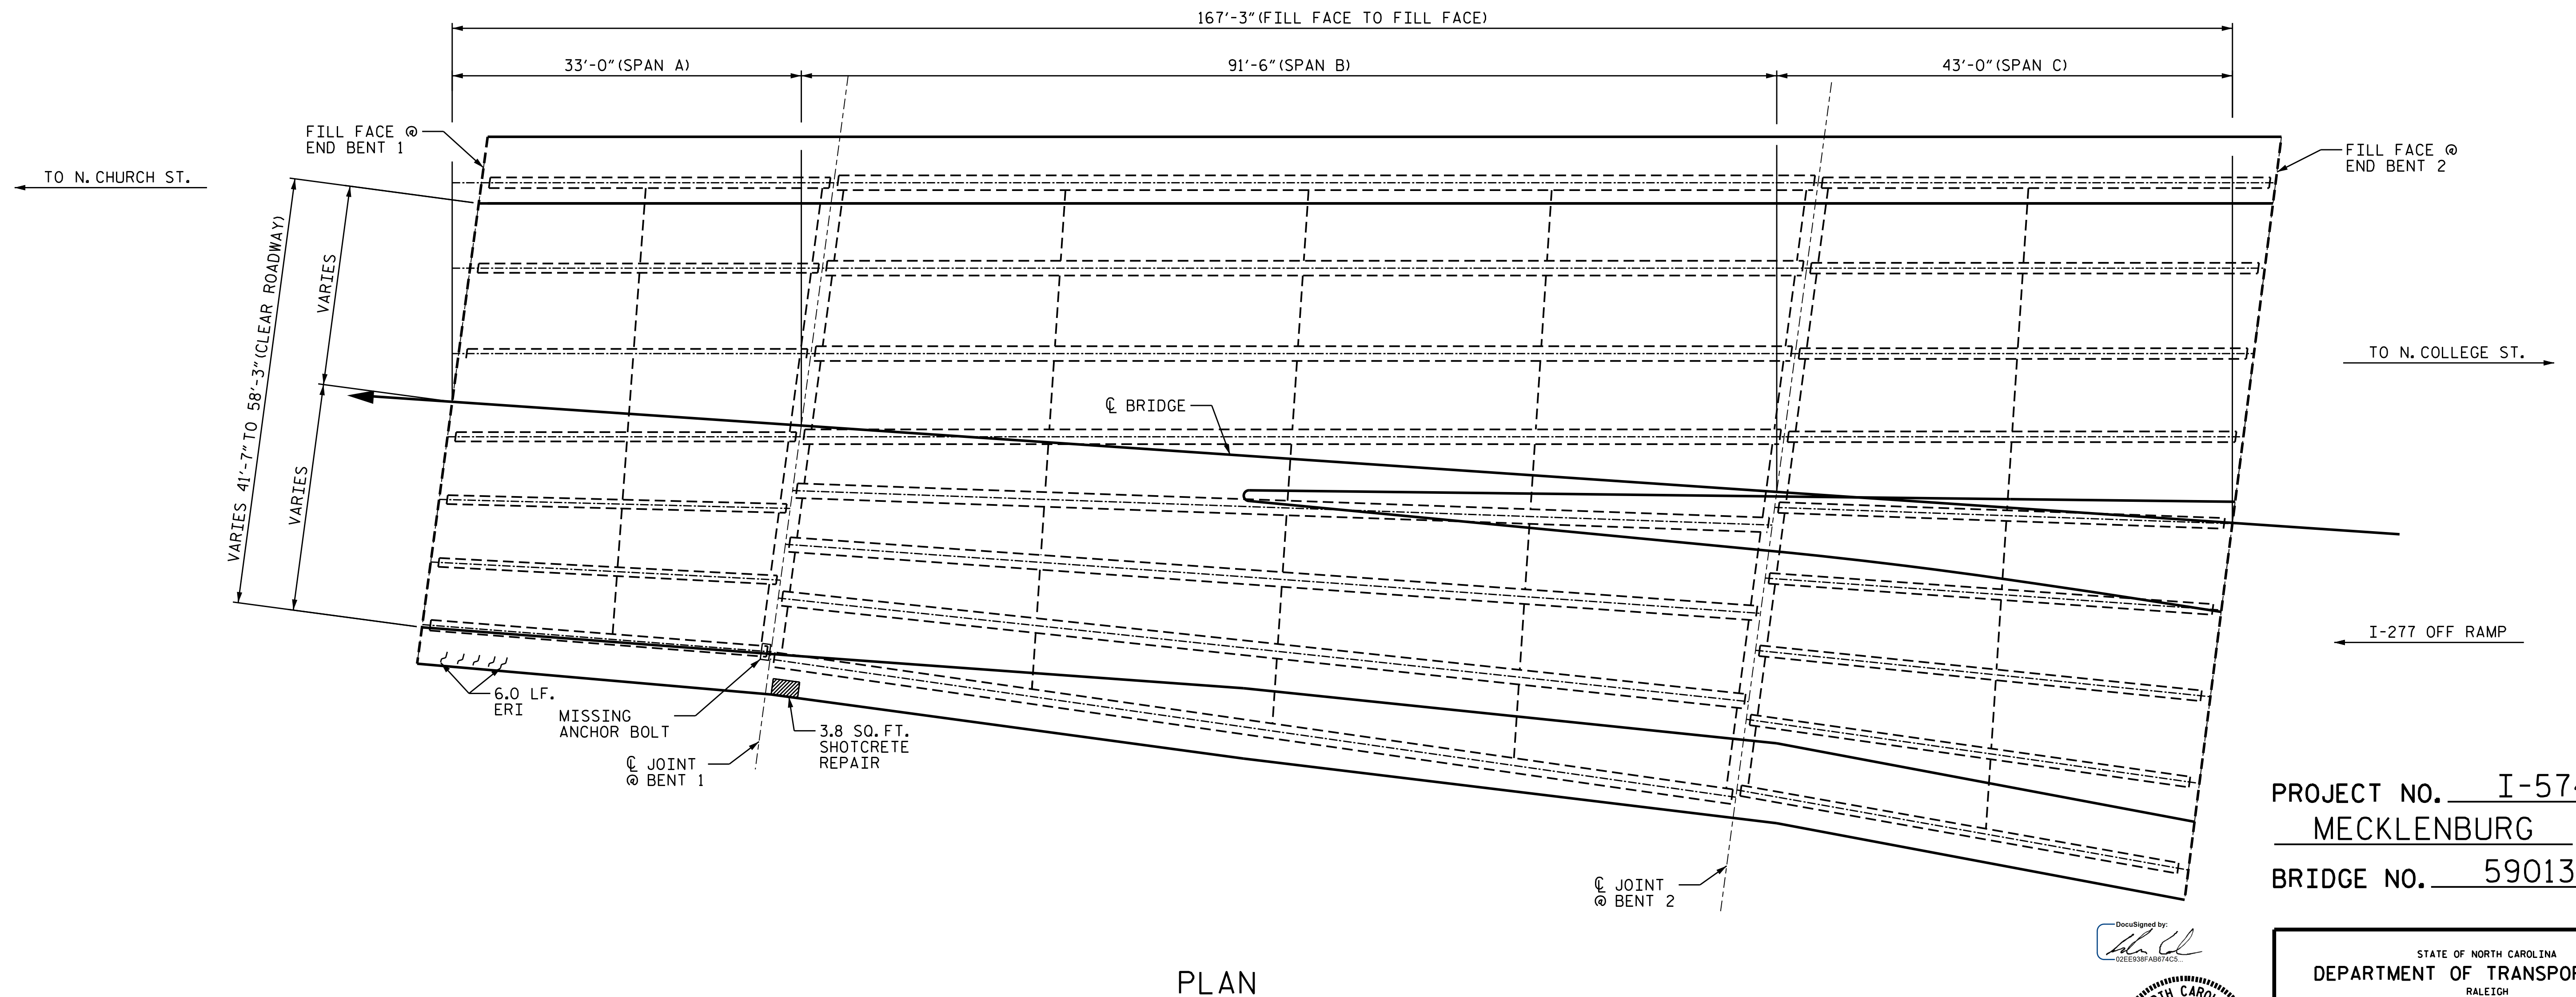
PLAN

UNDERSIDE DECK REPAIR
-

DIAPHRAGM REPAIR
-

ERI - EPOXY RESIN INJECTION

VALUES REPRESENT ESTIMATED UNDERSIDE OF DECK REPAIR TOTALS AFTER REMOVAL OF UNSOUND CONCRETE, MINIMUM OF 1" BEHIND REBAR AND MINIMUM OF 2" CLEAR TO SAWCUT. SEE REPAIR DETAILS.
