PROJECT NO. I-5746C
MECKLENBURG COUNTY
 BRIDGE NO. 590138

SHEET 1 OF 2

STATE OF NORTH CAROLINA
 DEPARTMENT OF TRANSPORTATION
 RALEIGH

BENT 1
 SPAN A FACE

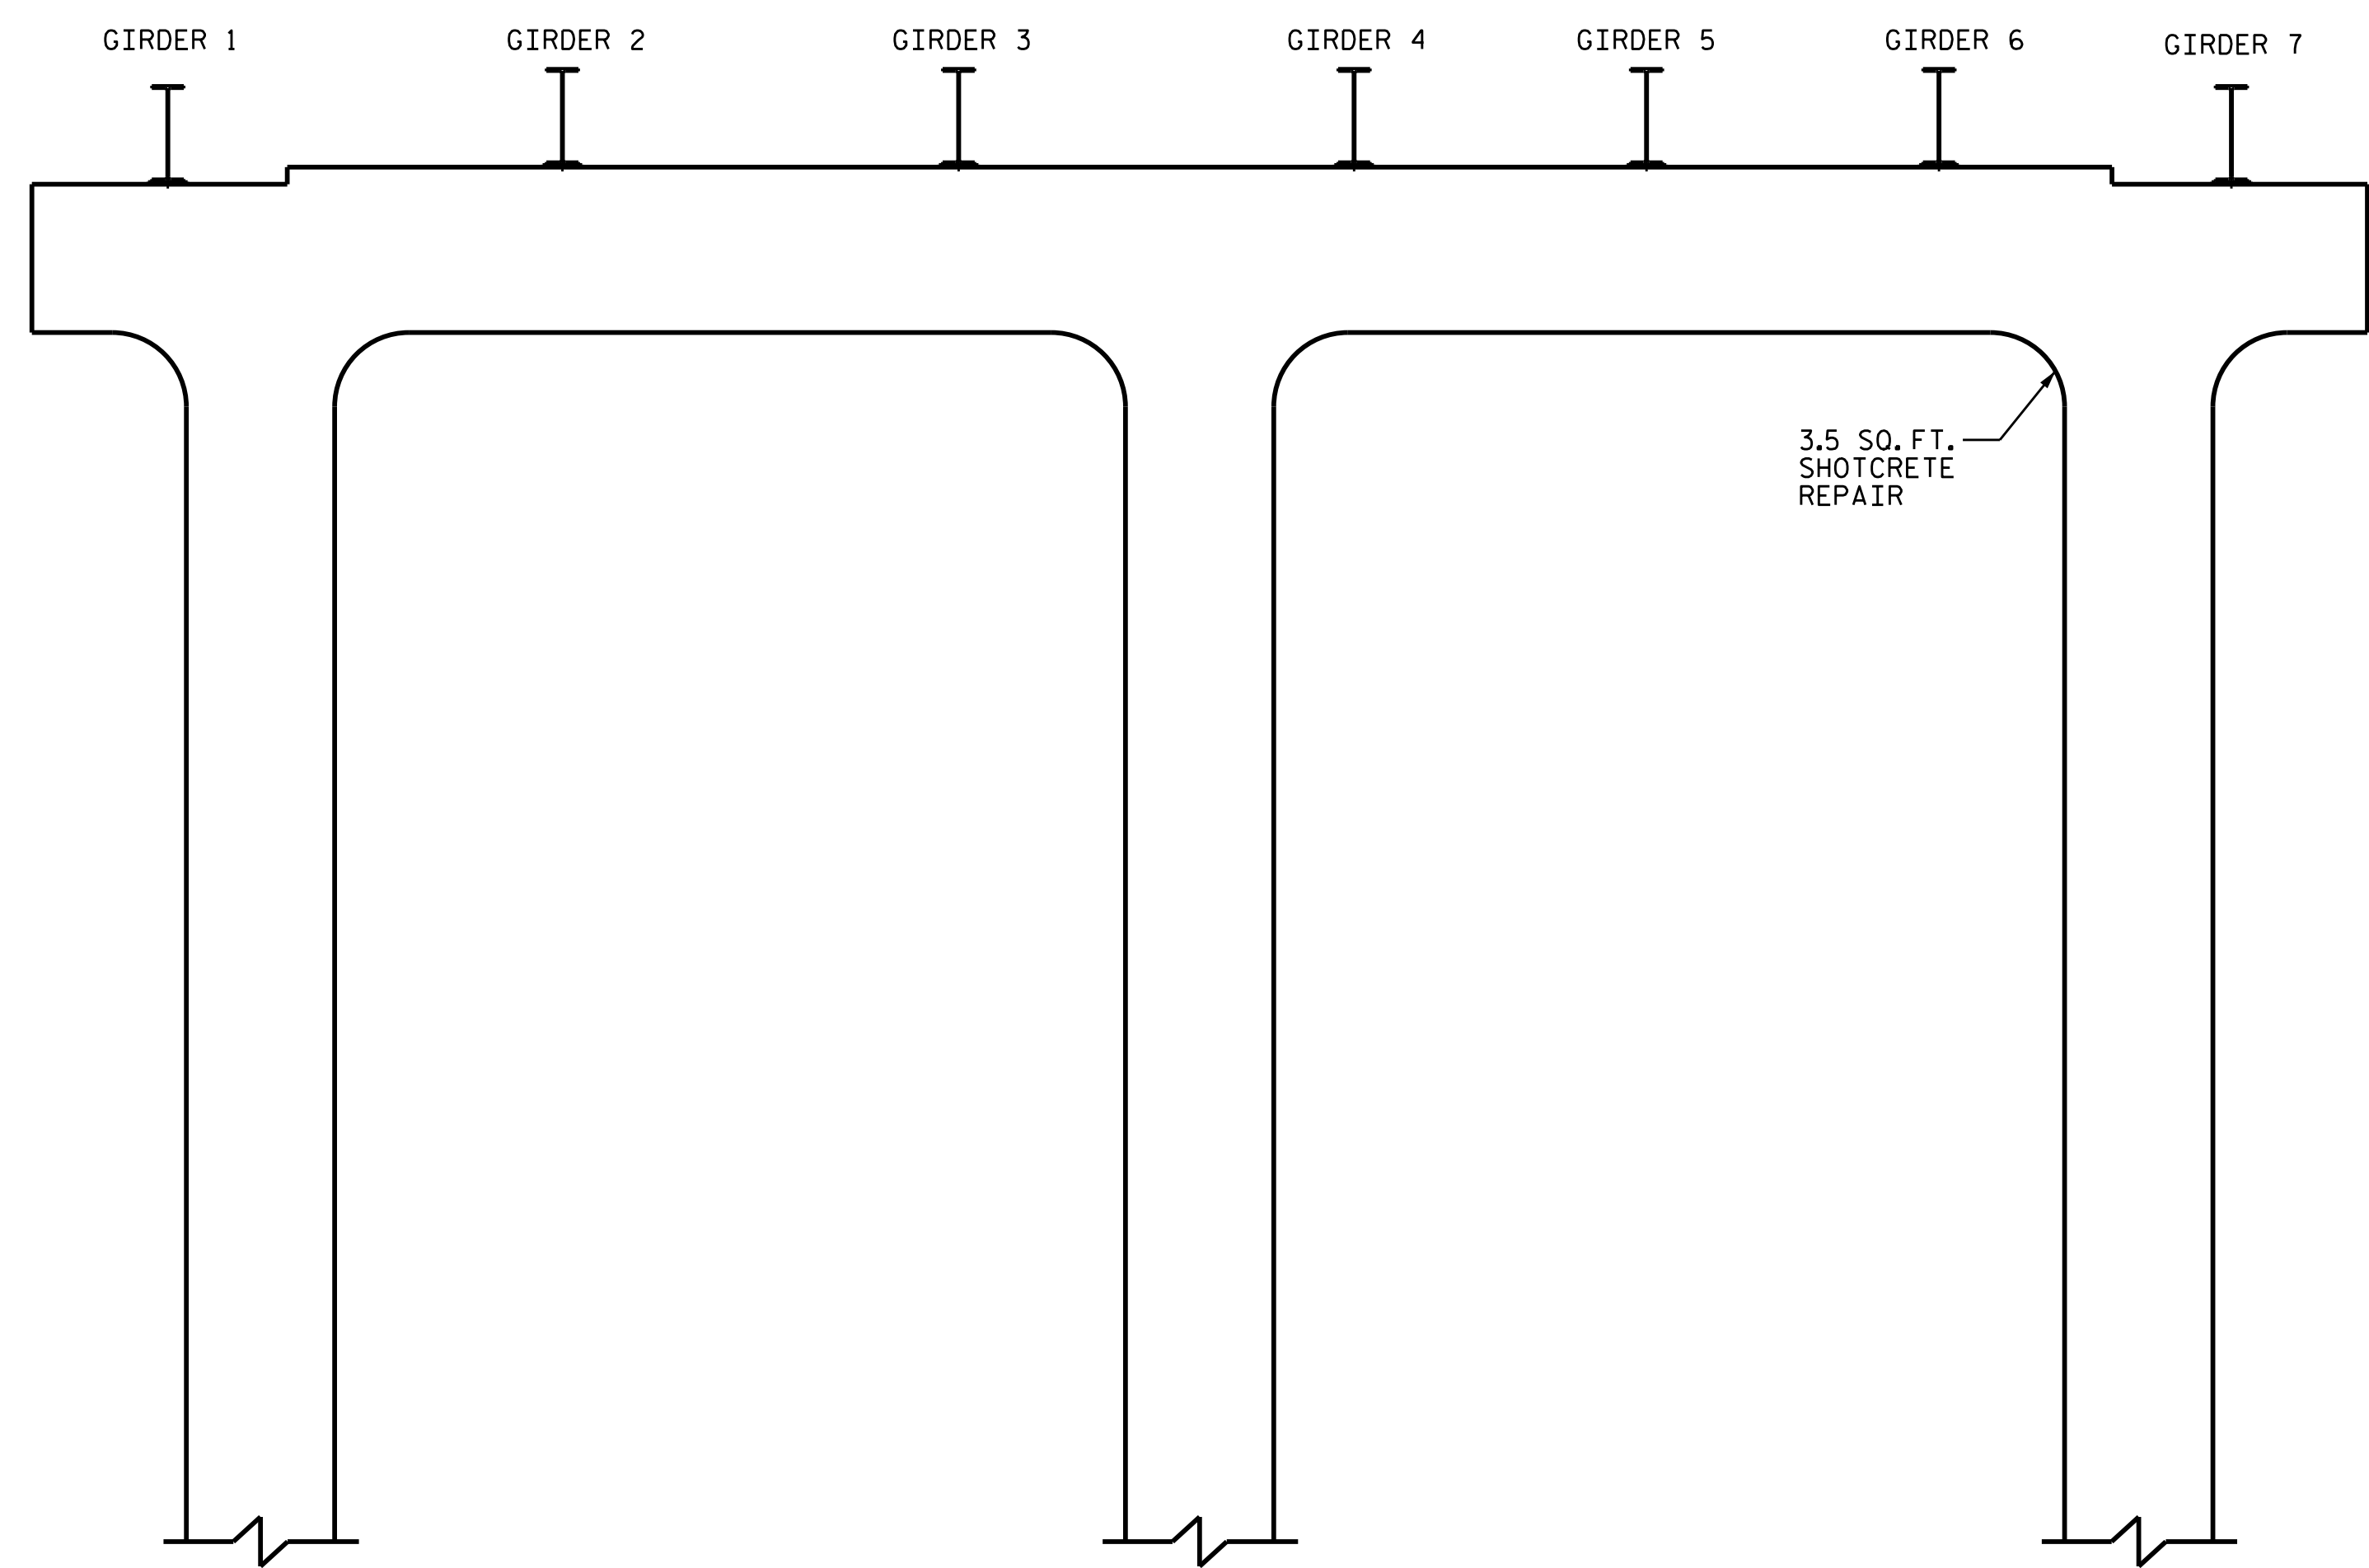
- BENT INFORMATION IS TAKEN FROM THE ROUTINE INSPECTION REPORT DATED 05/06/2020.
- REPAIR LOCATIONS AND ESTIMATE OF QUANTITIES ARE GIVEN BASED ON THE BEST INFORMATION AVAILABLE. IF ADDITIONAL REPAIRS NOT SHOWN ON THE DRAWINGS ARE DEEMED NECESSARY BY THE ENGINEER, THE ENGINEER SHALL NOTE ON THE DRAWINGS THE APPROXIMATE LOCATION AND DESCRIPTION OF THE REPAIRS AND ENTER THE ACTUAL QUANTITIES INTO THE AS-BUILT REPAIR QUANTITY TABLE.

- CLEAN AND REMOVE DEBRIS FROM THE TOP OF THE CAP AND APPLY EPOXY PROTECTIVE COATING. EPOXY COATING SHALL BE APPLIED TO THE TOP SURFACE OF THE CAP. THE CONTRACTOR SHALL NOT COAT THE AREA OF THE CAP BENEATH THE MASONRY PLATES. FOR EPOXY COATING, SEE SPECIAL PROVISIONS.

- CONCRETE REPAIRS MAYBE SUBSTITUTED IN LIEU OF SHOTCRETE REPAIRS WITH THE APPROVAL OF THE ENGINEER.
- FOR SHOTCRETE REPAIRS, SEE SPECIAL PROVISIONS.
- FOR CONCRETE REPAIRS, SEE SPECIAL PROVISIONS.

- FOR CAP REPAIRS, SEE TYPICAL CAP AND COLUMN REPAIR DETAILS SHEET.
