PROJECT NO. I-5746C
MECKLENBURG COUNTY
 BRIDGE NO. 590320

SHEET 1 OF 3

UNDERSIDE DECK REPAIR
 SPAN A

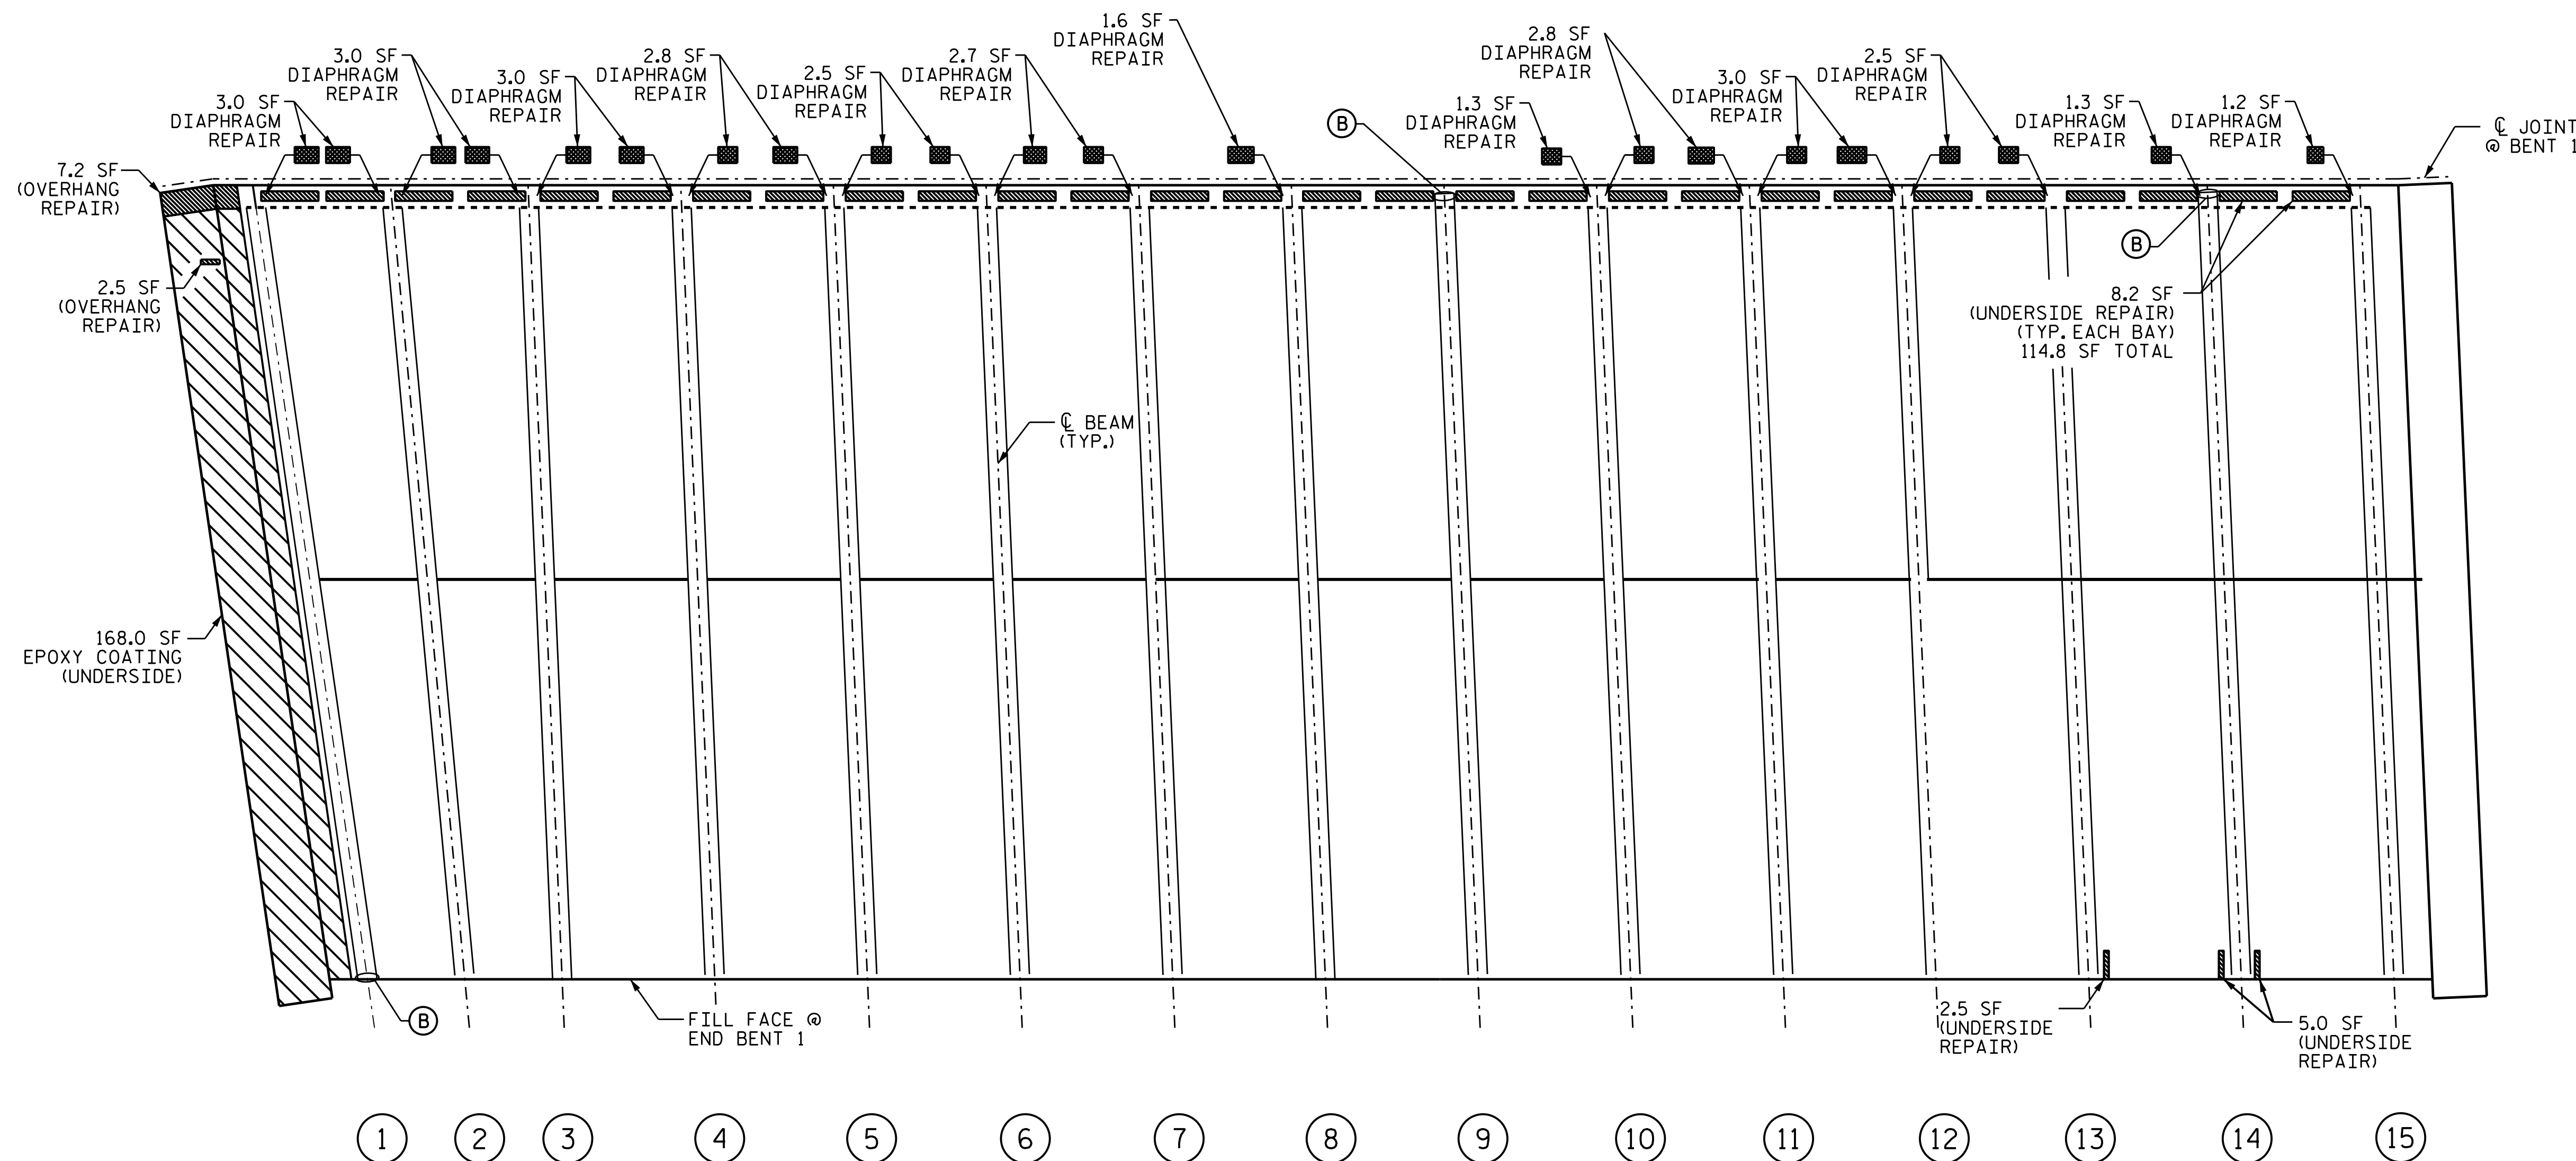
PLAN

VALUES REPRESENT ESTIMATED UNDERSIDE OF DECK REPAIR TOTALS AFTER REMOVAL OF UNSOUND CONCRETE, MINIMUM OF 1" BEHIND REBAR AND MINIMUM OF 2" CLEAR TO SAWCUT. SEE REPAIR DETAILS.

ANTICIPATED BEAM REPAIR LOCATIONS						
SPAN	BEAM	LOCATION	DIM "A"	DIM "B"	DIM "C"	DIM "D"
A	1	END BENT 1	8"	16"	-	-
A	9	BENT 1	8"	6"	3"	6"
A	14	BENT 1	12"	9"	1"	6"

AS-BUILT REPAIR QUANTITY TABLE				
UNDERSIDE OF DECK REPAIRS				
SHOTCRETE REPAIRS	ESTIMATE		ACTUAL	
	AREA SQ. FT.	VOLUME CU. FT.	AREA SQ. FT.	VOLUME CU. FT.
UNDERSIDE OF DECK	122.3	40.8		
UNDERSIDE OF OVERHANG	9.7	3.3		
INTERIOR DIAPHRAGMS	30.7	10.2		
	ESTIMATE		ACTUAL	
UNDERSIDE EPOXY RESIN INJECTION	0.0 LIN. FT.			
UNDERSIDE EPOXY COATING	168 SQ. FT.

BEAM REPAIR QUANTITY TABLE							
BEAM END REPAIR		PLATING REPAIR		STIFFENER REPAIR		DIAPHRAGM REPAIR	
LBS.		LBS.		LBS.		LBS.	
ESTIMATE	ACTUAL	ESTIMATE	ACTUAL	ESTIMATE	ACTUAL	ESTIMATE	ACTUAL
58.0		0		0		0
