PROJECT NO. I-5746C
MECKLENBURG COUNTY
 BRIDGE NO. 590328

STATE OF NORTH CAROLINA
 DEPARTMENT OF TRANSPORTATION
 RALEIGH
DECK UNDERSIDE DERAIR

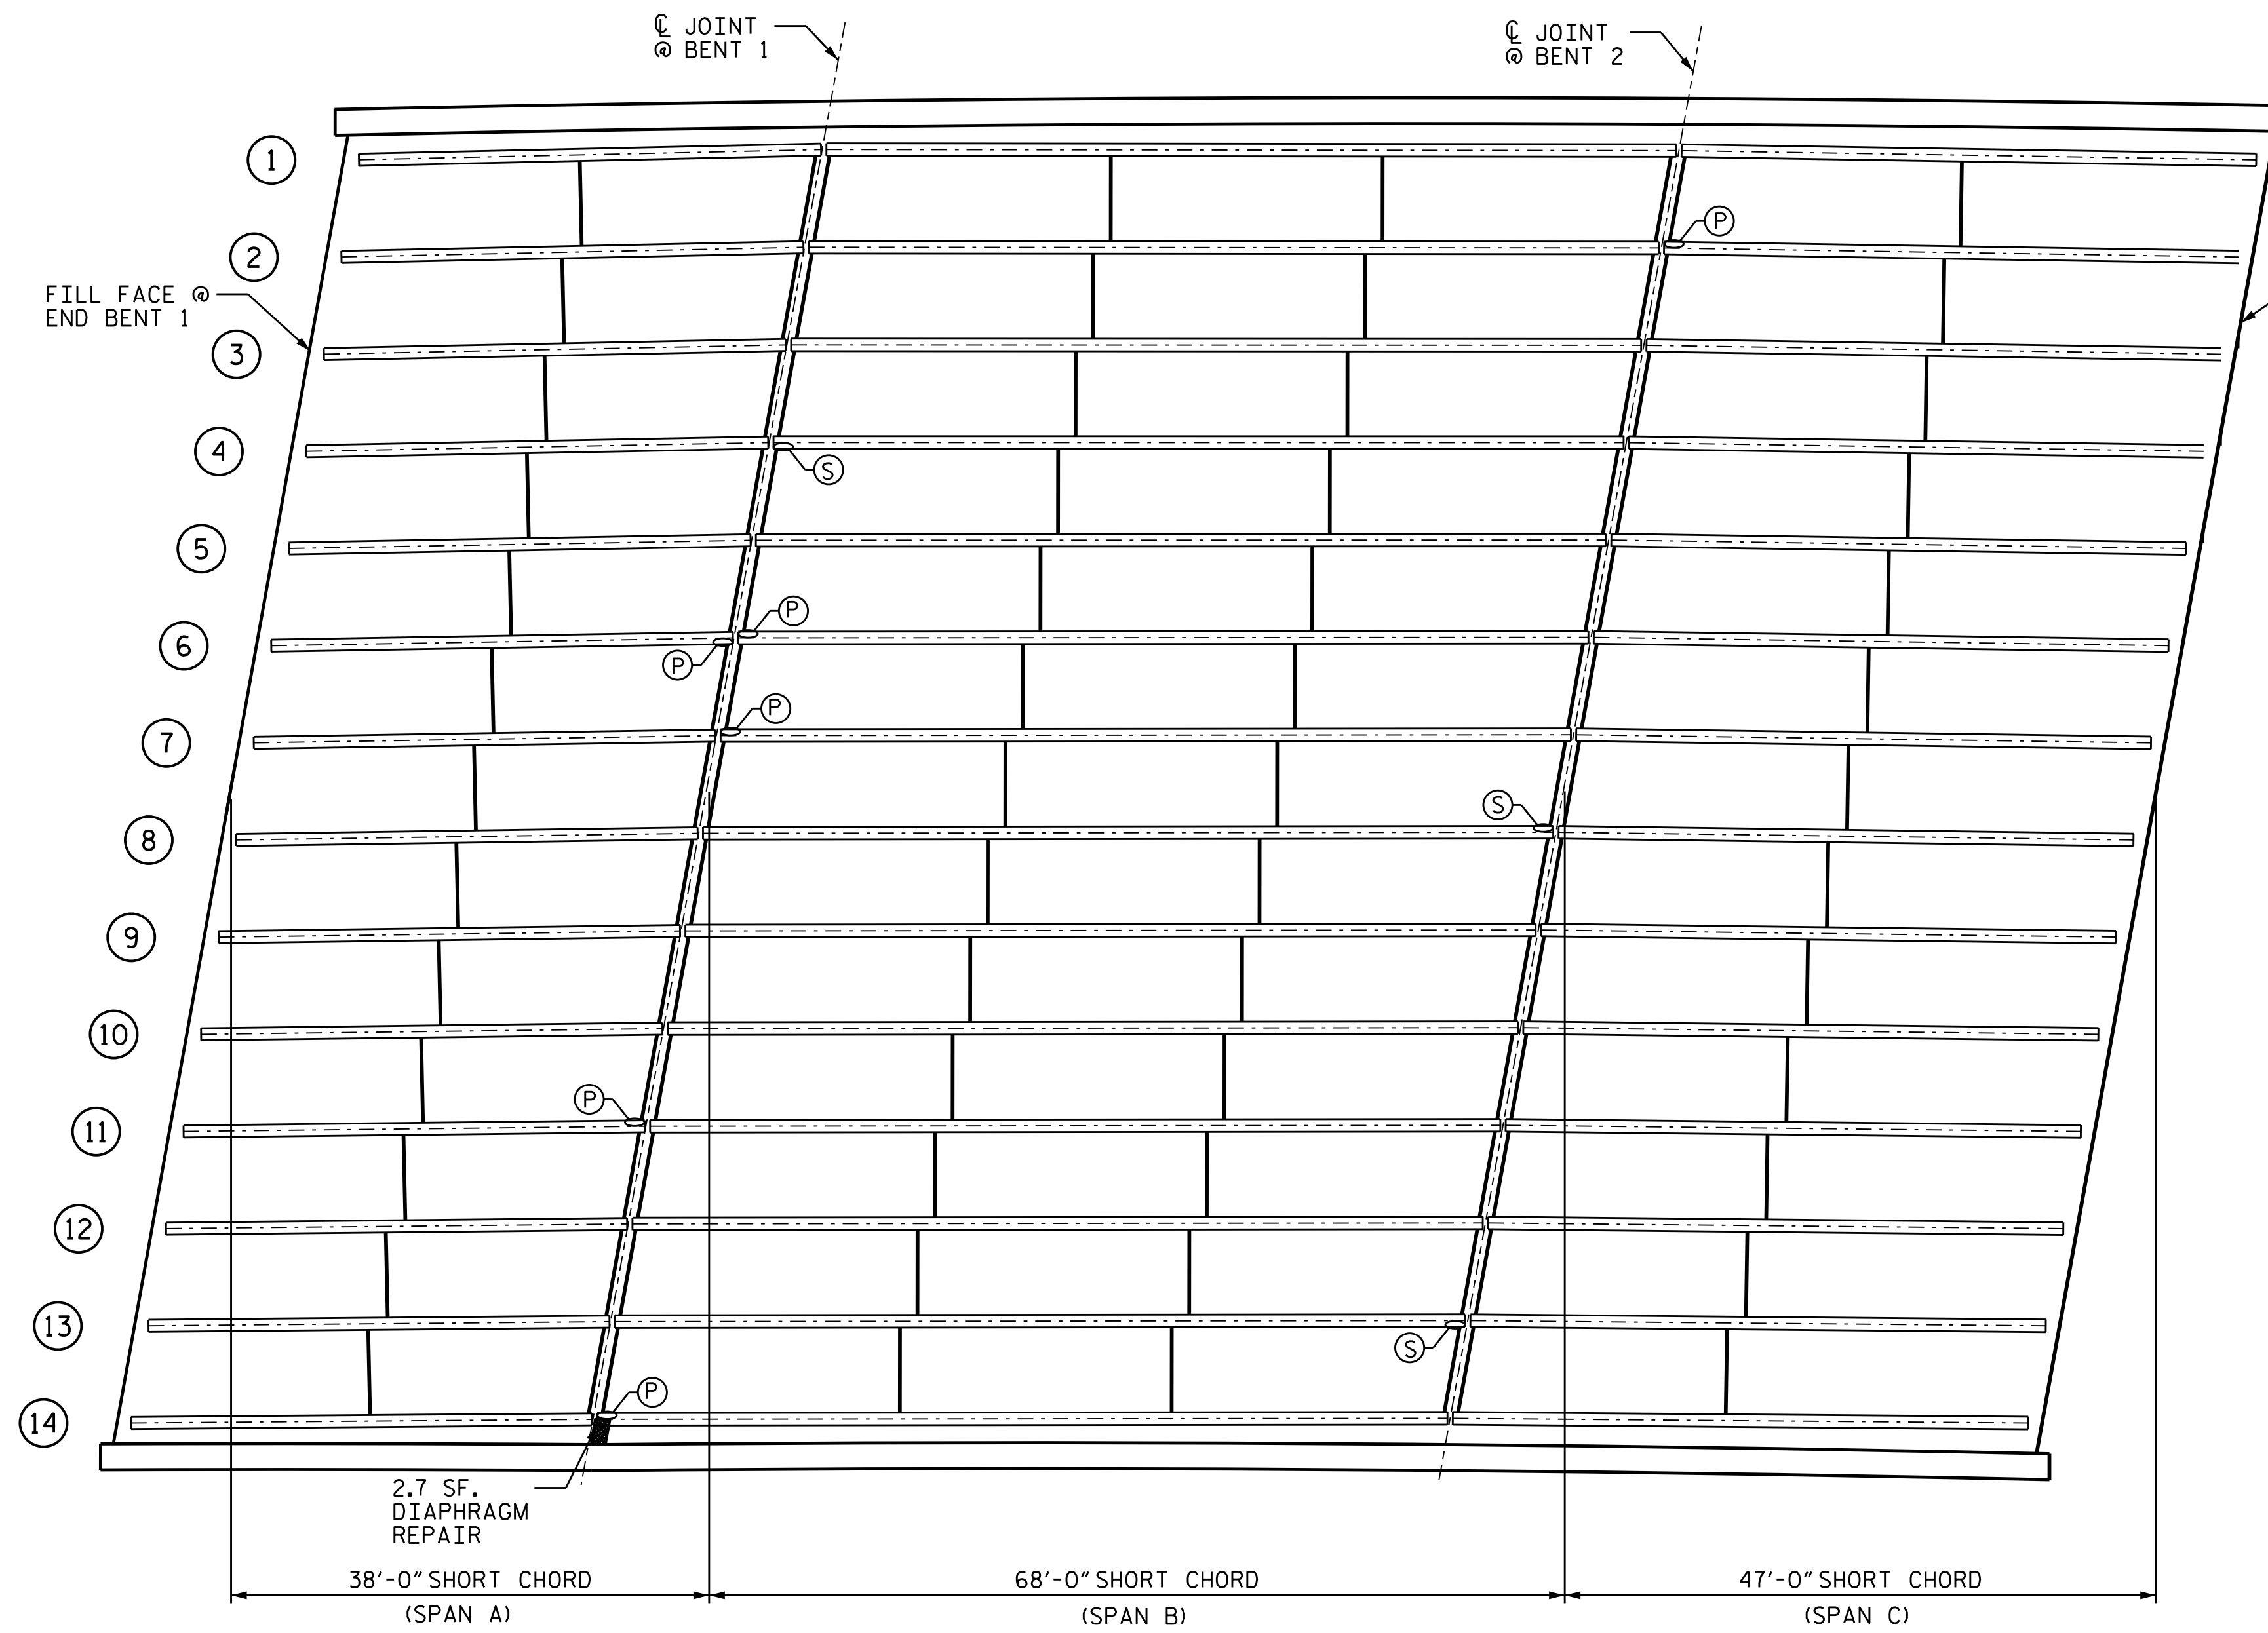
BEAM REPAIR LOCATIONS
(OTHER LOCATIONS MAY EXIST, SEE NOTES)

- UNDERSIDE EPOXY COATING
- UNDERSIDE REPAIR
- DIAPHRAGM REPAIR

SPAN	BEAM	LOCATION	DIM "A"	DIM "B"	DIM "C"	DIM "D"
A	6	BENT 1	3"	9"	-	-
A	11	BENT 1	4"	9"	-	-
B	4	BENT 1	6"	-	-	-
B	6	BENT 1	6"	9"	-	-
B	7	BENT 1	27"	9"	-	-
B	8	BENT 2	3"	-	-	-
B	13	BENT 2	3"	-	-	-
B	14	BENT 1	6"	9"	-	-
C	2	BENT 2	6"	9"	-	-

NOTES
 FOR BEAM REPAIR DETAILS, SEE "BEAM SECTION REPAIR DETAILS" SHEET.
 FOR BEAM PLATING REPAIR, SEE "BEAM PLATING REPAIR DETAILS" SHEET.
 FOR BRIDGE JACKING DETAILS, SEE "JACKING DETAILS" SHEET.
 FOR UNDERSIDE OF DECK AND OVERHANG REPAIRS, SEE "OVERHANG, DIAPHRAGM AND BRIDGE RAIL REPAIR DETAILS" SHEET.

VALUES REPRESENT ESTIMATED UNDERSIDE OF DECK REPAIR TOTALS AFTER REMOVAL OF UNSOUND CONCRETE, MINIMUM OF 1" BEHIND REBAR AND MINIMUM OF 2" CLEAR TO SAWCUT. SEE REPAIR DETAILS.
