PROJECT NO. I-5746CMECKLENBURG COUNTY BRIDGE NO.: 590328

> STATE OF NORTH CAROLINA DEPARTMENT OF TRANSPORTATION

> > BENT 1 SOUTHBOUND SPAN B FACE

SHEET NO REVISIONS NO. BY: DATE: S8-14 TOTAL SHEETS 274

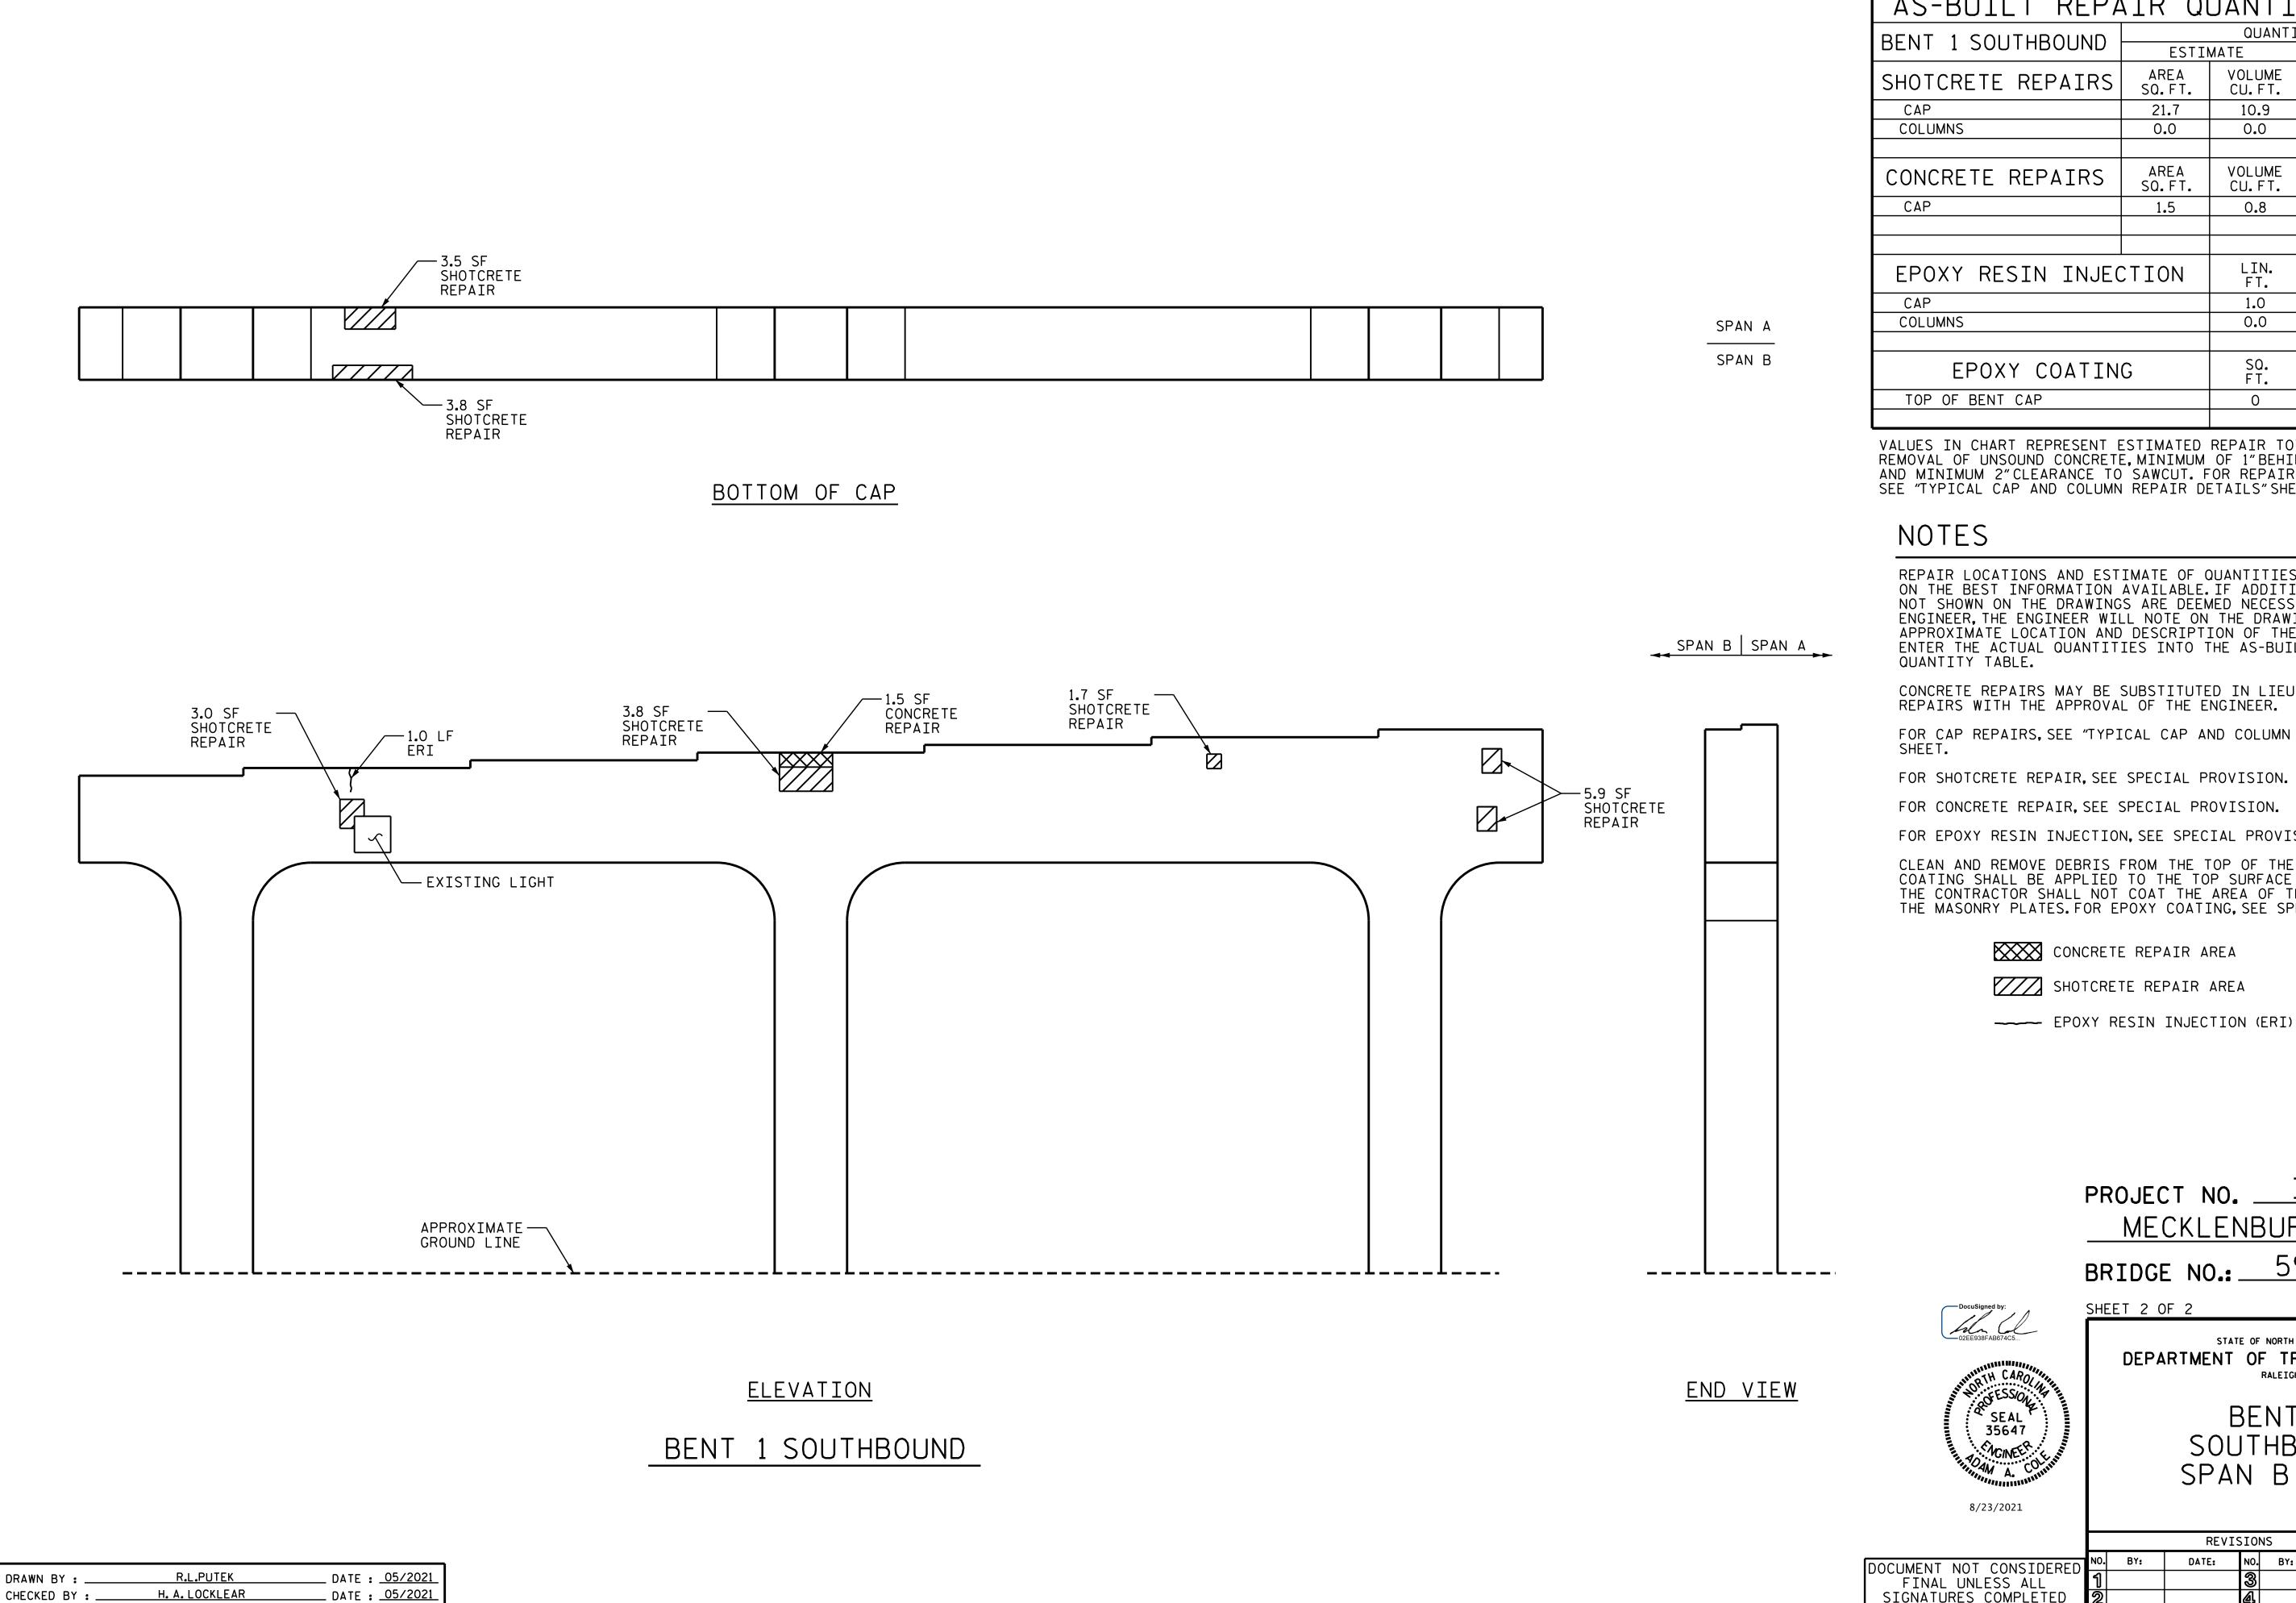
VALUES IN CHART REPRESENT ESTIMATED REPAIR TOTALS AFTER REMOVAL OF UNSOUND CONCRETE, MINIMUM OF 1"BEHIND REBAR AND MINIMUM 2"CLEARANCE TO SAWCUT. FOR REPAIR DETAILS, SEE "TYPICAL CAP AND COLUMN REPAIR DETAILS" SHEET.

CLEAN AND REMOVE DEBRIS FROM THE TOP OF THE CAP. EPOXY COATING SHALL BE APPLIED TO THE TOP SURFACE OF THE CAP. THE CONTRACTOR SHALL NOT COAT THE AREA OF THE CAP BENEATH THE MASONRY PLATES. FOR EPOXY COATING, SEE SPECIAL PROVISIONS.
