PROJECT NO. I-5746CMECKLENBURG COUNTY

STATE OF NORTH CAROLINA DEPARTMENT OF TRANSPORTATION

SHEET NO REVISIONS NO. BY: DATE: S8-18 DATE: DOCUMENT NOT CONSIDERED -FINAL UNLESS ALL SIGNATURES COMPLETED TOTAL SHEETS 274

BENT 2 SOUTHBOUND

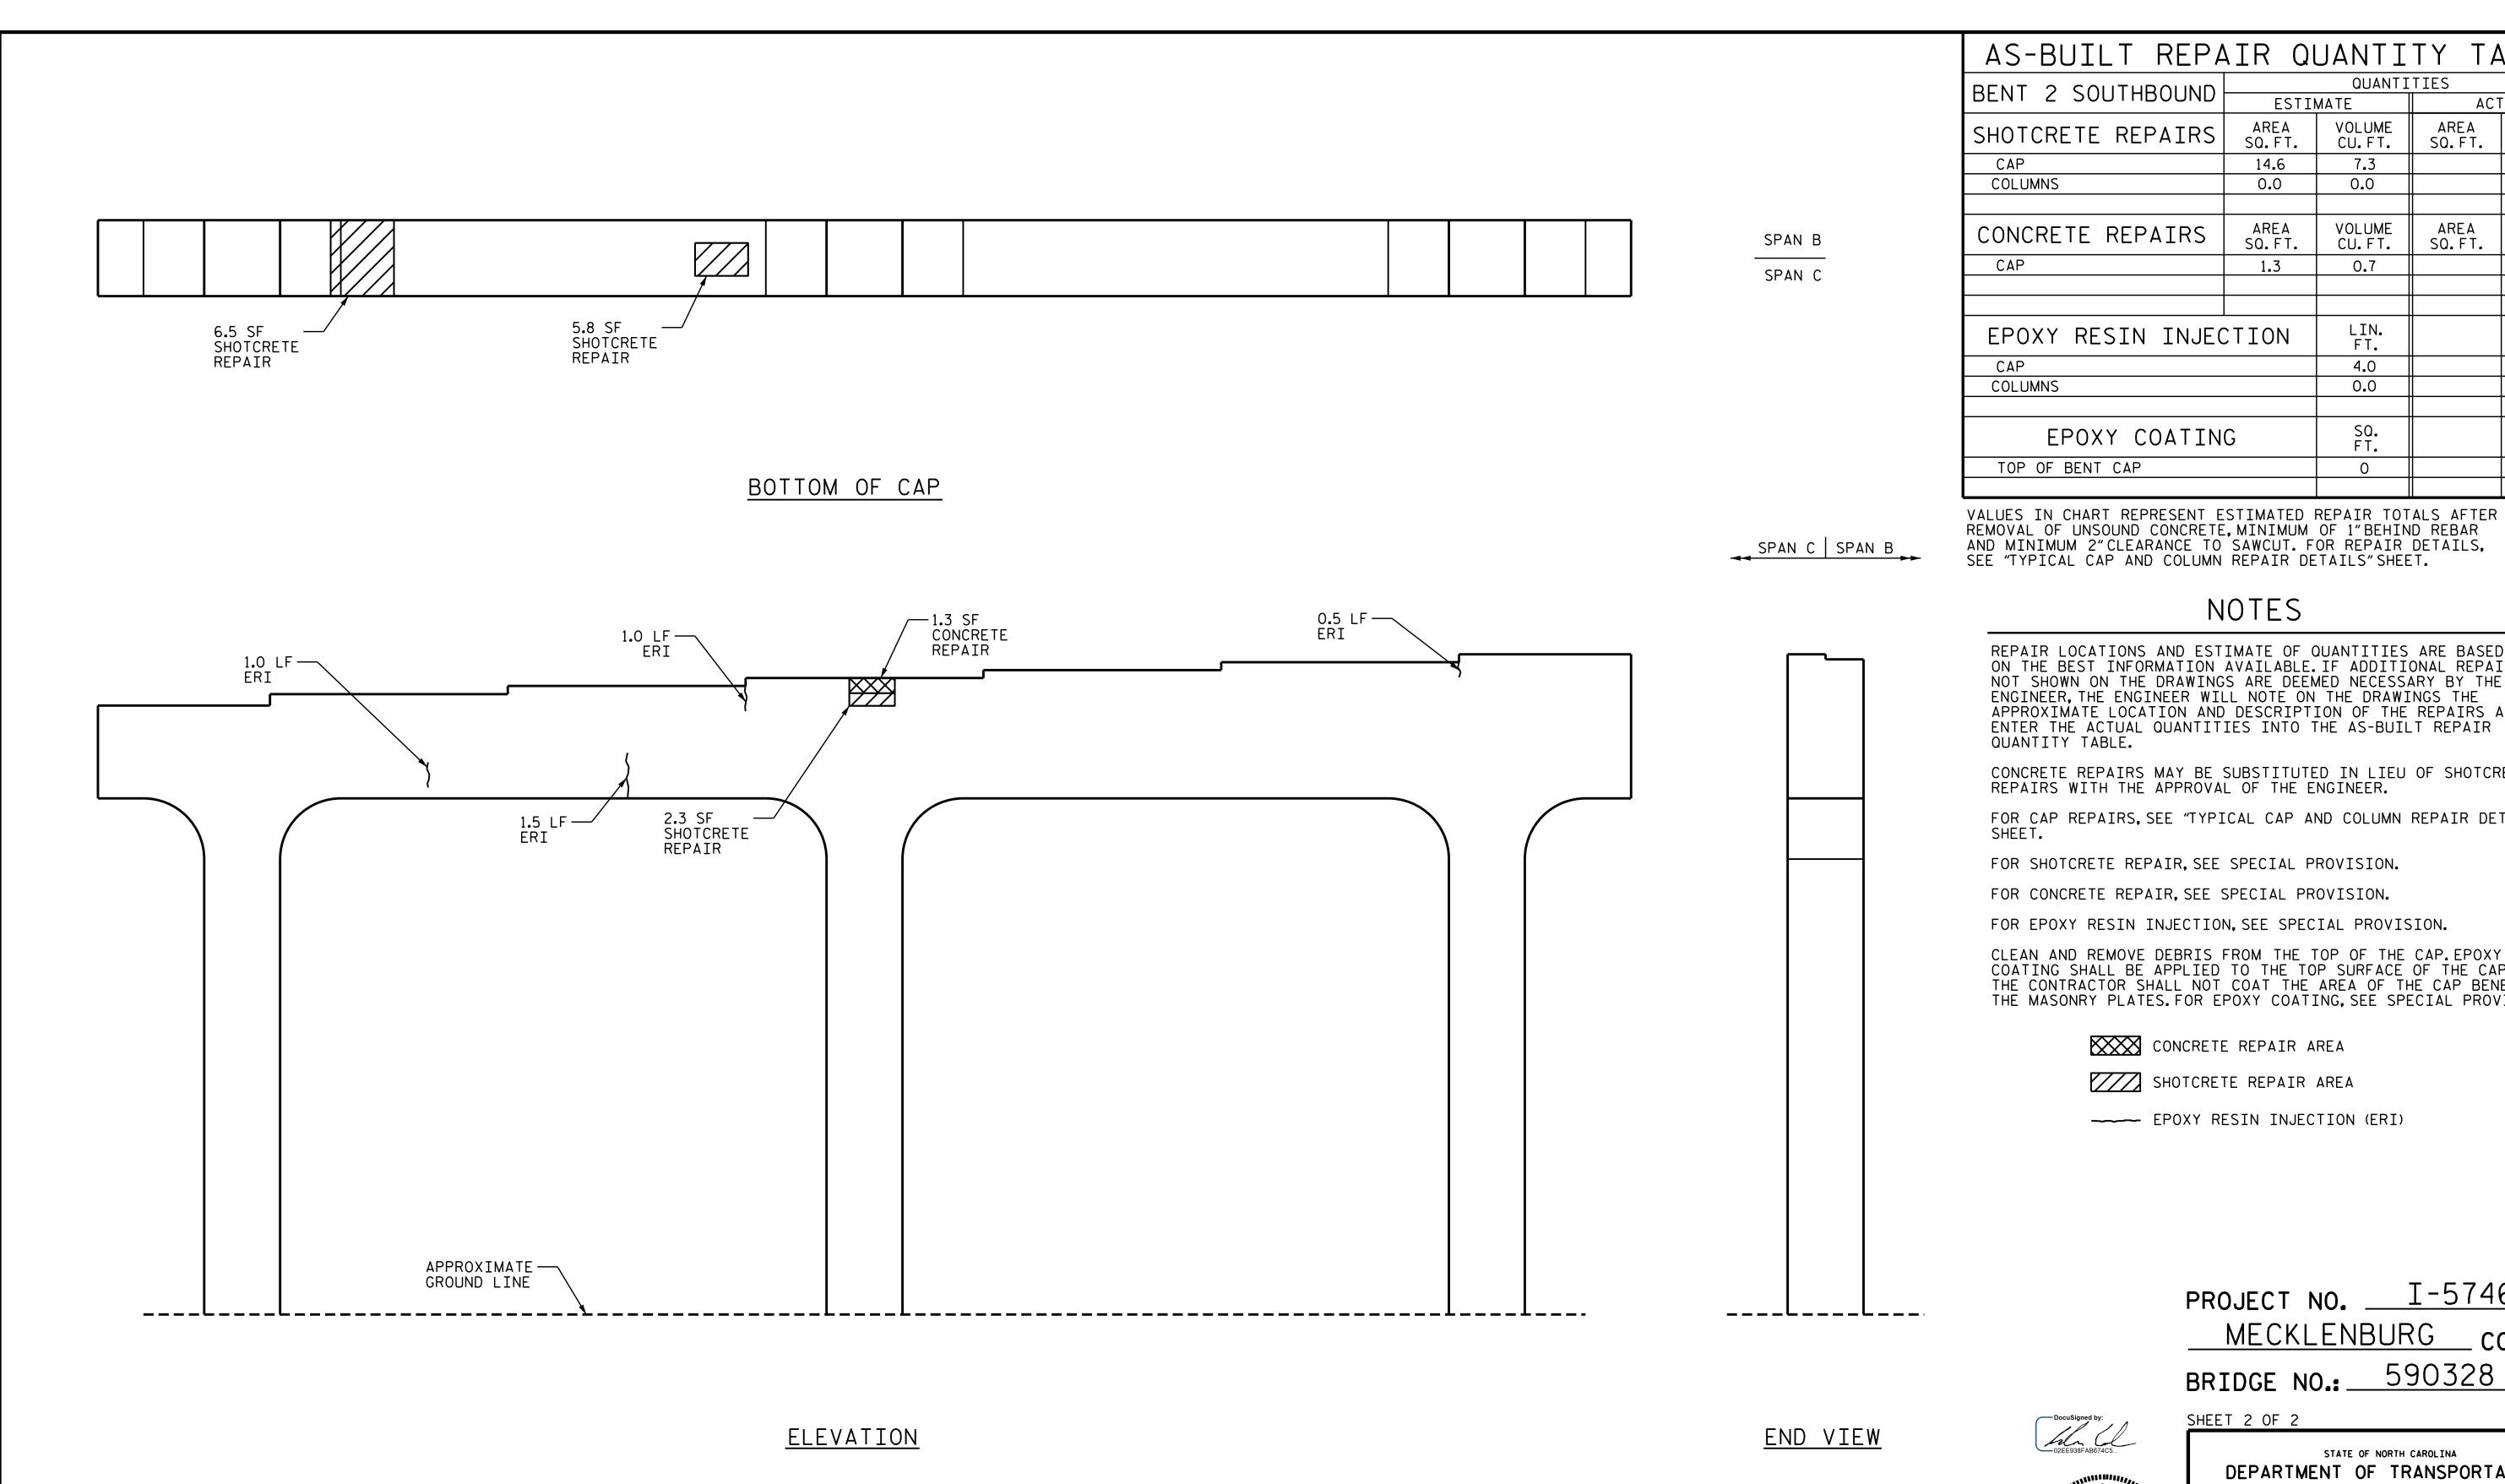
BENT 2

SOUTHBOUND SPAN C FACE

VALUES IN CHART REPRESENT ESTIMATED REPAIR TOTALS AFTER REMOVAL OF UNSOUND CONCRETE, MINIMUM OF 1"BEHIND REBAR AND MINIMUM 2"CLEARANCE TO SAWCUT. FOR REPAIR DETAILS, SEE "TYPICAL CAP AND COLUMN REPAIR DETAILS" SHEET.

FOR CAP REPAIRS, SEE "TYPICAL CAP AND COLUMN REPAIR DETAILS"

CLEAN AND REMOVE DEBRIS FROM THE TOP OF THE CAP. EPOXY COATING SHALL BE APPLIED TO THE TOP SURFACE OF THE CAP. THE CONTRACTOR SHALL NOT COAT THE AREA OF THE CAP BENEATH THE MASONRY PLATES. FOR EPOXY COATING, SEE SPECIAL PROVISIONS.
