PROJECT NO.	<u> </u>	·		
N	MECKLEN				
	BRIDGE No	590330			
DocuSigned by:	SHEET 1 OF 2				
02EE938FAB674C5	STATE OF NORTH CAROLINA DEPARTMENT OF TRANSPORTATION RALEIGH				
OFESSION A. COLUMNIA	BENT 2 NORTHBOUND SPAN B FACE				
8/23/2021	SFAN	I D FACE			
	REVISIONS SHEET NO.				
DOCUMENT NOT CONSIDERED		IO. BY: DATE:	S9-17		
FINAL UNLESS ALL SIGNATURES COMPLETED	1 4	3 A	TOTAL SHEETS 274

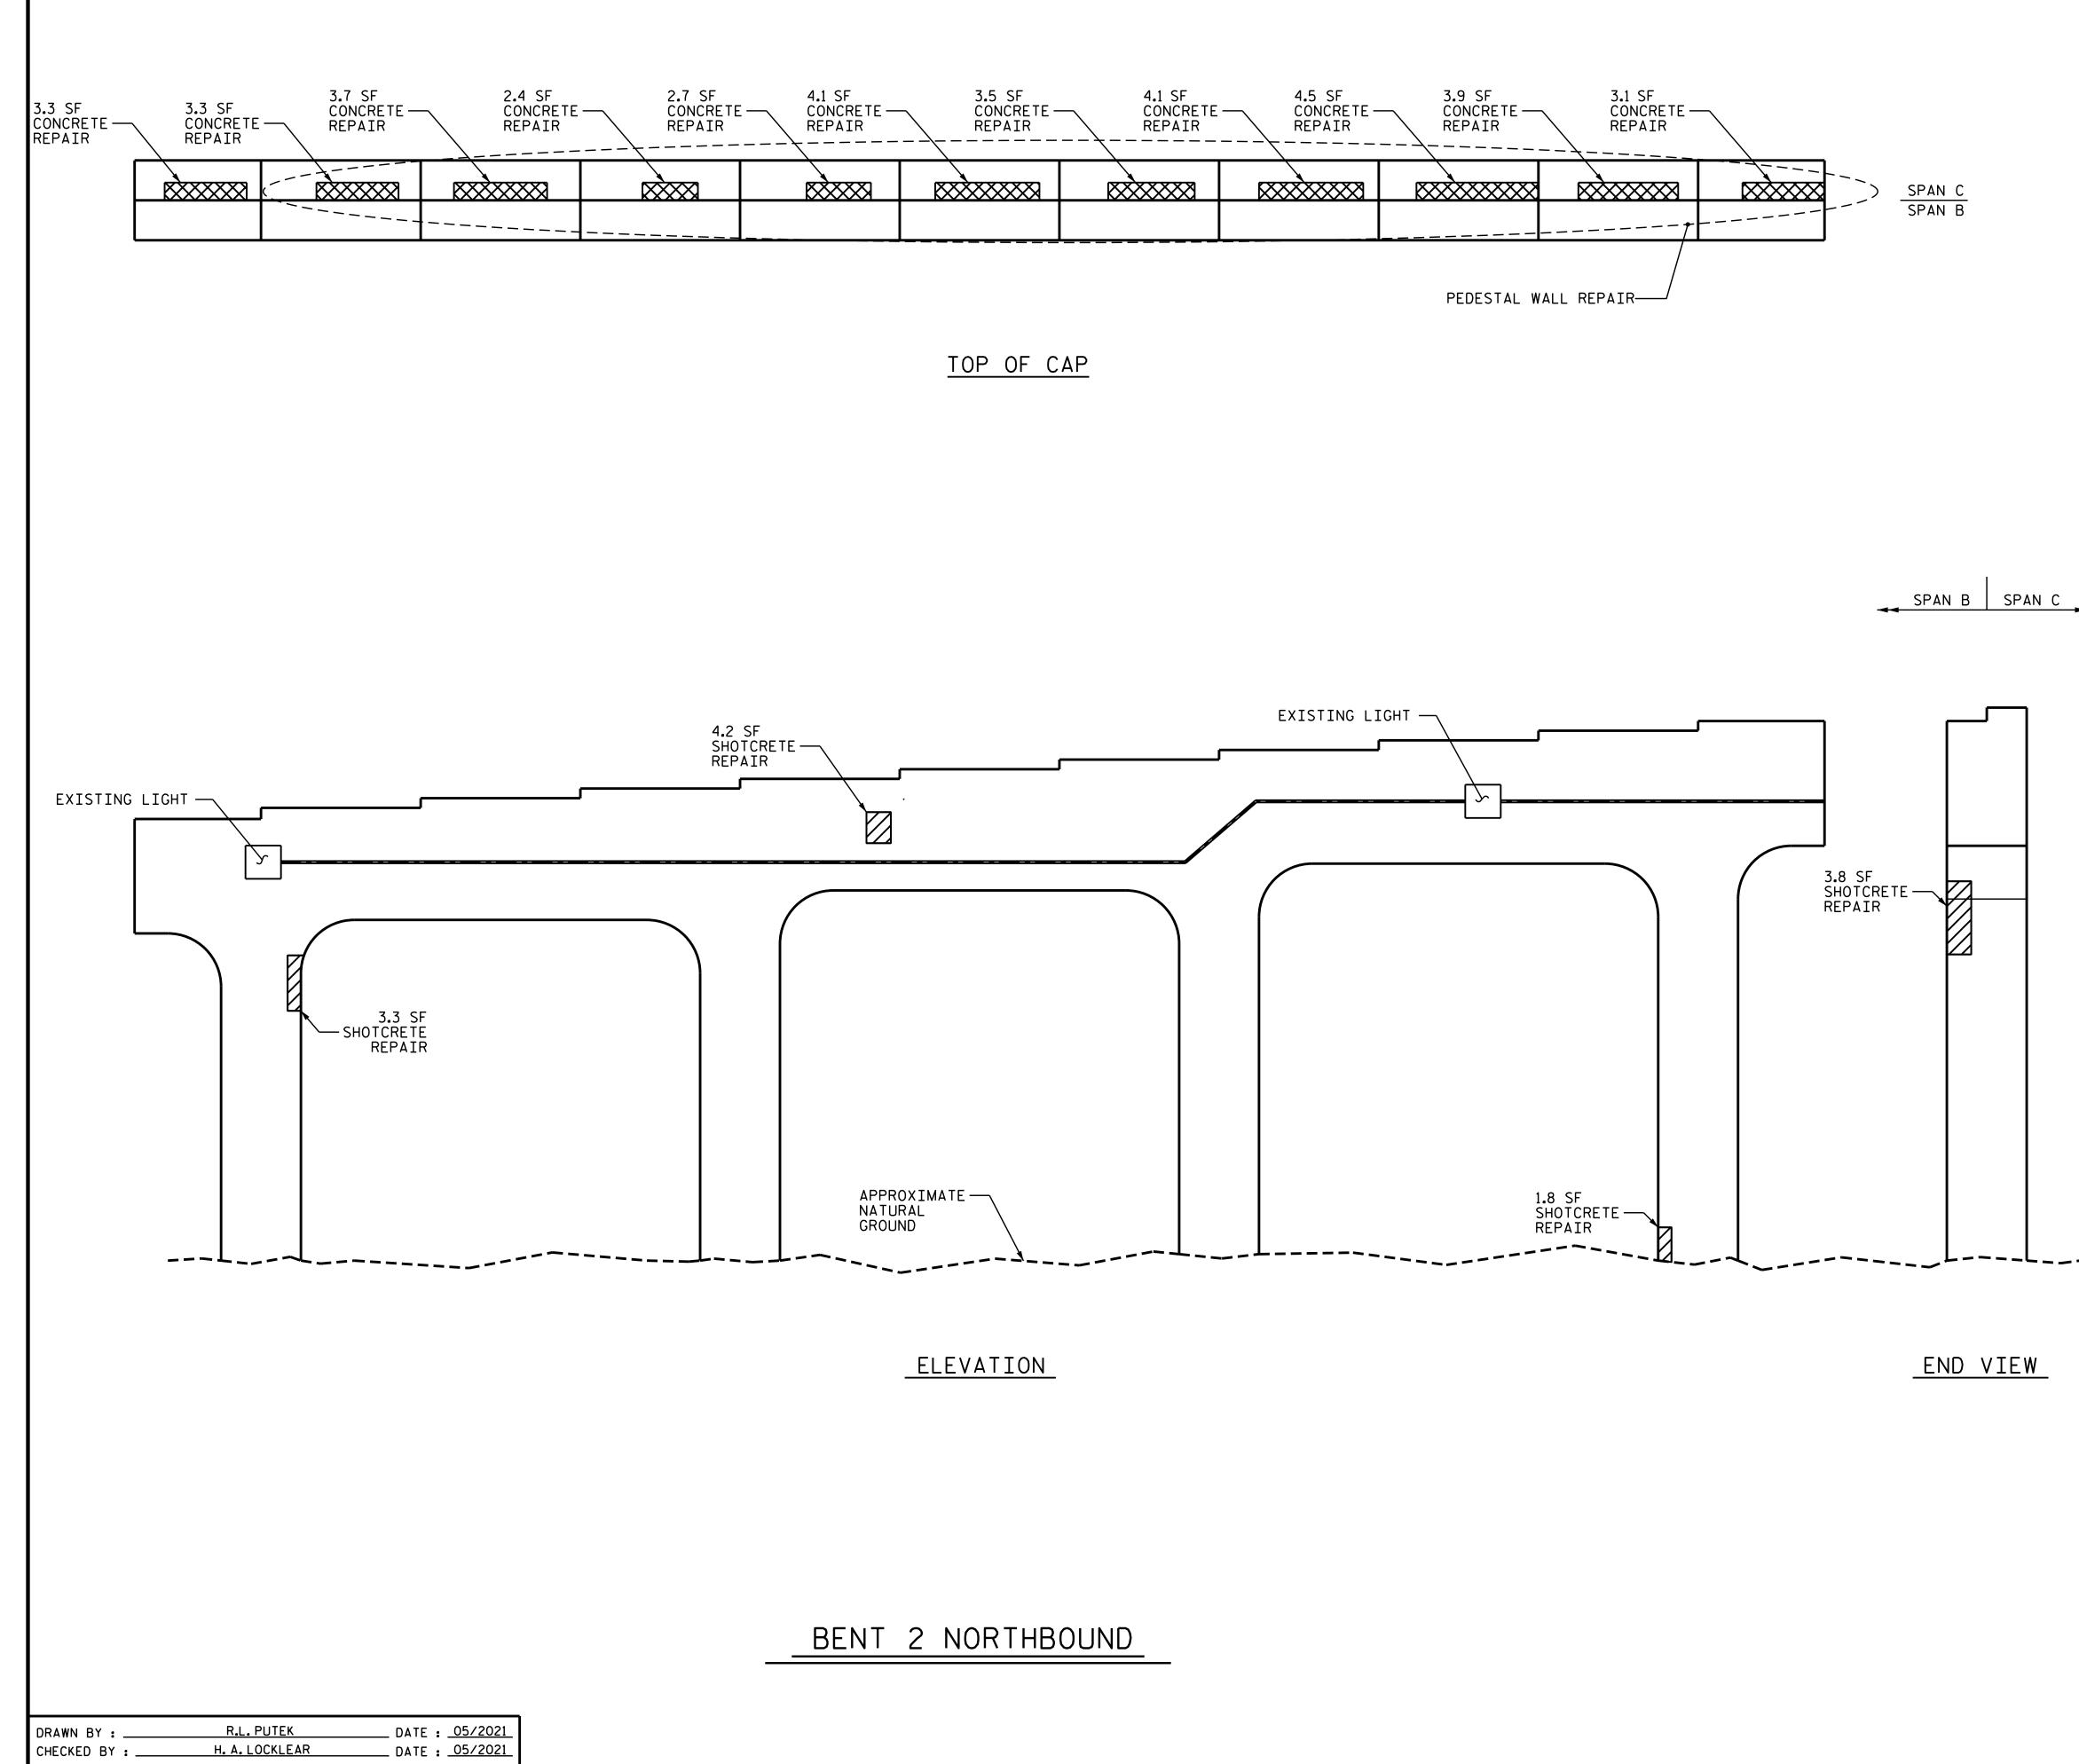
AS-BUILT REPA	IR QI	UANT]	ΤΥ Τ	ABLE
BENT 2 NORTHBOUND	QUANTITIES			
DEINI Z NORIHDUUND	ESTIMATE		ACTUAL	
SHOTCRETE REPAIRS	AREA SQ.FT.	VOLUME CU.FT.	AREA SQ.FT.	VOLUME CU.FT.
САР	4.2	2.1		
COLUMNS	8.9	4.5		
CONCRETE REPAIRS	AREA SQ.FT.	VOLUME CU.FT.	AREA SQ.FT.	VOLUME CU.FT.
САР	38.6	19.3		
EPOXY RESIN INJECTION		LIN. FT		LIN. FT
САР		0.0		
COLUMNS		0.0		
EPOXY COATING		SQ. FT.		SQ. FT.
TOP OF BENT CAP		202

VALUES IN CHART REPRESENT ESTIMATED REPAIR TOTALS AFTER REMOVAL OF UNSOUND CONCRETE, MINIMUM OF 1"BEHIND REBAR AND MINIMUM 2"CLEARANCE TO SAWCUT. FOR REPAIR DETAILS, SEE ``TYPICAL CAP AND COLUMN REPAIR DETAILS'' SHEET.

CLEAN AND REMOVE DEBRIS FROM THE TOP OF THE CAP. EPOXY COATING SHALL BE APPLIED TO THE TOP SURFACE OF THE CAP. THE CONTRACTOR SHALL NOT COAT THE AREA OF THE CAP BENEATH THE MASONRY PLATES. FOR EPOXY COATING, SEE SPECIAL PROVISIONS.

FOR PEDESTAL WALL REPAIR, SEE "TYPICAL CAP AND COLUMN REPAIR DETAILS" SHEET.
