AS-BUILT REPAIR QUANTITY TABLE

PROJECT NO. I-5746C
MECKLENBURG COUNTY
 BRIDGE NO. 590332

DECK UNDERSIDE REPAIR
 SPAN C & D

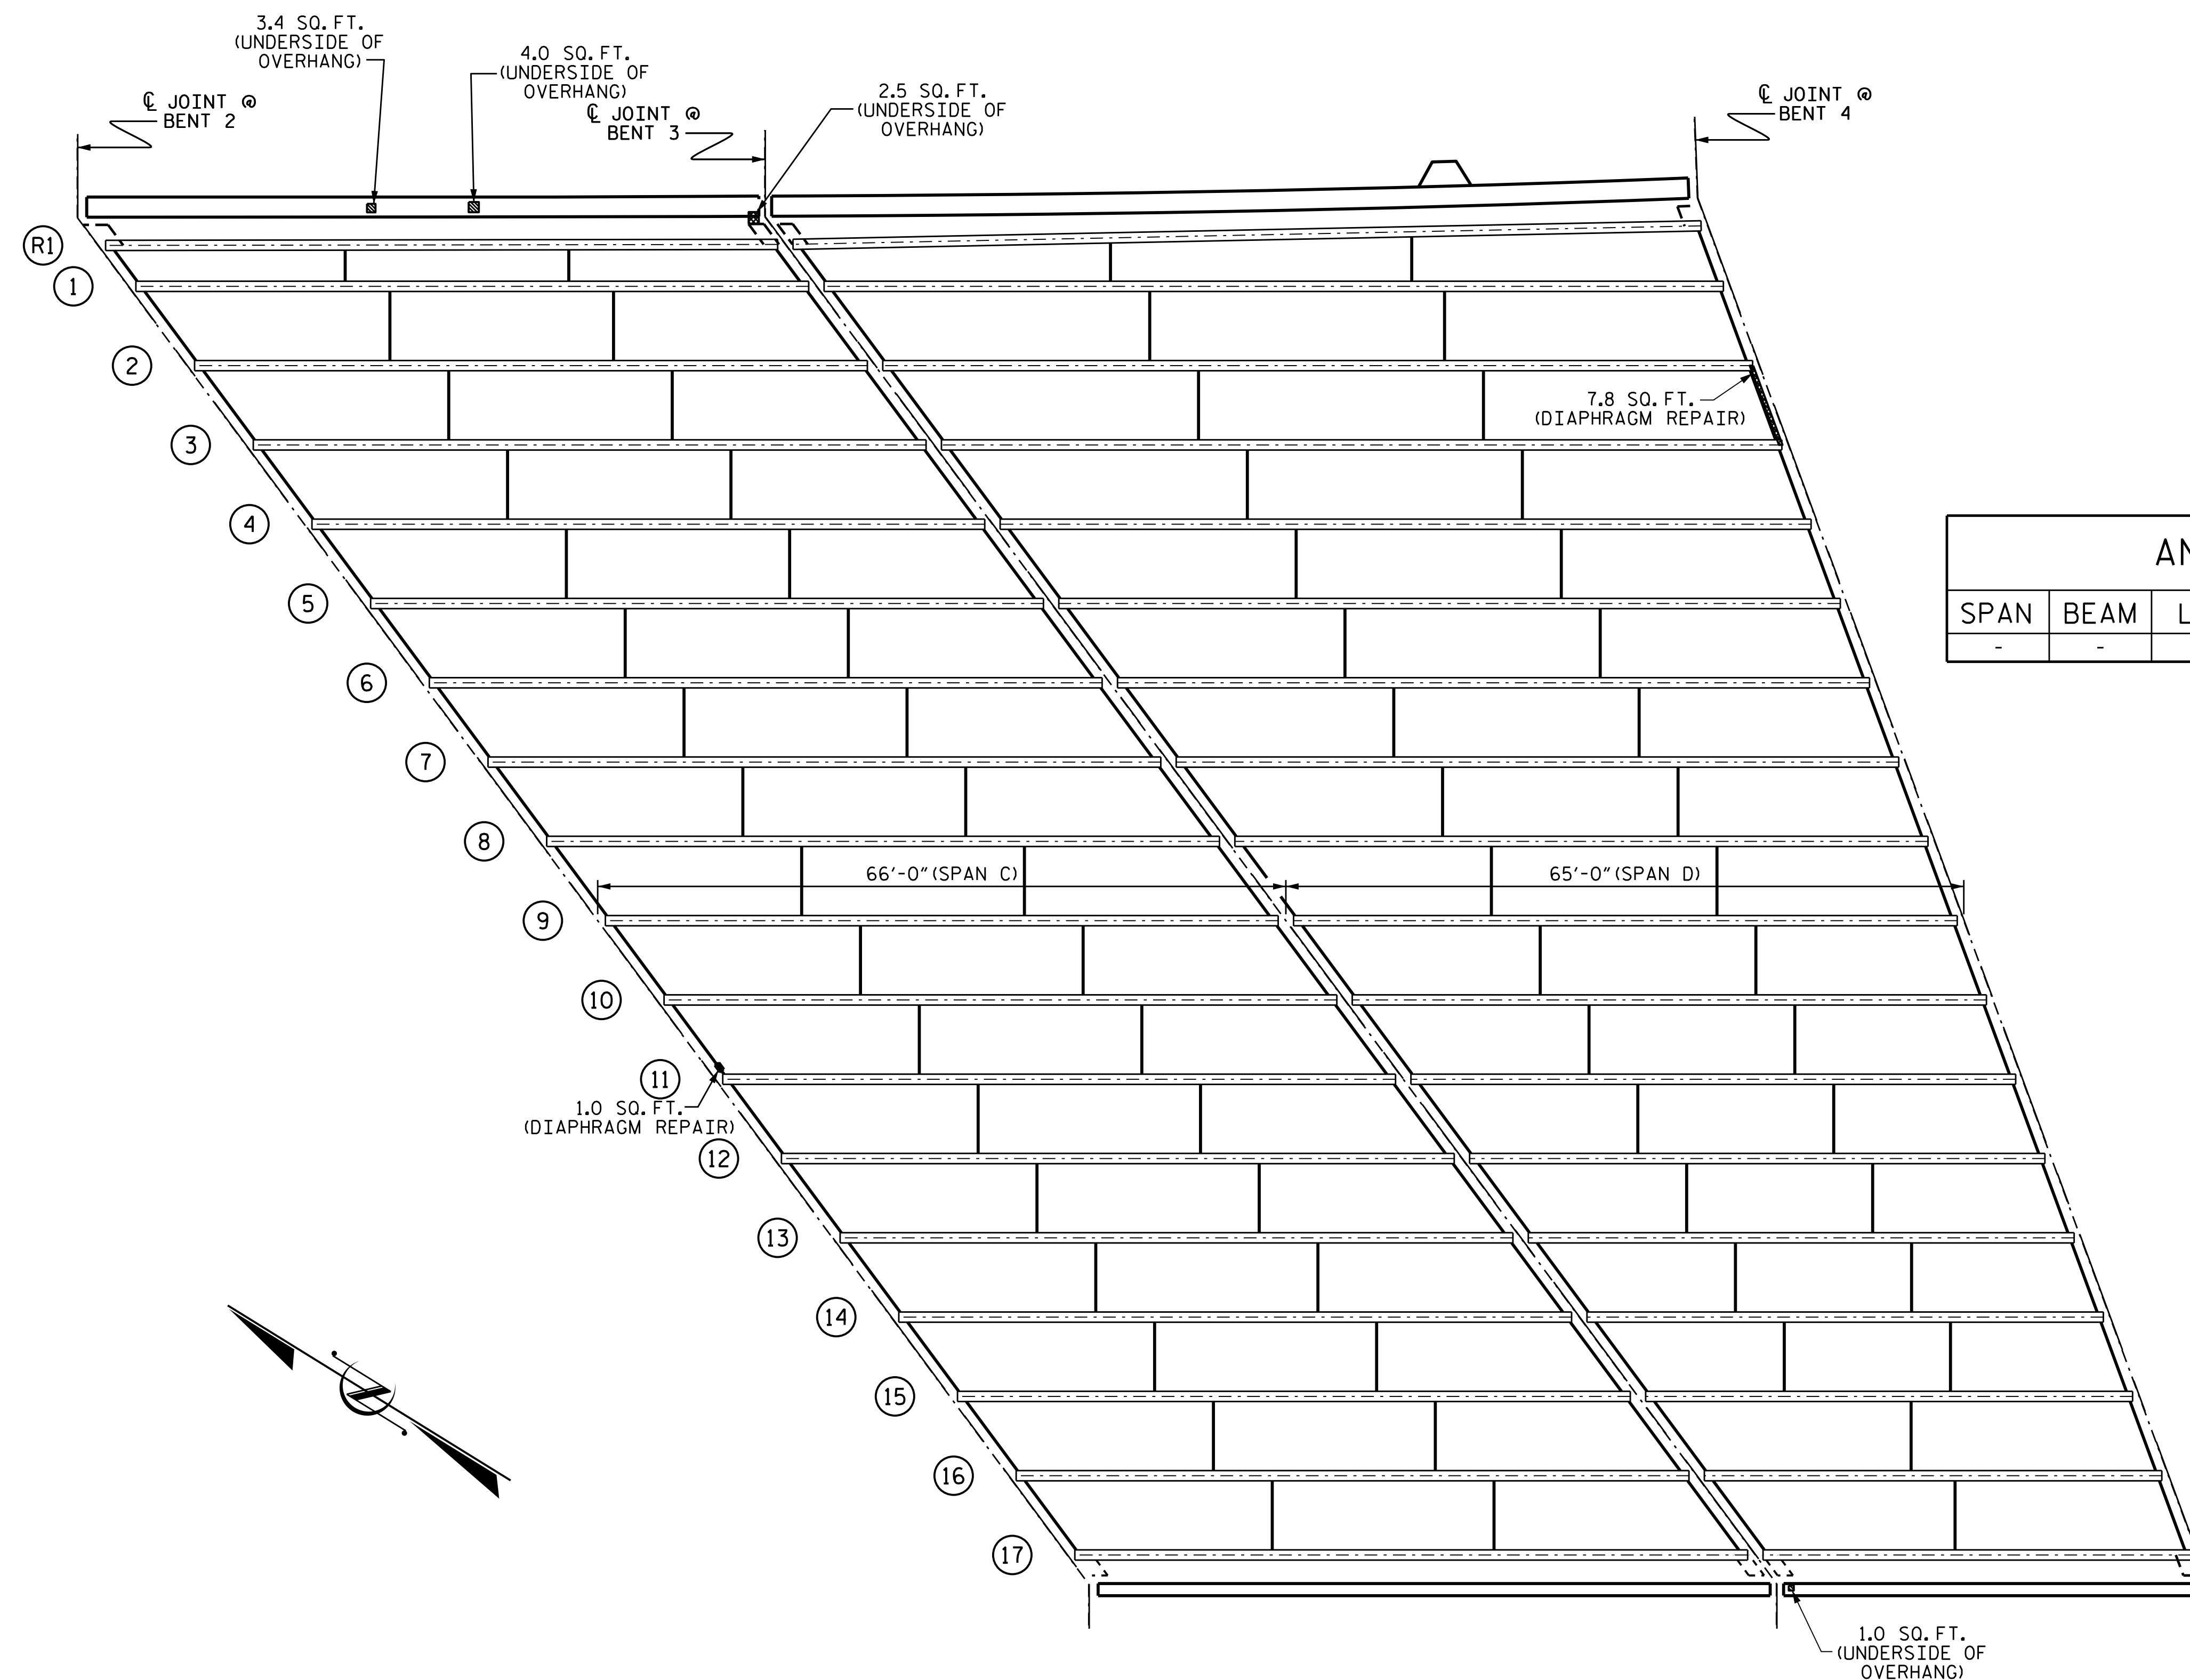
PLAN

SHOTCRETE REPAIRS	ESTIMATE		ACTUAL	
	AREA SQ. FT.	VOLUME CU. FT.	AREA SQ. FT.	VOLUME CU. FT.
UNDERSIDE OF DECK	0.0	0.0		
OVERHANG DIAPHRAGMS	0.0	0.0		
UNDERSIDE OF OVERHANG	10.9	3.6		
INTERIOR DIAPHRAGMS	8.8	2.9		
	ESTIMATE		ACTUAL	
UNDERSIDE EPOXY RESIN INJECTION	0.0 LIN. FT.			
UNDERSIDE EPOXY COATING	0 SQ. FT.

UNDERSIDE OF DECK REPAIR QUANTITIES REPRESENT ESTIMATED VALUES OF DECK REPAIR TOTALS AFTER REMOVAL OF UNSOUND CONCRETE, MINIMUM OF 1" BEHIND REBAR AND MINIMUM OF 2" CLEAR TO SAWCUT. SEE REPAIR DETAILS.
