PROJECT NO. I-5746C  
MECKLENBURG COUNTY  
 STATION: 590332

SHEET 8 OF 11

## DECK UNDERSIDE REPAIR

### SPAN P

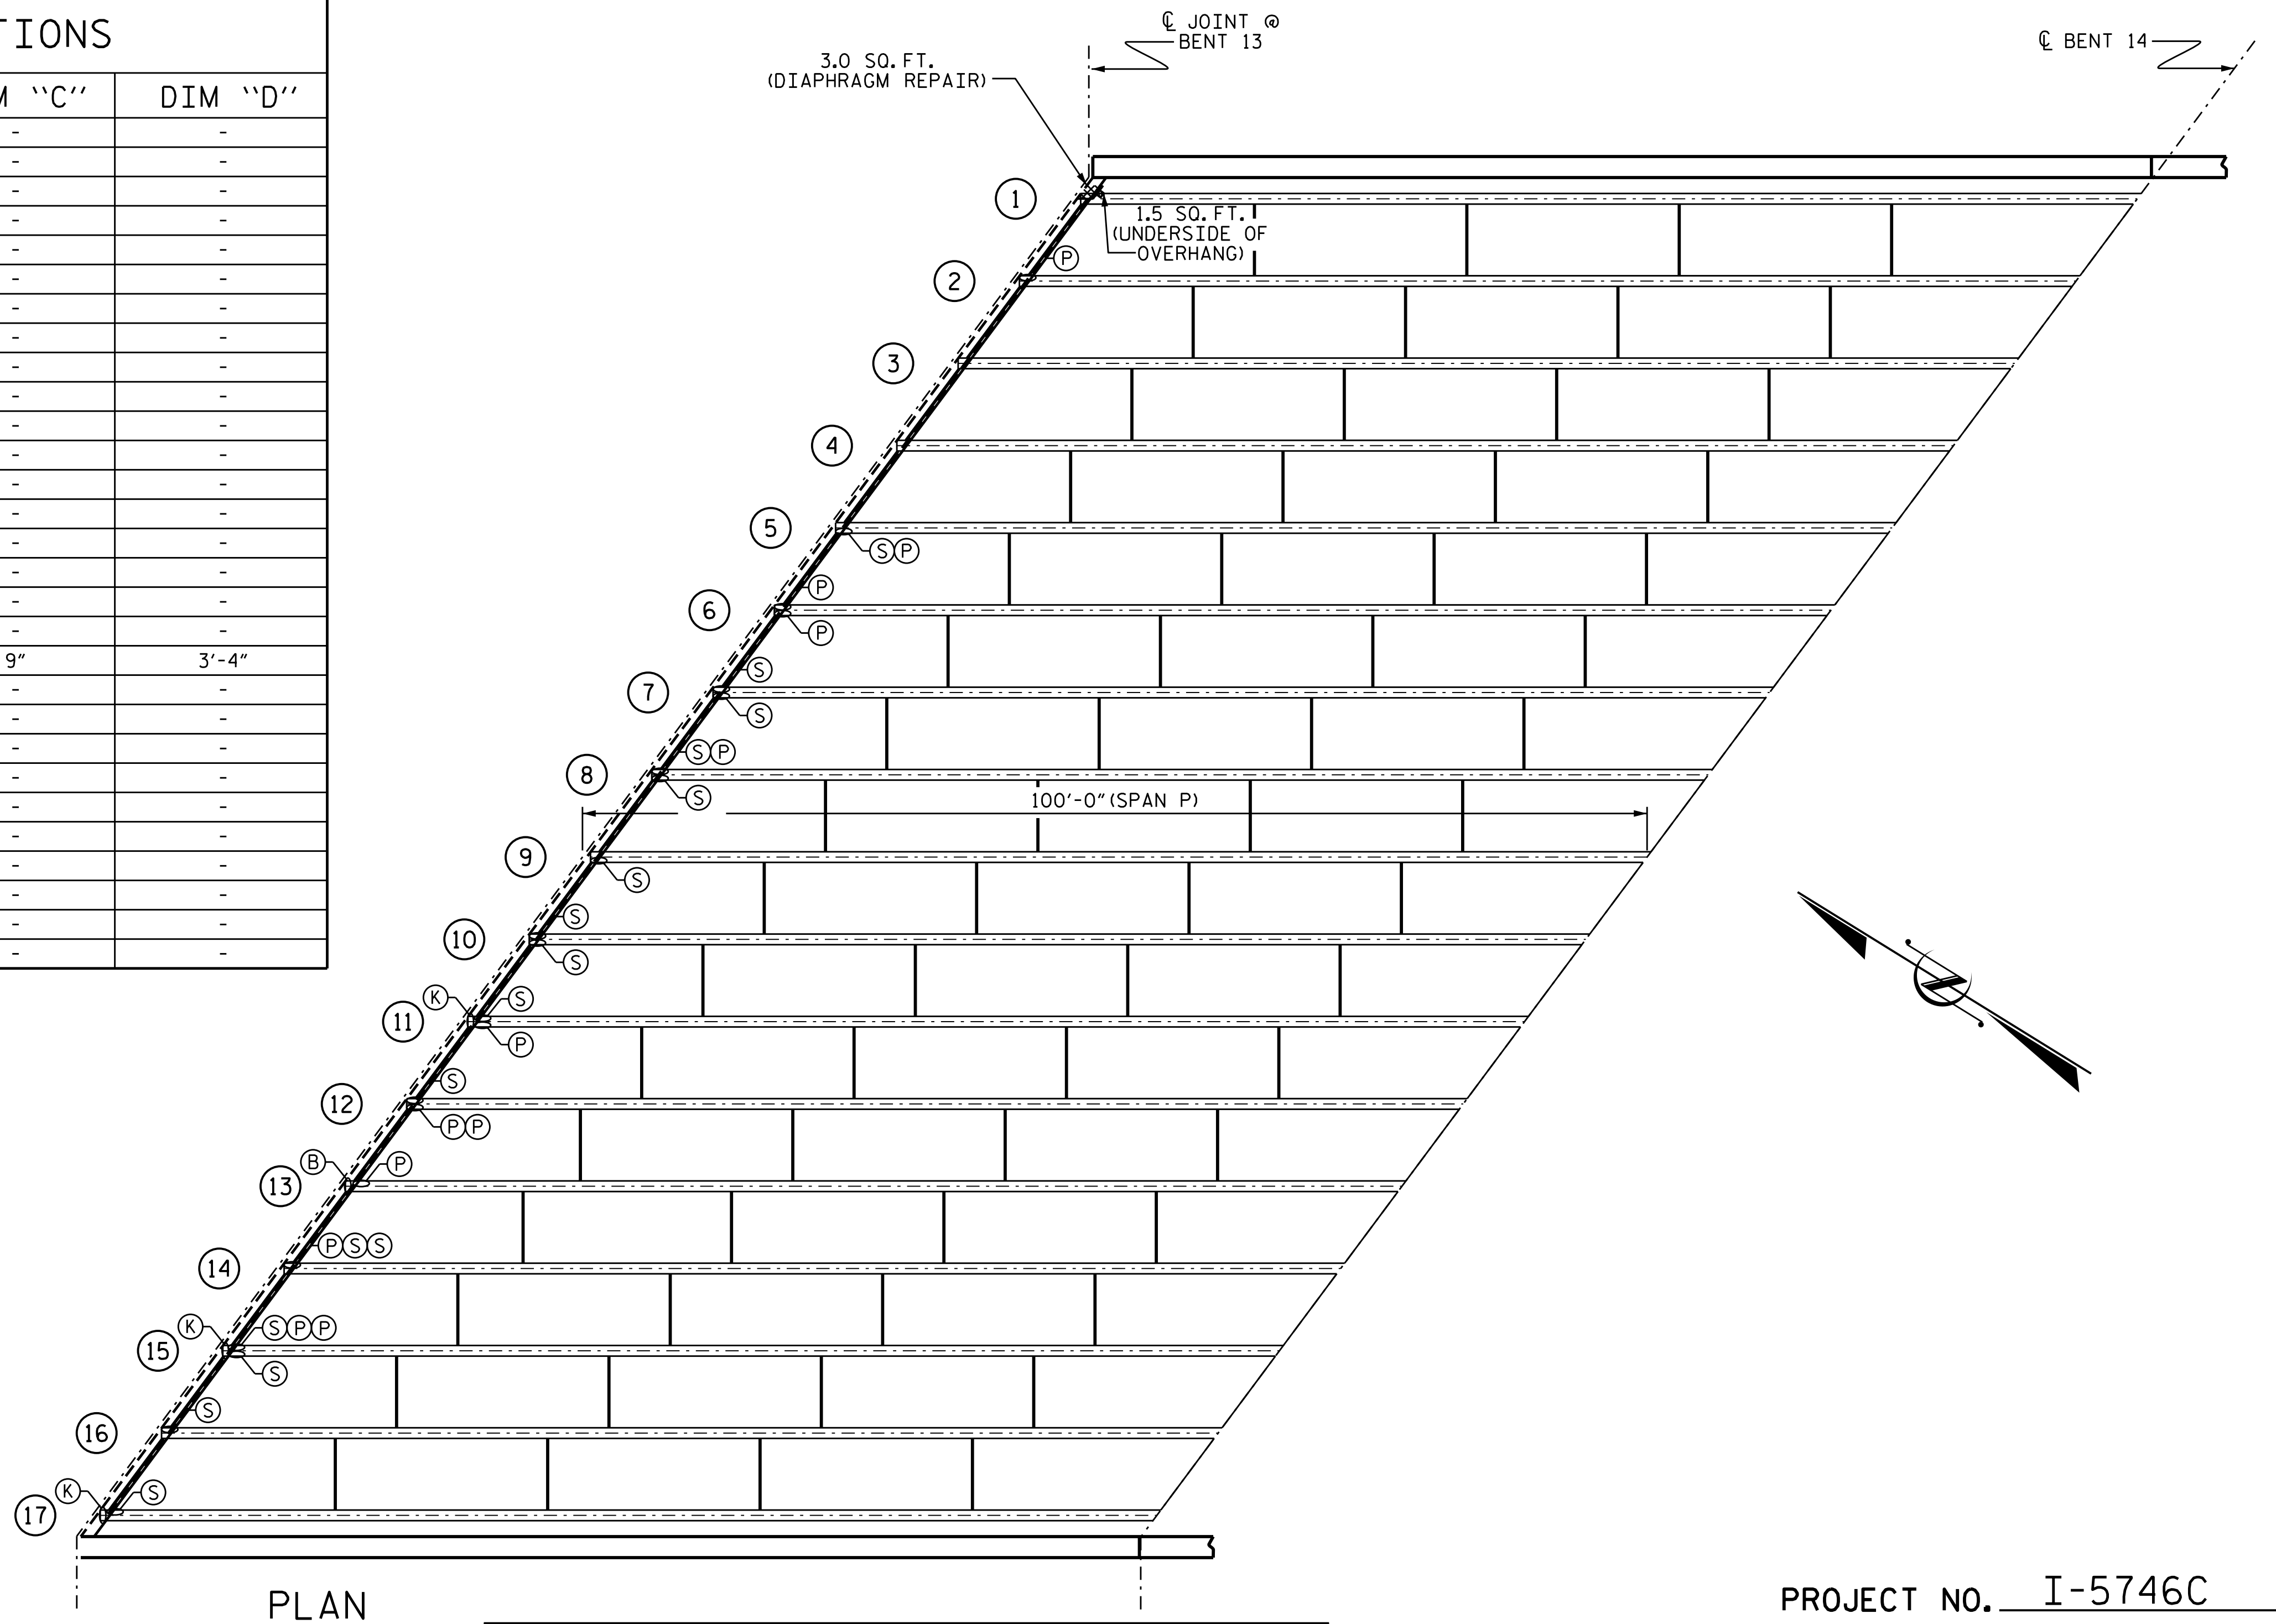
PLAN

### ANTICIPATED BEAM REPAIR LOCATIONS

SPAN	BEAM	LOCATION	DIM "A"	DIM "B"	DIM "C"	DIM "D"
P	2	BENT 13	1'-2"	1'-10"	-	-
P	5	BENT 13	1'-10"	-	-	-
P	5	BENT 13	1'-2"	1'-10"	-	-
P	6	BENT 13	10"	1'-2"	-	-
P	6	BENT 13	10"	1'-10"	-	-
P	7	BENT 13	10"	-	-	-
P	7	BENT 13	3'-3"	-	-	-
P	8	BENT 13	3'-3"	-	-	-
P	8	BENT 13	3'-3"	-	-	-
P	8	BENT 13	1'-2"	1'-10"	-	-
P	9	BENT 13	4"	-	-	-
P	10	BENT 13	3'-3"	-	-	-
P	10	BENT 13	3'-3"	-	-	-
P	11	BENT 13	1'-2"	1'-10"	-	-
P	11	BENT 13	8"	-	-	-
P	12	BENT 13	8"	-	-	-
P	12	BENT 13	1'-10"	1'-2"	-	-
P	12	BENT 13	8"	3'-7"	-	-
P	13	BENT 13	4'-8"	1'-2"	9"	3'-4"
P	13	BENT 13	2"	3'-0"	-	-
P	14	BENT 13	1'-4"	2'-3"	-	-
P	14	BENT 13	3'-3"	-	-	-
P	14	BENT 13	1'-11"	-	-	-
P	15	BENT 13	7"	1'-1"	-	-
P	15	BENT 13	7"	3'-0"	-	-
P	15	BENT 13	3'-3"	-	-	-
P	15	BENT 13	3'-3"	-	-	-
P	16	BENT 13	1'-0"	-	-	-
P	17	BENT 13	6"	-	-	-
