PROJECT NO. I-5746C  
MECKLENBURG COUNTY  
 STATION: 590332

STATE OF NORTH CAROLINA  
 DEPARTMENT OF TRANSPORTATION  
 RALEIGH

### DECK UNDERSIDE REPAIR SPAN T

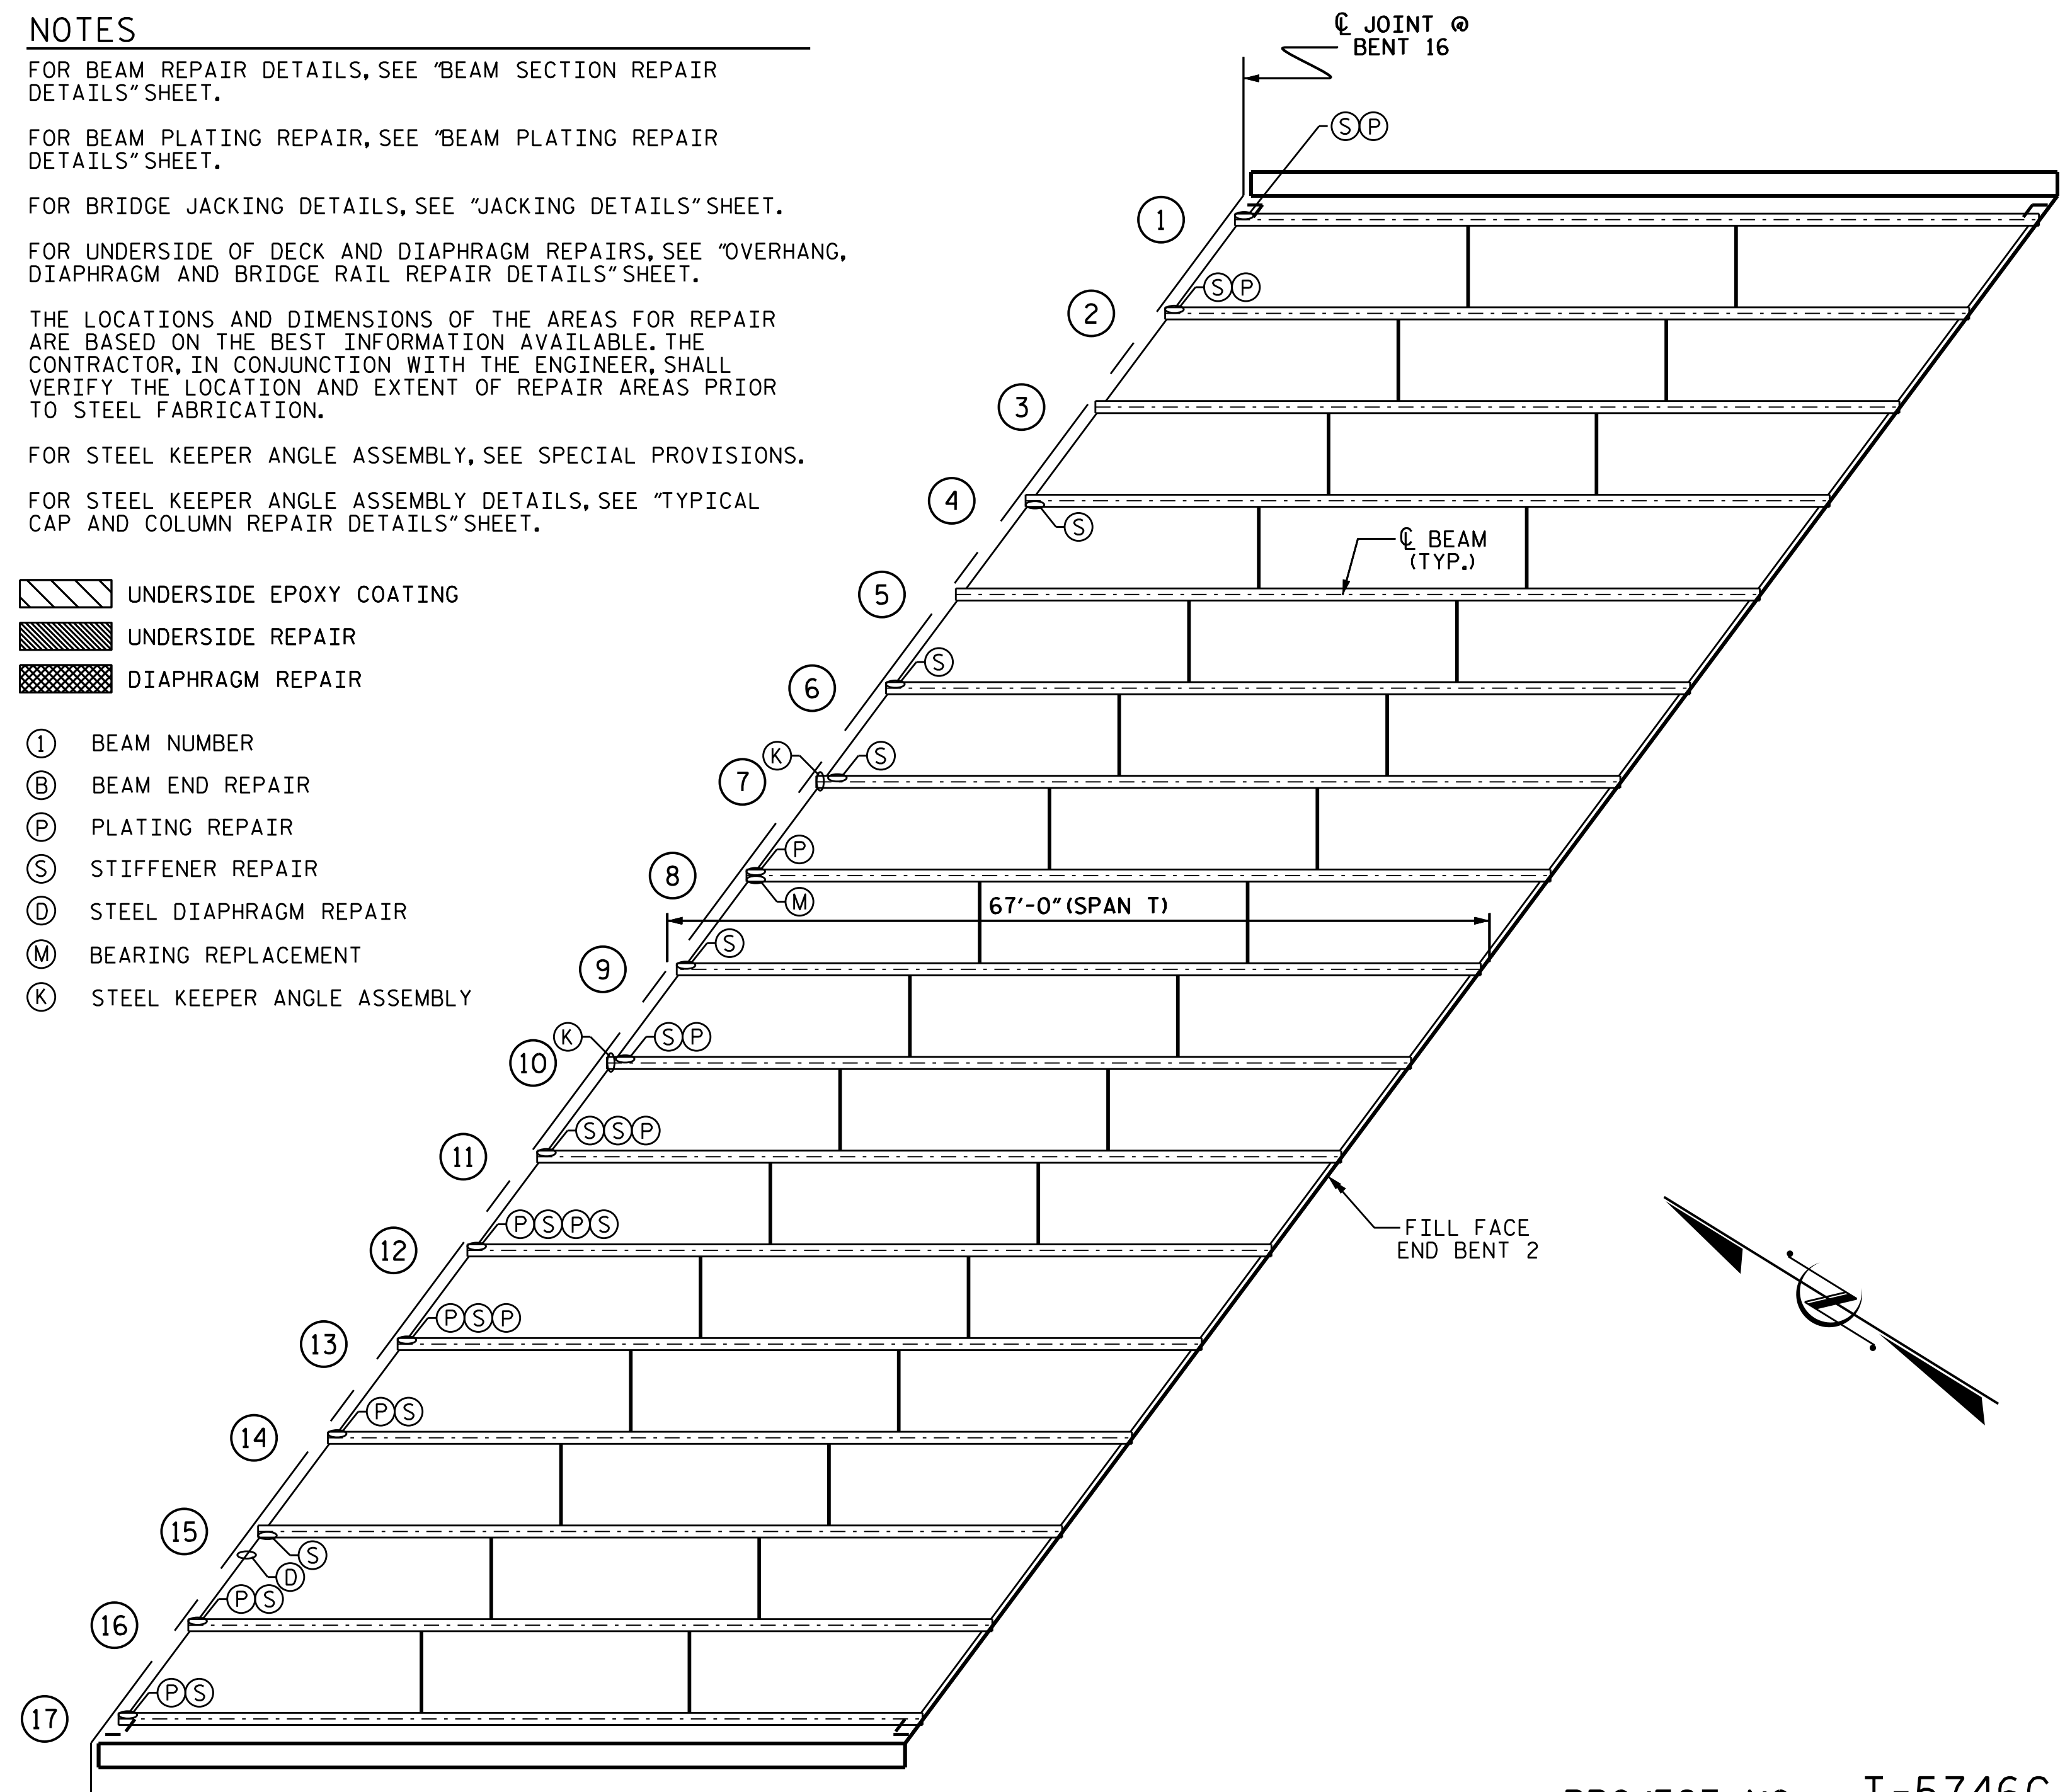
### PLAN

SPAN	BEAM	LOCATION	DIM "A"	DIM "B"	DIM "C"	DIM "D"
T	1	BENT 16	9"	1'-3"	-	-
T	1	BENT 16	4'-8"	-	-	-
T	2	BENT 16	6"	9"	-	-
T	2	BENT 16	3'-3"	-	-	-
T	4	BENT 16	4"	-	-	-
T	6	BENT 16	6"	-	-	-
T	7	BENT 16	10"	-	-	-
T	8	BENT 16	7"	1'-9"	-	-
T	9	BENT 16	2"	-	-	-
T	10	BENT 16	3'-3"	-	-	-
T	10	BENT 16	10"	1'-0"	-	-
T	11	BENT 16	1'-8"	10"	-	-
T	11	BENT 16	8"	-	-	-
T	11	BENT 16	4"	-	-	-
T	12	BENT 16	8"	1'-4"	-	-
T	12	BENT 16	8"	-	-	-
T	12	BENT 16	8"	-	-	-
T	12	BENT 16	1'-8"	10"	-	-
T	13	BENT 16	2'-3"	1'-0"	-	-
T	13	BENT 16	3'-3"	-	-	-
T	13	BENT 16	10"	1'-6"	-	-
T	14	BENT 16	1'-9"	10"	-	-
T	14	BENT 16	5"	-	-	-
T	15	BENT 16	7"	-	-	-
T	15	BENT 16	10"	1'-4"	-	-
T	16	BENT 16	1'-7"	9"	-	-
T	16	BENT 16	3'-3"	-	-	-
T	17	BENT 16	7"	1'-4"	-	-
T	17	BENT 16	7"	-	-	-

UNDERSIDE OF DECK REPAIR QUANTITIES REPRESENT ESTIMATED VALUES OF DECK REPAIR TOTALS AFTER REMOVAL OF UNSOUND CONCRETE, MINIMUM OF 1" BEHIND REBAR AND MINIMUM OF 2" CLEAR TO SAWCUT. SEE REPAIR DETAILS.

THE LOCATIONS AND DIMENSIONS OF THE AREAS FOR REPAIR ARE BASED ON THE BEST INFORMATION AVAILABLE. THE CONTRACTOR, IN CONJUNCTION WITH THE ENGINEER, SHALL VERIFY THE LOCATION AND EXTENT OF REPAIR AREAS PRIOR TO STEEL FABRICATION.

FOR BEAM REPAIR DETAILS, SEE "BEAM SECTION REPAIR DETAILS" SHEET.

FOR BEAM PLATING REPAIR, SEE "BEAM PLATING REPAIR DETAILS" SHEET.

FOR UNDERSIDE OF DECK AND DIAPHRAGM REPAIRS, SEE "OVERHANG, DIAPHRAGM AND BRIDGE RAIL REPAIR DETAILS" SHEET.
