PROJECT NO. \_\_\_\_\_\_\_ MECKLENBURG COUNTY BRIDGE NO. 590332 SHEET 1 OF 4 DocuSigned by: STATE OF NORTH CAROLINA DEPARTMENT OF TRANSPORTATION WINTH CARO RALEIGH T AN OFESSION SEAL 35647 BENT 3 OAM A. SPAN C FACE 8/23/2021 SHEET NO REVISIONS NO. DATE: S10-39 DATE: BY: BY: DOCUMENT NOT CONSIDERED FINAL UNLESS ALL SIGNATURES COMPLETED total sheets 274

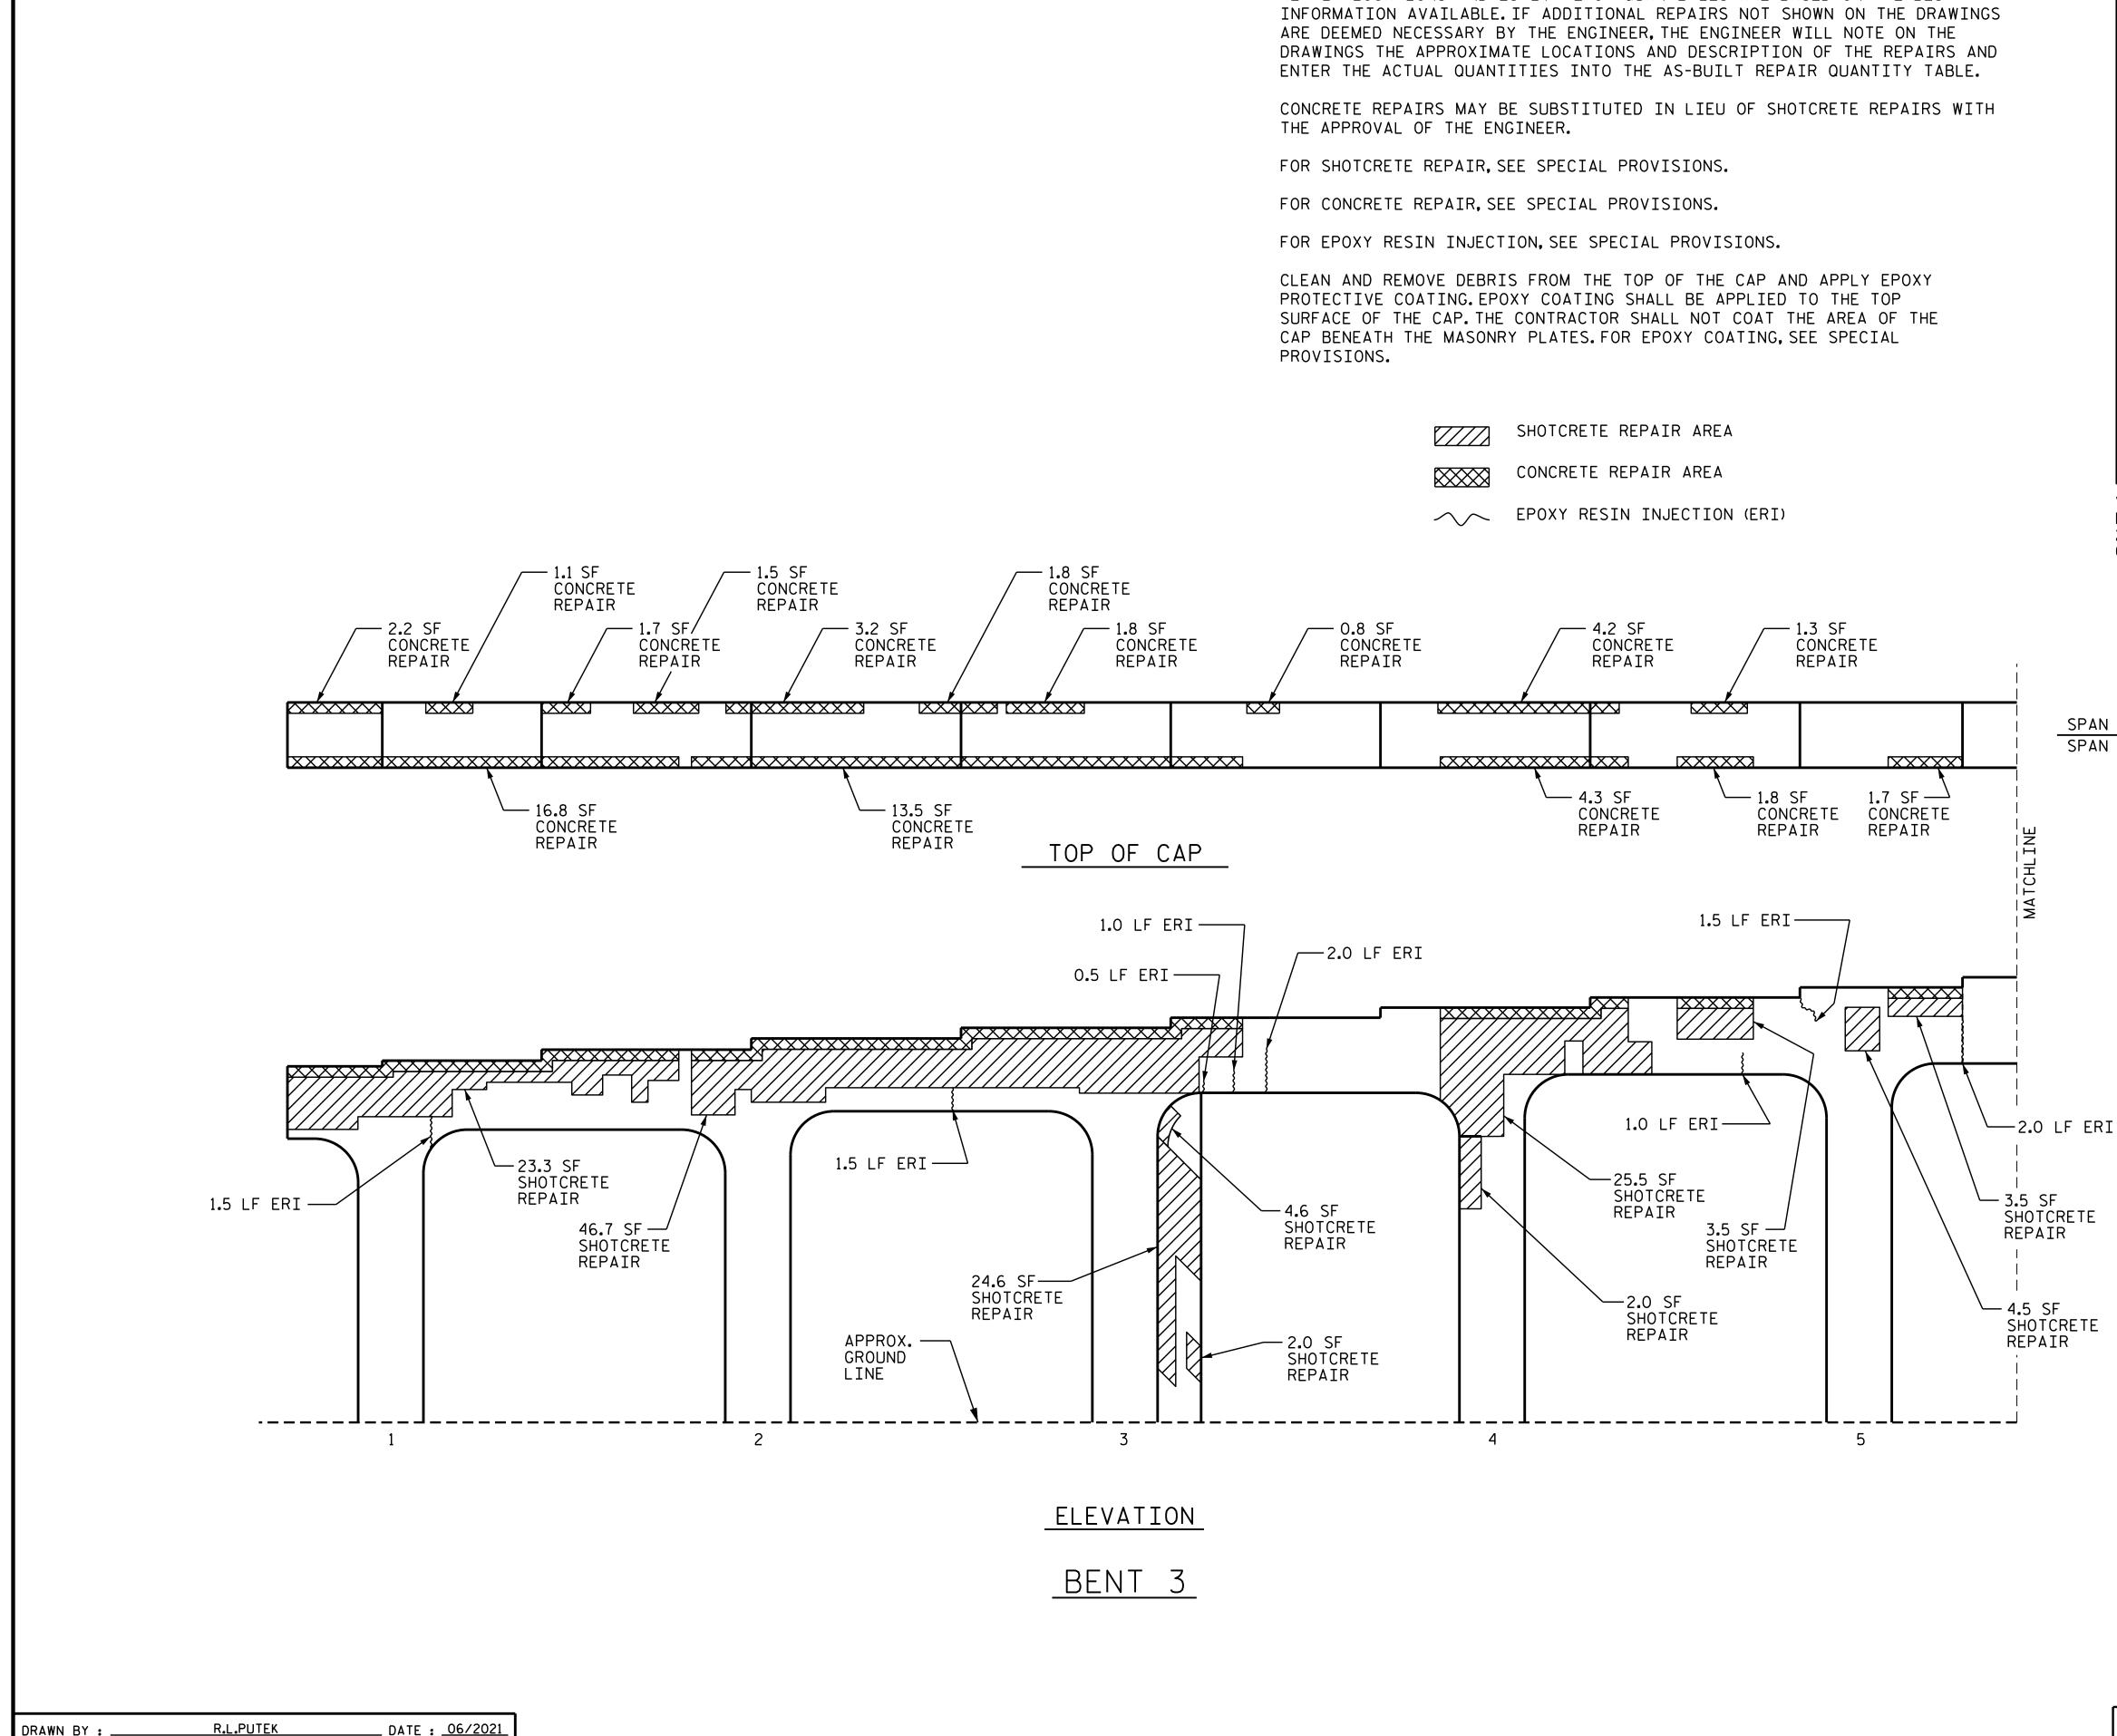
AS-BUILT REPAIR QUANTITY TABLE						
DENIT 3	QUANTITIES					
BENT 3	ESTIMATE		ACTUAL			
SHOTCRETE REPAIRS	AREA SQ.FT.	VOLUME CU.FT.	AREA SQ.FT.	VOLUME CU.FT.		
САР	111.6	55.8				
COLUMNS	28.6	14.3				
CONCRETE REPAIRS	AREA SQ.FT.	VOLUME CU.FT.	AREA SQ.FT.	VOLUME CU.FT.		
САР	57.7	28.9				
EPOXY RESIN INJECT	LIN.FT		LIN.FT			
САР	11.0					
COLUMNS		0.0				
EPOXY COATING	SQ.FT.		SQ.FT.			
TOP OF BENT CAP	239

VALUES IN CHART REPRESENT ESTIMATED REPAIR TOTALS AFTER REMOVAL OF UNSOUND CONCRETE, MIN. OF 1"BEHIND REBAR AND 2" MIN. CLEAR TO SAWCUT. FOR REPAIR DETAILS, SEE "TYPICAL CAP AND COLUMN REPAIR DETAILS" SHEET.
