4.2 SF SHOTCRETE REPAIR					
	PROJECT NO. <u>I-5746C</u>					
	MECKLENBURG COUNTY					
	BRIDGE NO. 590332					
_	END VIEW DocuSigned by: SHEET 2 OF 4					
	DEPARTMENT OF TRANSPORTATION					
	RALEIGH					
	BENT 3					
	BENT 3 SPAN A. COLUMN 8/23/2021 BENT 3 SPAN C FACE					
	8/23/2021	_	-			
			EVISIONS		SHEET NO.	
ſ	FINAL UNLESS ALL	BY: DATE:	3	DATE:	S10-40 TOTAL SHEETS	
	SIGNATURES COMPLETED 🙎		4		274

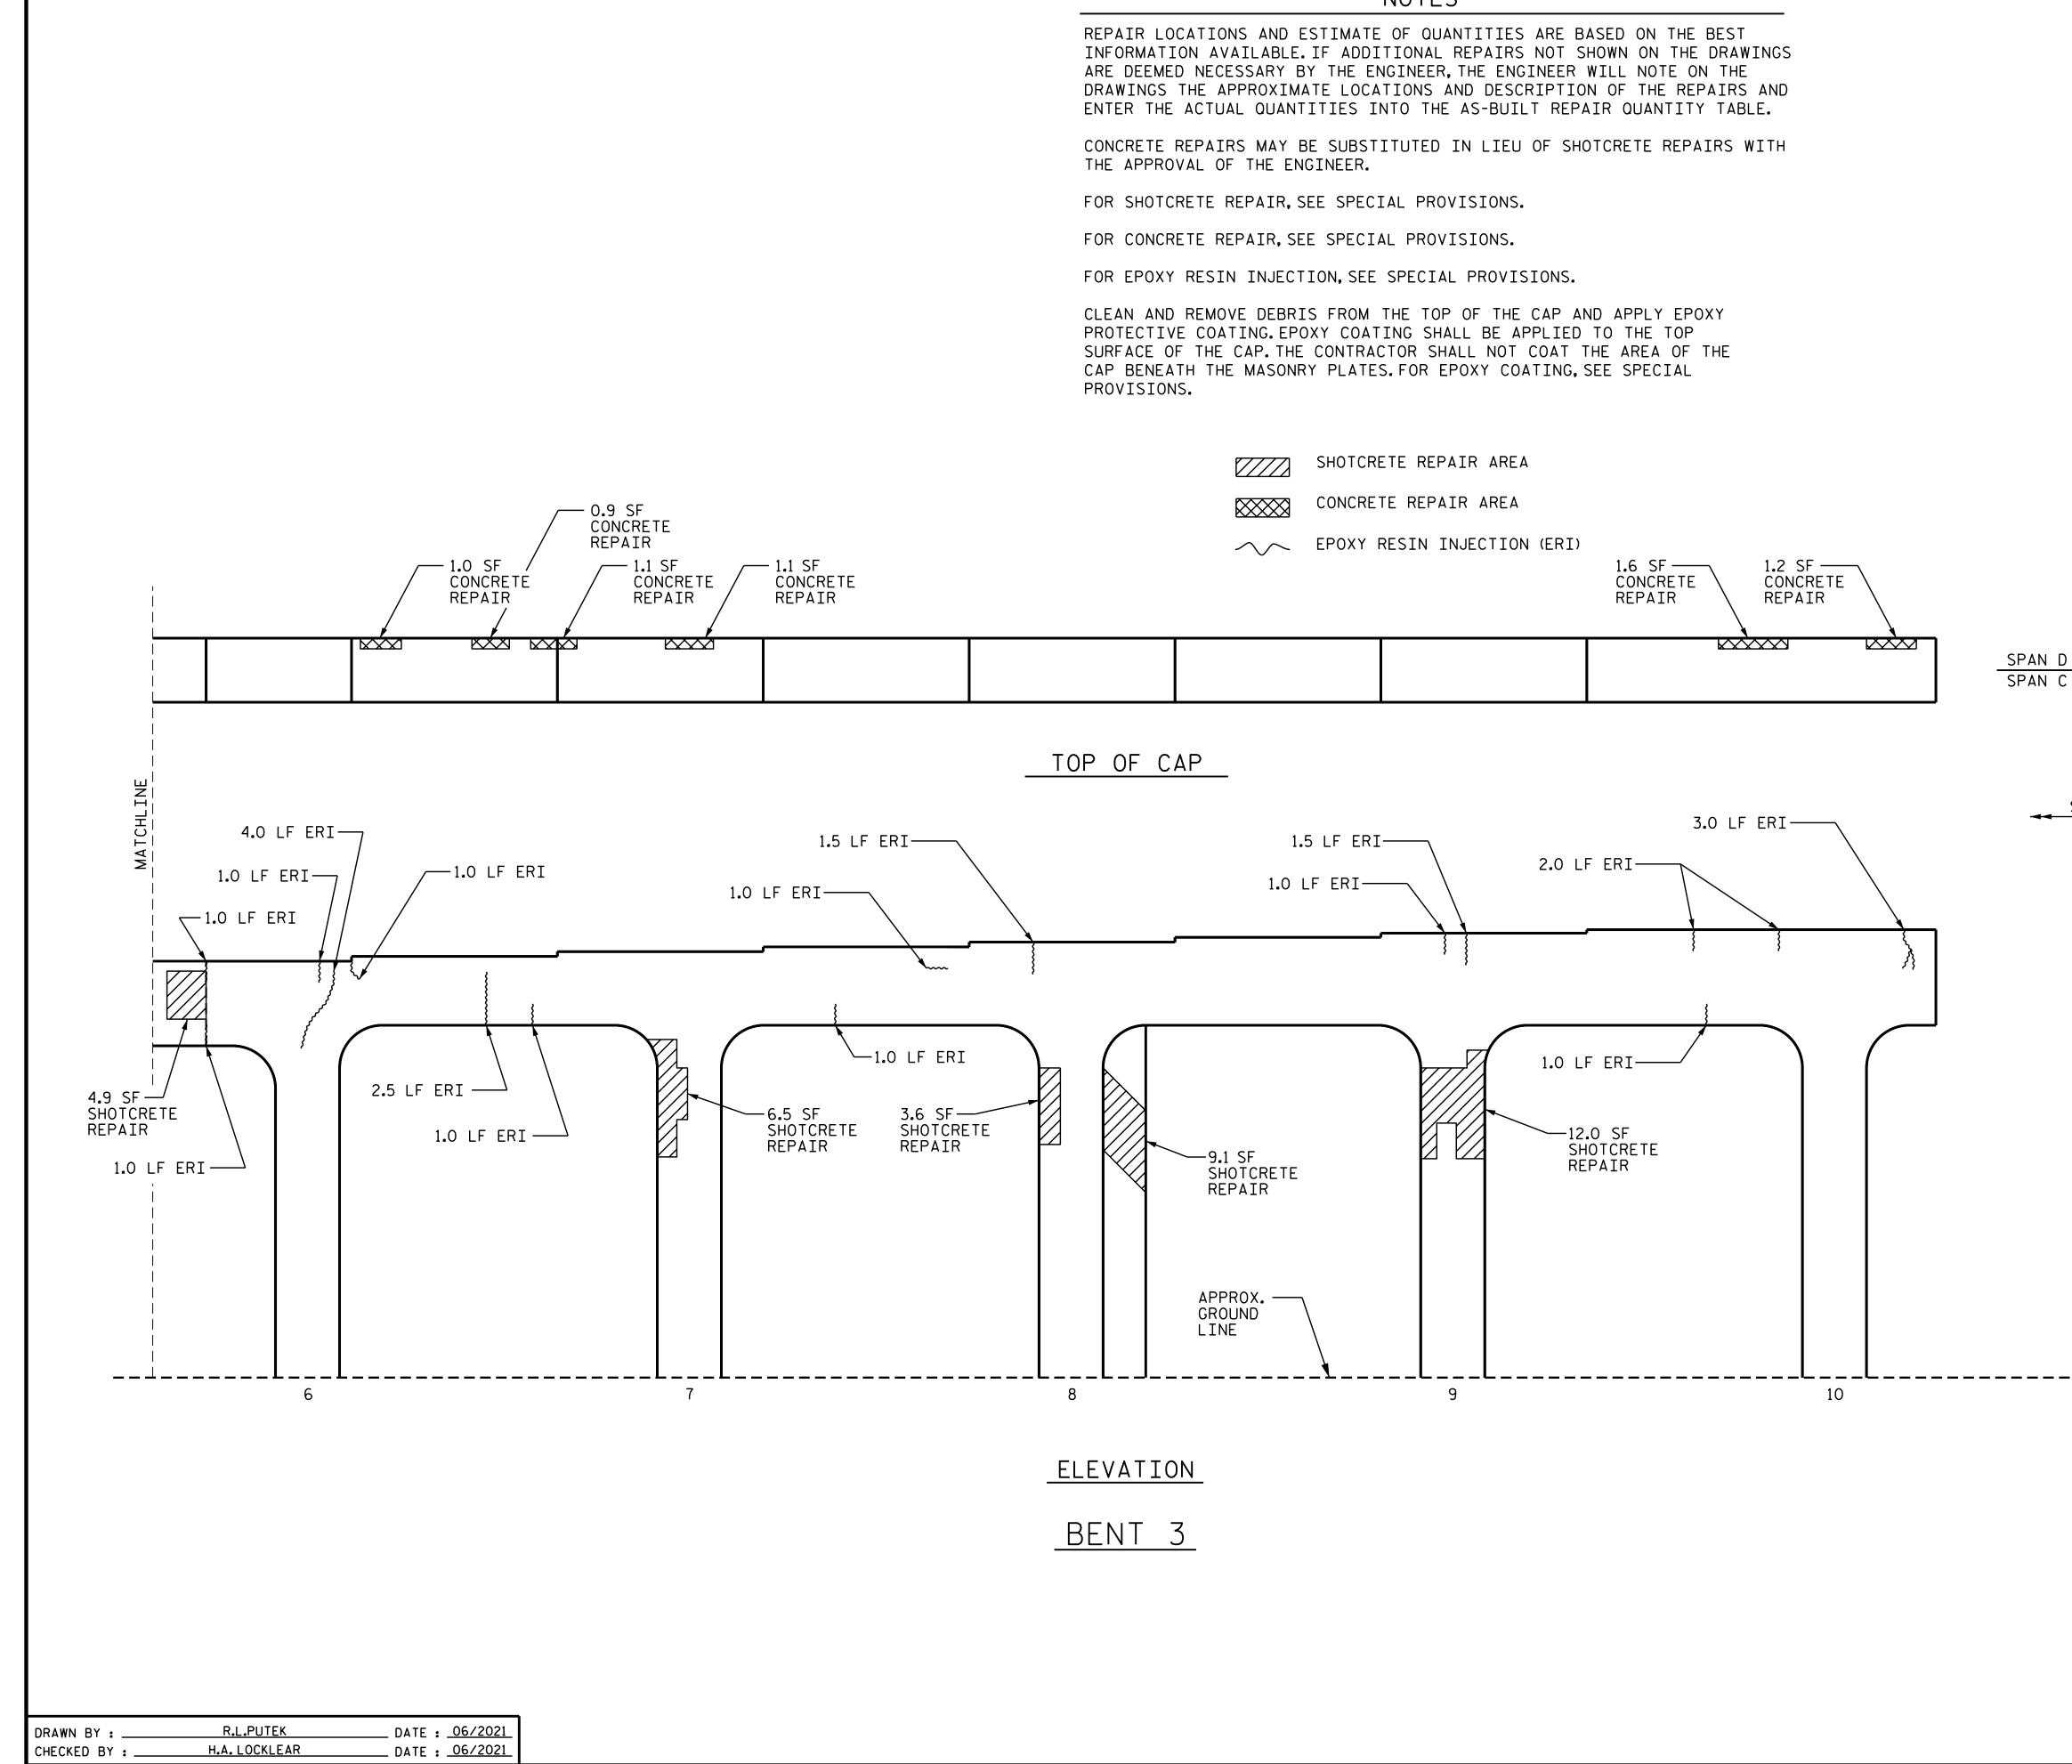
AS-BUILT REPA	TR QI	JANTTI	ΓΥ ΤΔ	BLF	
	BENT 3 QUANTITIES					
	SHOTCRETE REPAIRS	ESTI AREA	VOLUME	ACT AREA	VOLUME	
	CAP	SQ.FT. 4.9	CU.FT. 2.5	SQ.FT.	CU.FT.	
	COLUMNS	35.4	17.7			
	CONCRETE REPAIRS	AREA SQ.FT.	VOLUME CU.FT.	AREA SQ.FT.	VOLUME CU.FT.	
	САР	6.9	3.5			
	EPOXY RESIN INJECT	LIN.FT		LIN.FT		
	CAP COLUMNS	25 . 0 0 . 0				
	EPOXY COATING		SQ. FT.		SQ.FT.	
	TOP OF BENT CAP 251 VALUES IN CHART REPRESENT ESTIMATED REPAIR TOTALS AFTER					
	REMOVAL OF UNSOUND CONCRETE, MIN. OF 1" BEHIND REBAR AND 2" MIN. CLEAR TO SAWCUT. FOR REPAIR DETAILS, SEE "TYPICAL CAR AND COLUMN REPAIR DETAILS" SHEET					
	CAP AND COLUMN REPAIR DETAILS"SHEET.					
_						
<u>)</u> C						
SPAN C SPAN D						
∕—1.5 LF ERI						
	}
