RETE R		
E		
		PROJECT NO. <u>I-5746C</u> <u>MECKLENBURG</u> COUNTY
	END VIEW	BRIDGE NO. 590332
	D2EE938FAB674C5	STATE OF NORTH CAROLINA DEPARTMENT OF TRANSPORTATION RALEIGH
	SEAL 35647 ************************************	BENT 3 SPAN D FACE
	8/23/2021	SFAN D FACE
		REVISIONS SHEET NO. NO. BY: DATE: NO. BY: DATE: S10-42
	DOCUMENT NOT CONSIDER FINAL UNLESS ALL SIGNATURES COMPLETED	1 TOTAL SHEETS

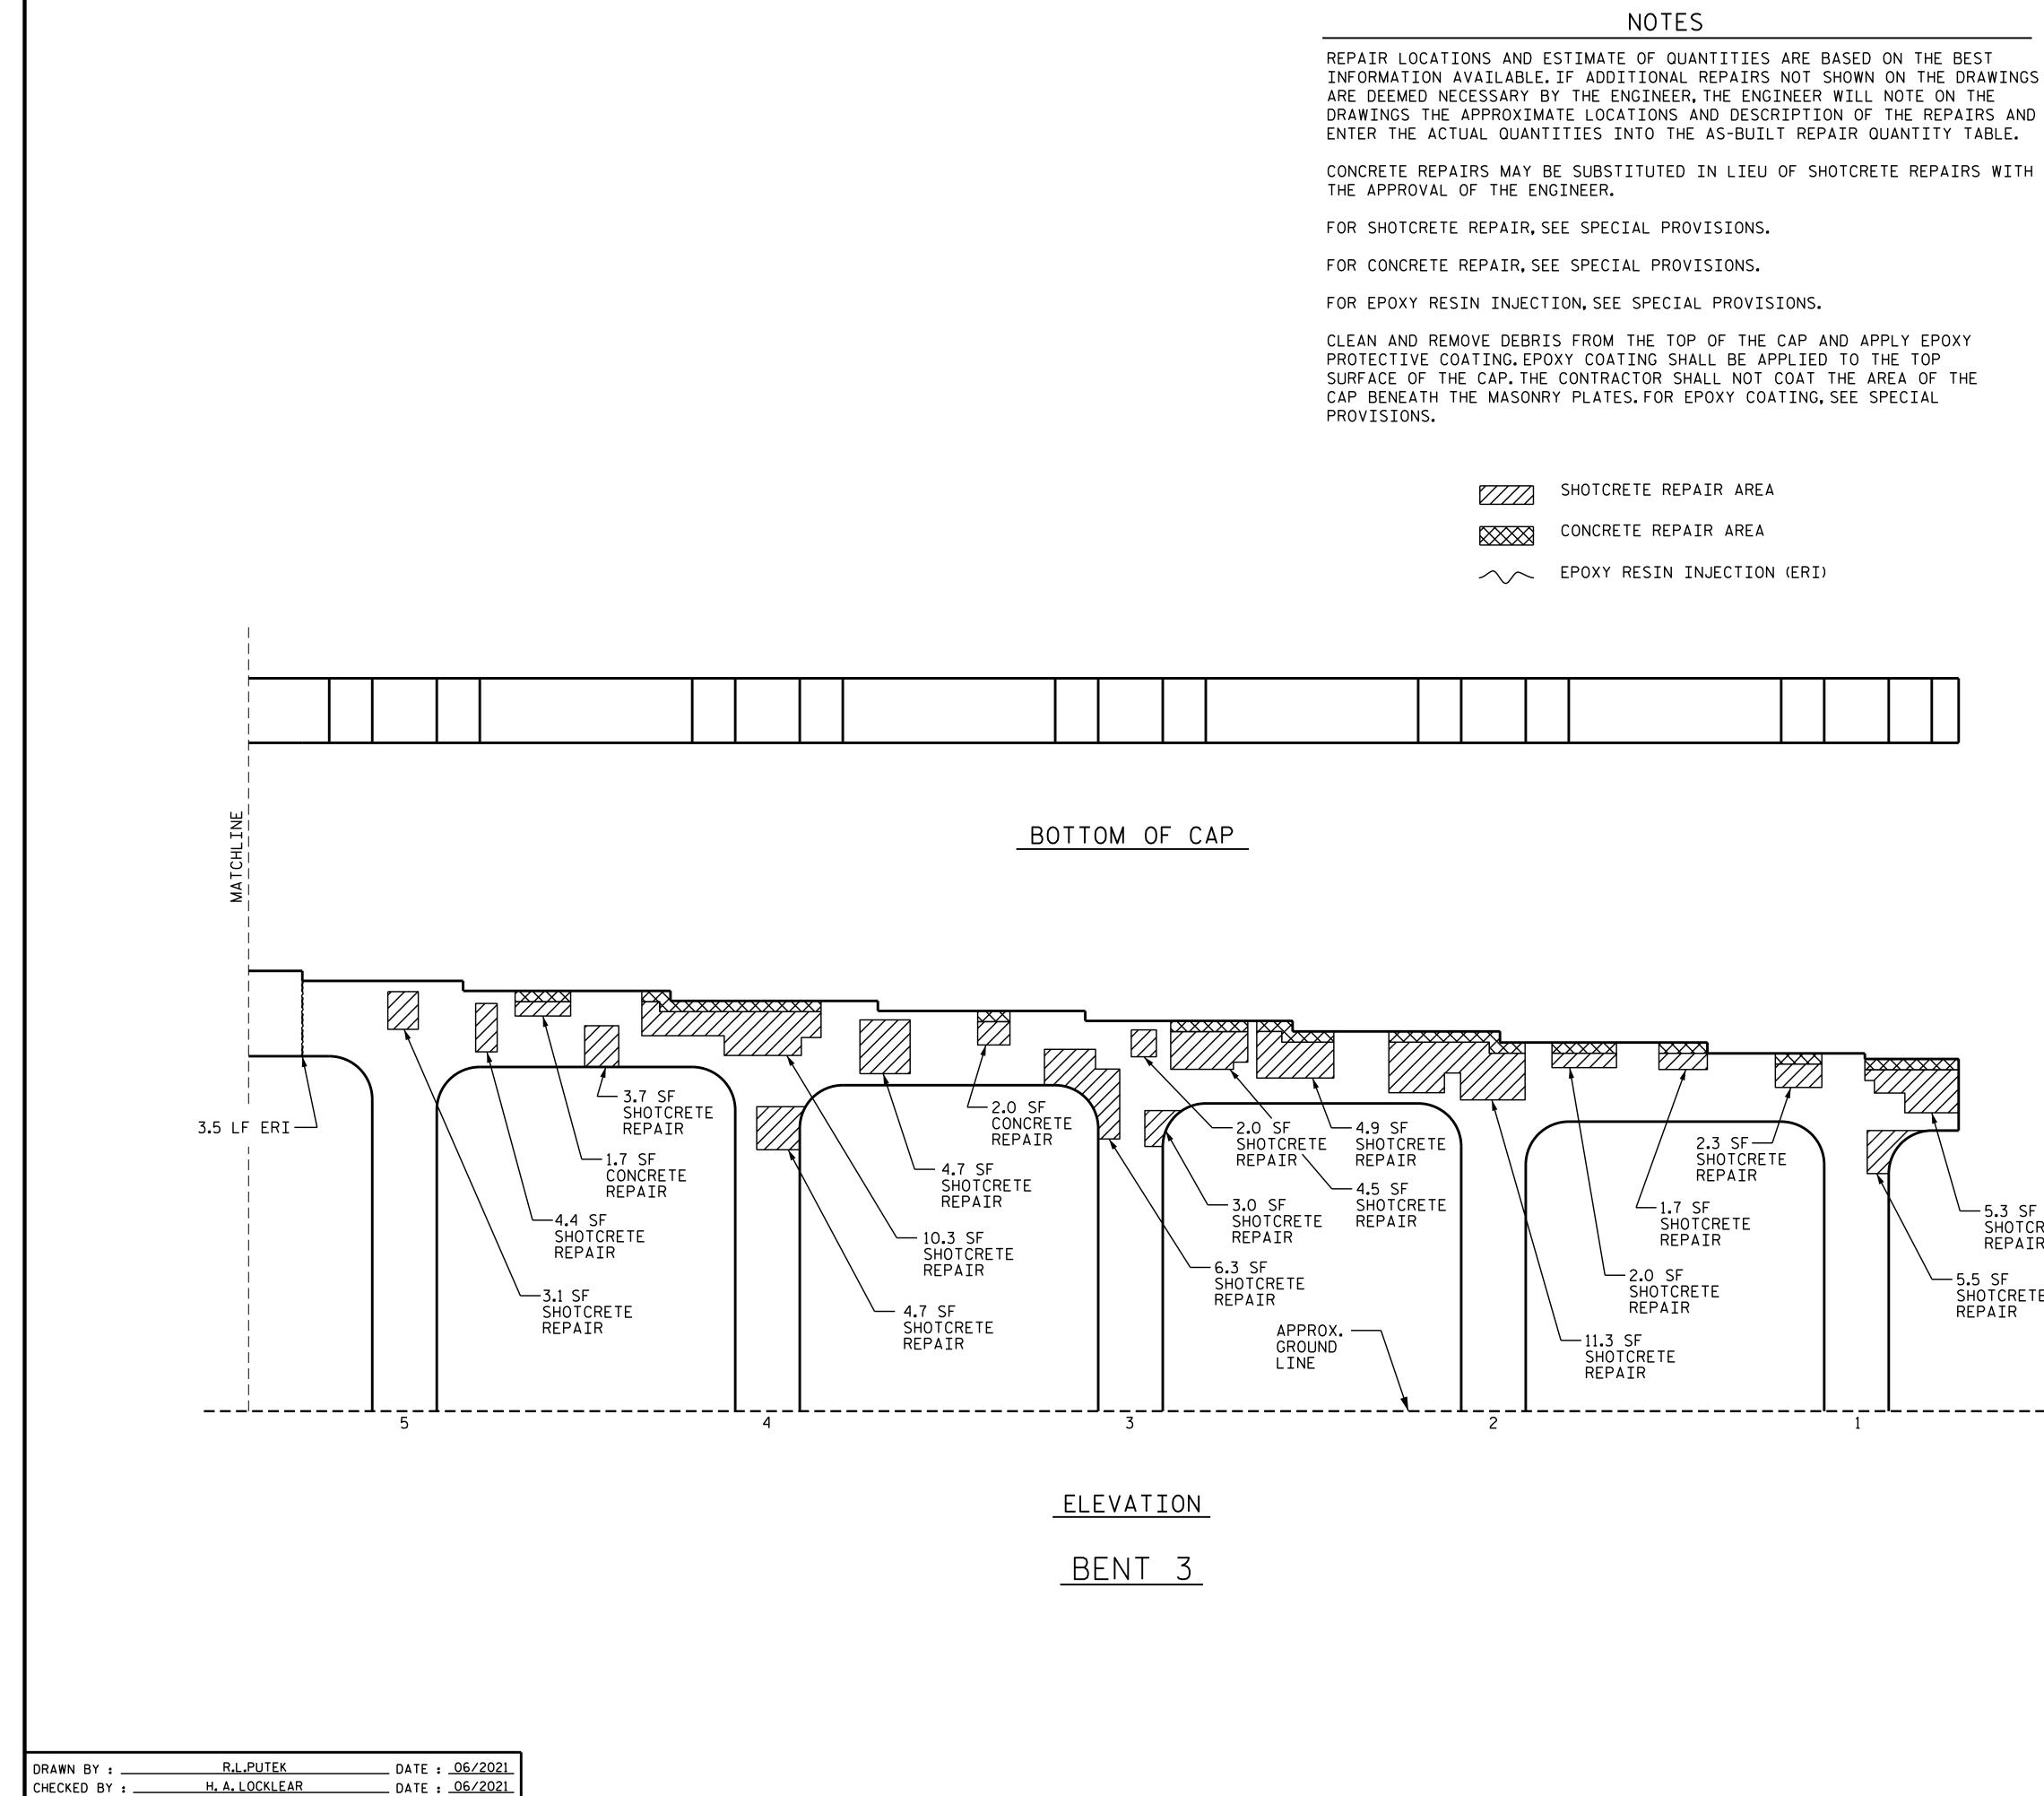
AS-BUILT REPA	IR QU	IANTI	ΓΥ ΤΑ	BLE		
BENT 3	QUANTITIES					
	ESTI			UAL		
SHOTCRETE REPAIRS	AREA SQ.FT.	VOLUME CU.FT.	AREA SQ.FT.	VOLUME CU.FT.		
САР	78.7	39.4				
COLUMNS	4.7	2.4				
CONCRETE REPAIRS	AREA SQ.FT.	VOLUME CU.FT.	AREA SQ.FT.	VOLUME CU.FT.		
САР	0.0	0.0				
EPOXY RESIN INJECT	EPOXY RESIN INJECTION					
САР	САР					
COLUMNS	COLUMNS					
EPOXY COATING	EPOXY COATING					
TOP OF BENT CAP	TOP OF BENT CAP					
VALUES IN CHART REPRESENT ESTIMATED REPAIR TOTALS AFTER REMOVAL OF UNSOUND CONCRETE, MIN. OF 1"BEHIND REBAR AND 2" MIN. CLEAR TO SAWCUT. FOR REPAIR DETAILS, SEE "TYPICAL CAP AND COLUMN REPAIR DETAILS" SHEET. SPAN D SPAN C						
SPAN D SPAN C
