23-AUG-2021 12:04 R:\Structures\FINAL PLANS\Bridge 332\410_103_I5746C_SMU_B6F_S10-52_590332.dgn aacole

| <u> </u> | ECT NO. <u>I-5746C</u> <u>ECKLENBURG</u> county GE NO. <u>590332</u> | | | | |
| W 8/23/2021 | BENT 6 SPAN F FACE | | | | |

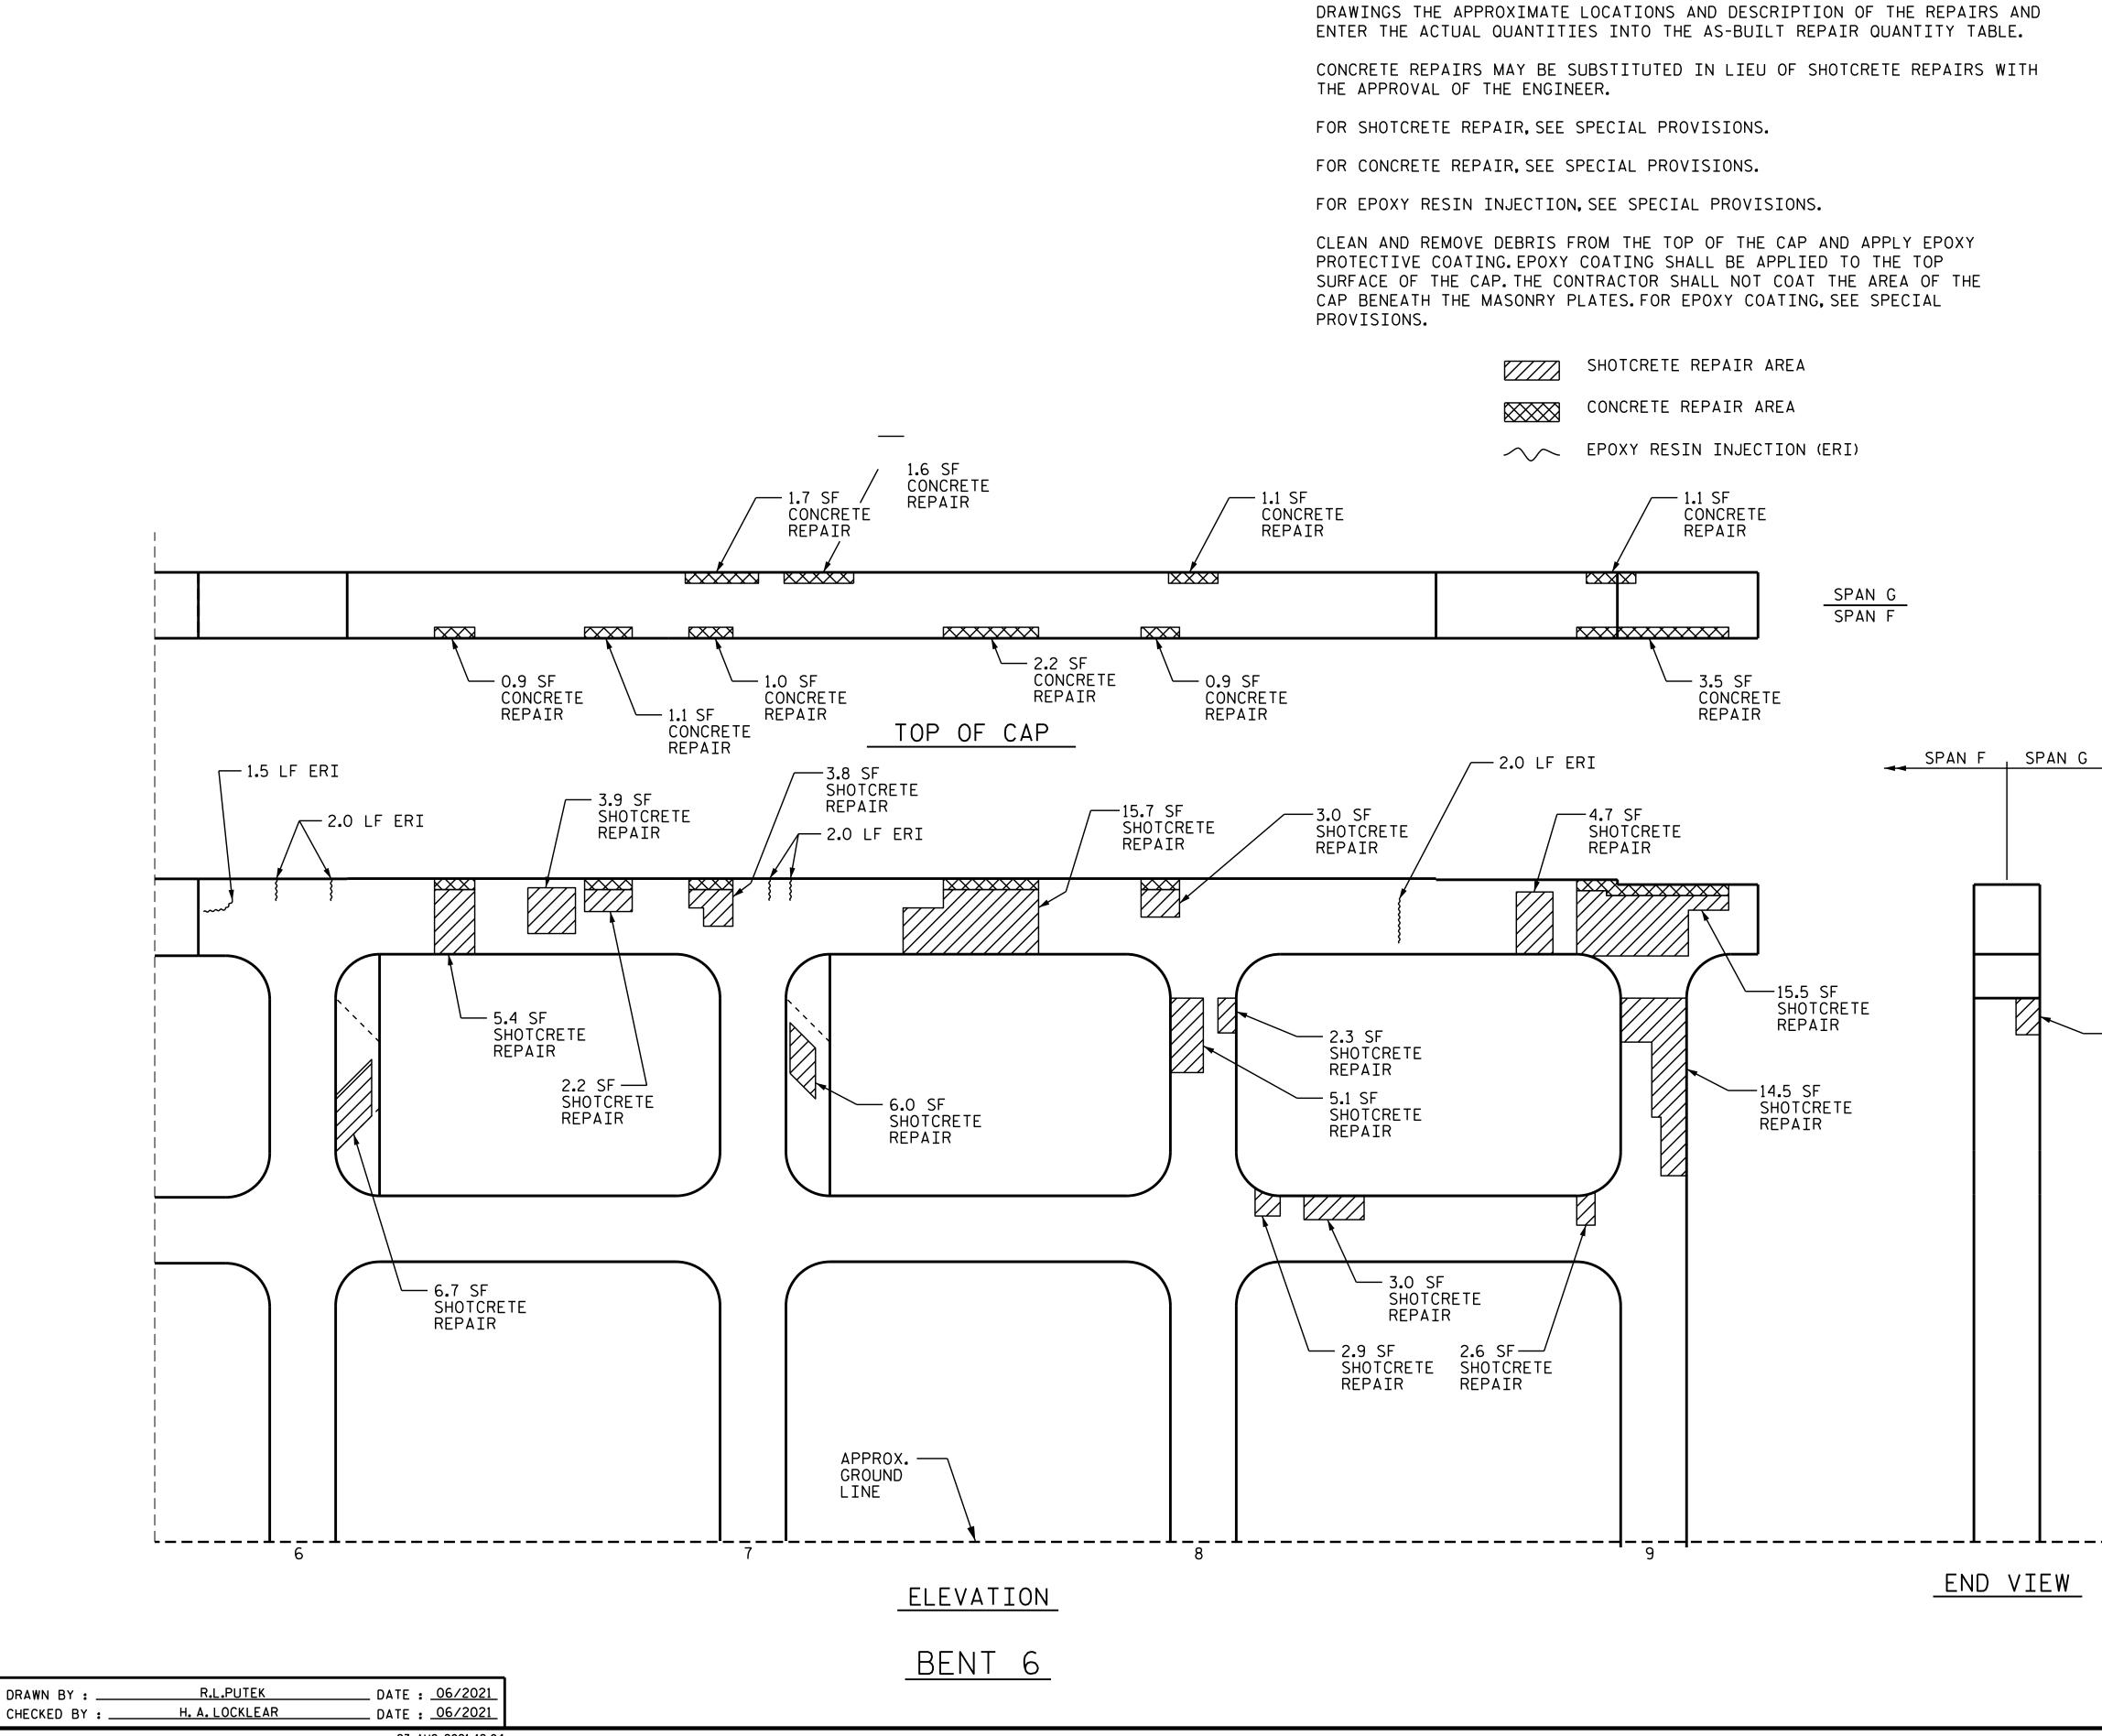
-2.3 SF SHOTCRETE REPAIR

VALUES IN CHART REPRESENT ESTIMATED REPAIR TOTALS AFTER REMOVAL OF UNSOUND CONCRETE, MIN. OF 1" BEHIND REBAR AND 2" MIN. CLEAR TO SAWCUT. FOR REPAIR DETAILS, SEE "TYPICAL CAP AND COLUMN REPAIR DETAILS" SHEET.
