STATE OF NORTH CAROLINA DEPARTMENT OF TRANSPORTATION

SUPERSTRUCTURE REPAIRS

SPANS 4 THRU 6

BRIDGE NO. \_

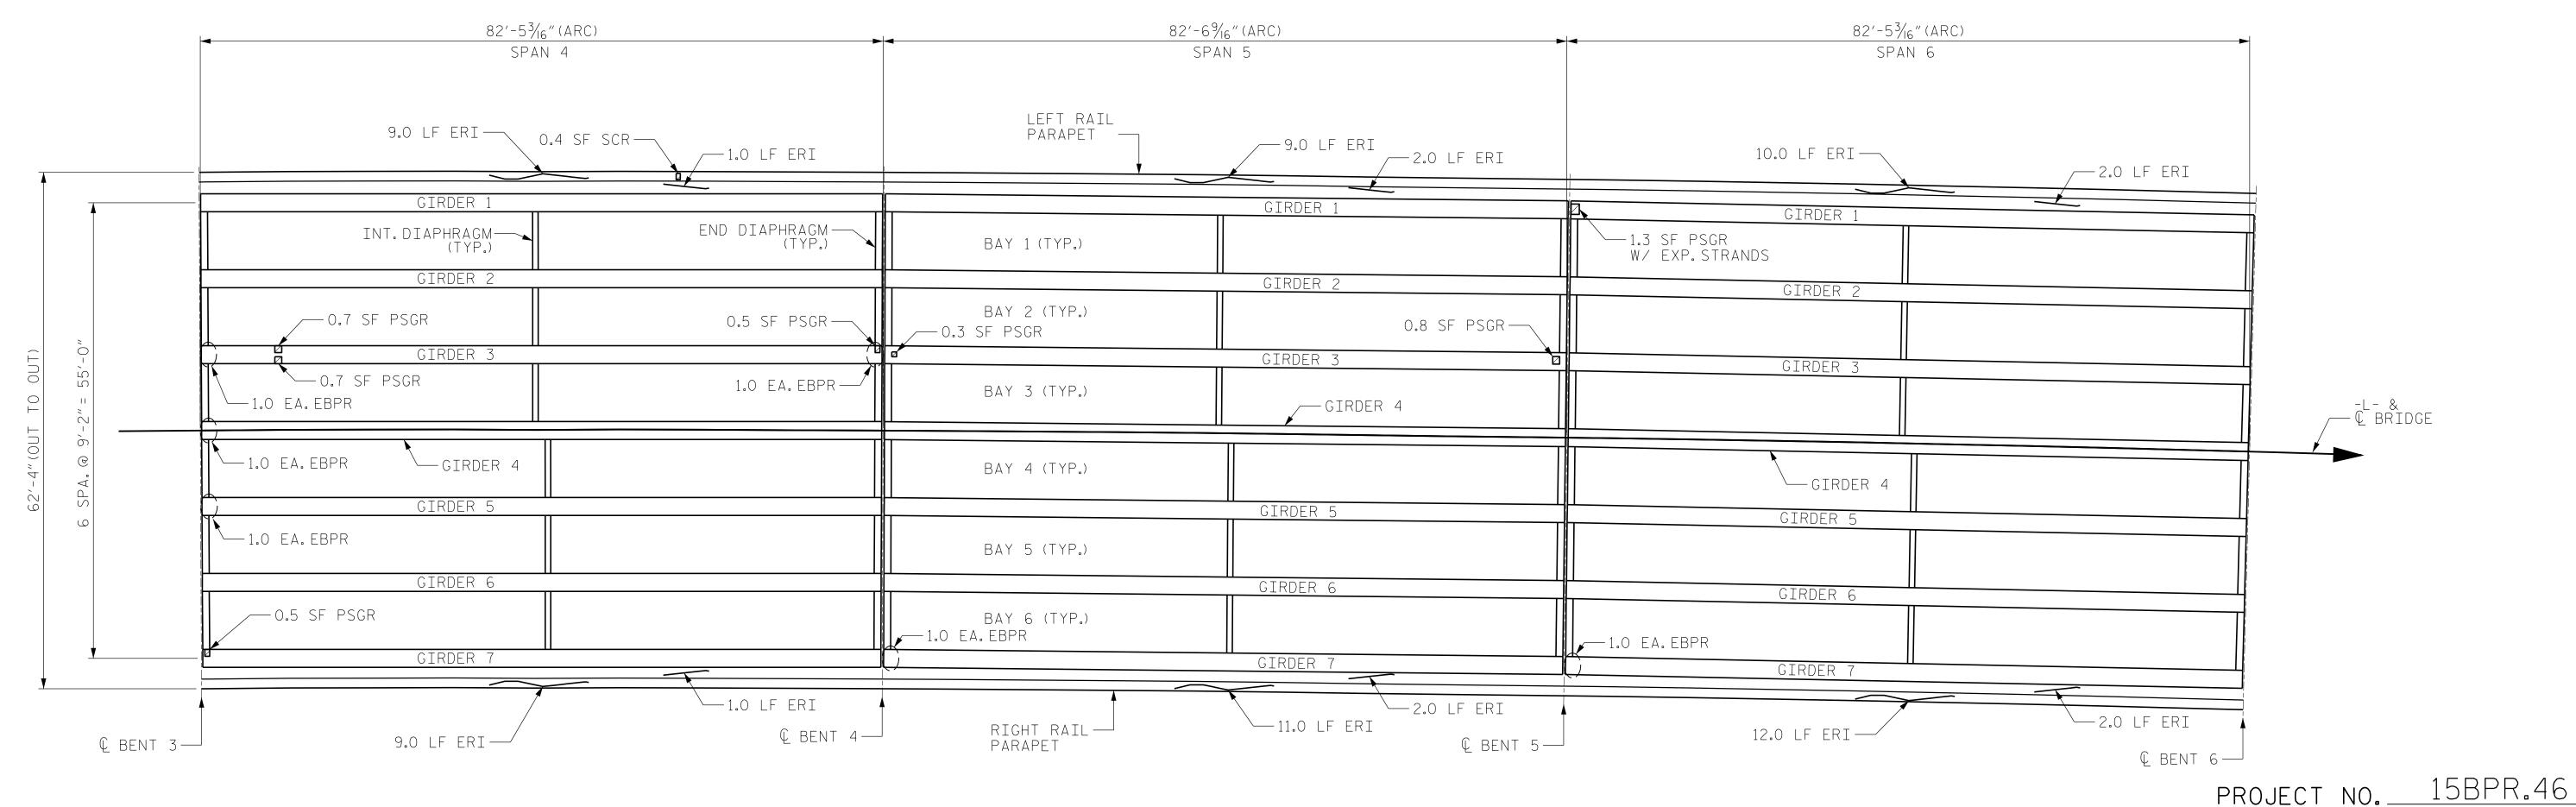
PLAN OF SPAN

CRACKING LOCATIONS AND QUANTITIES FOR LOCATIONS DESCRIBED AS "SCATTERED THROUGHOUT" IN THE INSPECTION REPORT ARE BASED ON THE BEST INFORMATION AVAILABLE. THE ENGINEER AND CONTRACTOR SHALL IDENTIFY AND REPAIR ALL CRACKS >= $\frac{1}{16}$ " AS DESCRIBED IN THE SPECIAL PROVISIONS.

ADDITIONAL QUANTITIES OF CONCRETE REPAIR AREAS ARE ANTICIPATED. DUE TO LACK OF INFORMATION, ALL AREAS ARE NOT KNOWN. QUANTITY INCLUDES CONTINGENCIES AND ARE ANTICIPATED TO BE SUFFICIENT FOR ACTUAL QUANTITIES ENCOUNTERED.

FOR CONCRETE AND SHOTCRETE REPAIRS, SEE "CONCRETE RESTORATION DETAILS"

REPAIRS TO PRESTRESSED CONCRETE GIRDERS, SEE SPECIAL PROVISIONS FOR "PRESTRESSED CONCRETE GIRDERS WITH THERMAL SPRAY ANODE".

CONTRACTOR IS RESPONSIBLE FOR REPAIRING ALL MISSING AND/OR DAMAGED RAIL COMPONENTS, AS WELL AS TIGHTENING ALL LOOSE RAIL CONNECTIONS.
