STATE OF NORTH CAROLINA DEPARTMENT OF TRANSPORTATION

SUPERSTRUCTURE REPAIRS

SPANS 41 THRU 44

S-36

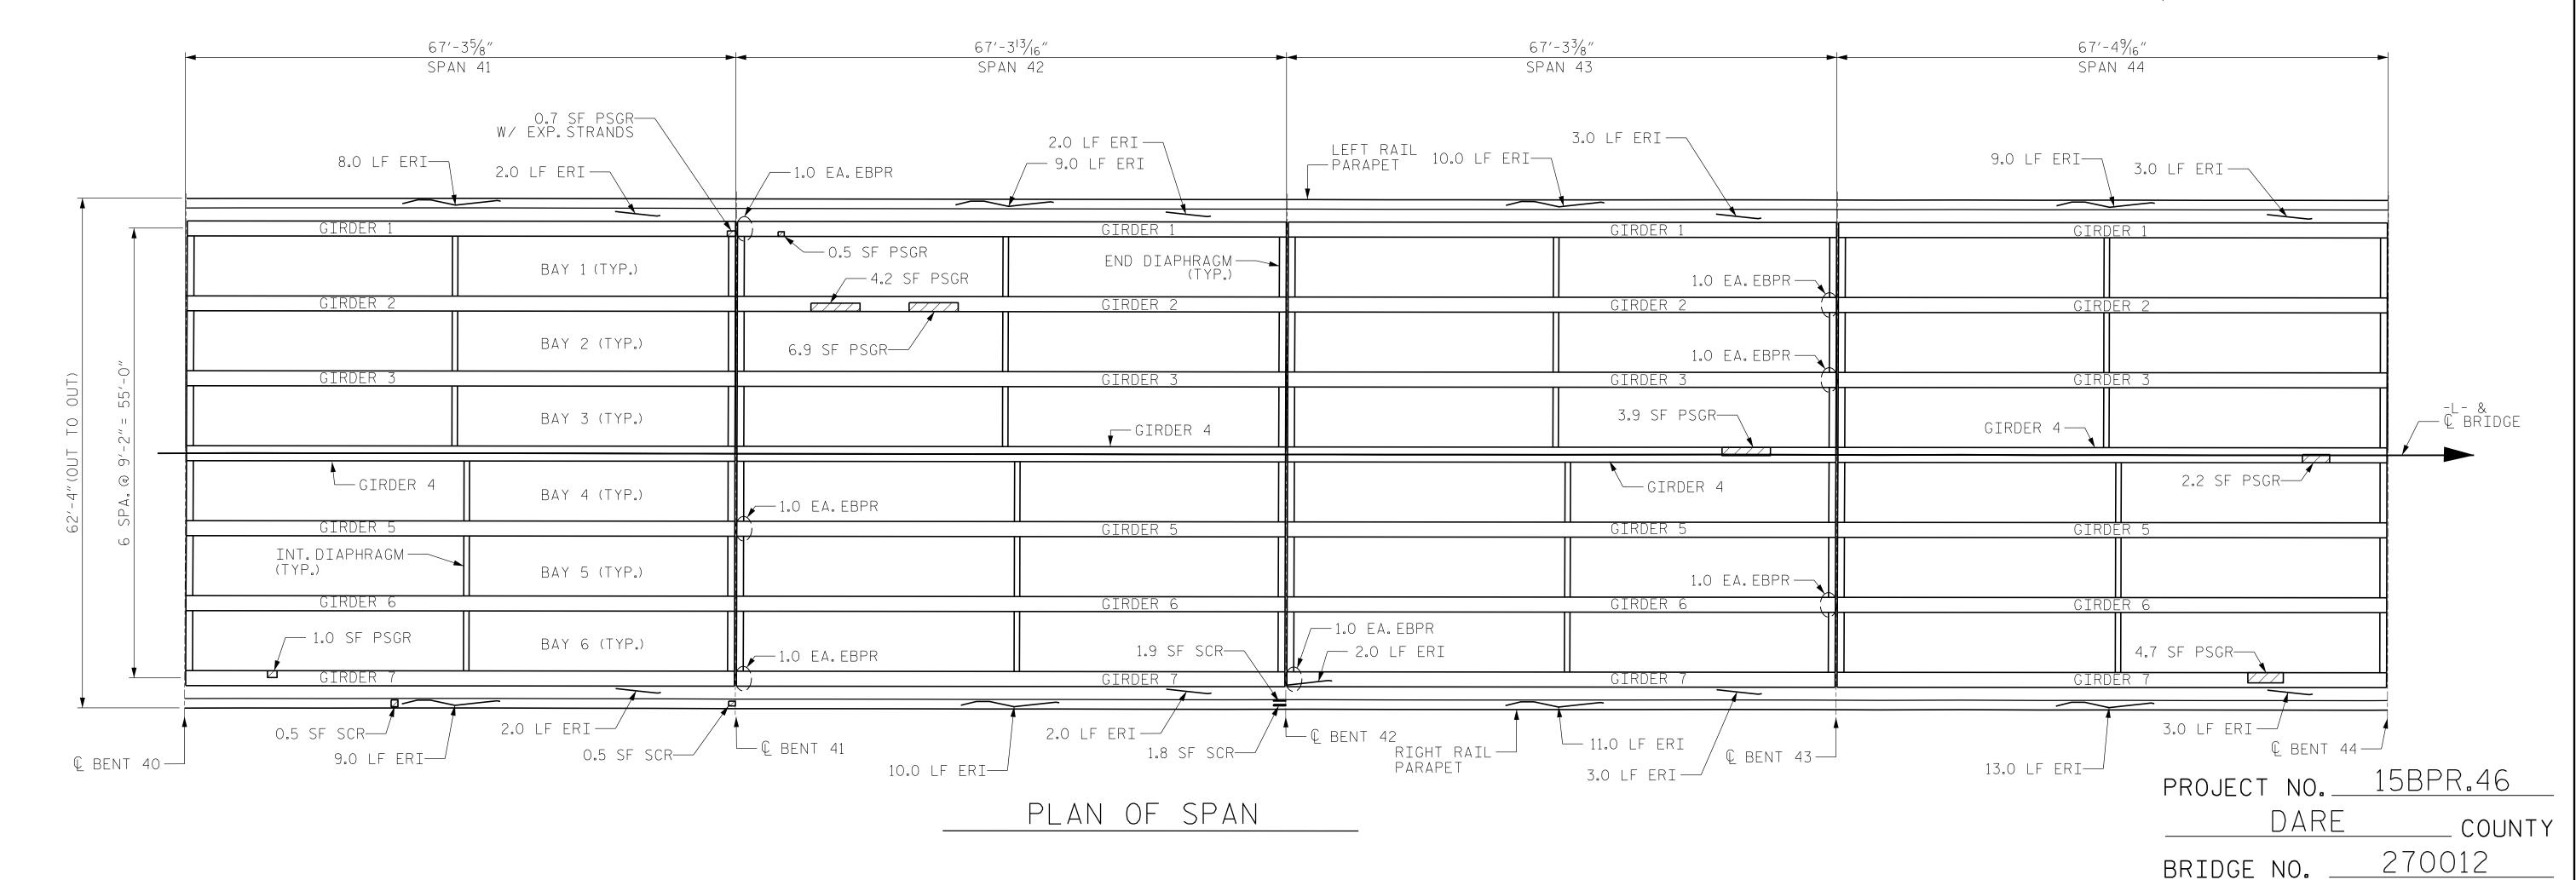
VALUES IN CHART REPRESENT ESTIMATED REPAIR TOTALS AFTER REMOVAL OF UNSOUND CONCRETE. MINIMUM OF 1"BEHIND REBAR AND MINIMUM 2"CLEARANCE TO SAWCUT. FOR REPAIR DETAILS, SEE "CONCRETE RESTORATION DETAILS" SHEETS.
