STATE OF NORTH CAROLINA DEPARTMENT OF TRANSPORTATION

SUPERSTRUCTURE REPAIRS

SPANS 49 THRU 52

SHEET NO REVISIONS S-38 DATE: DATE: BY: NO. BY: TOTAL SHEETS 137

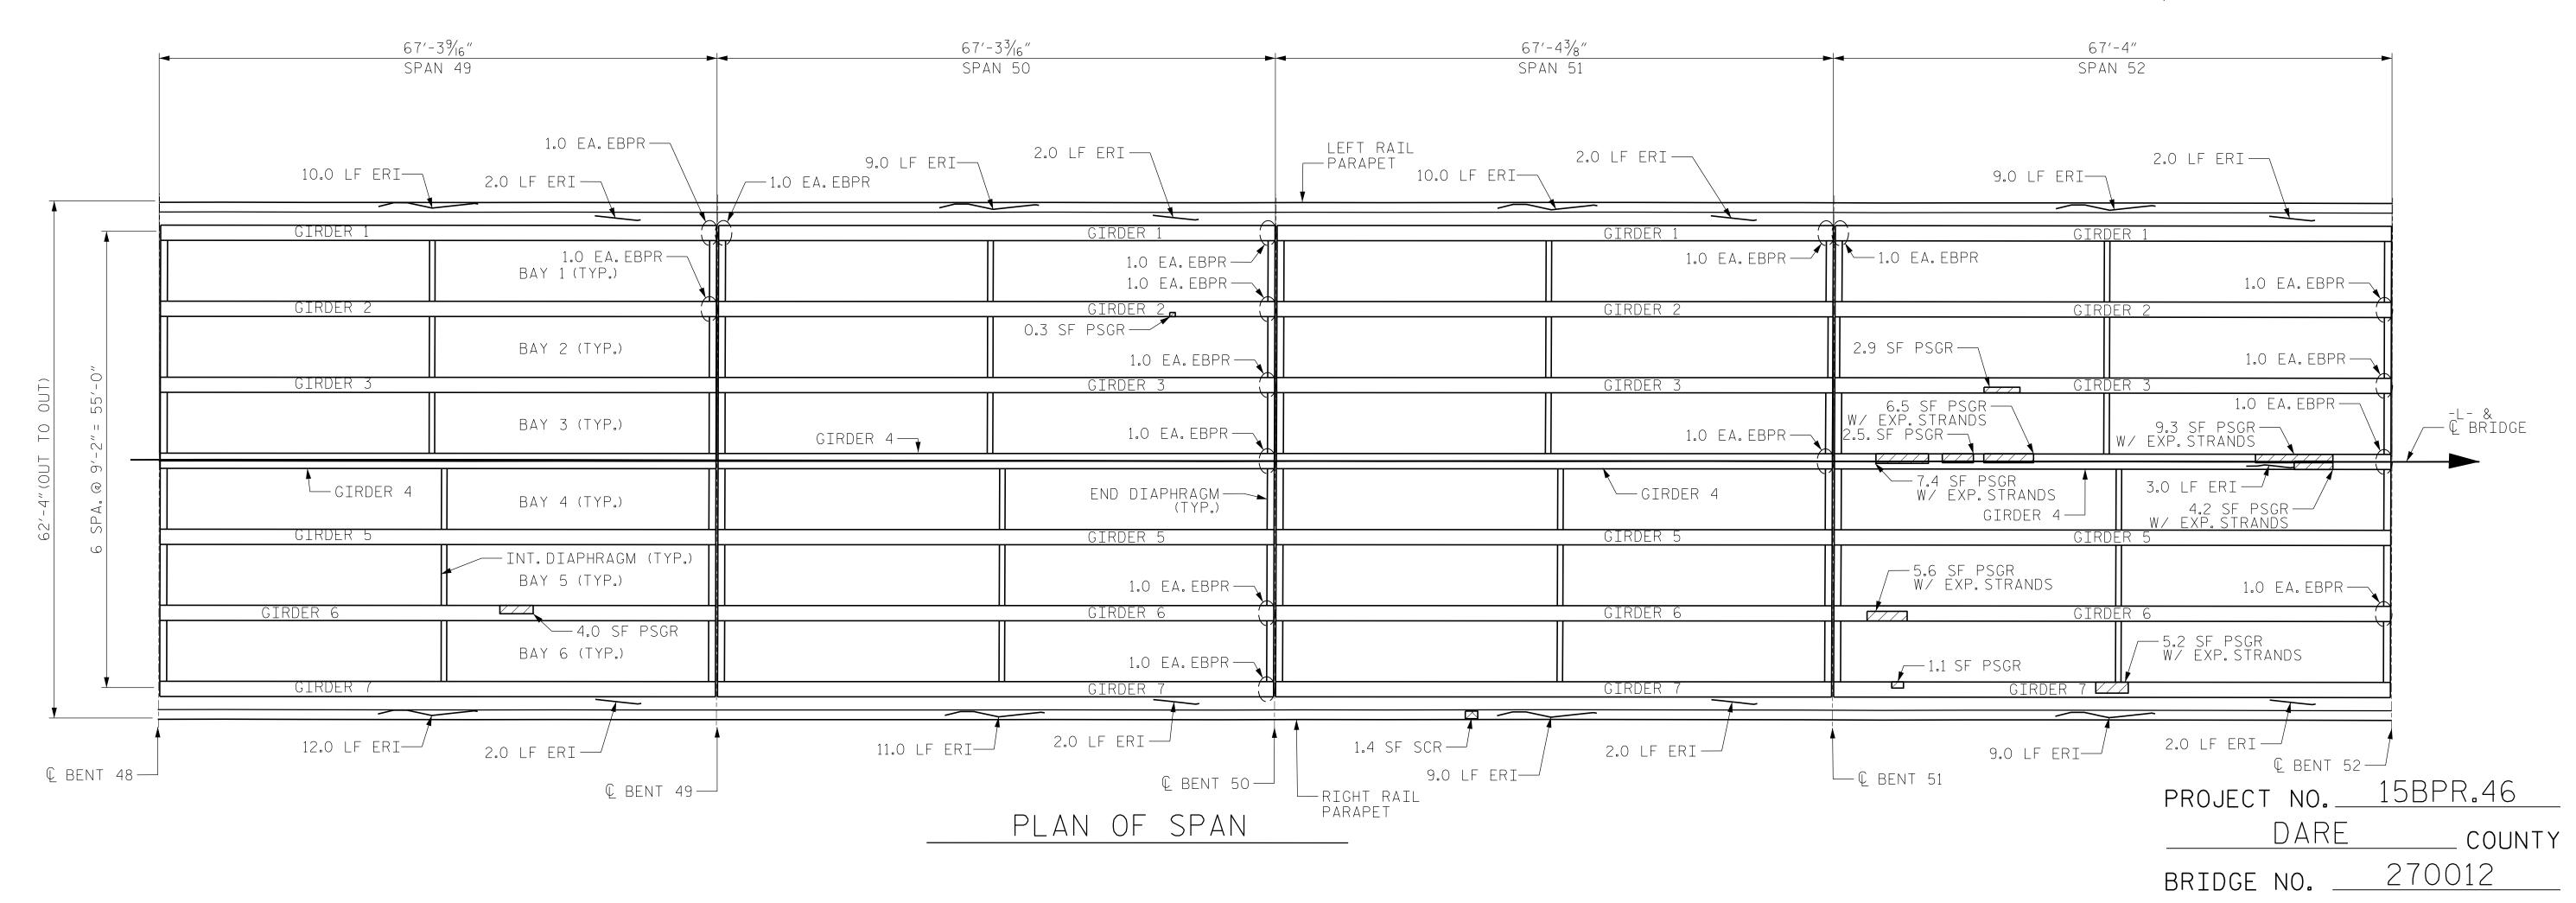
CRACKING LOCATIONS AND QUANTITIES FOR LOCATIONS DESCRIBED AS "SCATTERED THROUGHOUT" IN THE INSPECTION REPORT ARE BASED ON THE BEST INFORMATION AVAILABLE. THE ENGINEER AND CONTRACTOR SHALL IDENTIFY AND REPAIR ALL CRACKS >= 1/16" AS DESCRIBED IN THE SPECIAL PROVISIONS.

ADDITIONAL QUANTITIES OF CONCRETE REPAIR AREAS ARE ANTICIPATED. DUE TO LACK OF INFORMATION, ALL AREAS ARE NOT KNOWN. QUANTITY INCLUDES CONTINGENCIES AND ARE ANTICIPATED TO BE SUFFICIENT FOR ACTUAL QUANTITIES ENCOUNTERED.

REPAIR LOCATIONS AND ESTIMATED QUANTITIES ARE GIVEN WITH THE BEST INFORMATION AVAILABLE. IF ADDITIONAL REPAIRS NOT SHOWN ON THE DRAWINGS SHEETS. ARE DEEMED NECESSARY BY THE ENGINEER, THE ENGINEER WILL NOTE ON THE DRAWINGS THE APPROXIMATE LOCATIONS AND DESCRIPTION OF THE REPAIRS AND ADJUST THE ACTUAL QUANTITIES ENTERED INTO THE TABLE ABOVE.

FOR CONCRETE AND SHOTCRETE REPAIRS, SEE "CONCRETE RESTORATION DETAILS"

SHOTCRETE REPAIRS MAY BE REPLACED WITH CONCRETE REPAIRS WITH THE APPROVAL OF THE ENGINEER.

REPAIRS TO PRESTRESSED CONCRETE GIRDERS, SEE SPECIAL PROVISIONS FOR "PRESTRESSED CONCRETE GIRDERS WITH THERMAL SPRAY ANODE".

CONTRACTOR IS RESPONSIBLE FOR REPAIRING ALL MISSING AND/OR DAMAGED RAIL COMPONENTS, AS WELL AS TIGHTENING ALL LOOSE RAIL CONNECTIONS.

FOR 2-BAR METAL RAIL REPAIRS, SEE SPECIAL PROVISIONS.

FOR BEARINGS, SEE BEARING REPLACEMENT SHEETS.

VALUES IN CHART REPRESENT ESTIMATED REPAIR TOTALS AFTER REMOVAL OF UNSOUND CONCRETE. MINIMUM OF 1"BEHIND REBAR AND MINIMUM 2"CLEARANCE TO SAWCUT. FOR REPAIR DETAILS, SEE "CONCRETE RESTORATION DETAILS" SHEETS.
