PROJECT NO. 15BPR.46  
DARE COUNTY  
BRIDGE NO. 270012

STATE OF NORTH CAROLINA  
DEPARTMENT OF TRANSPORTATION  
RALEIGH

**SUBSTRUCTURE REPAIRS**

BENT 53

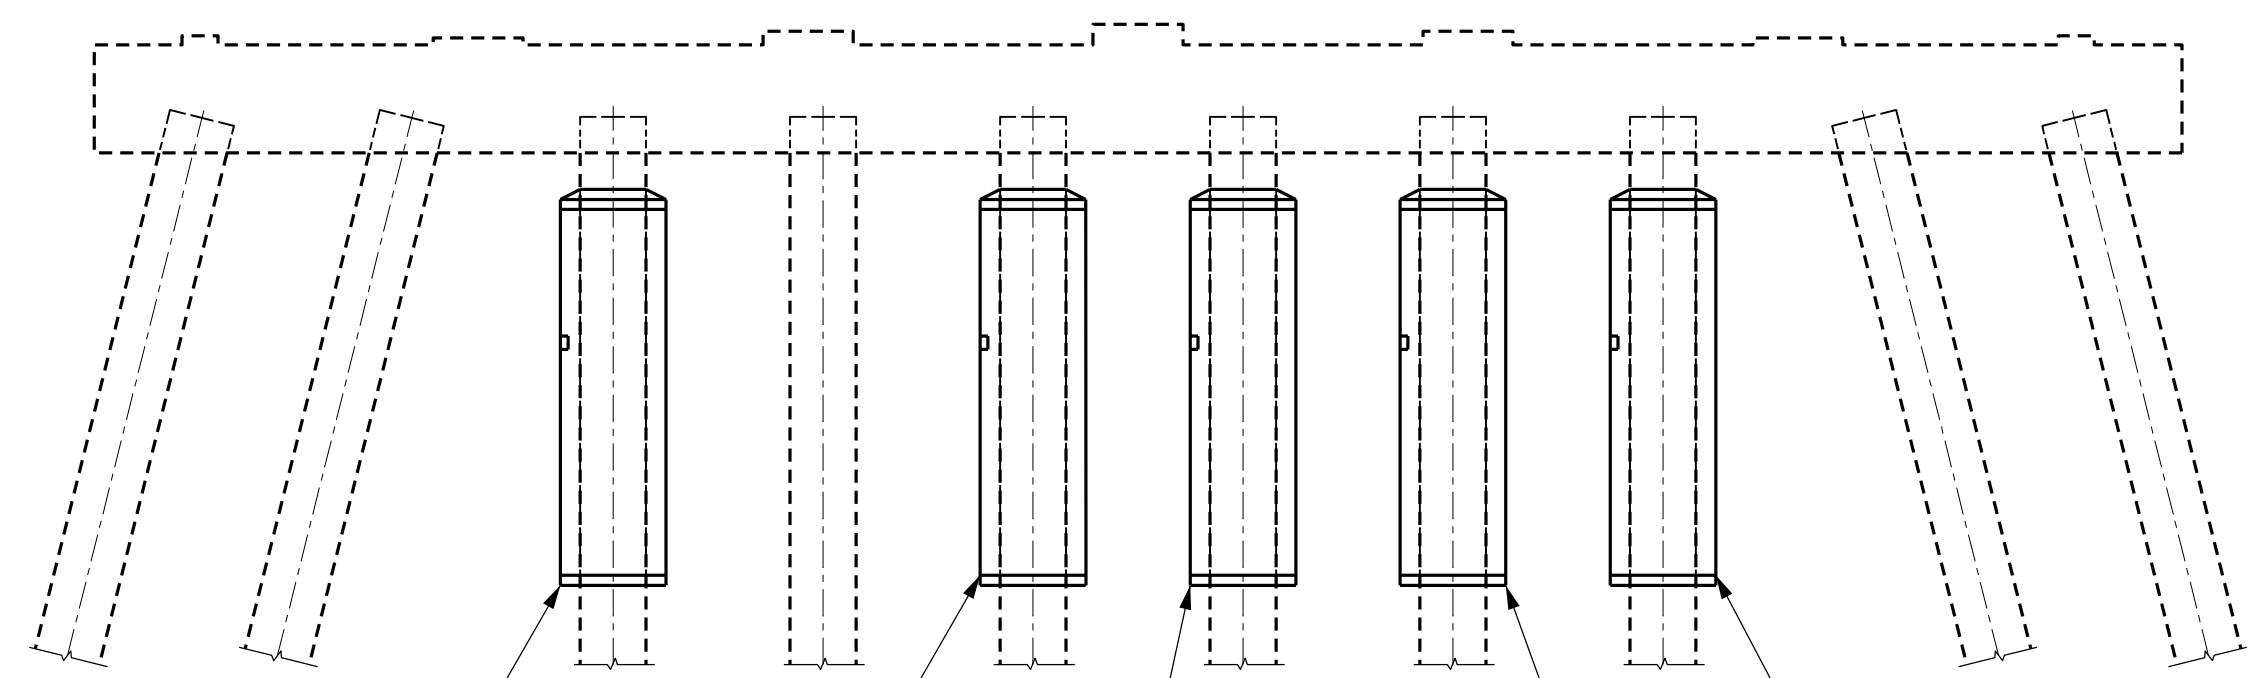
EAST ELEVATION

PILE JACKET PILE JACKET PILE JACKET PILE JACKET PILE JACKET

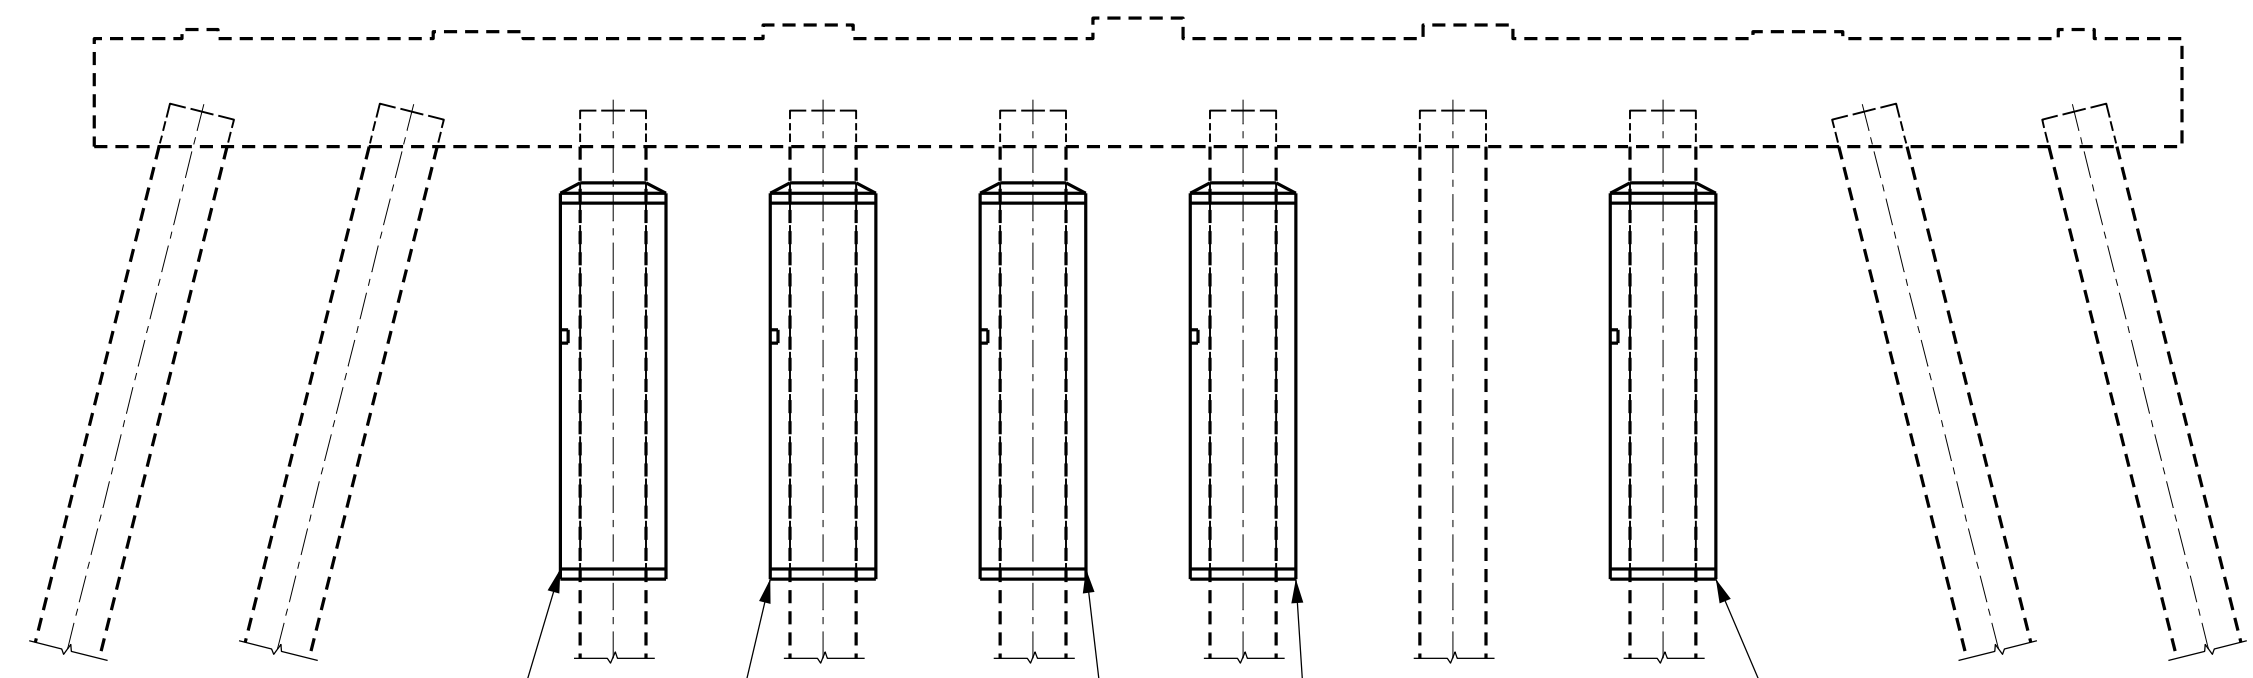
WEST ELEVATION

5.0 LF PILE JACKET 5.0 LF PILE JACKET 5.0 LF PILE JACKET 5.0 LF PILE JACKET 5.0 LF PILE JACKET
