Preliminary Site Assessment Report

November 20, 2018
WBS Element: 44625.1.1
State Project: U-5888
Haywood County

at
Clifford Gould LLC Property
Parcel #008
783 N Main Street, Waynesville, NC 28786
PIN #: 8615-59-6508
Facility ID No.: N/A
Groundwater Incident No.: 41466

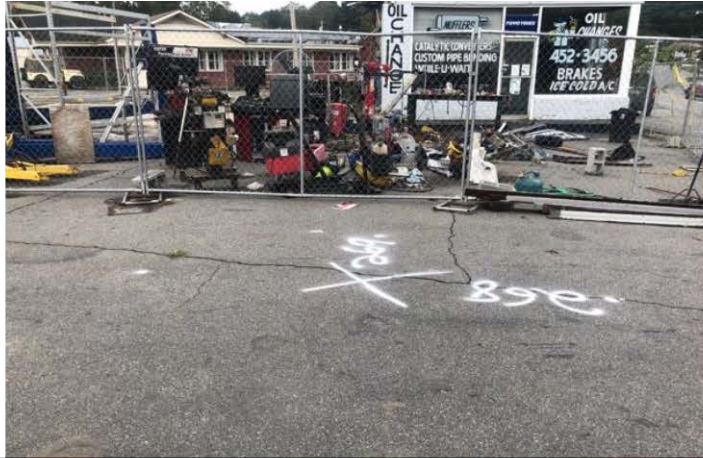
1. Tools and equipment left outside of the remnants of the auto-repair shop at Parcel #008.

2. Building footing and remaining half of building at Parcel #008. Former restaurant building visible in background.

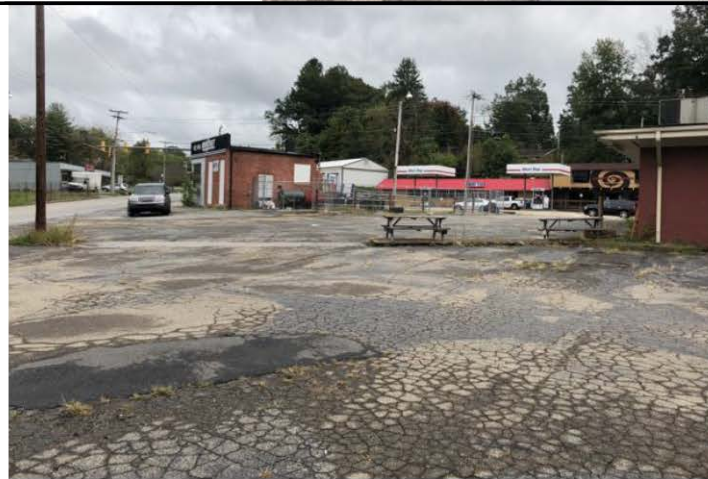
3. View along north side of property from the northwest corner.

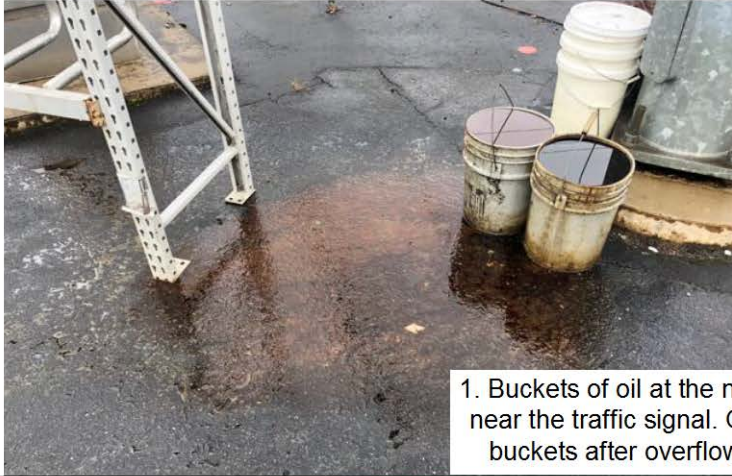
Two buckets of oil were observed on the property near the northeast parcel corner where the traffic signal box is located (Plate 2). These had overflowed in the recent rains and a puddle of oil formed on the pavement. Seramur & Associates personnel called the Town of Waynesville to inform them of the situation. The Town of Waynesville sent over a police officer who contacted the last occupants of the auto-repair shop. The occupants arrived on site and transferred the oil into the ASTs on the west side of the building. They did not clean up the puddle of oil that had spilled onto the asphalt.

1. Buckets of oil at the northeast property corner near the traffic signal. Oil has spilled from both buckets after overflowing during rain event.

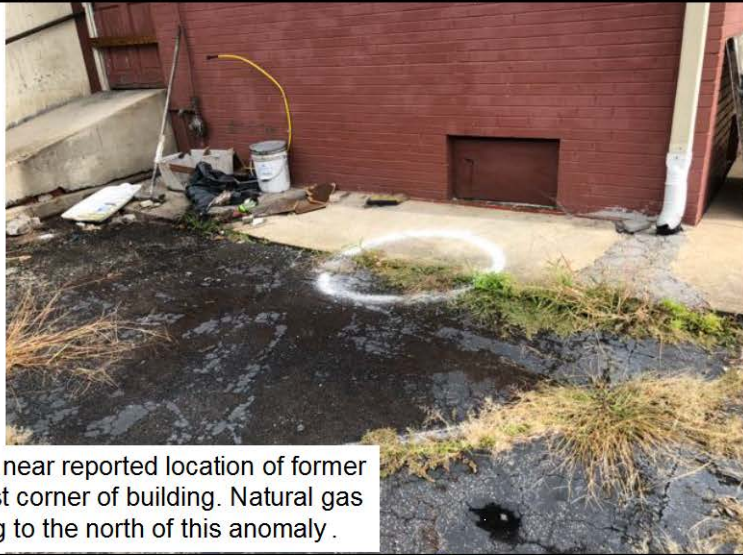
2. Magnetic anomaly A near reported location of former heating oil UST off west corner of building. Natural gas line runs into building to the north of this anomaly .

Two magnetic anomalies were detected in Grid 4. Anomaly A was detected at the reported

location of a former heating oil UST. The property manager had stated that the UST was removed and we could identify the former location by the patched asphalt. This anomaly appeared smaller than what would be expected for a UST. Access to the GPR was limited as the anomaly was partially located under a sidewalk that ran along the building. Two perpendicular GPR profiles were collected across Anomaly A (Figure 5). These show a distinct set of reflections indicating some type of reflective material. It is possible that the GPR and magnetometer are picking up remnant piping and asphalt or concrete dumped into the heating oil UST excavation. It is also possible that a heating oil UST remains under the sidewalk. The 2.4-2.9 GPR depth slice shows a reflection at this location that could represent a UST (Figure 5).

The heating oil UST behind the restaurant was reportedly removed and the asphalt in this area has been patched. However, the geophysical survey did detect Magnetic anomaly A in Grid 4 adjacent to the reported UST location. GPR profiles show reflection characteristics that could be interpreted as a UST. The GPR depth slices show an anomaly of the size and shape of a buried UST. The magnetic anomaly and GPR reflections could be related to debris placed in the excavation or could be a UST. Based on the NCDOT UST Level of Confidence ranking, the evidence would indicate that this should be considered a “possible UST”.

SAPC recommends that the possible UST adjacent to the restaurant building be investigated further. If a UST is confirmed at this location, then a licensed engineer or geologist should supervise the UST closure.

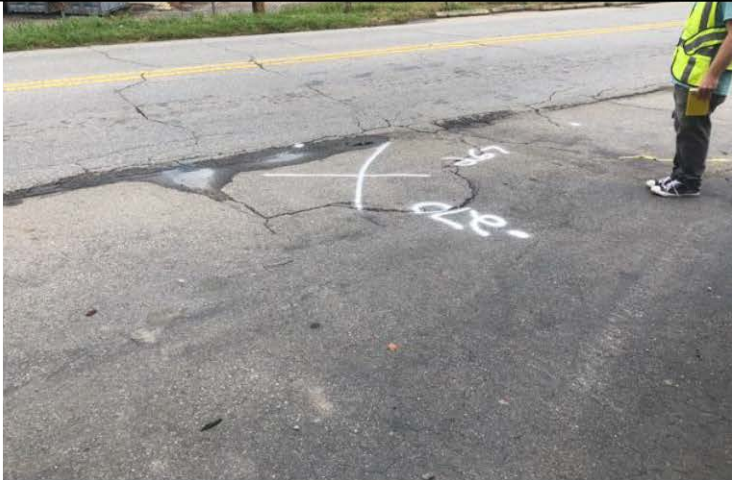
3. Magnetic anomaly C north of the auto-repair shop. Appears to be a utility under newer pavement.

Two magnetic anomalies (C & D) were recorded outside of our grid locations (Figure 5). GPR Profiles 1 and 2 were collected across anomaly C (Figure 4). GPR Profile 1 shows a hyperbola that could be interpreted as a UST, but Profile 2 shows that this reflector is too small to be a UST (Figure 9). There is an irregular shaped asphalt patch at this location and the water line runs along this side of the road. This anomaly is interpreted to be related to a utility.

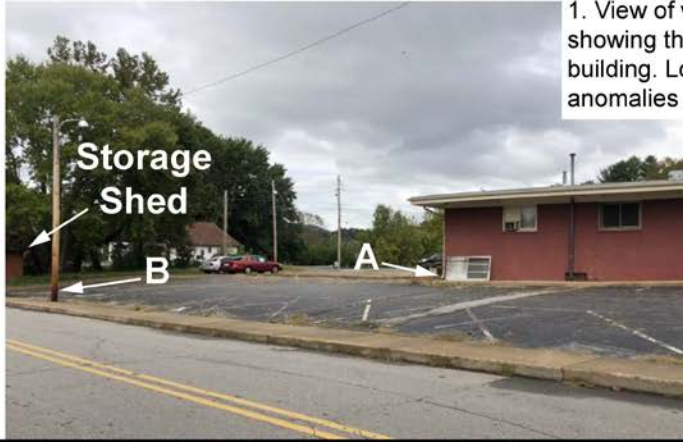
1. View of west side of Parcel #008 showing the back of the restaurant building. Location of magnetic anomalies A & B are shown.

Anomaly B was located in the northwestern portion of the parcel near the edge of the parking lot. This anomaly was larger, but the GPR profiles do not show reflection characteristics typical of a UST. This anomaly appears to be a point reflector on the GPR profiles and the 1.1-1.6 foot GPR depth slice (Figure 5).

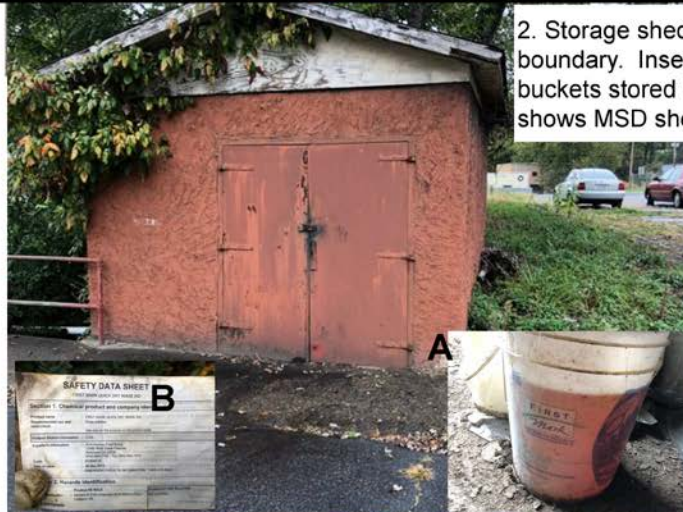
Seramur and Associates personnel made a pedestrian reconnaissance of the property during the initial site visit on September 25, 2018. A storage shed is located at the northwest corner of the property. This shed appears to have been used to store materials for the restaurant. Several buckets of "Quick Dry Rinse Aid" were observed in the shed. The material safety data sheet on one of these buckets described the material as C10-C16 ethoxylated alcohol (Plate 3).

2. Storage shed along western property boundary. Inset A shows one of the buckets stored in the building. Inset B shows MSD sheet for buckets

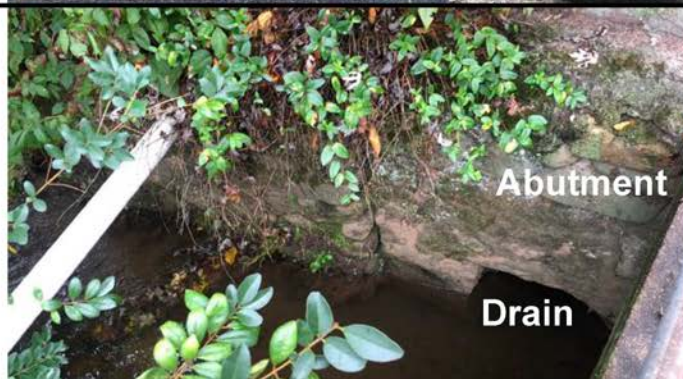
3. Stream at bridge abutment showing storm water drain (lower right) and PVC utility line that extend onto the property. Bridge abutment forms the northwest footing of the storage shed.

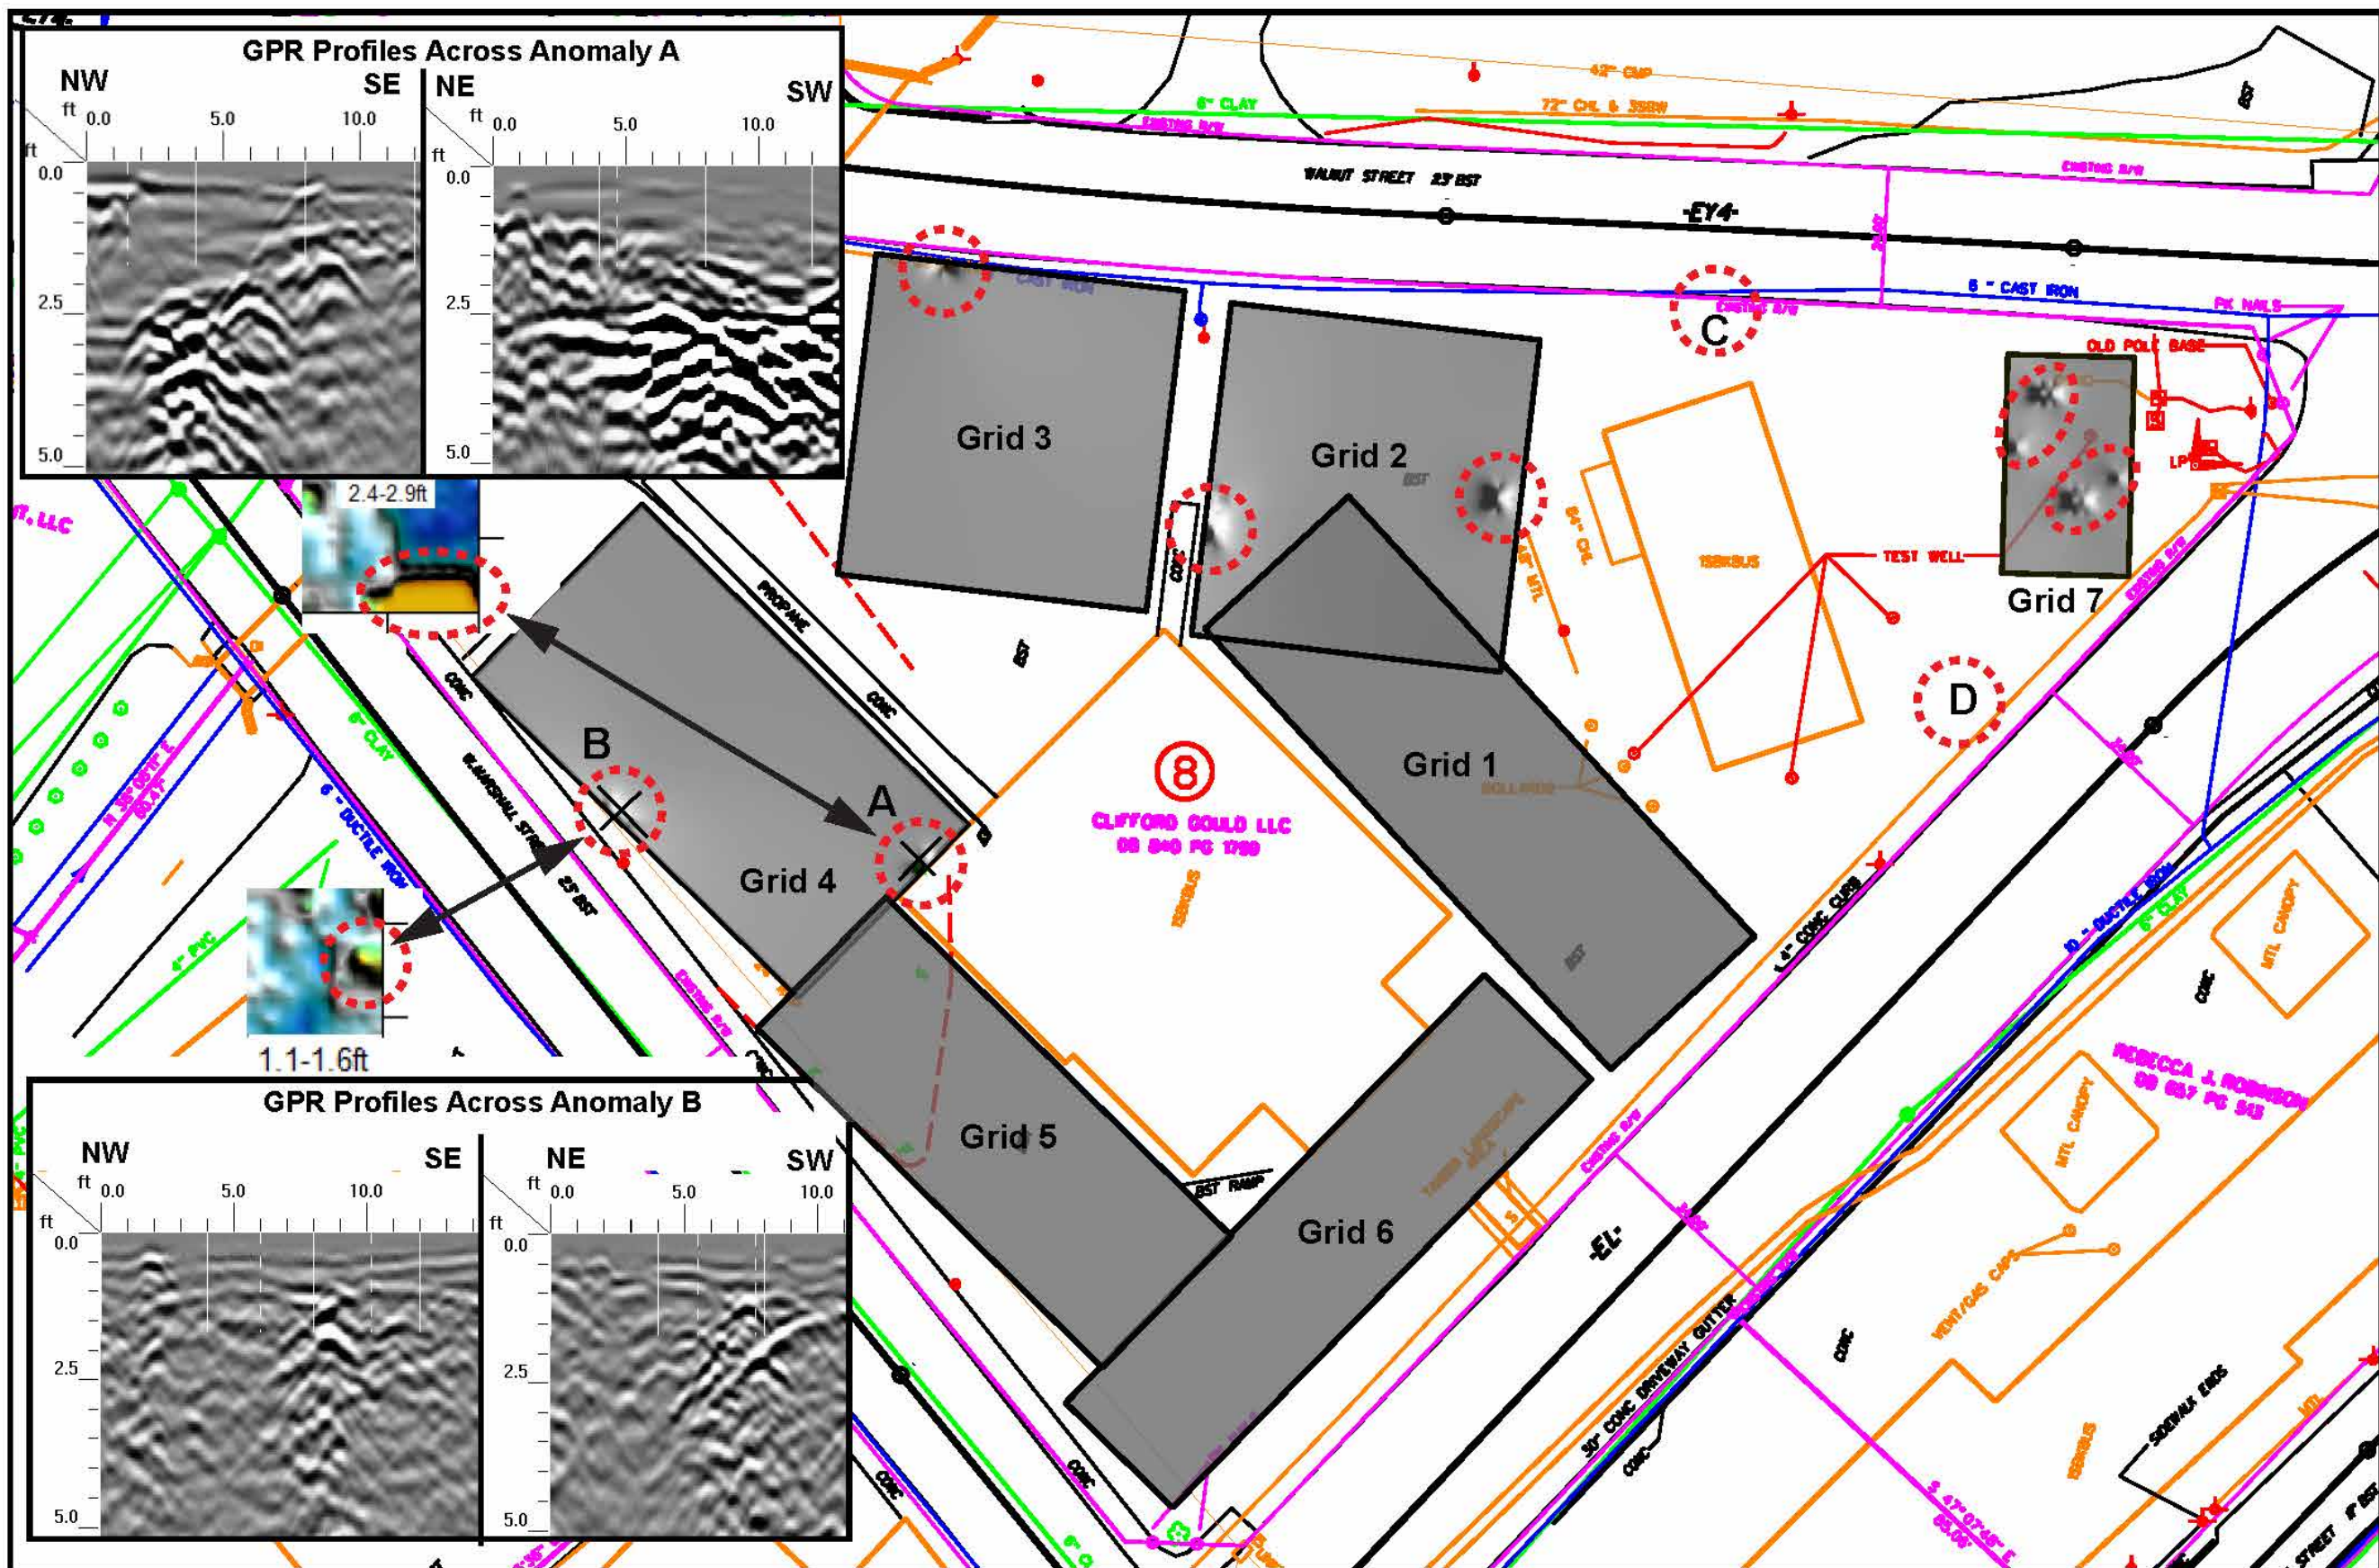
Figure 5
Magnetometer
Survey Results

Two small magnetic anomalies were detected in Grid 2 (Figure 5). These were localized anomalies and the GPR profiles did not show reflection characteristics typical of a UST. One small magnetic anomaly was detected in Grid 3 (Figure 5). This was also a localized anomaly. The GPR profiles show an area of soil disturbance at this location and the reflection characteristics are not typical of a UST.

Several small magnetic anomalies were detected in Grid 7 (Figure 5). These were localized anomalies and the GPR profiles did not show reflection characteristics typical of a UST. This area appears disturbed on the GPR profiles. This was also the location of some of the highest concentrations of petroleum constituents detected in soil samples. The magnetic anomalies detected in Grid 7 are interpreted to be remnant infrastructure from the former UST system on Parcel #008.

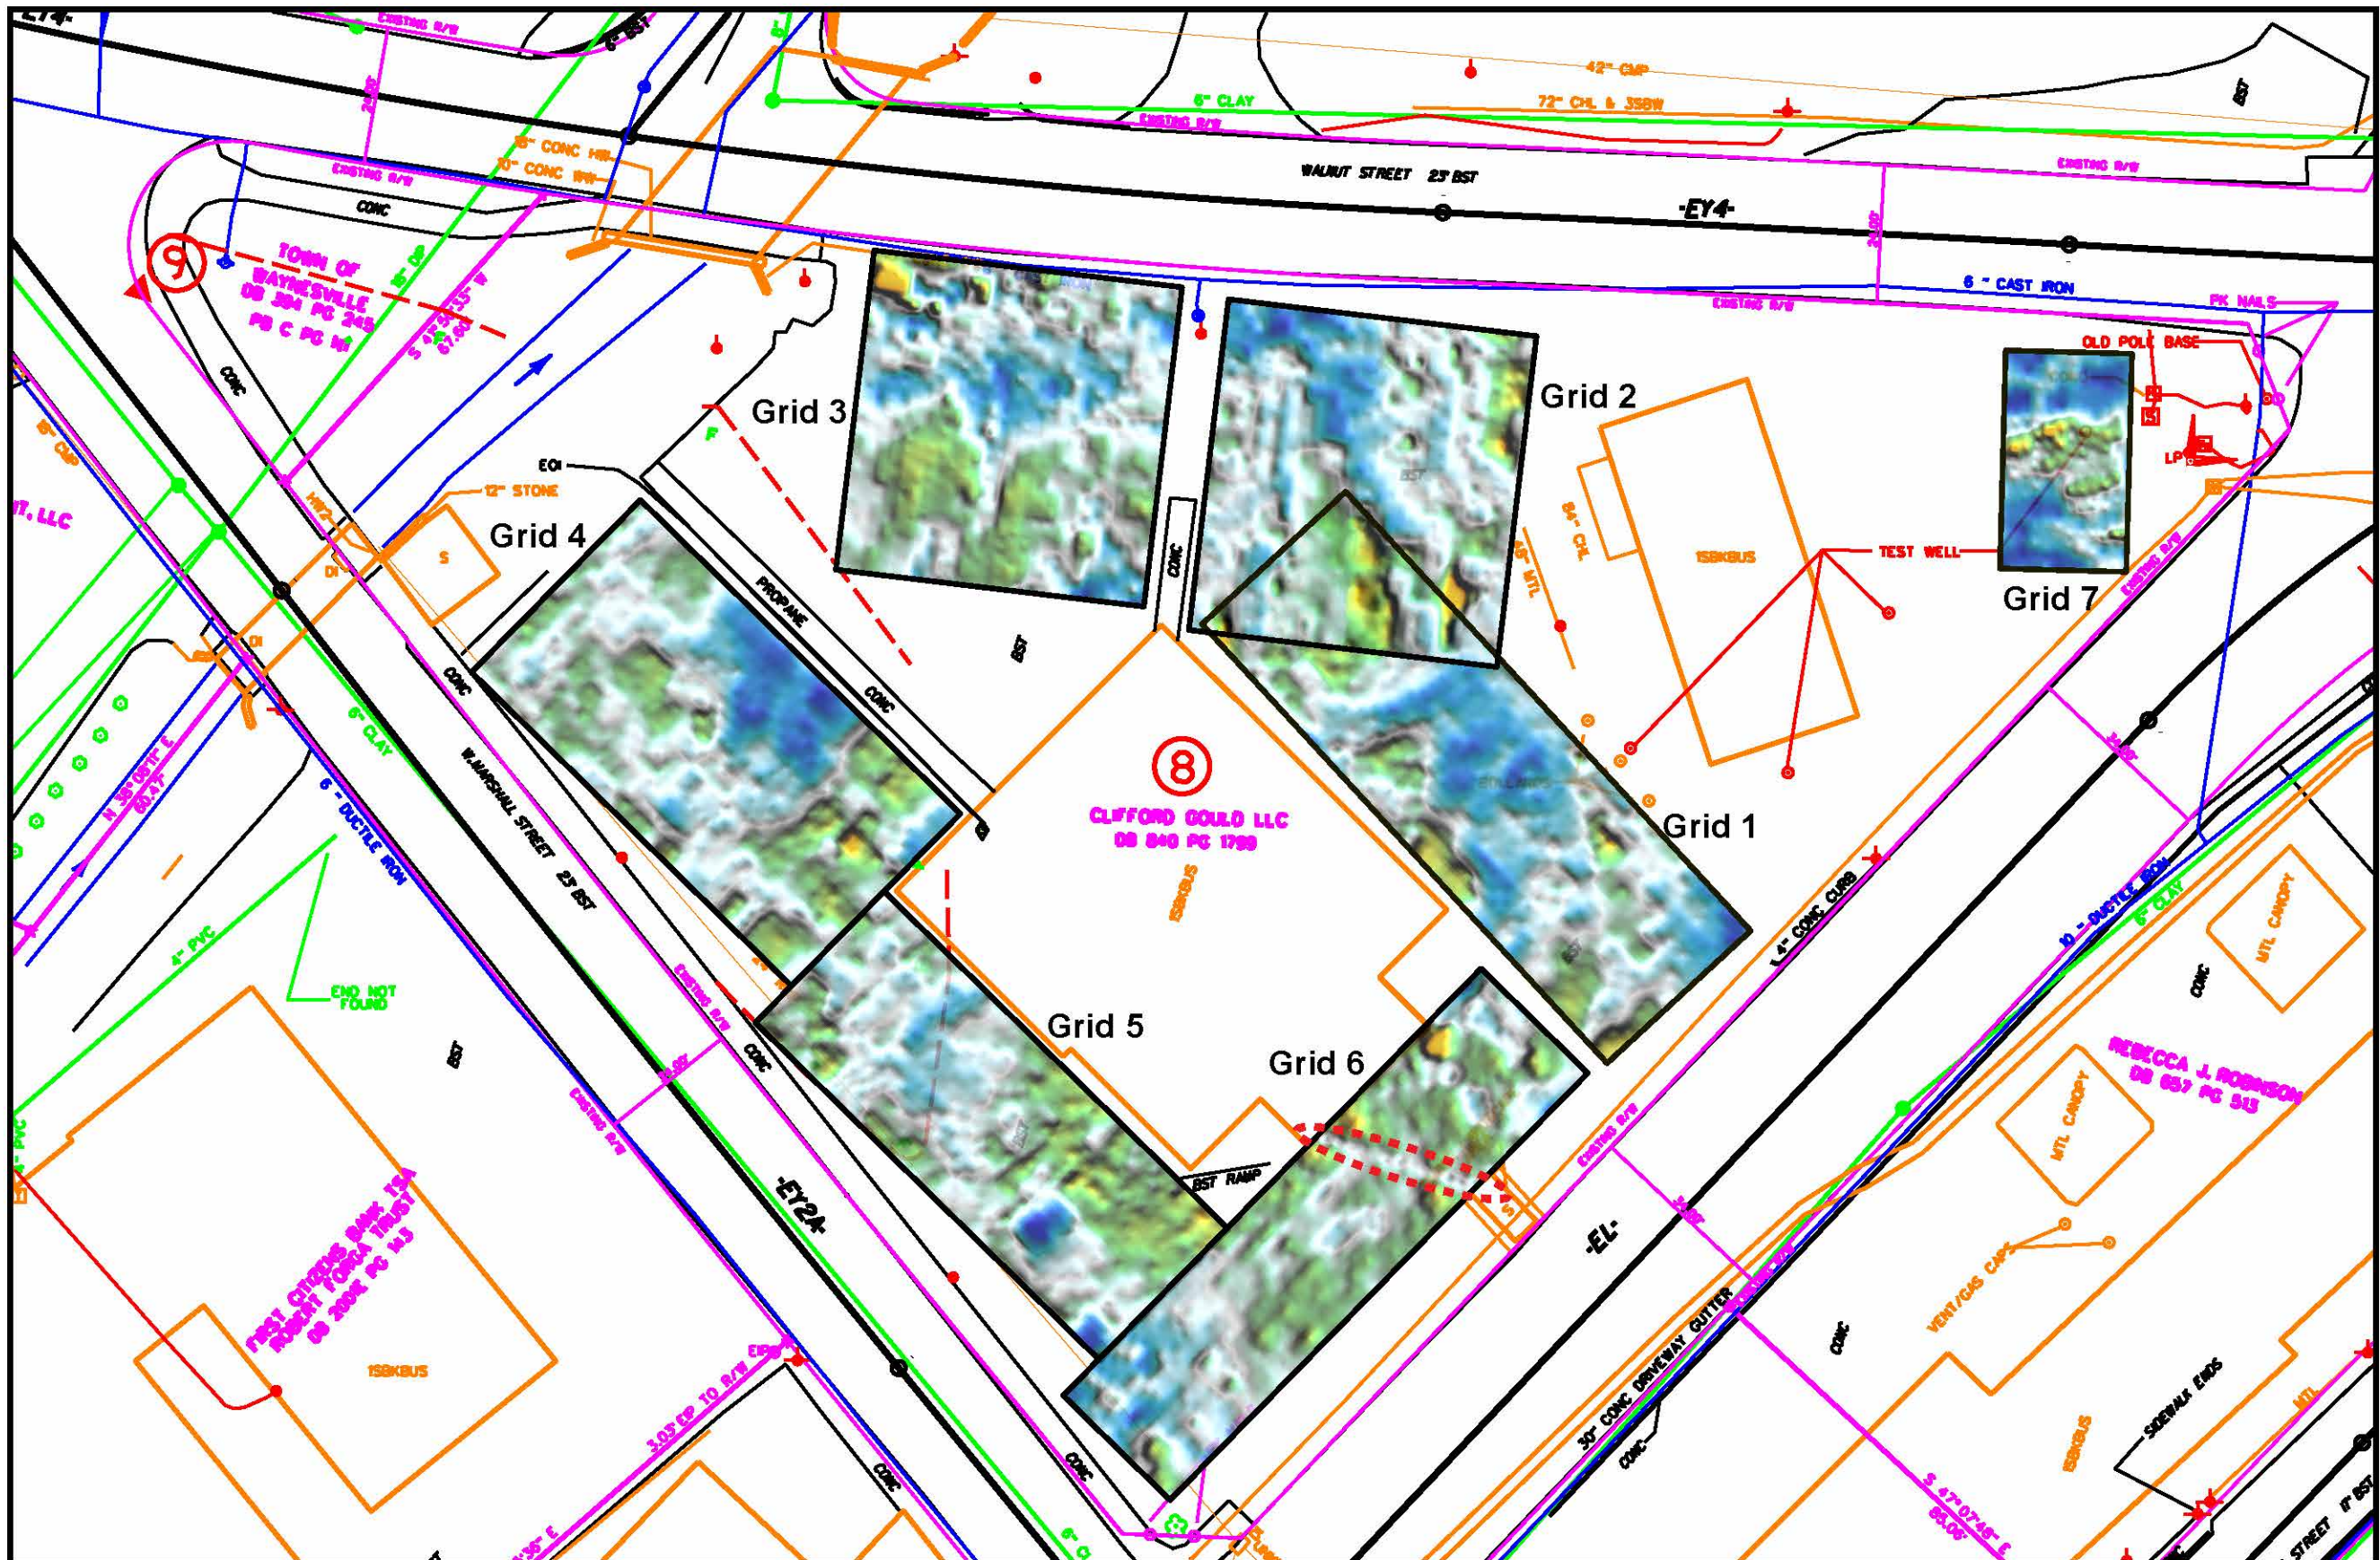
Figure 6

The 0.3-0.8 GPR depth slices shows an electric line extending across Grid 6 between the restaurant building a sign (Figure 6). This is about the only buried infrastructure that can be seen in these depth slices.

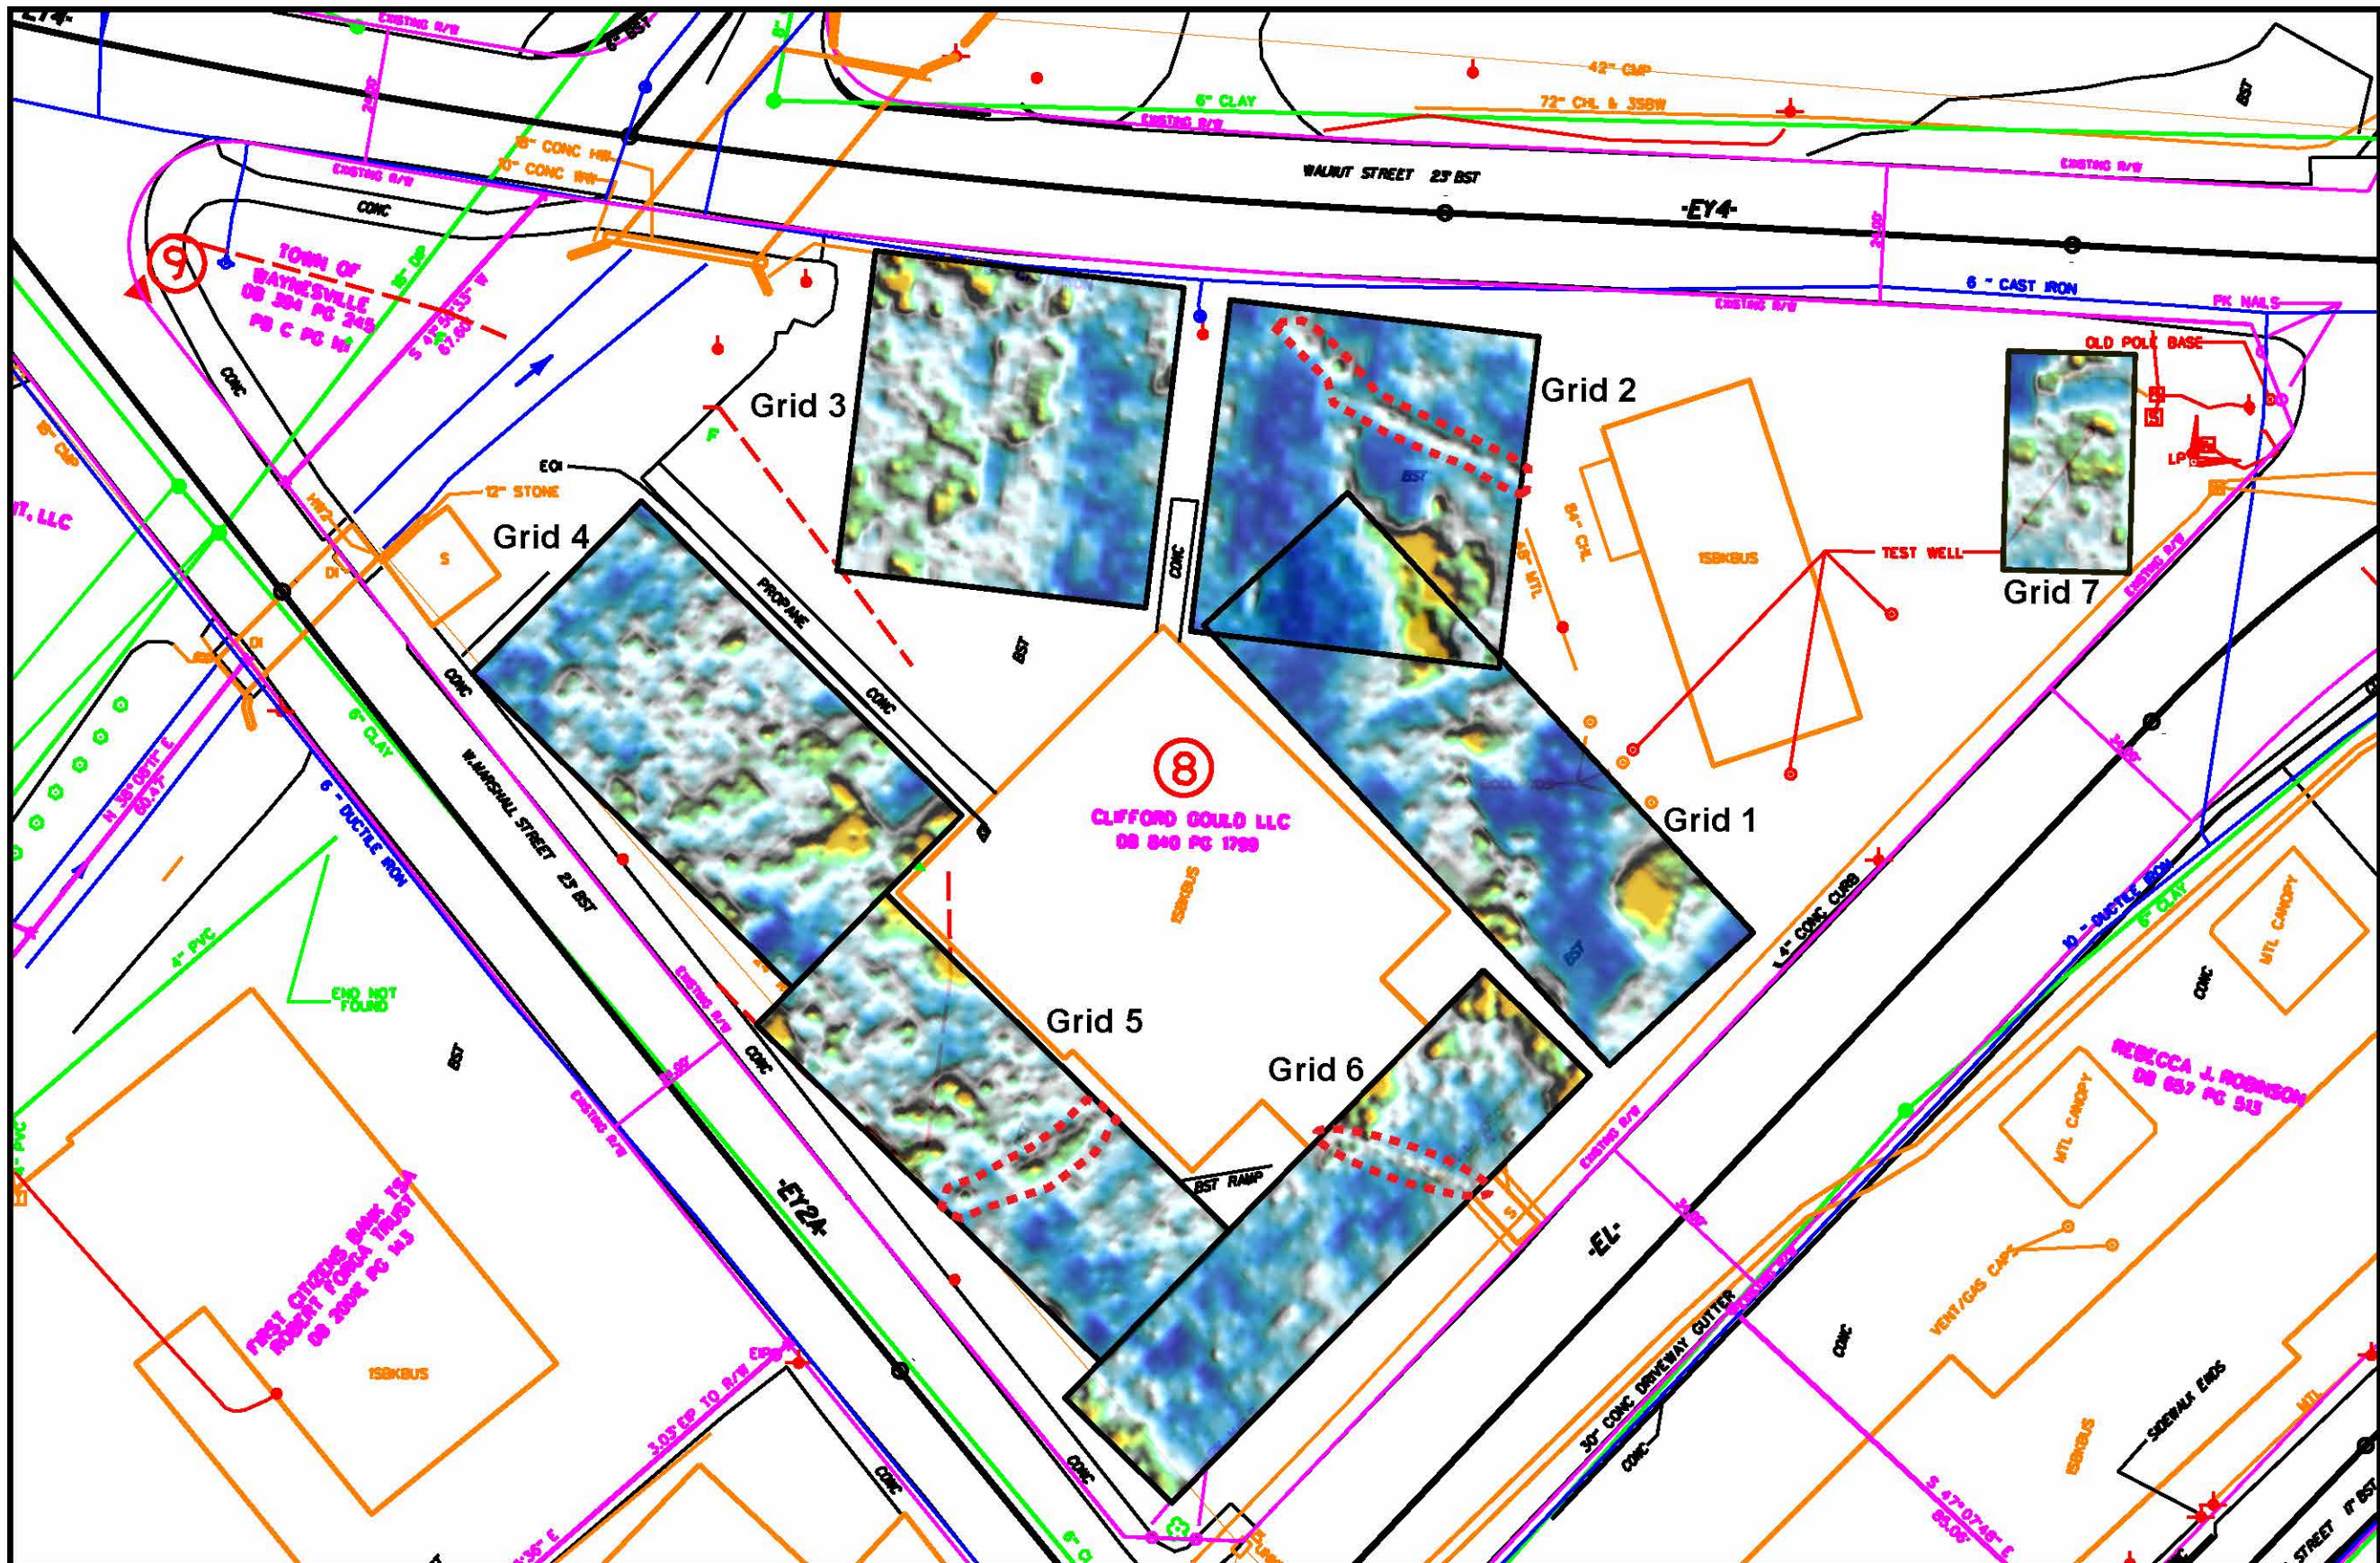
Figure 7

The 1.3-1.9 GPR depth slices show utility lines extending across Grids 2, 5 and 6 (Figure 7).

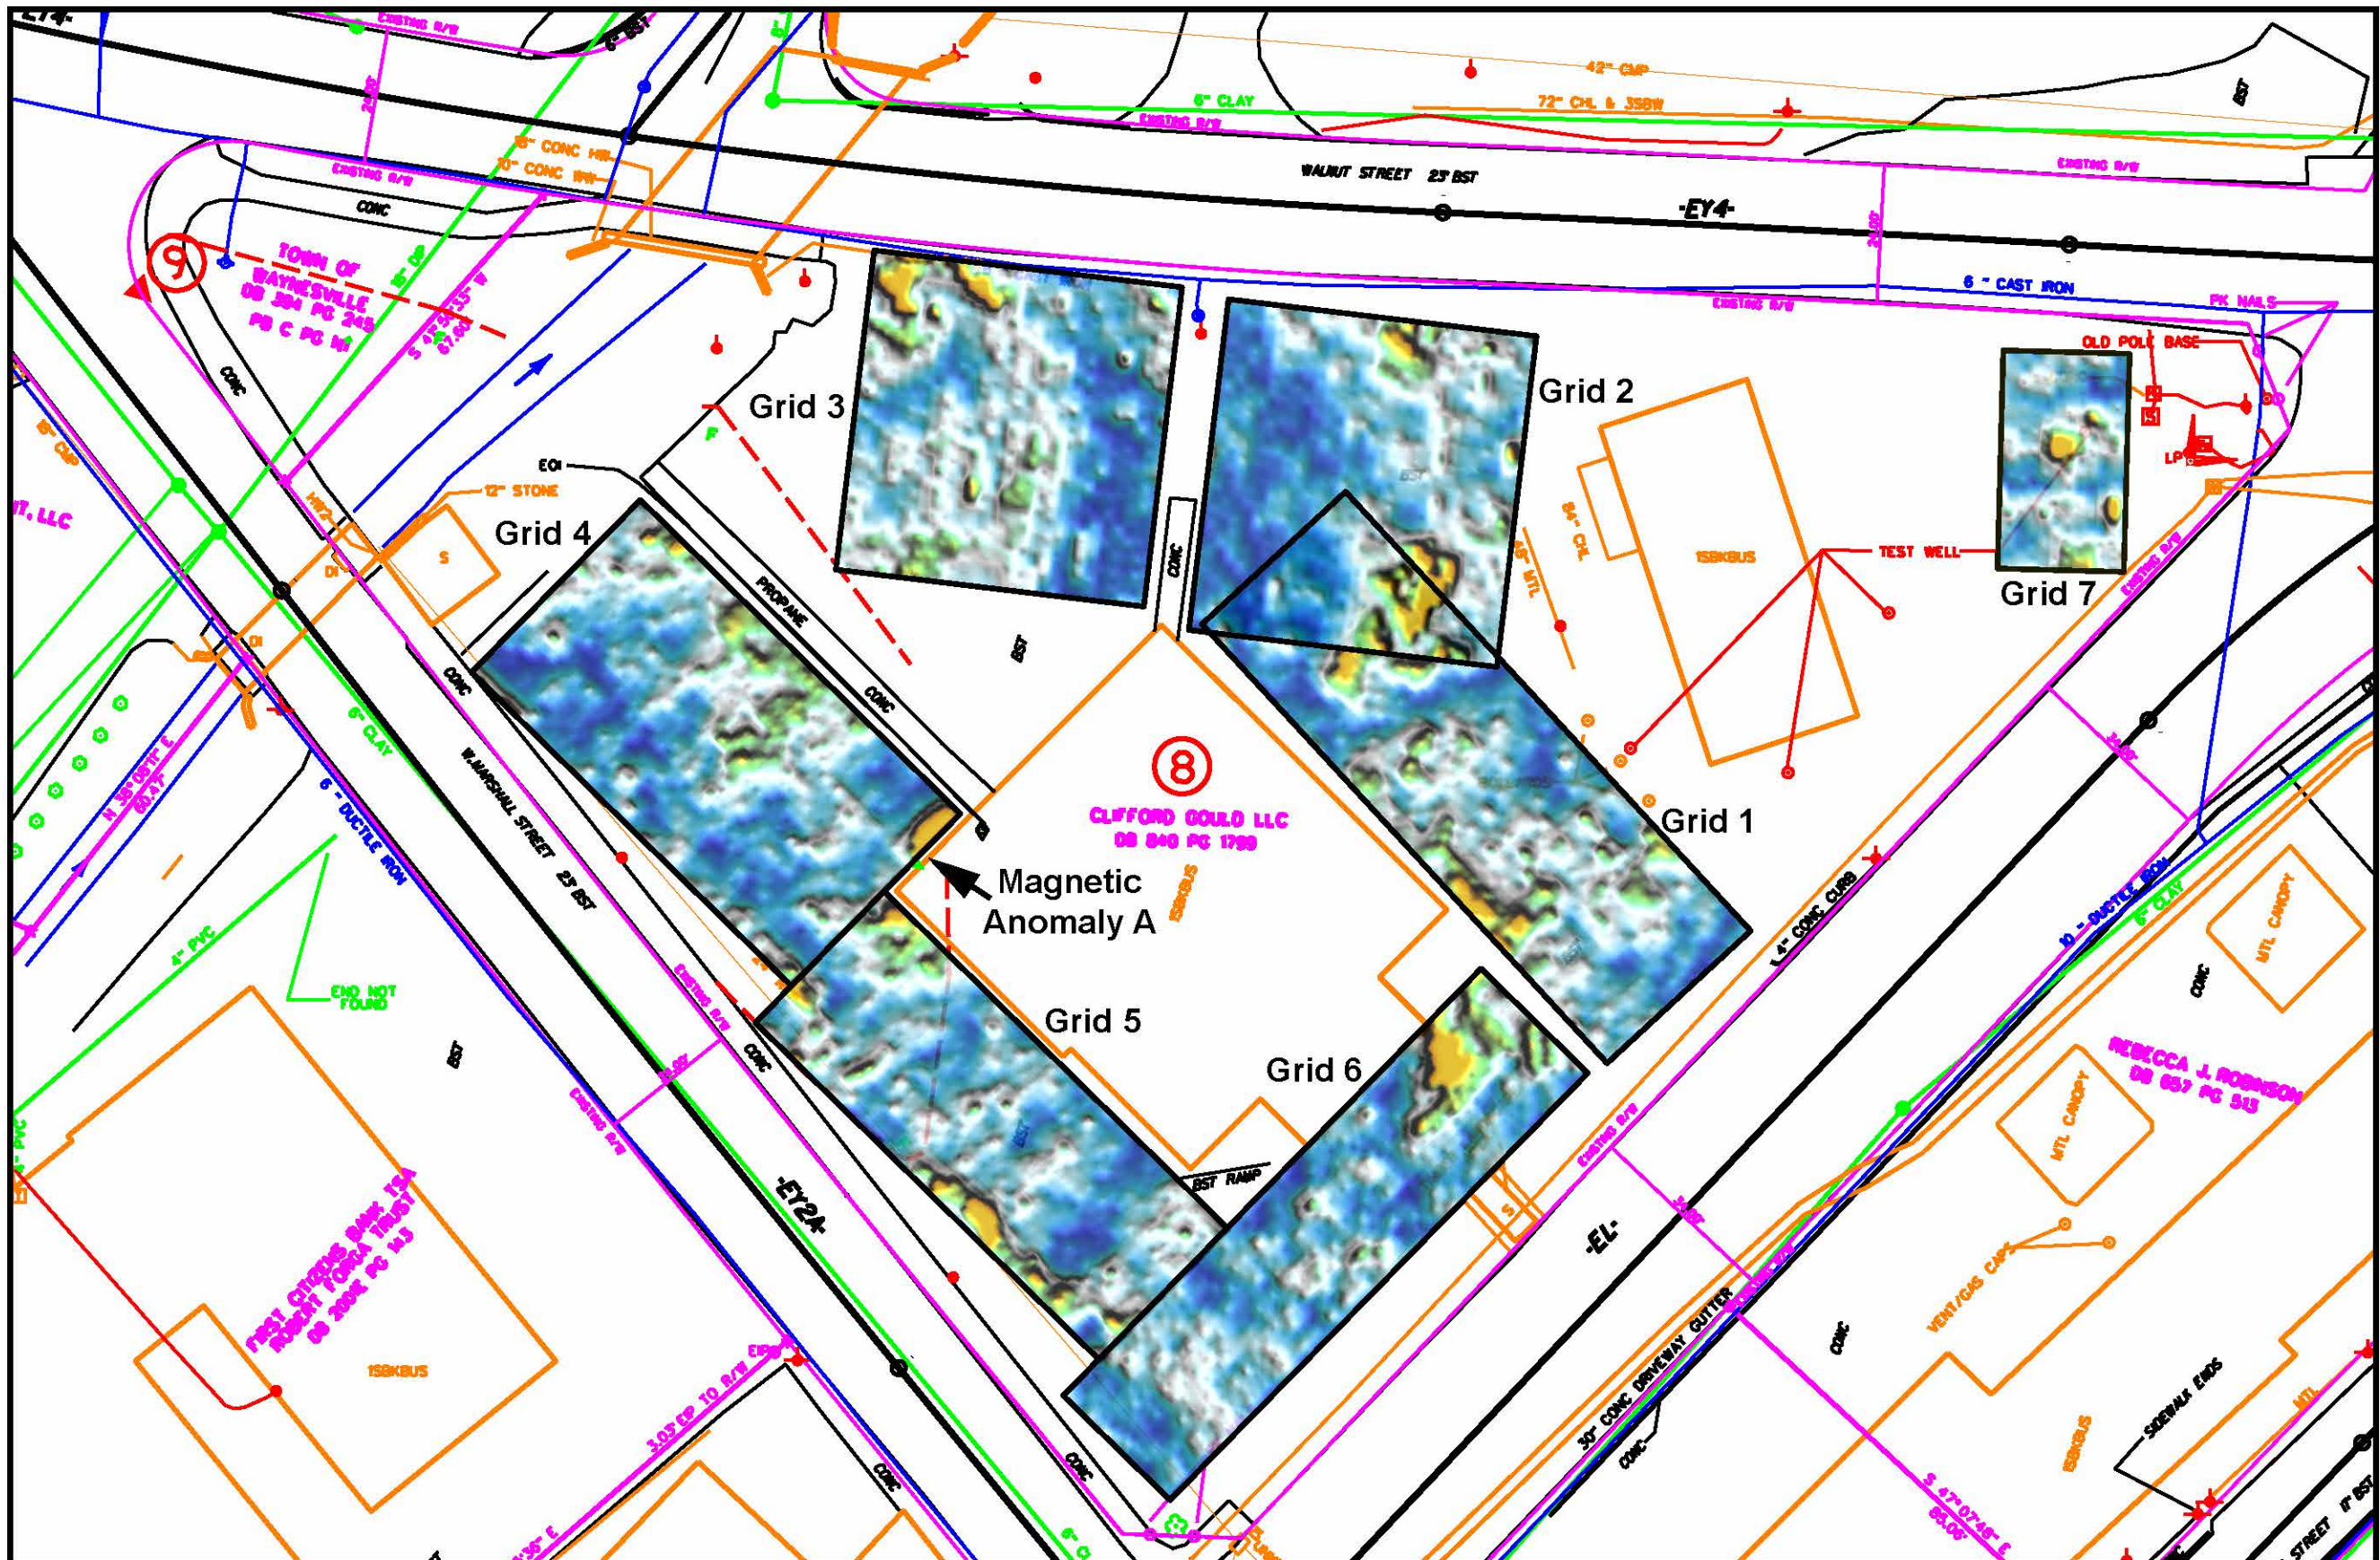
Figure 8

The 3.2-3.7 GPR depth slices show a couple of high amplitude reflections in Grid 7, but these reflections are between the magnetic anomalies detected in this grid (Figure 7). The high

amplitude reflection at magnetic anomaly A in Grid 4 can be seen adjacent to the restaurant building in these depth slices.

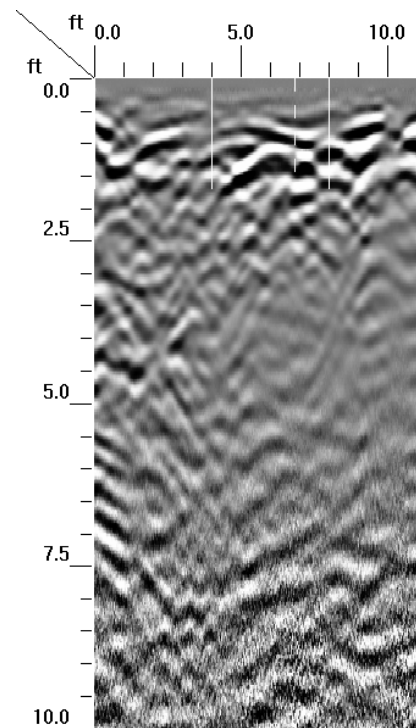
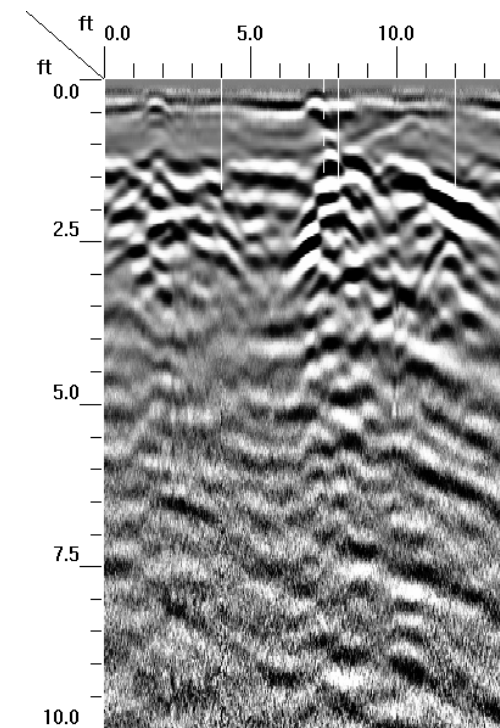
Figure 9
GPR Profiles 1-6

GPR Profiles 3 and 4 were collected across Anomaly D (Figure 4). These profiles show evidence of soil disturbance but no reflections characteristic of a UST (Figure 9).

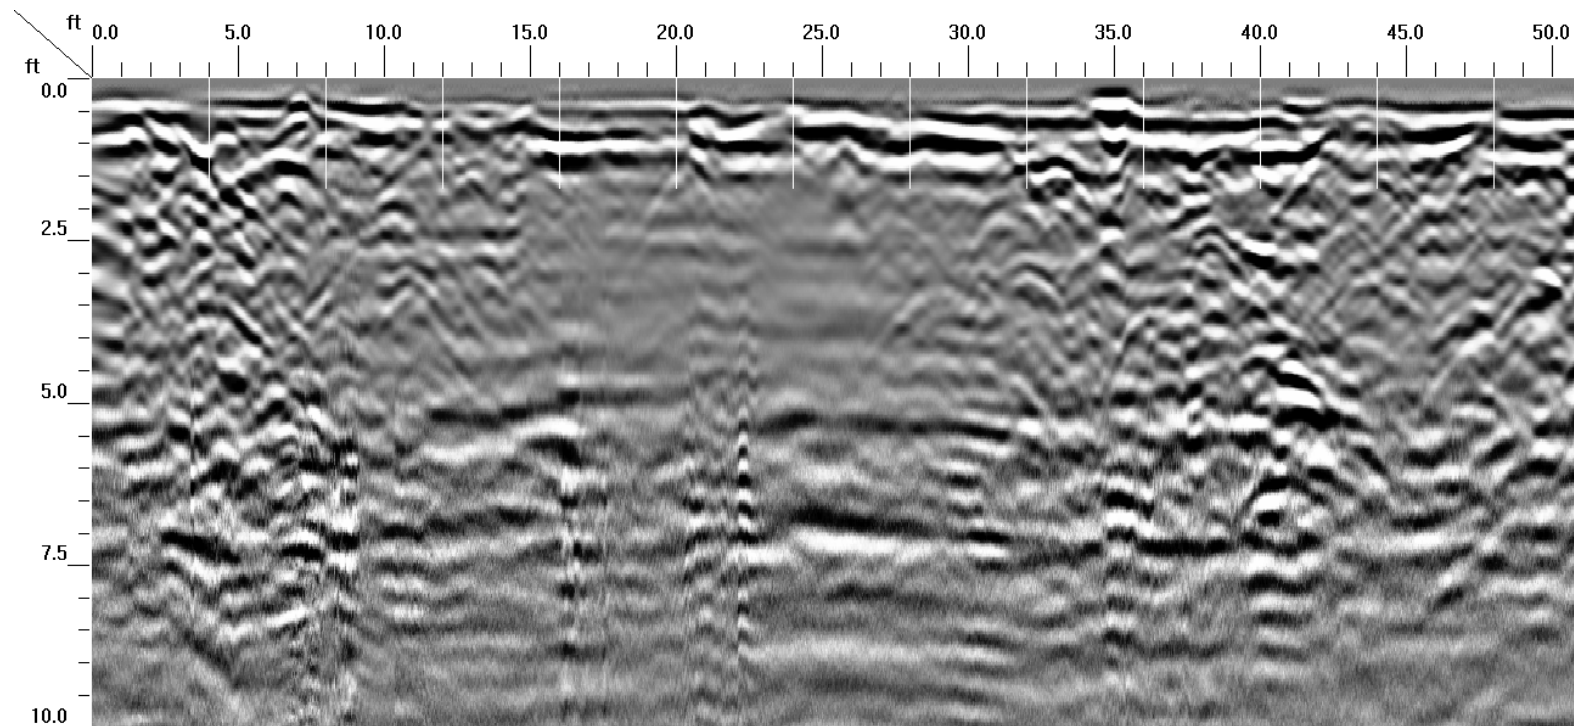
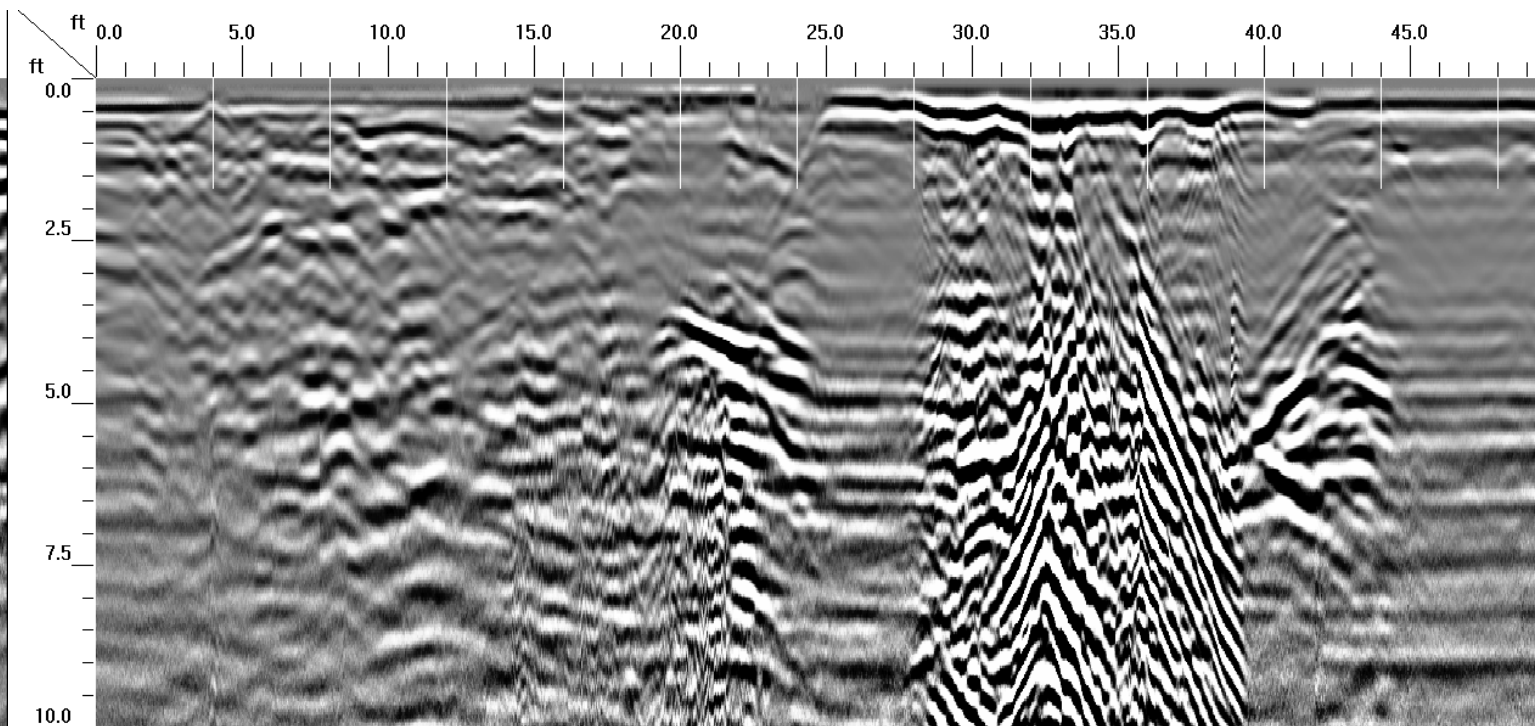
Two GPR profiles (P5 and P6) were collected around the former auto repair shop (Figure 4). These profiles did not show any reflections characteristic of a UST (Figure 9).
