Preliminary Site Assessment Report

November 20, 2018
WBS Element: 44625.1.1
State Project: U-5888
Haywood County

at
Clifford Gould LLC Property
Parcel #008
783 N Main Street, Waynesville, NC 28786
PIN #: 8615-59-6508
Facility ID No.: N/A
Groundwater Incident No.: 41466

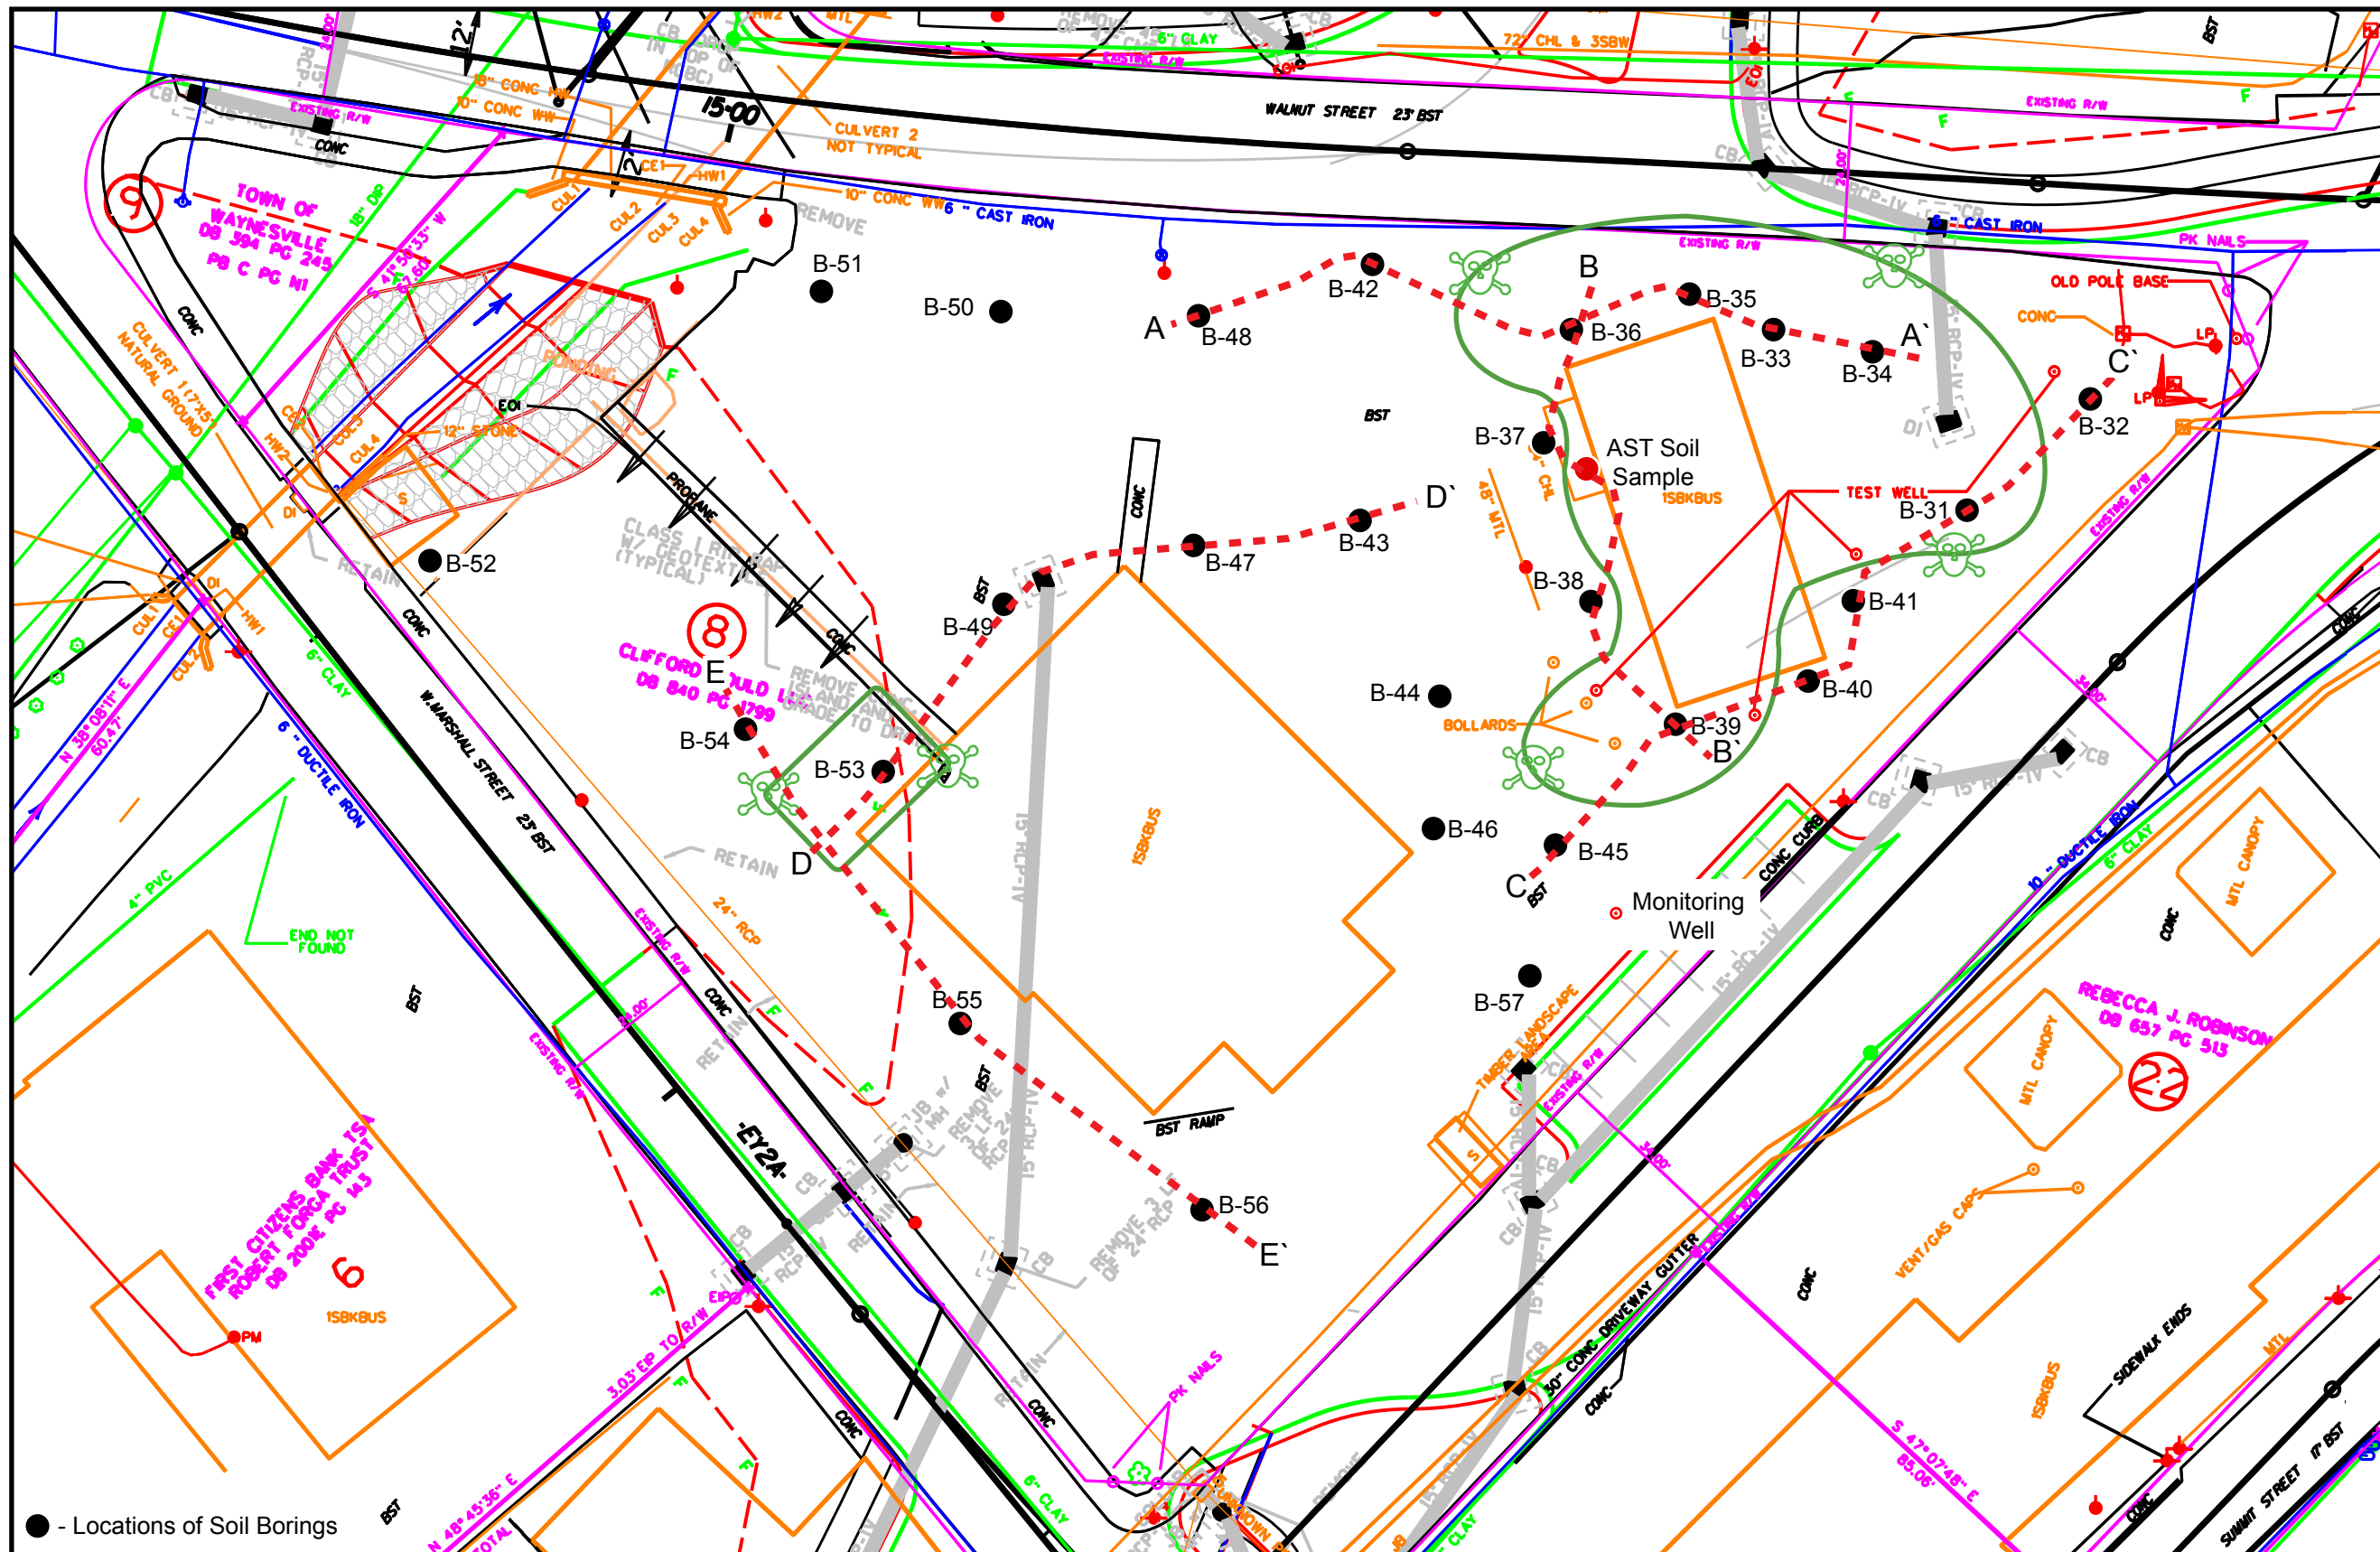
Contaminated soil defined as GRO concentrations above 50 ppm and DRO concentrations above 100 ppm was detected in soil samples collected at Parcel #008. The sources of this soil contamination are suspected to be the UST systems that previously operated at this facility as well as the AST system which is still in place.

In total, Seramur & Associates estimates that 1,213 cubic yards or approximately 1,819.5 tons of contaminated soil would be encountered at the property to a depth of 10 feet. Approximate extent of soil contamination is interpreted throughout cross-sections A-A' and E-E' (Figures 12-14)

Contaminated soil around the ASTs covers an area of 300 ft². The upper foot of soil should be removed from this location. Contaminated soil around the proposed storm drain extends across an area of about 180 ft². Contaminated soil will need to be excavated to a depth of about 3 feet in this area. The total volume of contaminated soil that needs to be removed in order to safely complete grading and install the storm drain is estimated to be about 30 yards.

SAPC recommends that a licensed geologist or engineer supervise the excavation and removal of contaminated soil in the vicinity of boring B-34 and the ASTs. This work could be completed at the same time that the possible UST is investigated. Contaminated soil removed from Parcel #008 should be sent to a remediation facility.
