PROJECT NO. 15BPR.21 MONTGOMERY COUNTY BRIDGE NO. 610006

> STATE OF NORTH CAROLINA DEPARTMENT OF TRANSPORTATION

> > BENT 5 SPAN E FACE

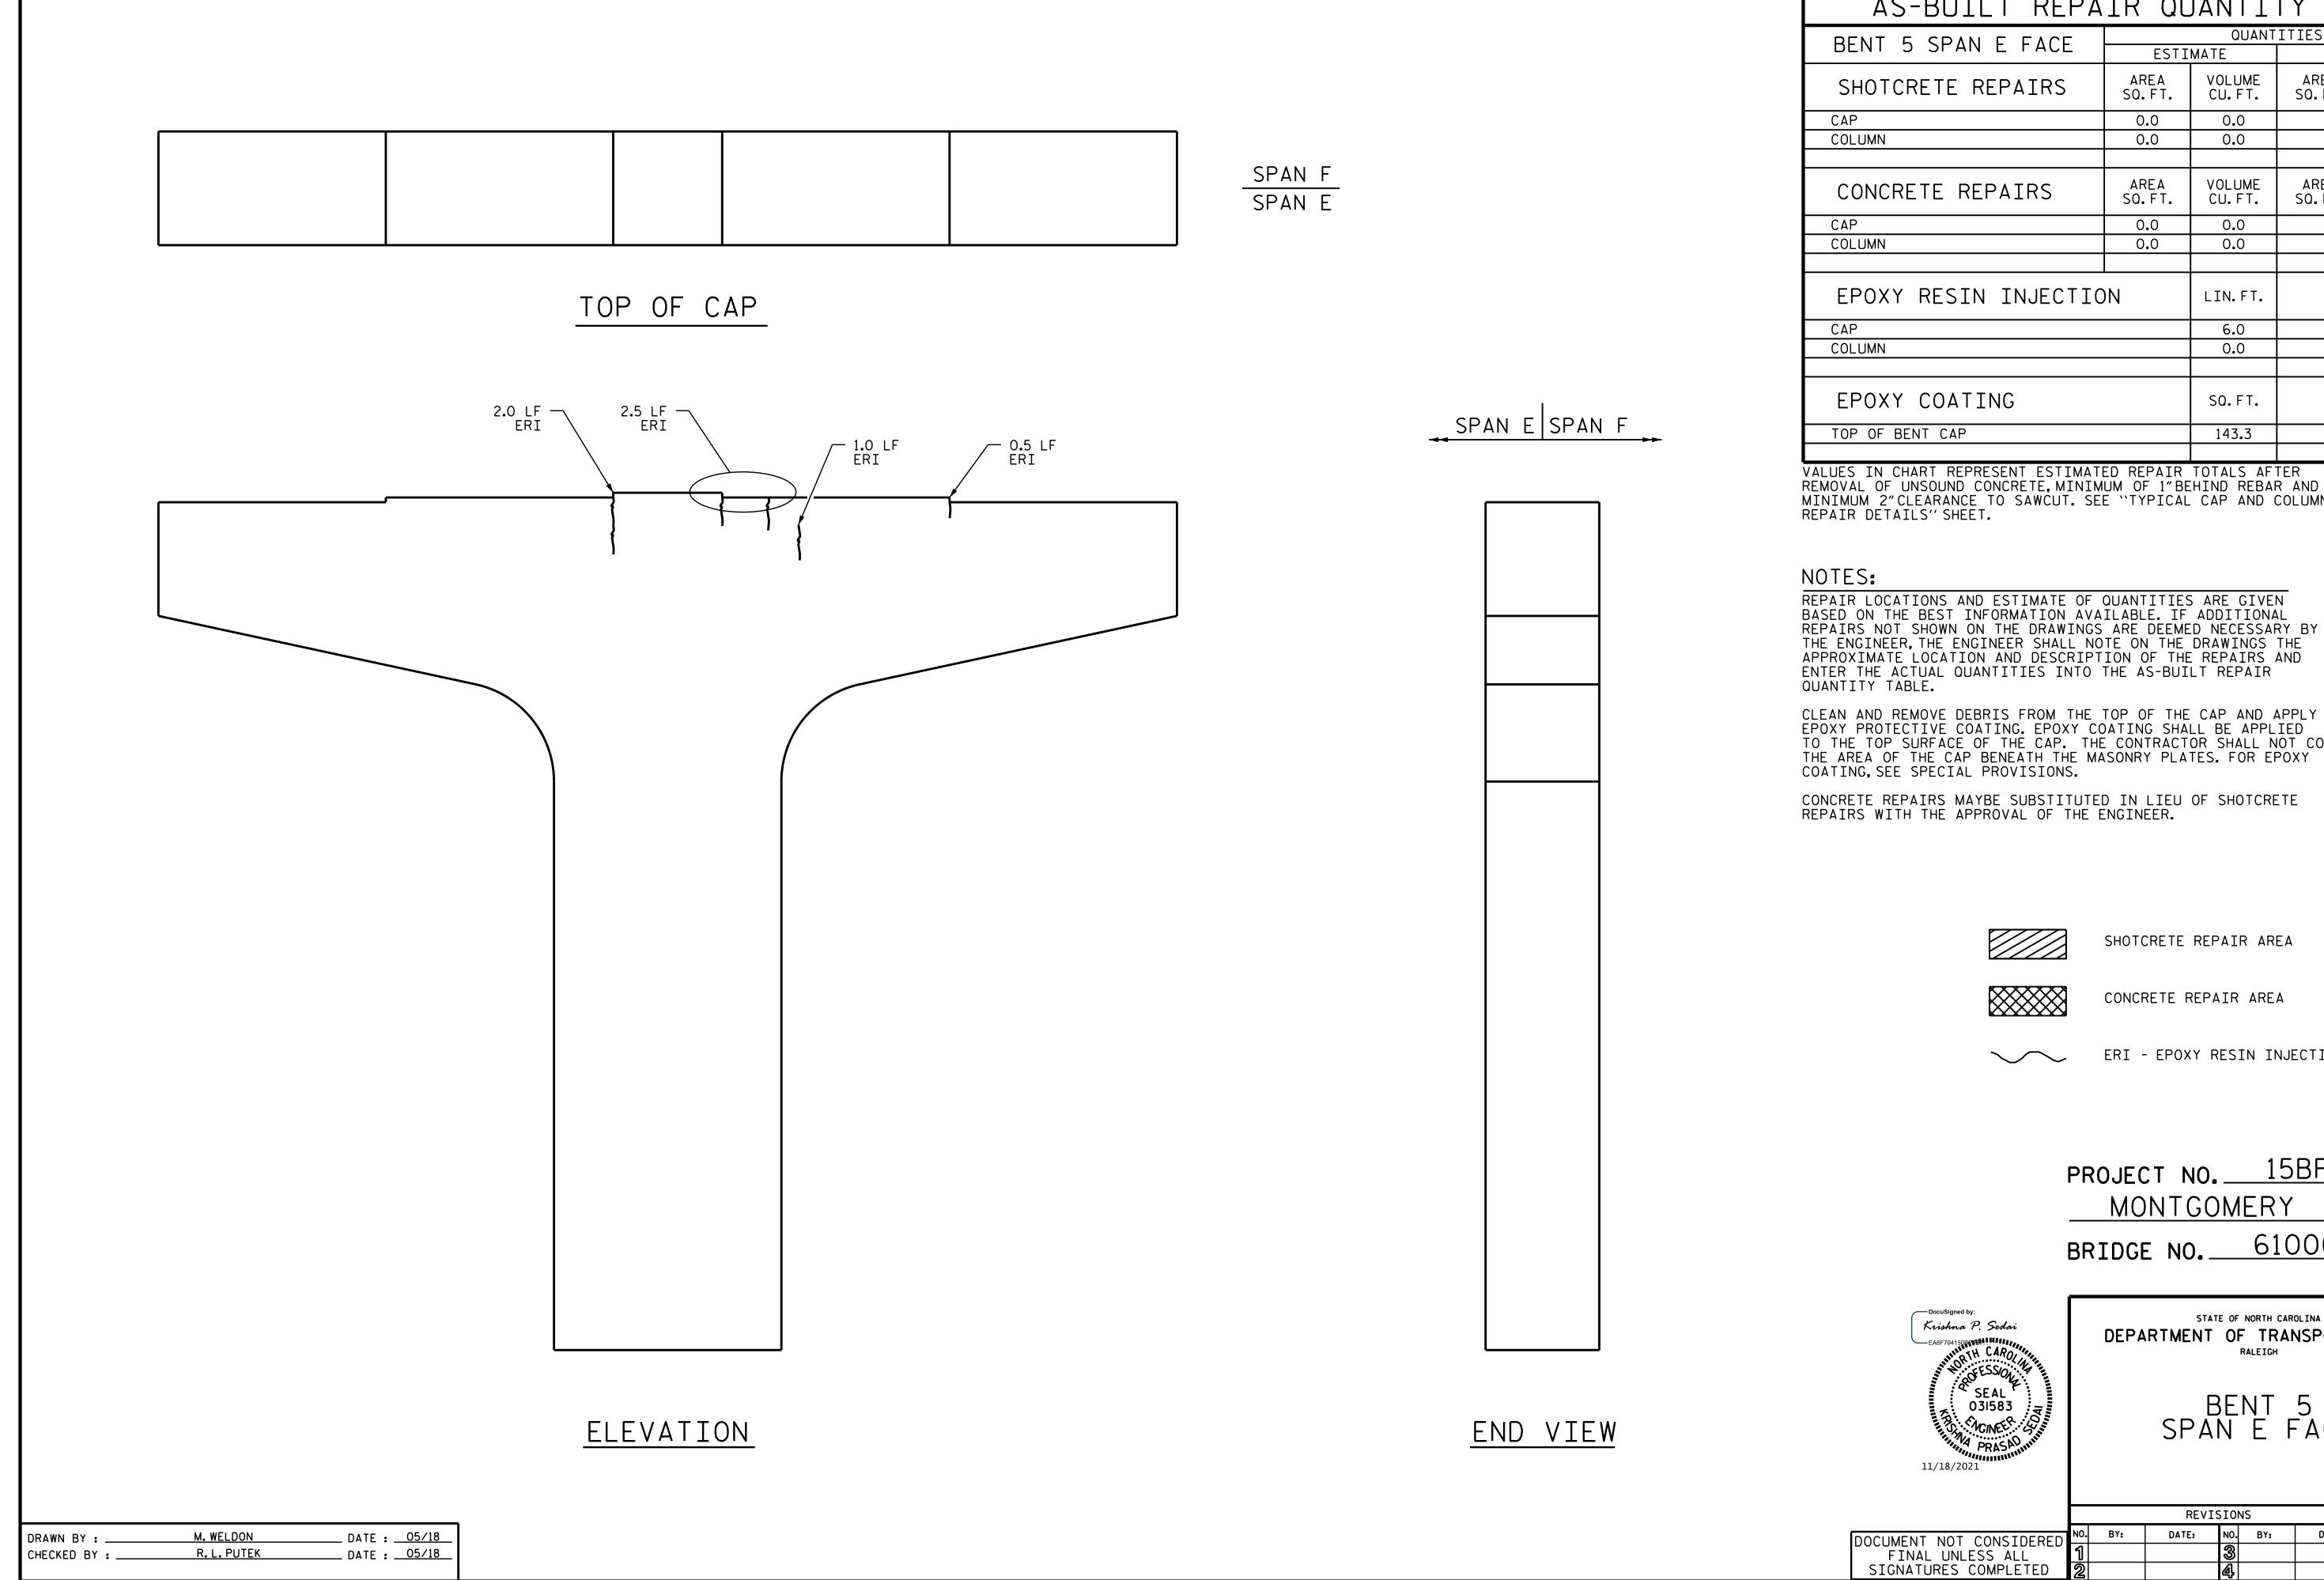
REMOVAL OF UNSOUND CONCRETE, MINIMUM OF 1"BEHIND REBAR AND MINIMUM 2"CLEARANCE TO SAWCUT. SEE "TYPICAL CAP AND COLUMN

EPOXY PROTECTIVE COATING. EPOXY COATING SHALL BE APPLIED TO THE TOP SURFACE OF THE CAP. THE CONTRACTOR SHALL NOT COAT THE AREA OF THE CAP BENEATH THE MASONRY PLATES. FOR EPOXY COATING, SEE SPECIAL PROVISIONS.

CONCRETE REPAIRS MAYBE SUBSTITUTED IN LIEU OF SHOTCRETE
