PROJECT NO. 15BPR.55 FORSYTH COUNTY BRIDGE NO. 330392

SHEET 2 OF 2

DEPARTMENT OF TRANSPORTATION
RALEIGH SUBSTRUCTURE REPAIRS BENT 2 SPAN C FACE

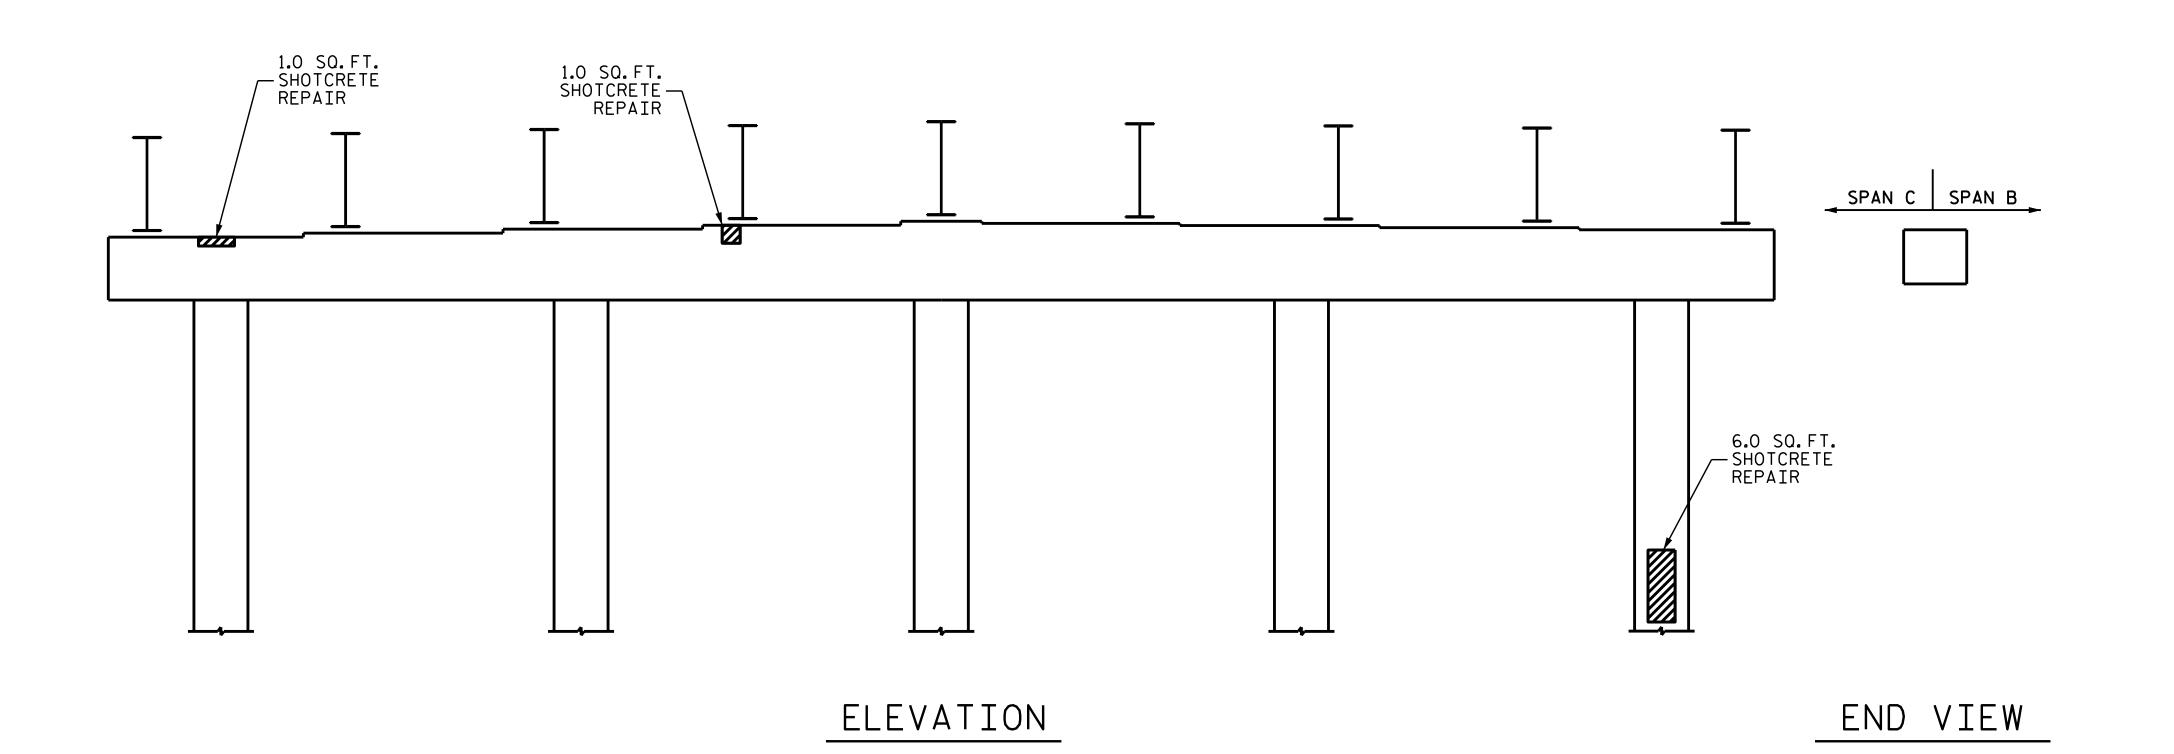
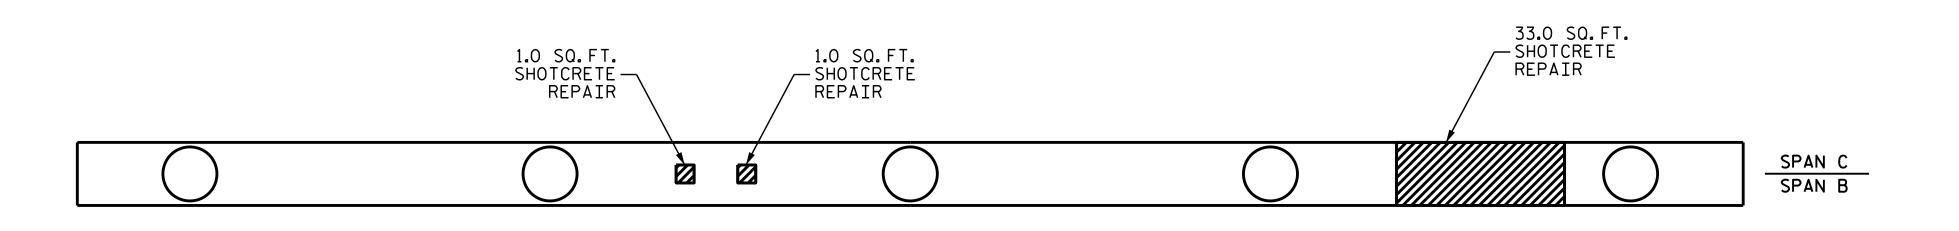
## BOTTOM OF CAP

AS-BUILT REPAIR QUANTITY TABLE										
BENT 2 SPAN C FACE	QUANTITIES									
DENI Z SPAN C PACE	ESTI	MATE	ACTUAL							
SHOTCRETE REPAIRS	AREA SQ.FT.	VOLUME CU.FT.	AREA SQ.FT.	VOLUME CU.FT.						
CAP	37.0	18.5								
COLUMN	6.0	3.0								
CONCRETE REPAIRS	AREA SQ.FT.	VOLUME CU.FT.	AREA SQ.FT.	VOLUME CU.FT.						
CAP	0.0	0.0								
COLUMN	0.0	0.0								
EPOXY RESIN INJECTION		LIN.FT.	LIN.FT.							
CAP	0.0									
COLUMN		0.0								
EPOXY COATING	SQ.FT.	SQ.FT.								
TOP OF BENT CAP	0.0

VALUES IN CHART REPRESENT ESTIMATED REPAIR TOTALS AFTER REMOVAL OF UNSOUND CONCRETE, MINIMUM OF 1"BEHIND REBAR AND MINIMUM 2"CLEARANCE TO SAWCUT. SEE "TYPICAL CAP AND COLUMN REPAIR DETAILS" SHEET.

FOR CONCRETE REPAIRS, SEE SPECIAL PROVISIONS.

FOR CAP REPAIRS, SEE "TYPICAL CAP AND COLUMN REPAIR DETAILS" SHEET.
