PROJECT NO. 15BPR.55 FORSYTH ____ COUNTY BRIDGE NO. 330392

STATE OF NORTH CAROLINA DEPARTMENT OF TRANSPORTATION

SUBSTRUCTURE REPAIR END BENT 2

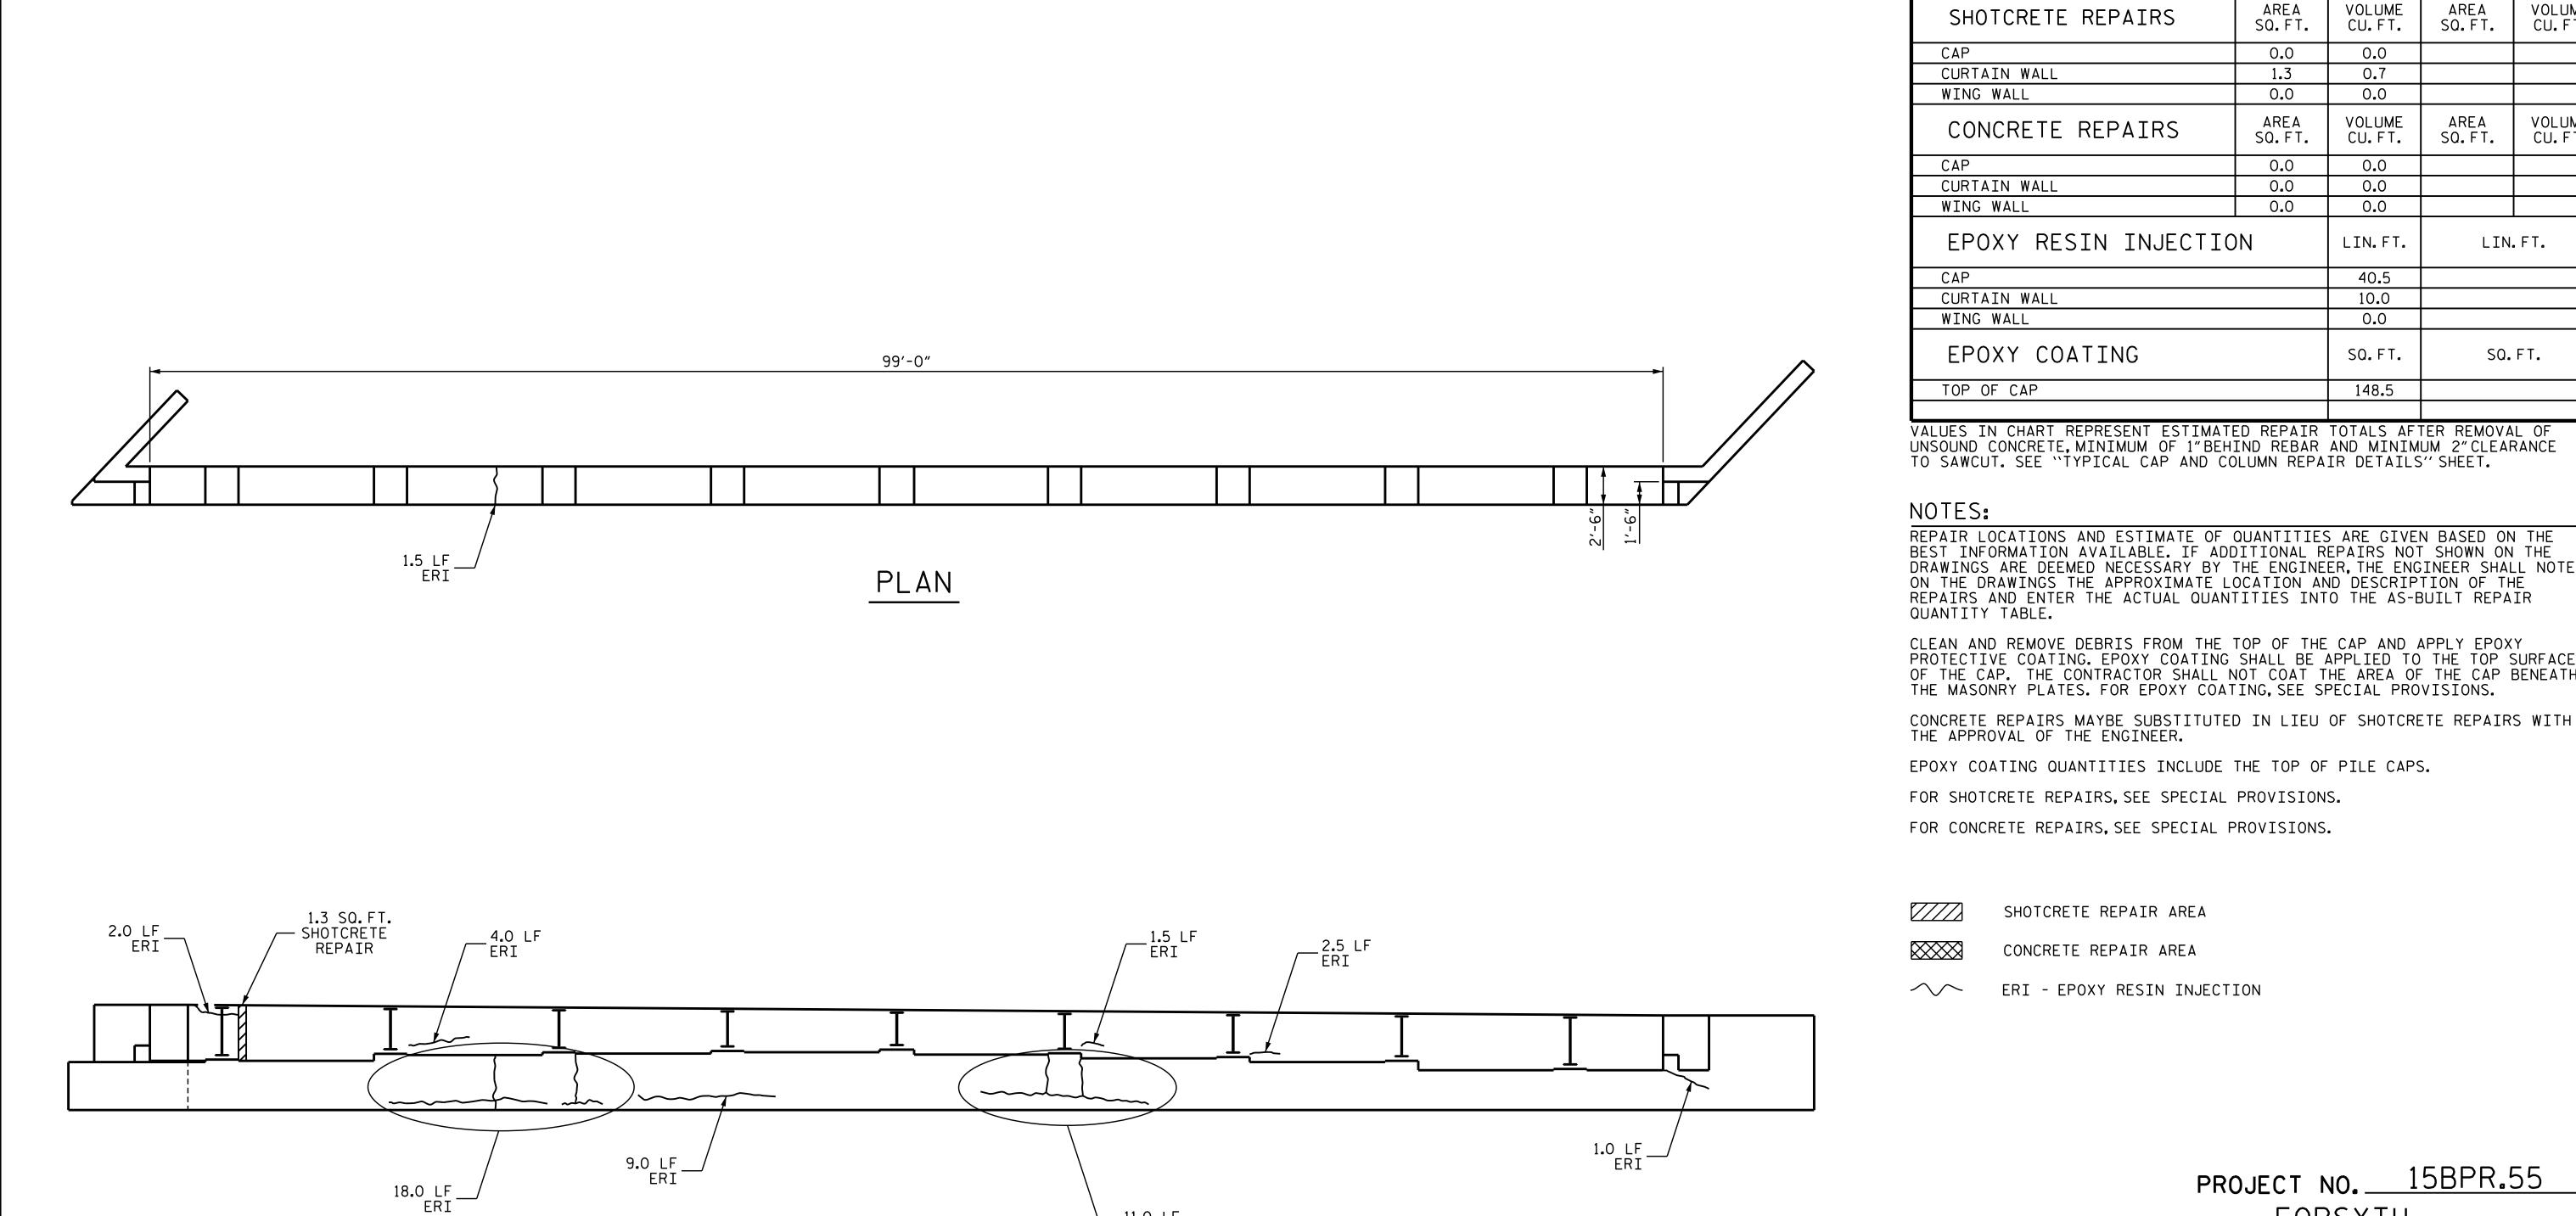
ELEVATION

__11.0 LF __ERI

CLEAN AND REMOVE DEBRIS FROM THE TOP OF THE CAP AND APPLY EPOXY PROTECTIVE COATING. EPOXY COATING SHALL BE APPLIED TO THE TOP SURFACE OF THE CAP. THE CONTRACTOR SHALL NOT COAT THE AREA OF THE CAP BENEATH THE MASONRY PLATES. FOR EPOXY COATING, SEE SPECIAL PROVISIONS.
