NC DEPARTMENT OF TRANSPORTATION
 DIVISION OF HIGHWAYS
 STRUCTURE MANAGEMENT UNIT

ATTENTION: **PRIORITY ACTION REQUEST, TYPICAL SECTION SKETCH REVISED, UNDERCLEARANCE SKETCHES REVISED**

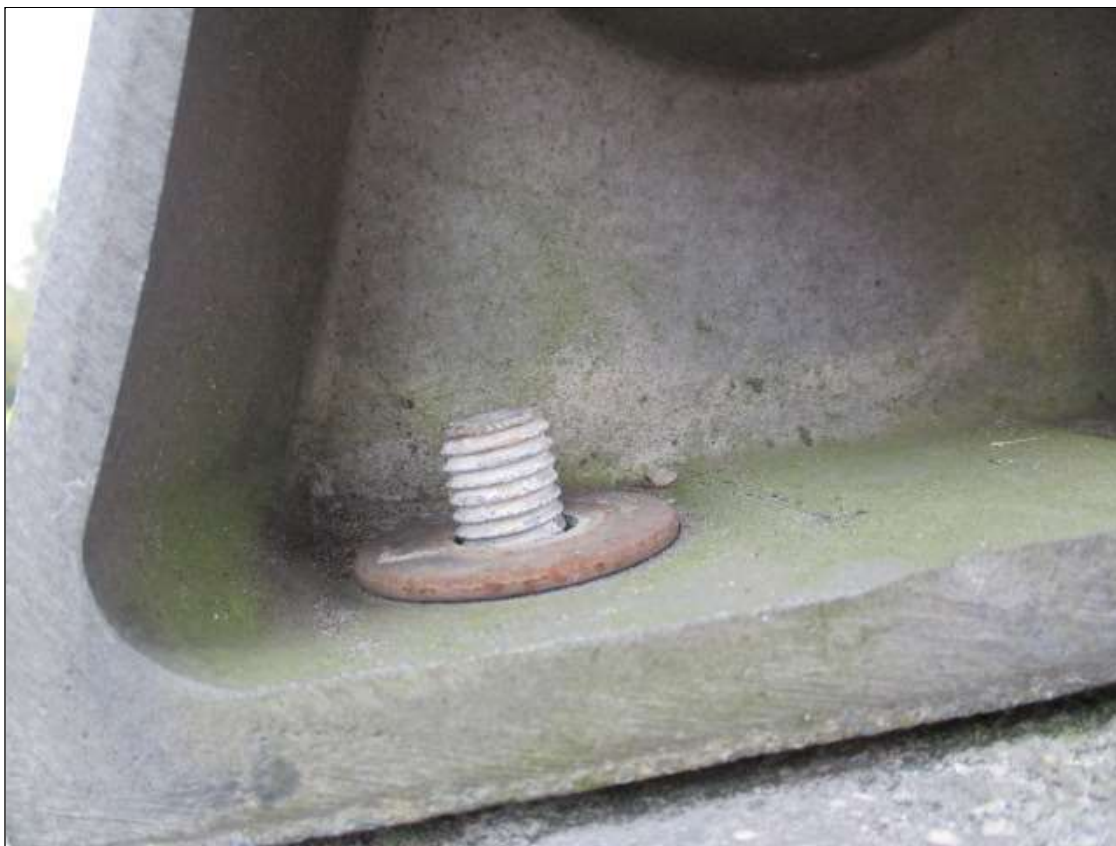
Span 2 Right Bridge Rail: PAR: MISSING BOLT NUT ON LAST POST IN SPAN

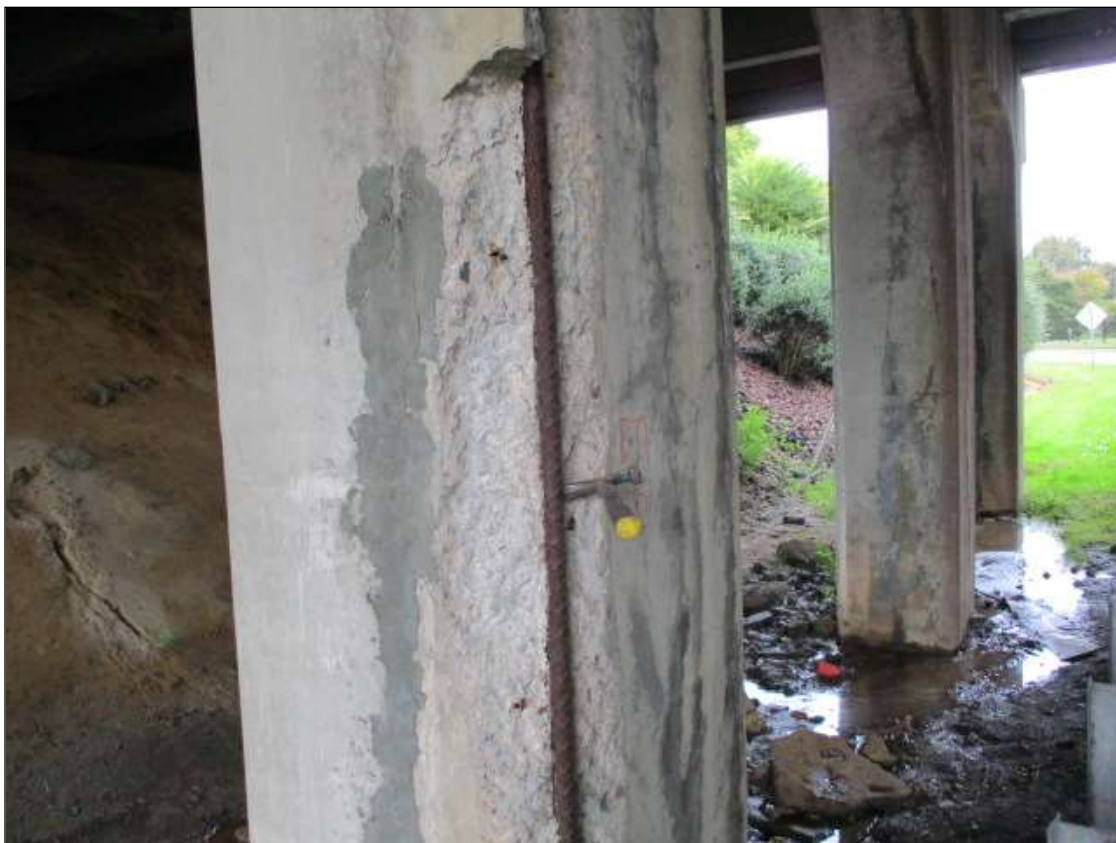
Bent 1 Pile 3: PAR: 9' X 8" X 8" SPALL WITH EXPOSED REBAR WITH SECTION LOSS ON SOUTHEAST CORNER

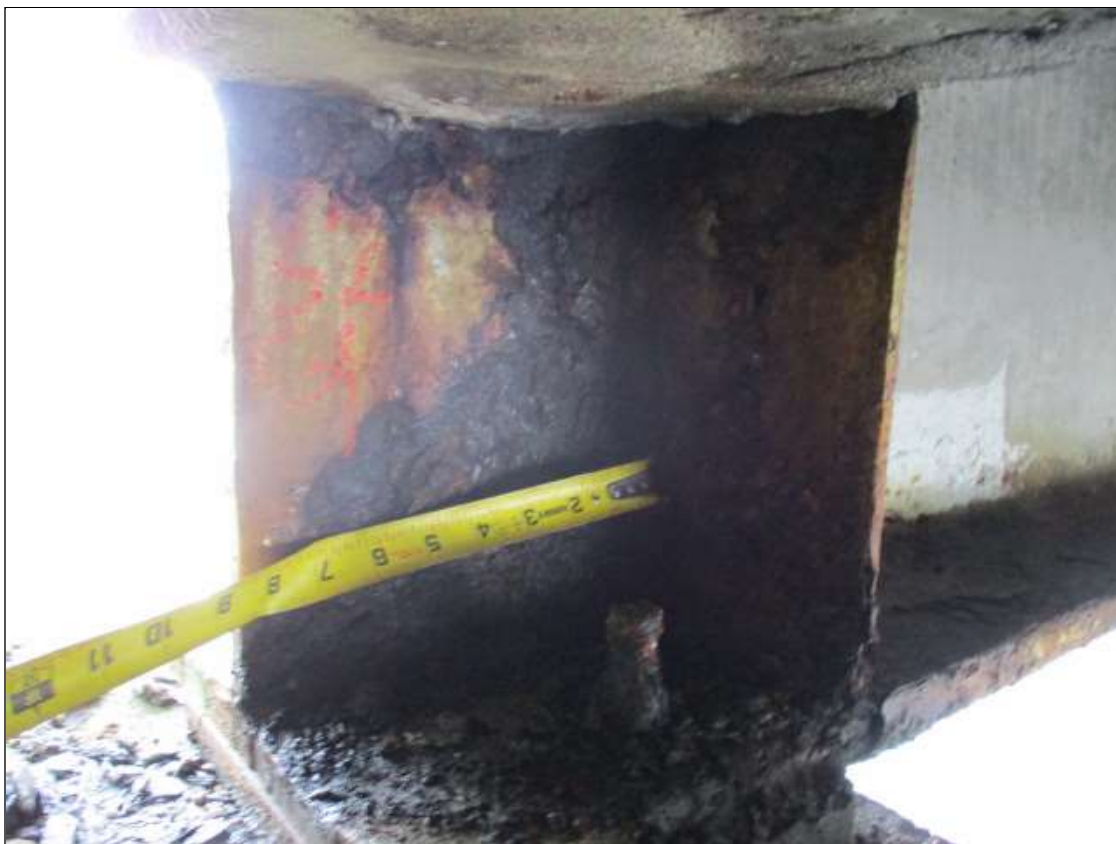
Span 2 Beam 1: PAR: 3/8" REMAINING (1/4" SECTION LOSS) ON FULL HEIGHT OF WEB UNDER DIAPHRAGM FOR 8" LONG AT BENT 1

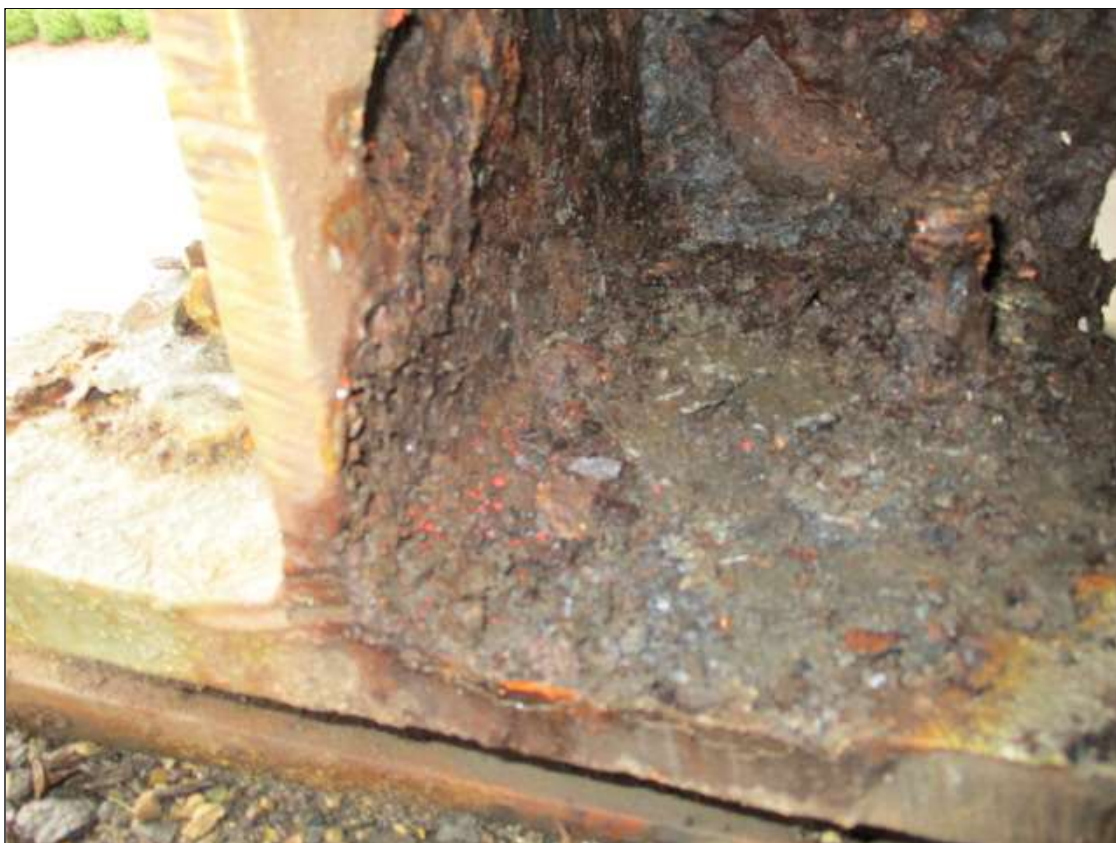
Span 2 Beam 1 - Beam 1 Near Bearing: PAR: MISSING RIGHT ANCHOR BOLT NUT

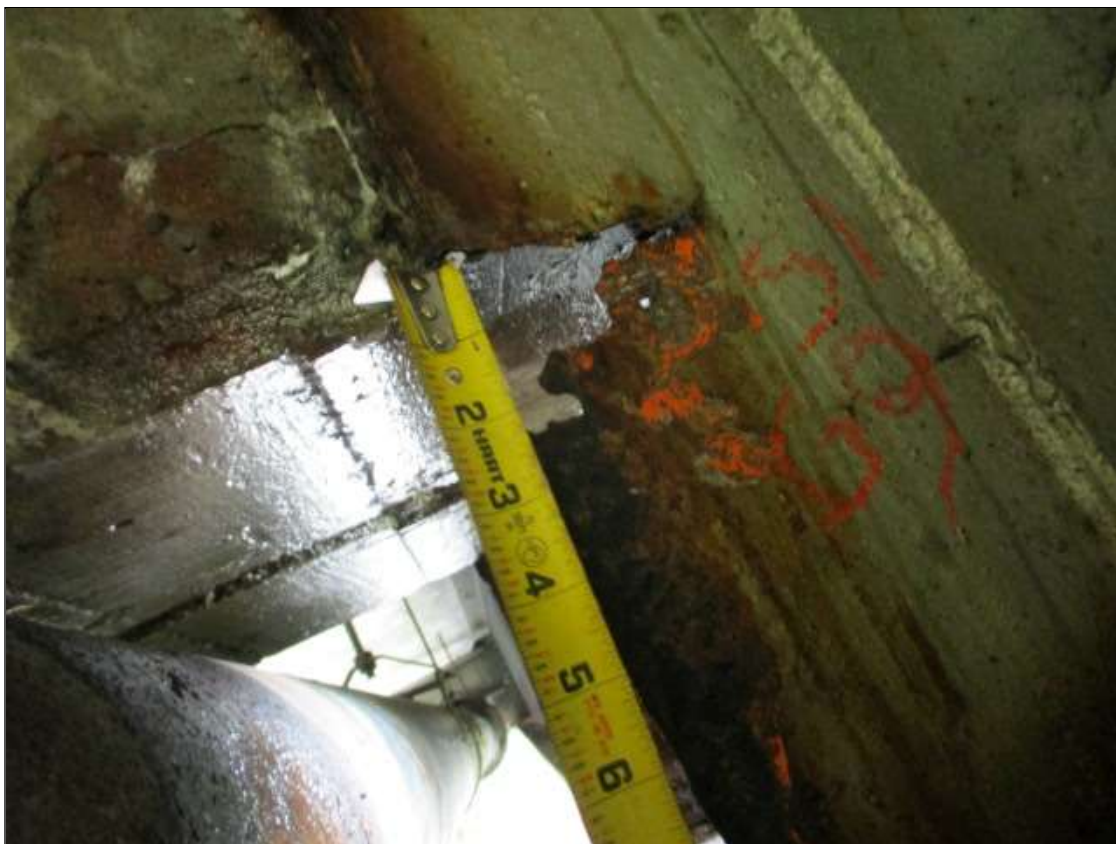
Span 1 Beam 9: PAR: 2 1/2" X 3 1/2" HOLE IN LEFT STIFFENER AT DIAPHRAGM AT BENT 1

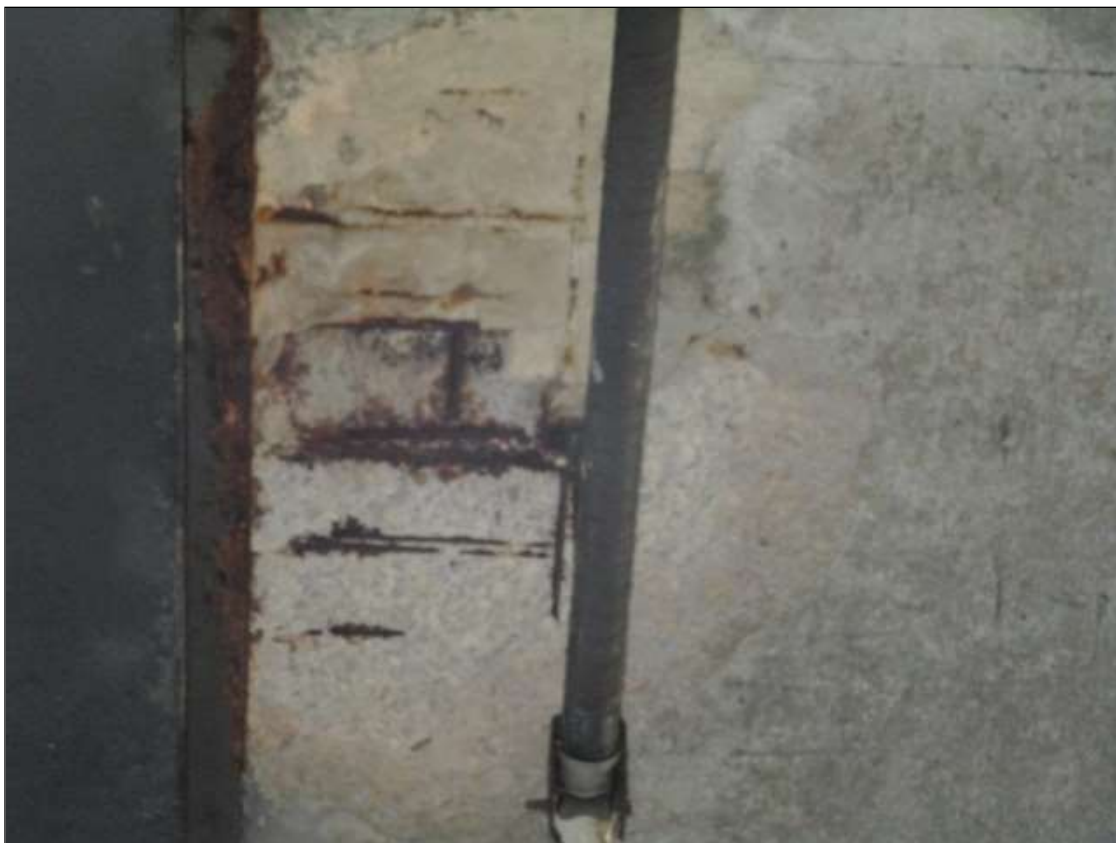
Span 2 Deck: PAR: 3' DIAMETER X 2" DEEP SPALL WITH EXPOSED REBAR WITH SECTION LOSS IN BAY 1 AT 2ND UTILITY HANGER

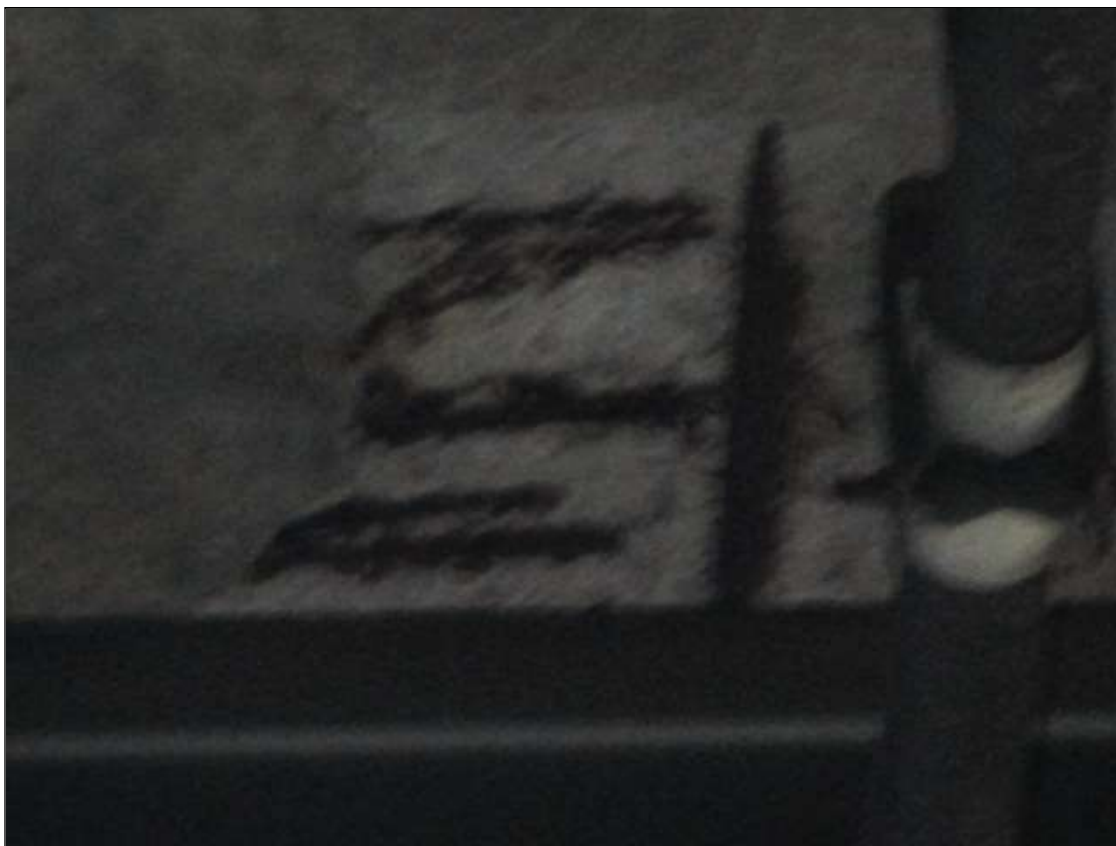
Span 2 Deck: PAR: 18" X 12" X 2" DEEP SPALL WITH EXPOSED REBAR WITH SECTION LOSS IN BAY 1 OVER FIRST DIAPHRAGM

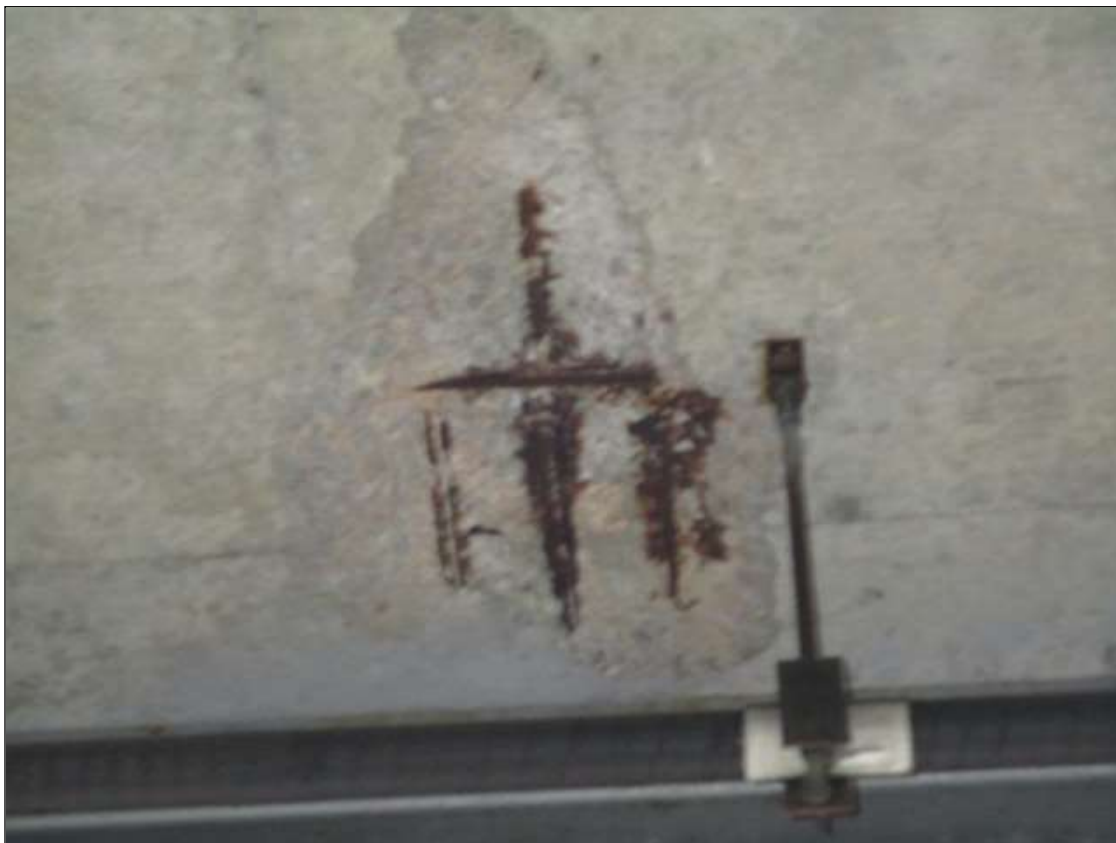
Span 2 Deck: PAR: 30" X 20" X 2" DEEP SPALL WITH EXPOSED REBAR WITH SECTION LOSS IN BAY 1 AT 5TH UTILITY HANGER

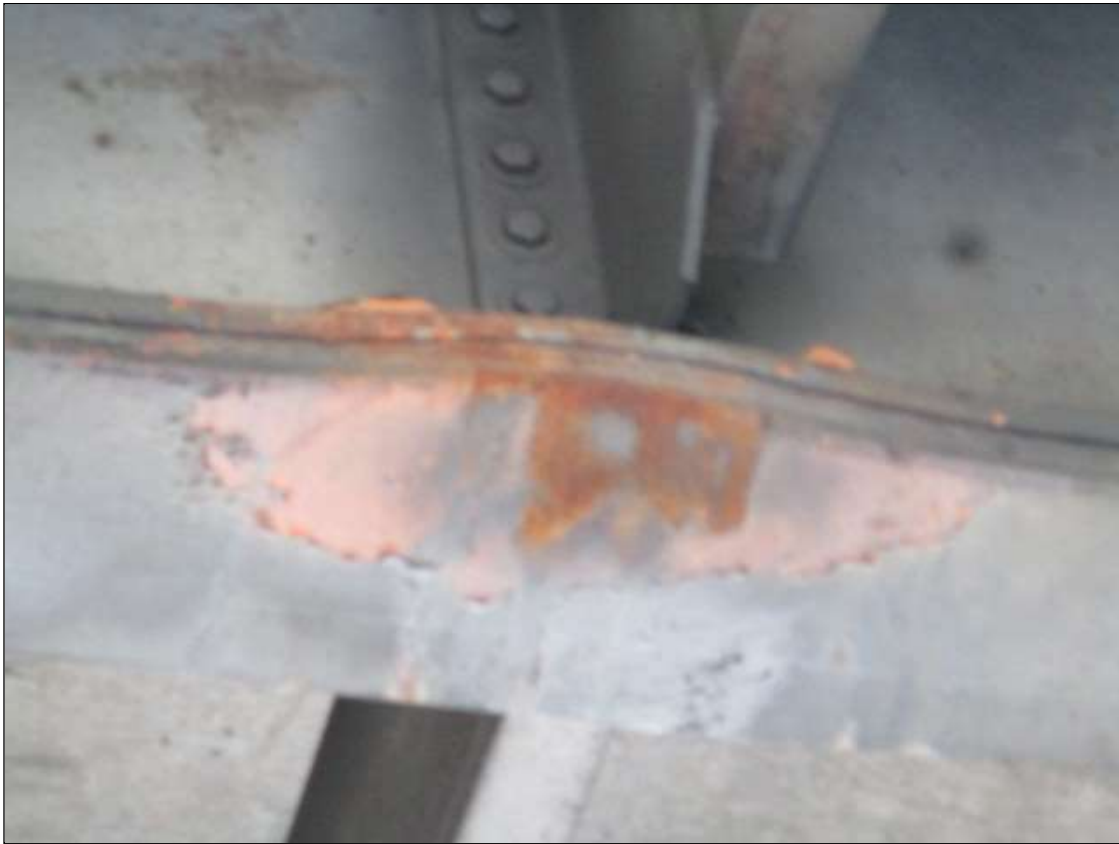
Span 2 Beam 4: PAR: at 22ft-11in from bent 1 bearing, impact damage - bottom flange bent upward 2-1/2in with lower web buckled [up to 1-1/2in] and gouge in cover plate [1/8in deep]

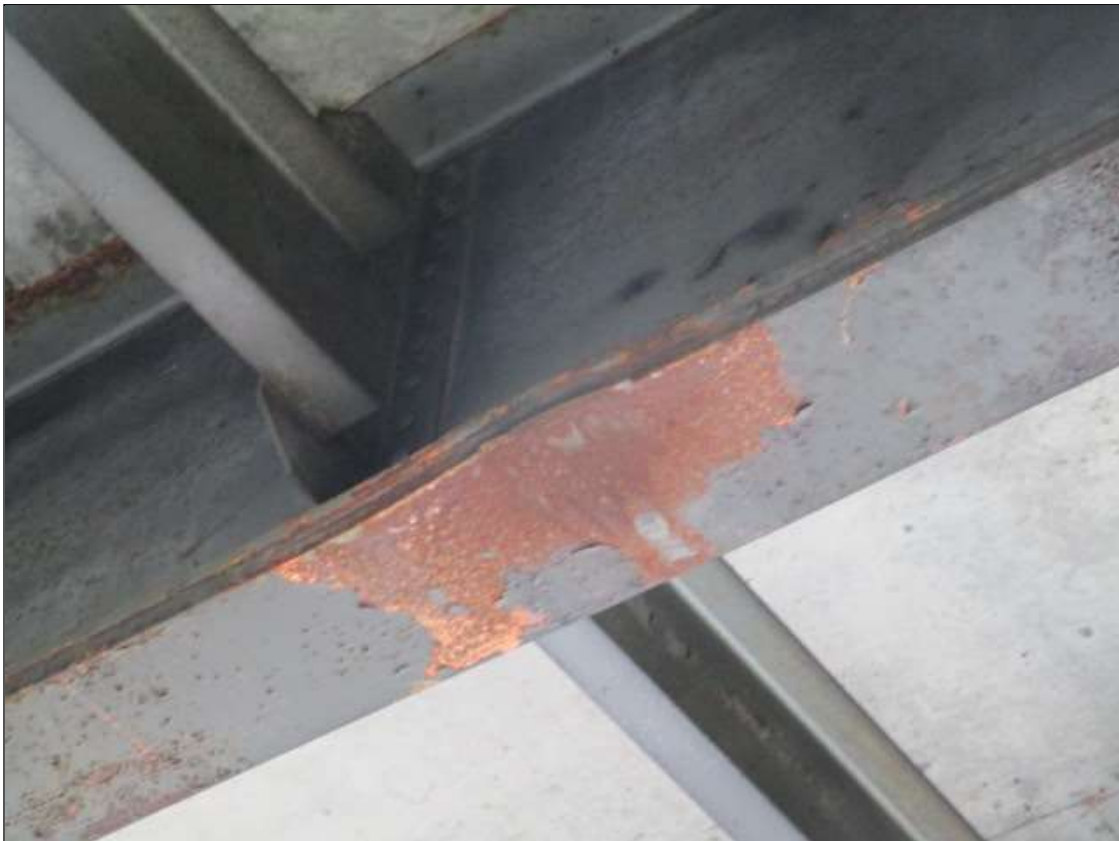
Span 2 Beam 7: PAR: at 21ft-7in from Bent 1 bearing, impact damage - bottom flange bent upward 2-1/8in, web bent 1-1/4in with gouge in bottom flange [1/8in deep], diaphragm 12in east of impact bent at bottom bolts

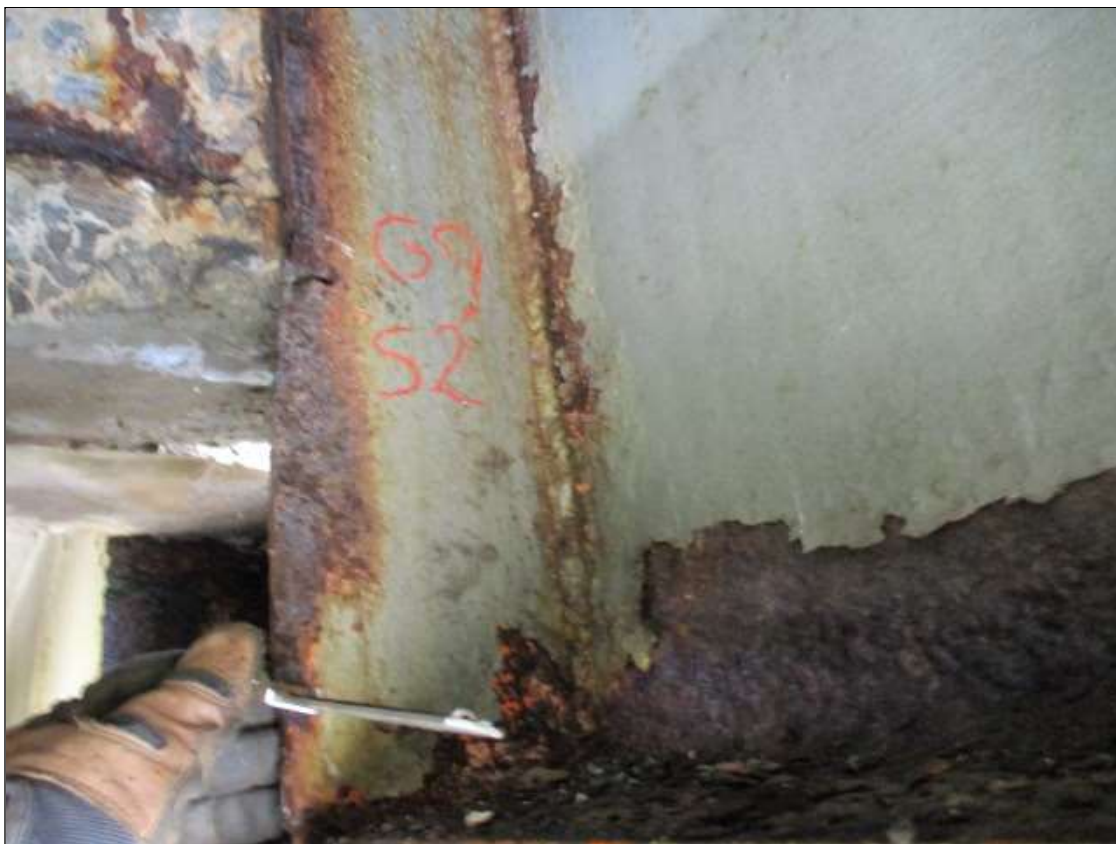
Span 2 Beam 9: PAR: 3/4" X 3/4" HOLE IN LEFT STIFFENER AT DIAPHRAGM AT BENT 2

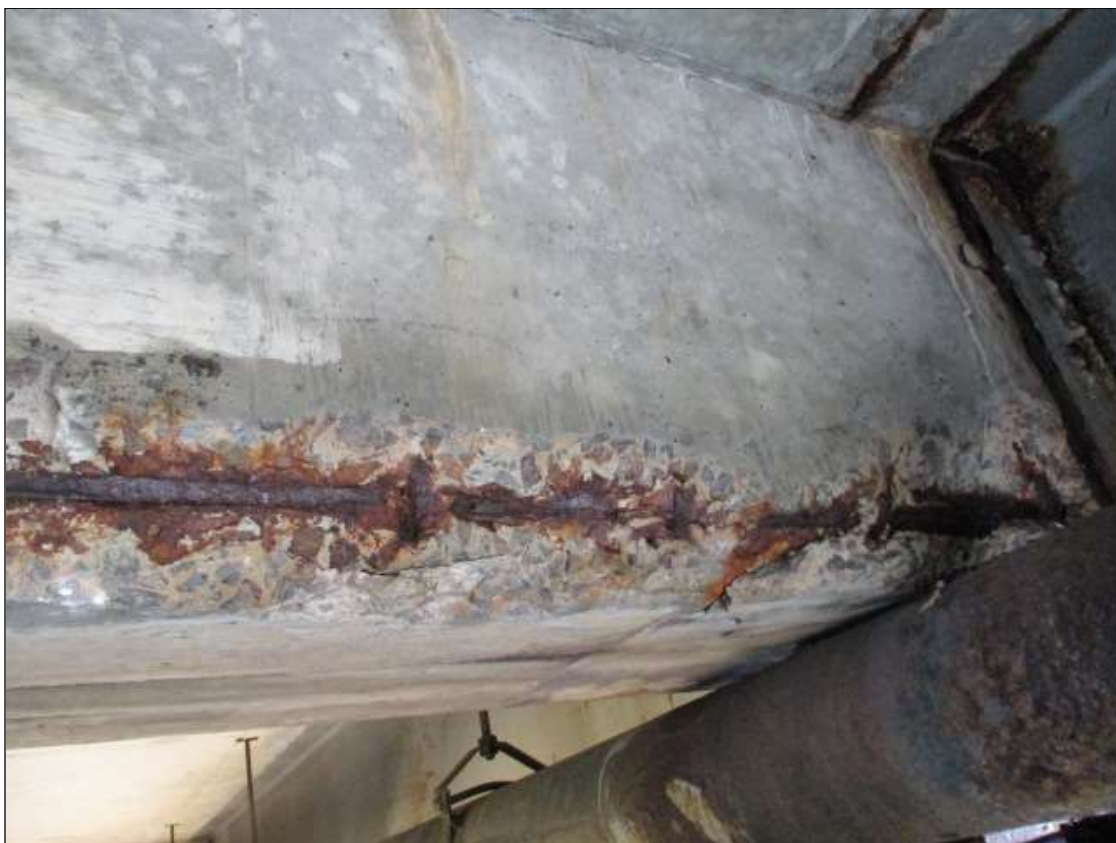
Span 2 Deck: PAR: 5' X 8" X 5" SPALL WITH EXPOSED REBAR WITH SECTION LOSS IN BAY 8 DIAPHRAGM OVER BENT 2

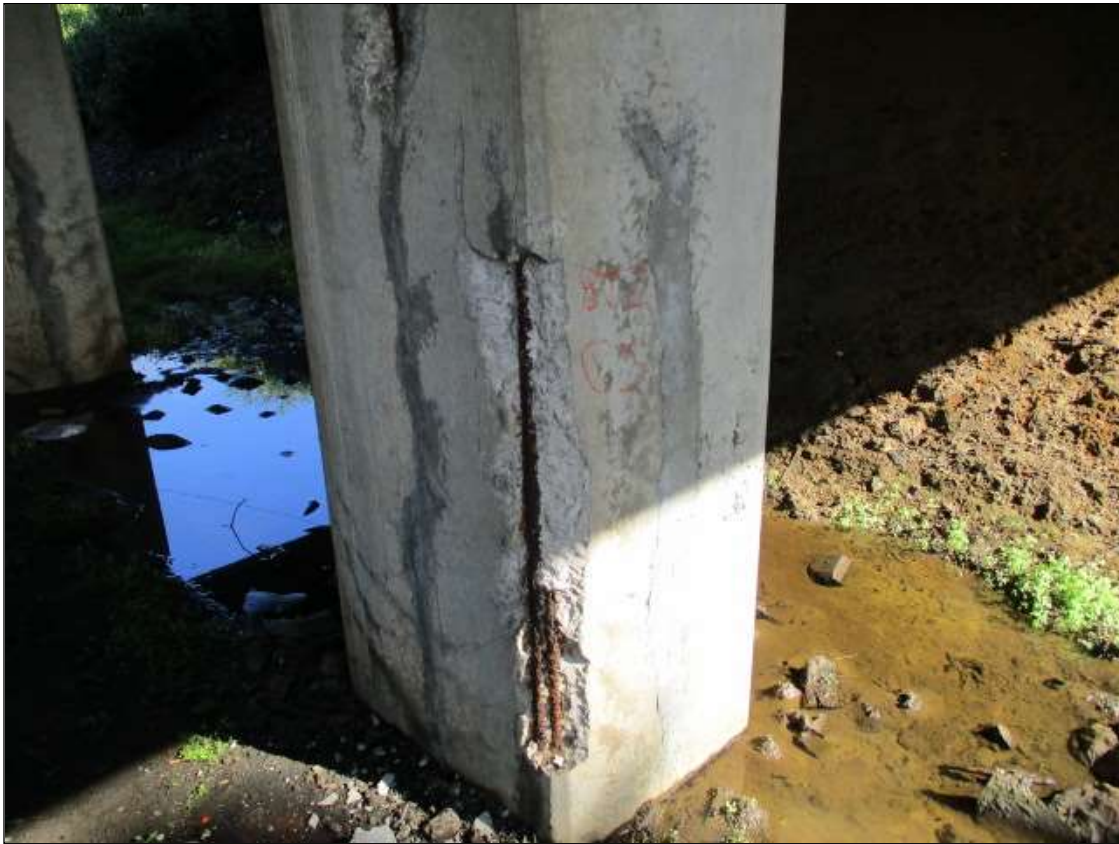
Bent 2 Pile 3: PAR: 4' X 8" X 6" SPALL WITH EXPOSED REBAR WITH SECTION LOSS ON SOUTHWEST CORNER

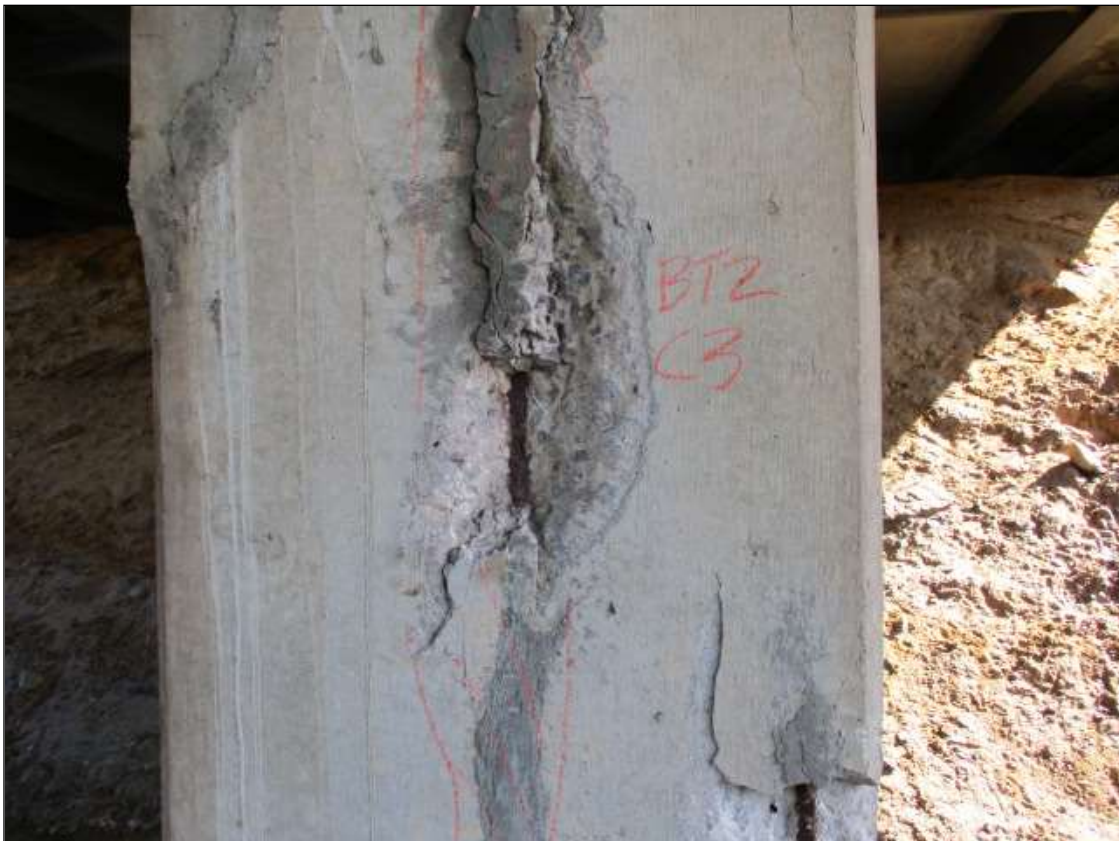
Bent 2 Pile 3: PAR: 30" X 11" X 2 1/2" SPALL WITH EXPOSED REBAR WITH SECTION LOSS ON WEST FACE

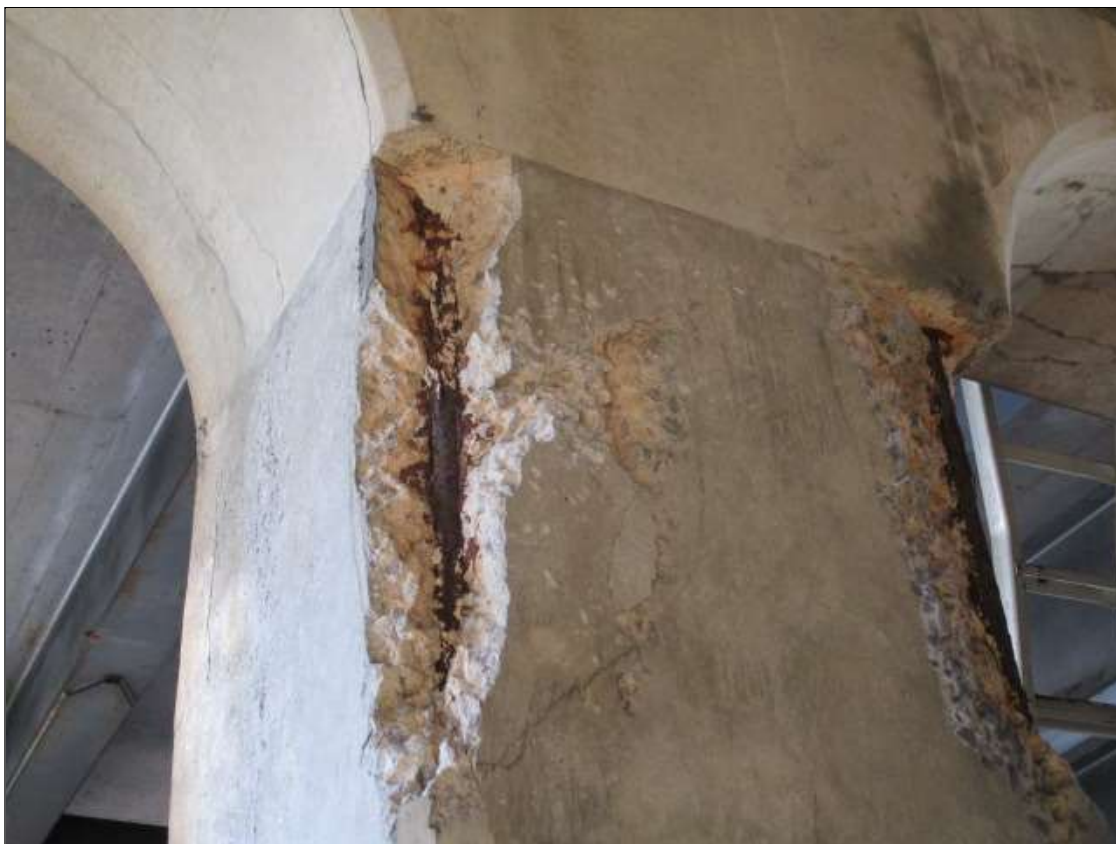
Bent 2 Pile 3: PAR: 3' X 6" X 6" SPALL WITH EXPOSED REBAR WITH SECTION LOSS ON SOUTHEAST CORNER

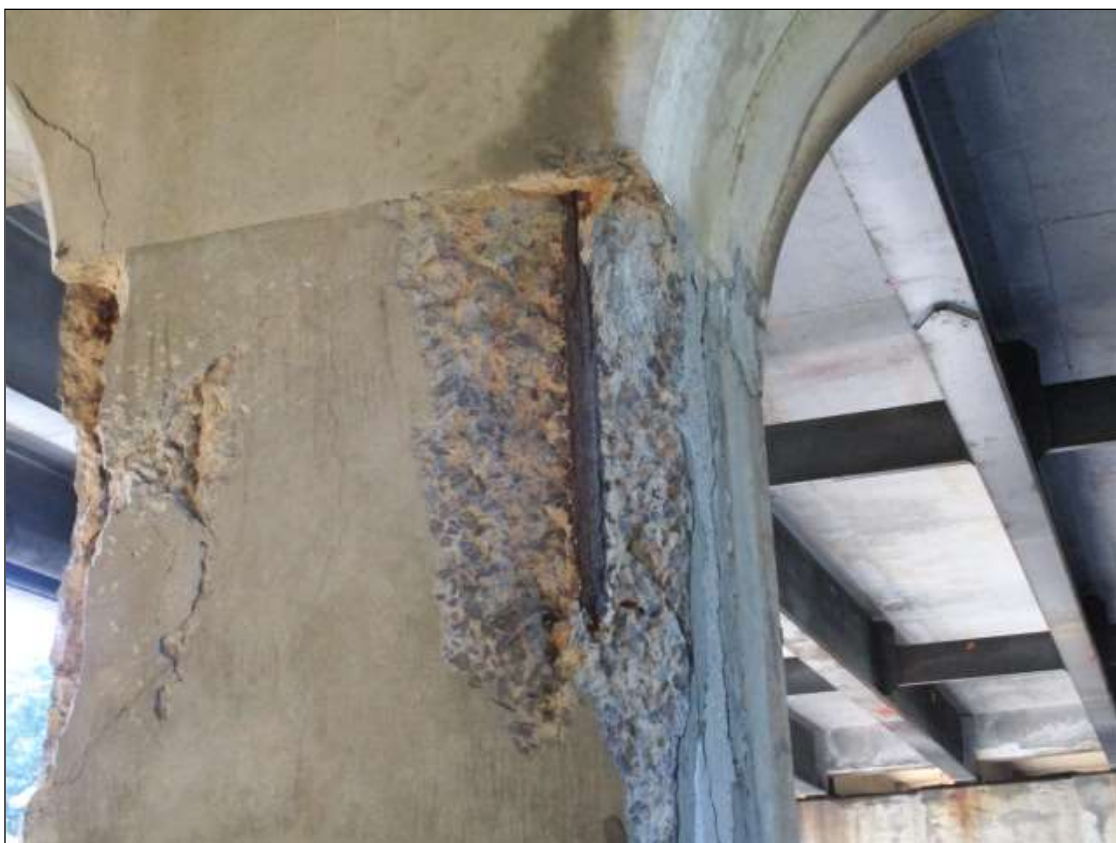
Bent 2 Pile 3: PAR: 3' X 15" X 12" SPALL WITH EXPOSED REBAR WITH SECTION LOSS ON NORTHEAST CORNER

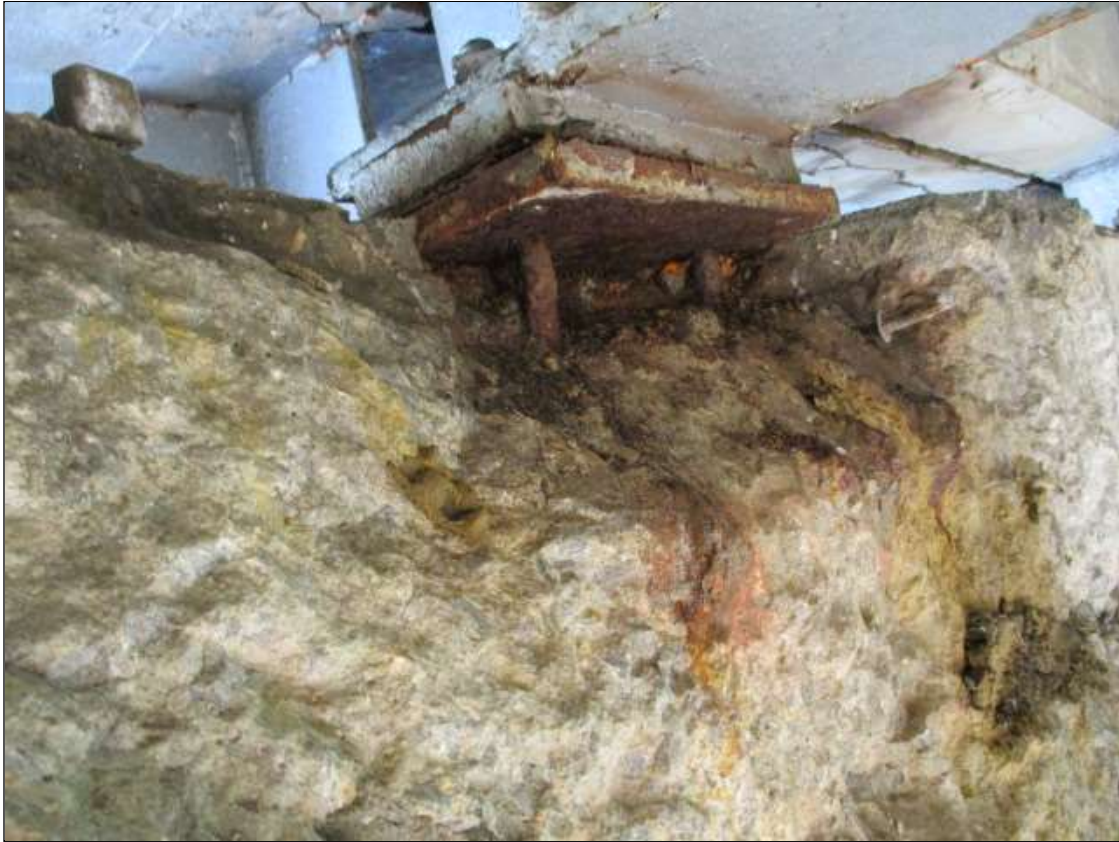
Bent 2 Cap 1: PAR: 51" X 18" X 11" DEEP SPALL WITH EXPOSED REBAR WITH SECTION LOSS UNDER GIRDER
7 SPAN 3 WITH UP TO 6.5" DEEP LOSS OF BEARING

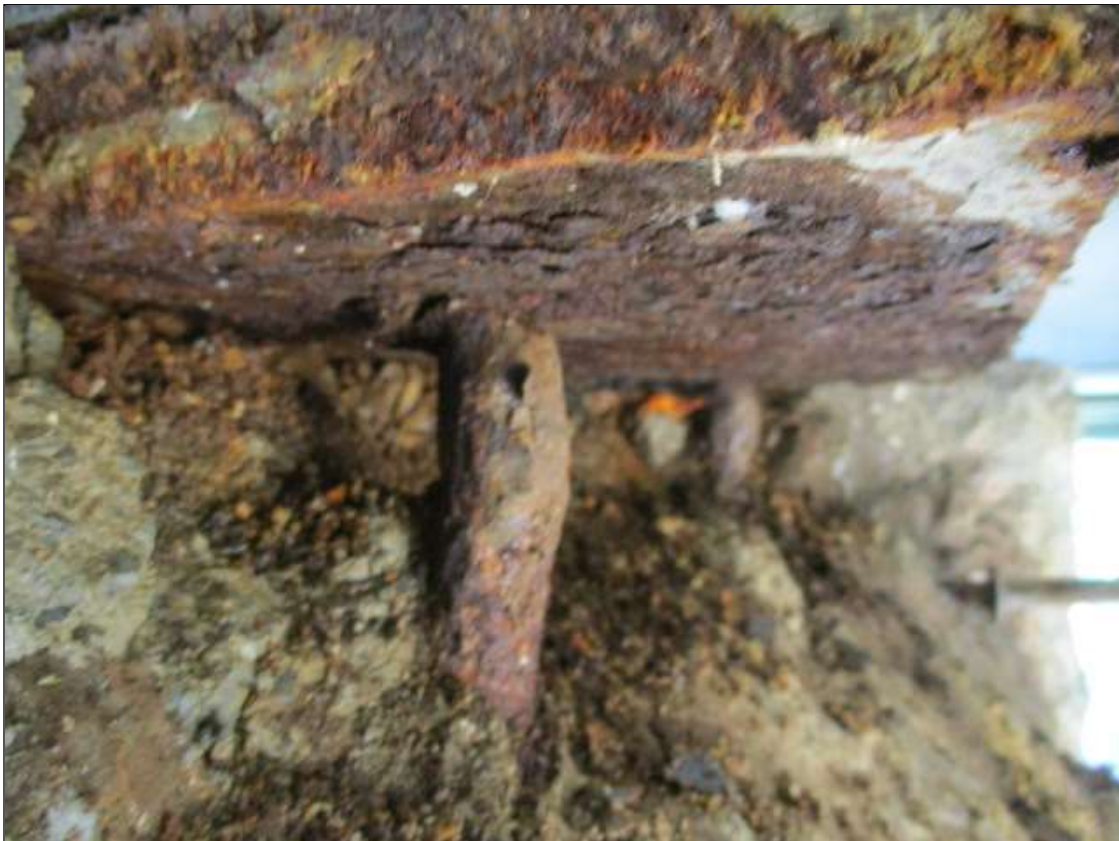
Span 3 Beam 7 - Beam 7 Near Bearing: PAR: SHEARED AND BENT BOLTS FROM BEARING TO CAP DUE TO
LARGE SPALL ON CAP UNDER GIRDER

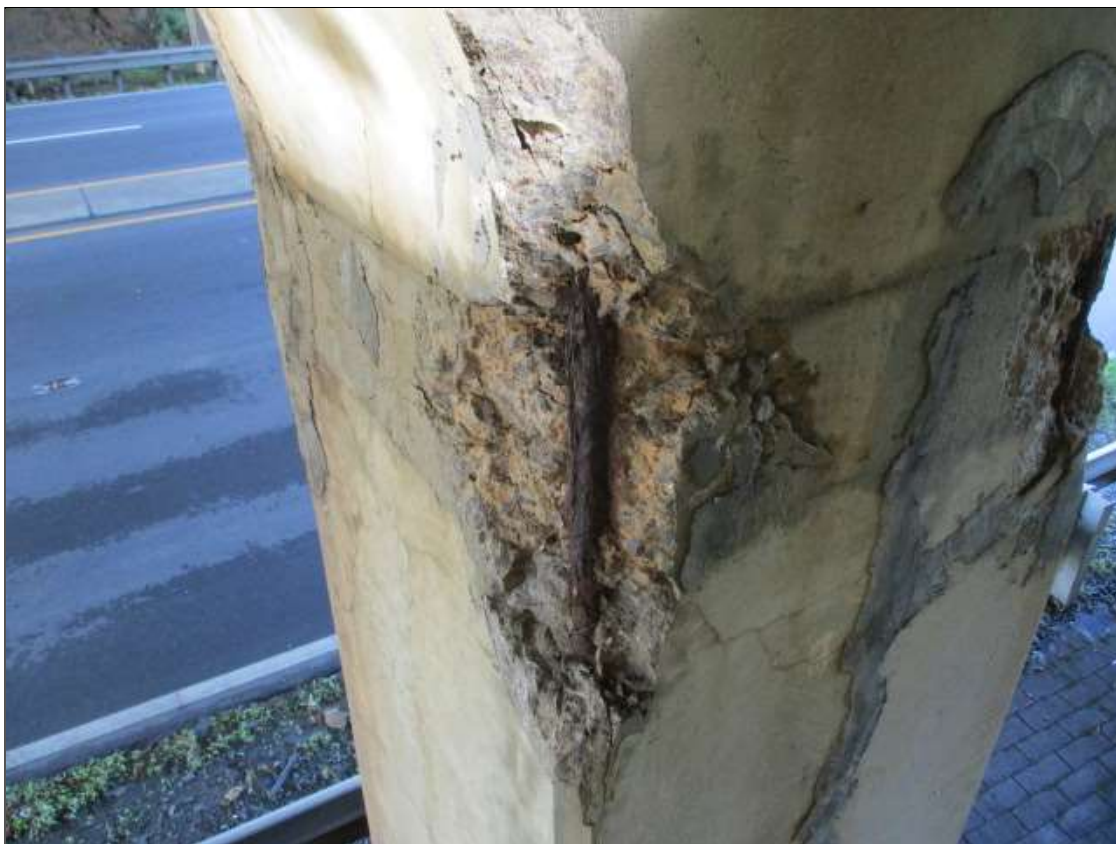
Bent 2 Pile 2: PAR: 3' X 10" X 11" SPALL WITH EXPOSED REBAR WITH SECTION LOSS ON SOUTHEAST CORNER AT TOP

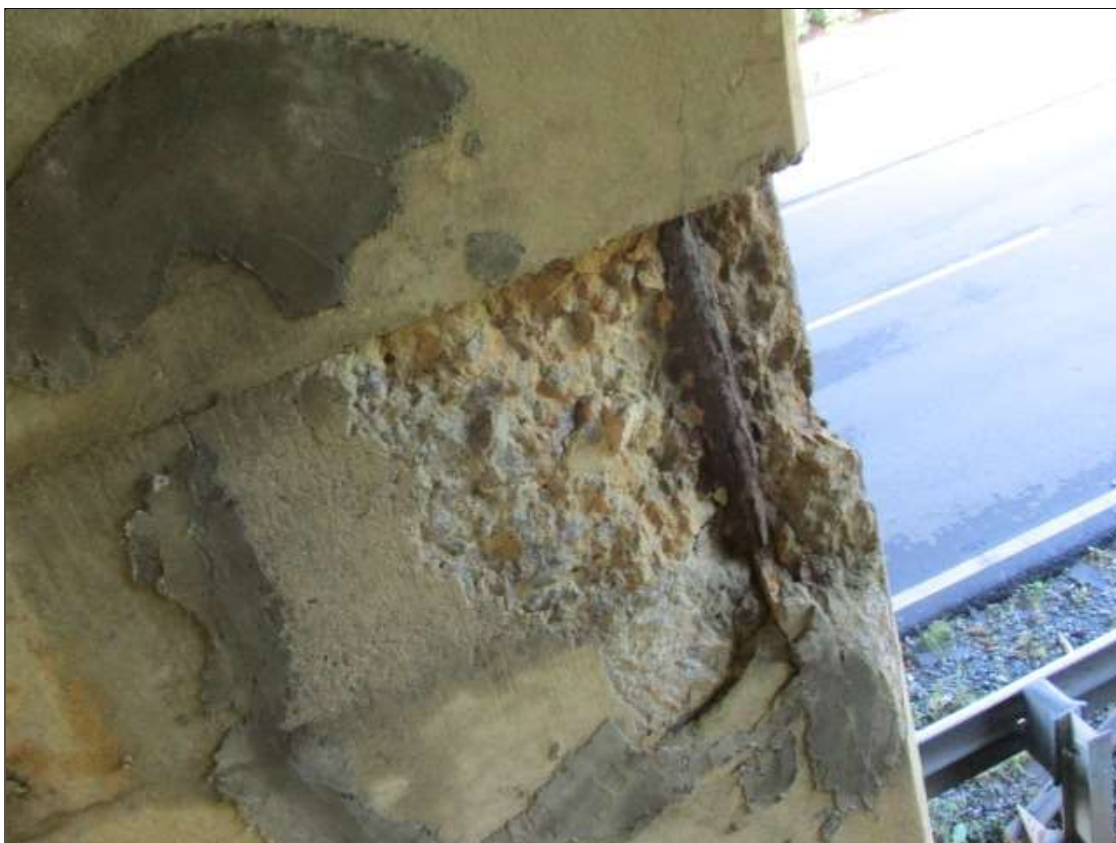
Bent 2 Pile 2: PAR: 16" X 15" X 4" SPALL WITH EXPOSED REBAR WITH SECTION LOSS ON NORTHEAST CORNER AT TOP

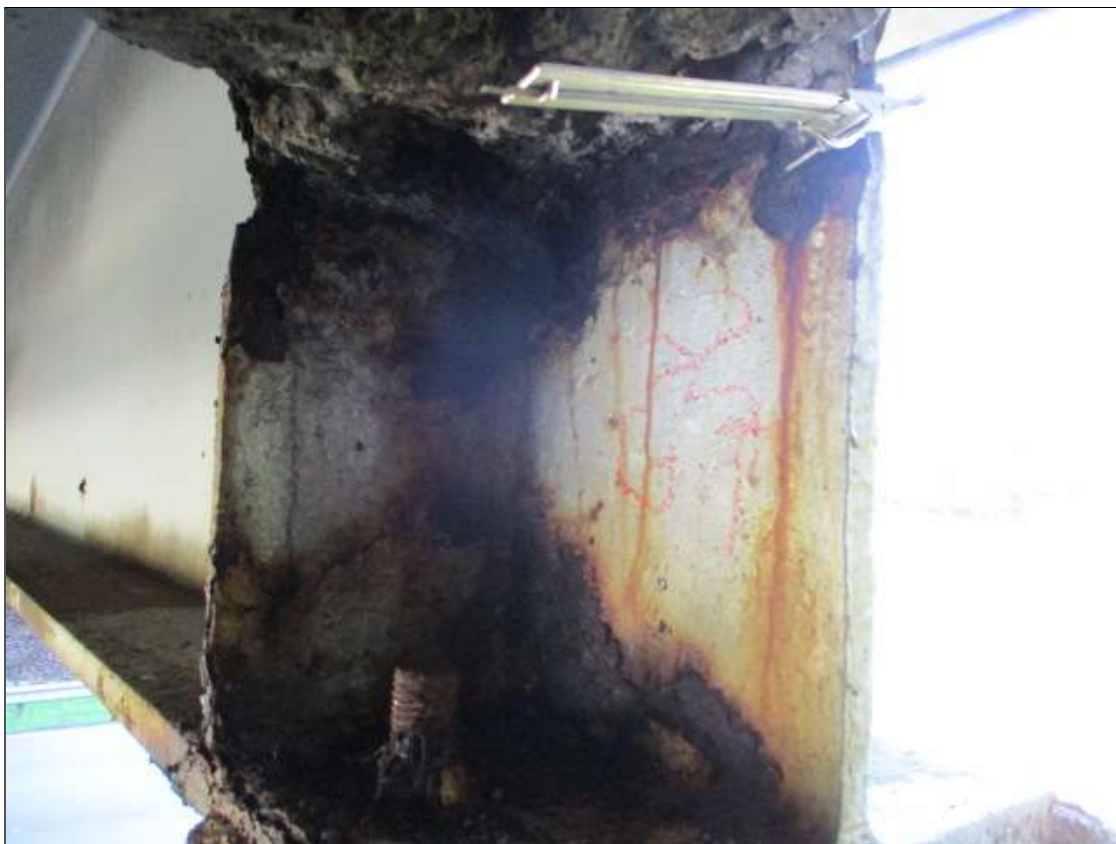
Span 2 Beam 1: PAR: 3/8" REMAINING (1/4" SECTION LOSS) ON TOP 3" OF WEB FOR 8" LONG UNDER DIAPHRAGM AT BENT 2

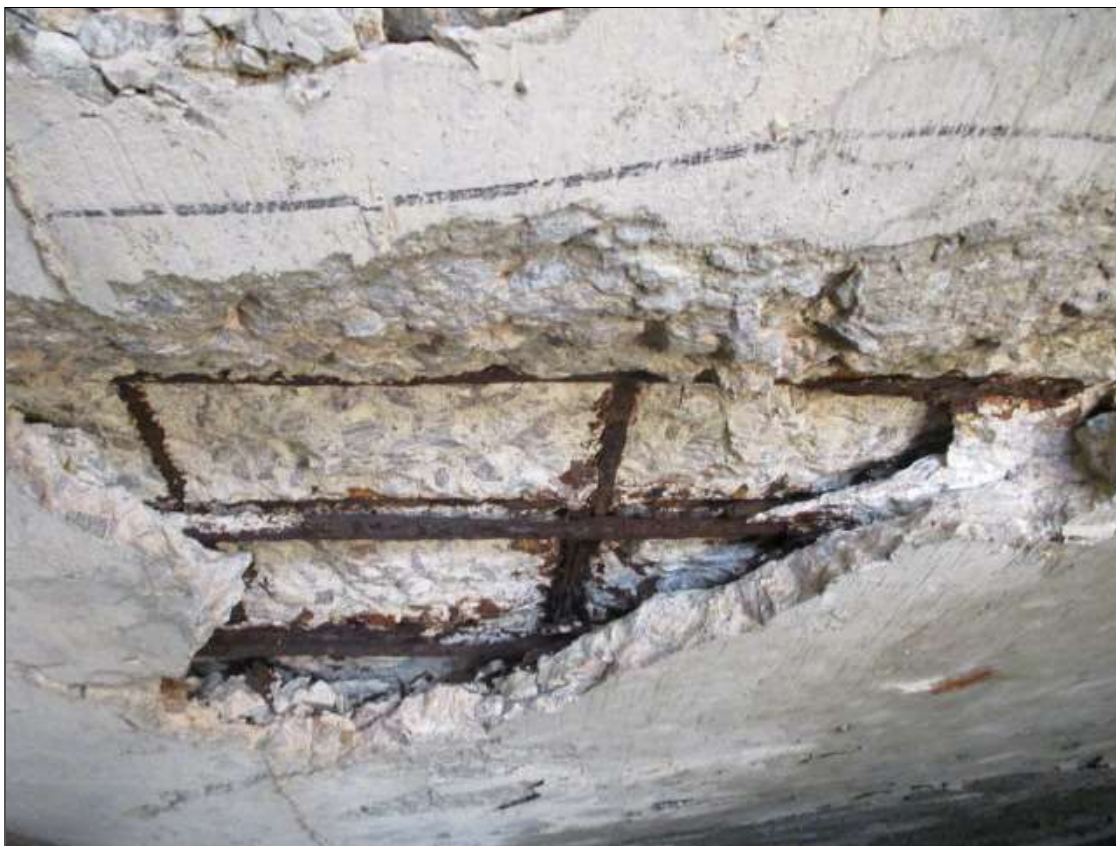
Span 3 Deck: PAR: 30" X 24" X 3" DEEP SPALL WITH EXPOSED REBAR WITH SECTION LOSS IN BAY 8 AT 8' FROM END BENT 2

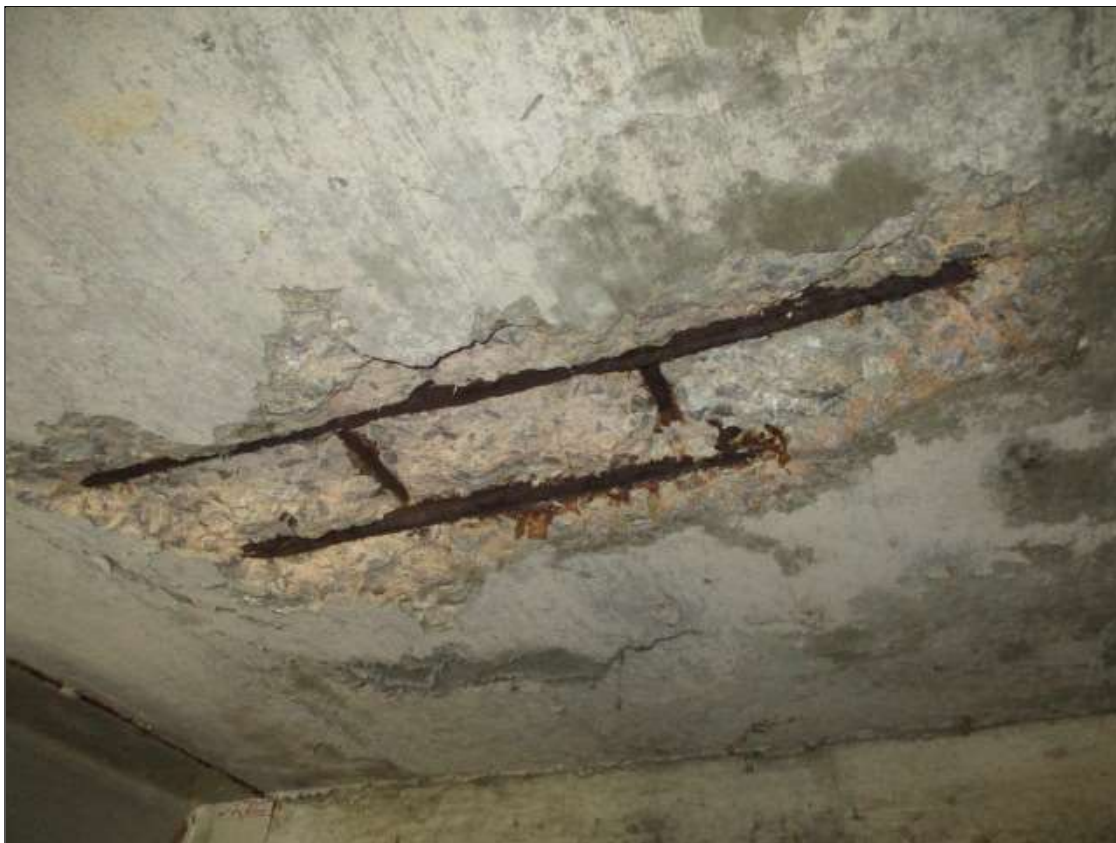
Span 3 Deck: PAR: 30" X 15" X 2 1/2" DEEP SPALL WITH EXPOSED REBAR WITH SECTION LOSS IN BAY 7 AT 2' FROM END BENT 2

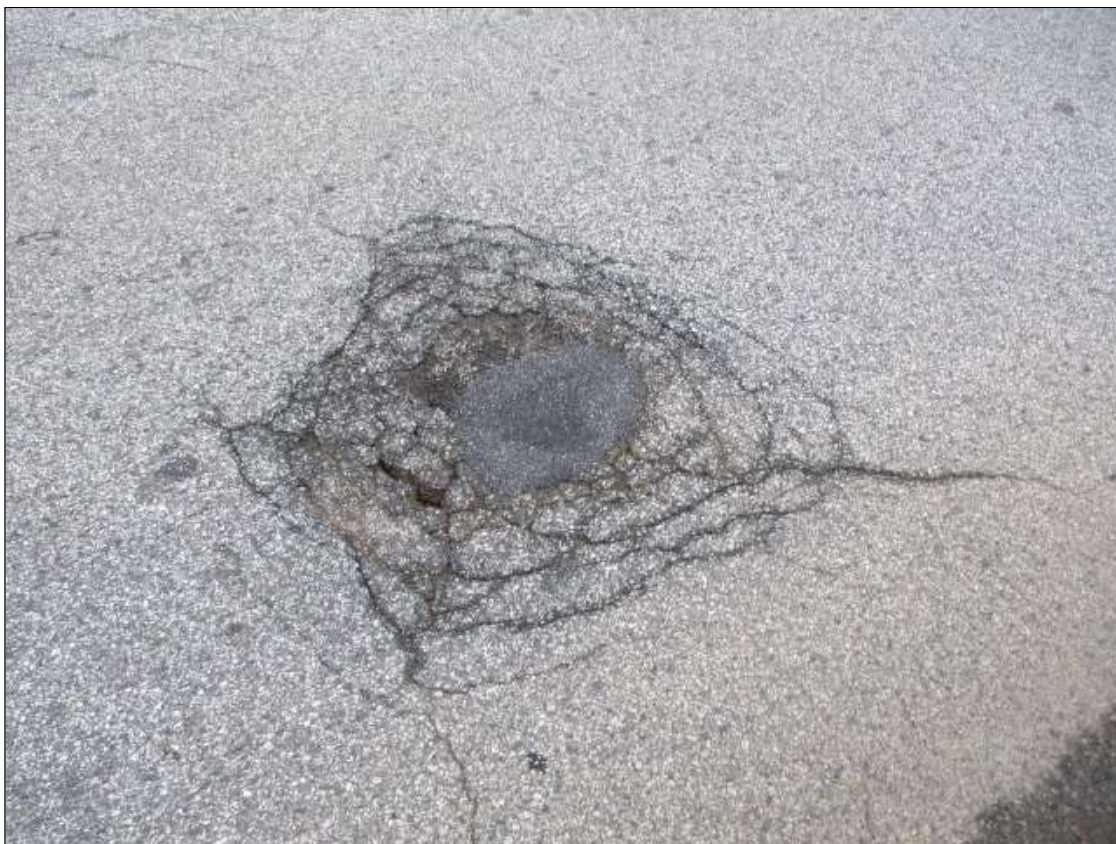
Span 1 Wearing Surface: 8 sq. ft. of sound patches thru out the top of the wearing surface
