NC DEPARTMENT OF TRANSPORTATION
 DIVISION OF HIGHWAYS
 STRUCTURE MANAGEMENT UNIT

ATTENTION: **PRIORITY ACTION REQUEST, TYPICAL SECTION SKETCH REVISED, UNDERCLEARANCE SKETCHES REVISED**

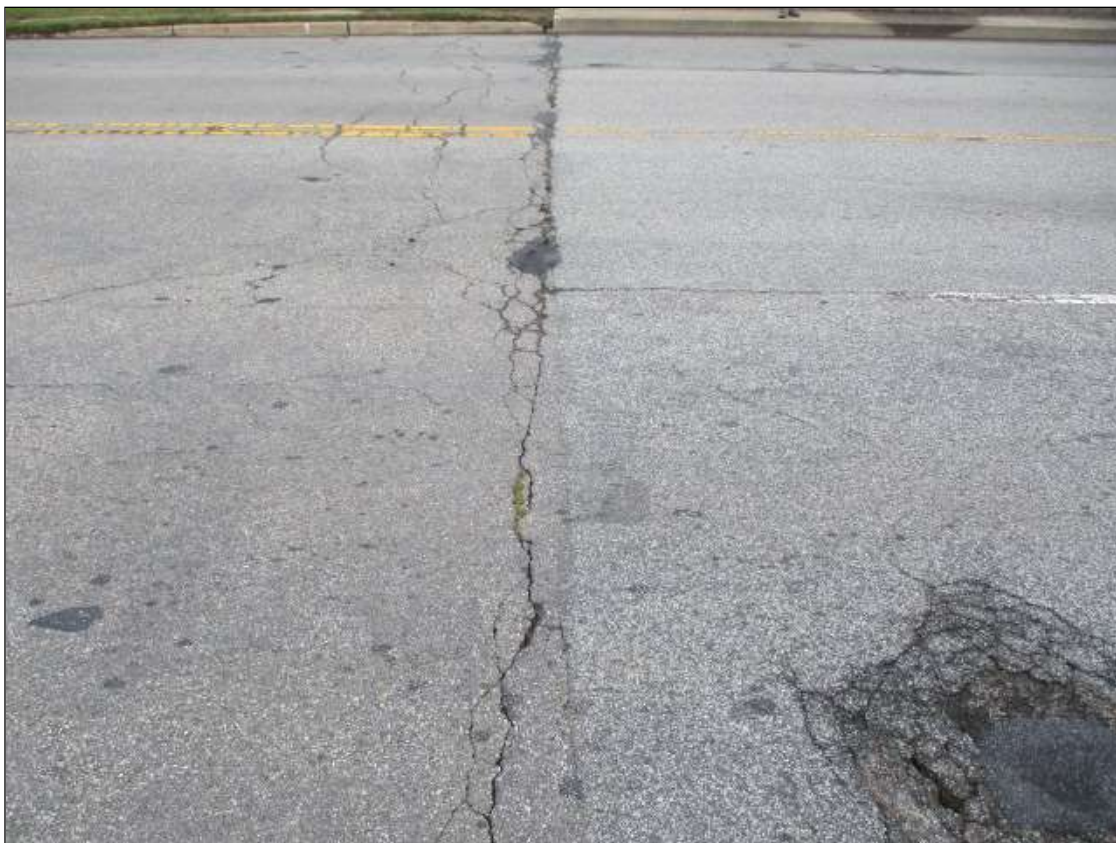
Span 1 Wearing Surface: 1" TRANSVERSE CRACK OVER END BENT 1

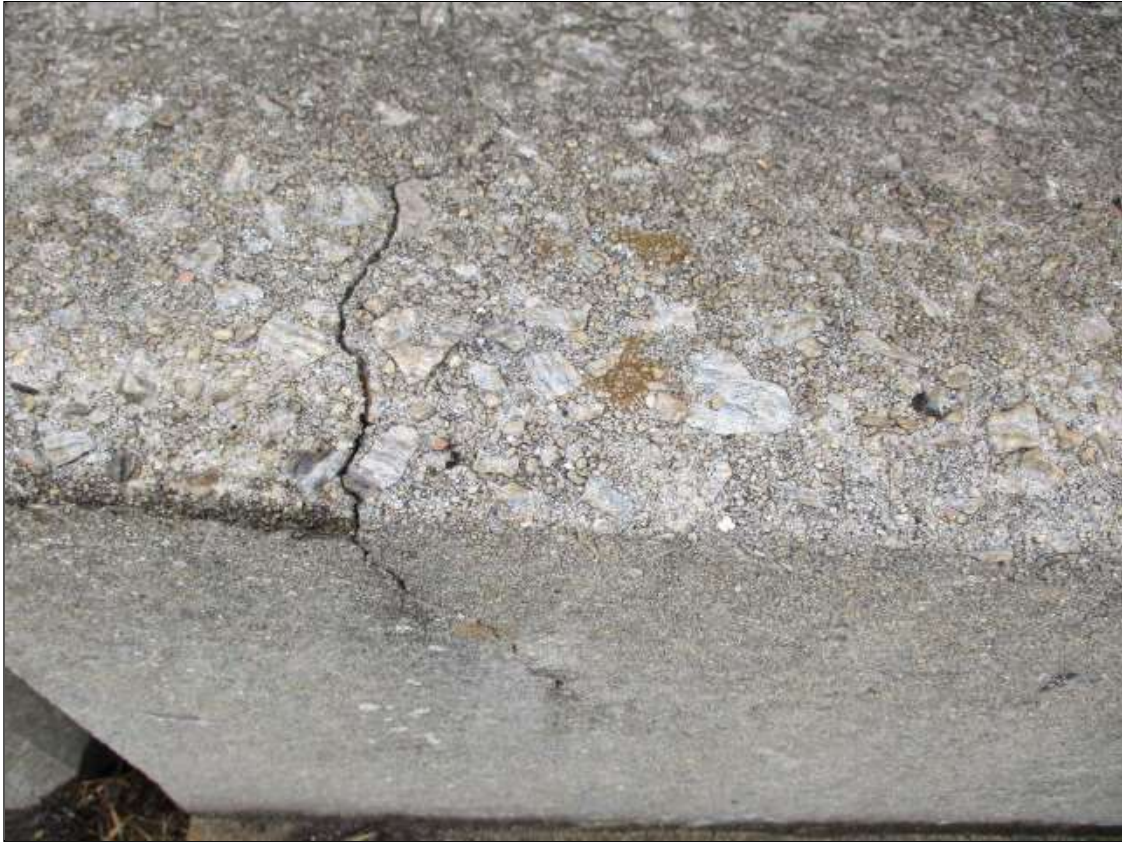
Span 1 Left Bridge Rail: 1/32" wide vertical cracks thru out the length of the rail

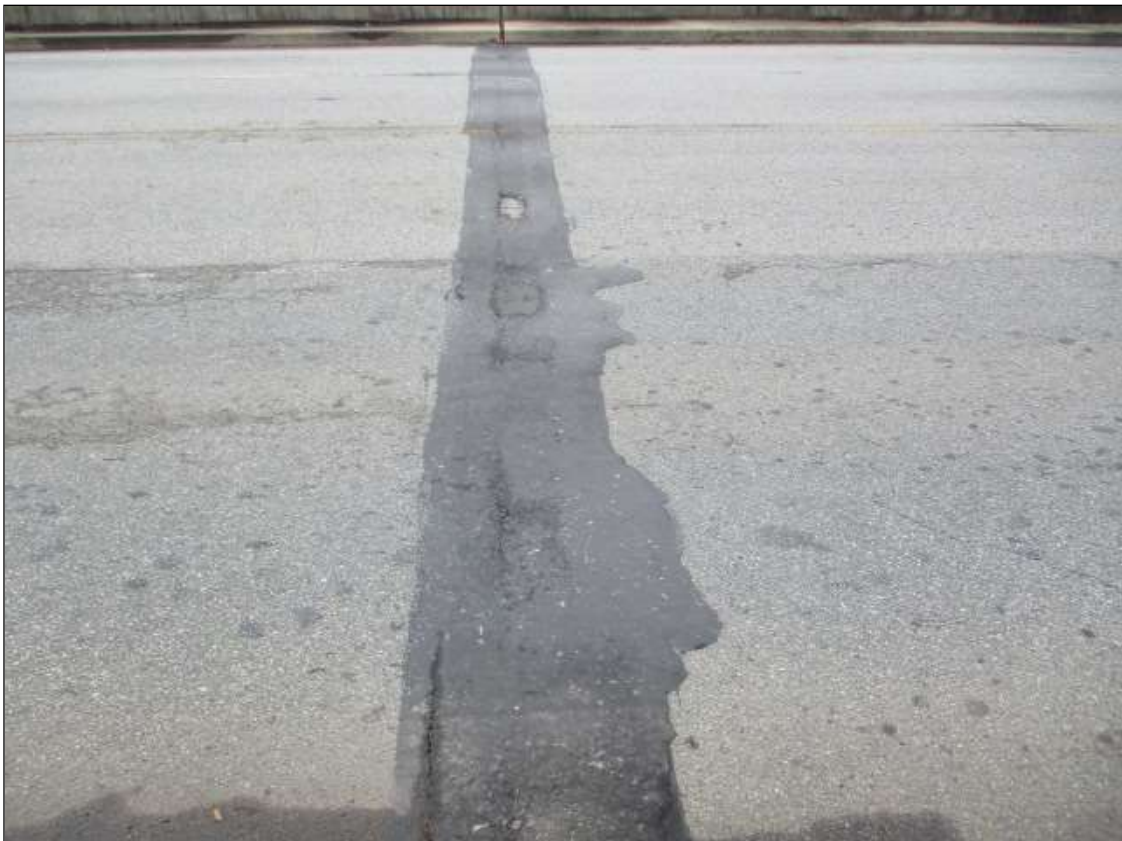
Span 2 Wearing Surface: PATCHED AREA OVER BENT 1

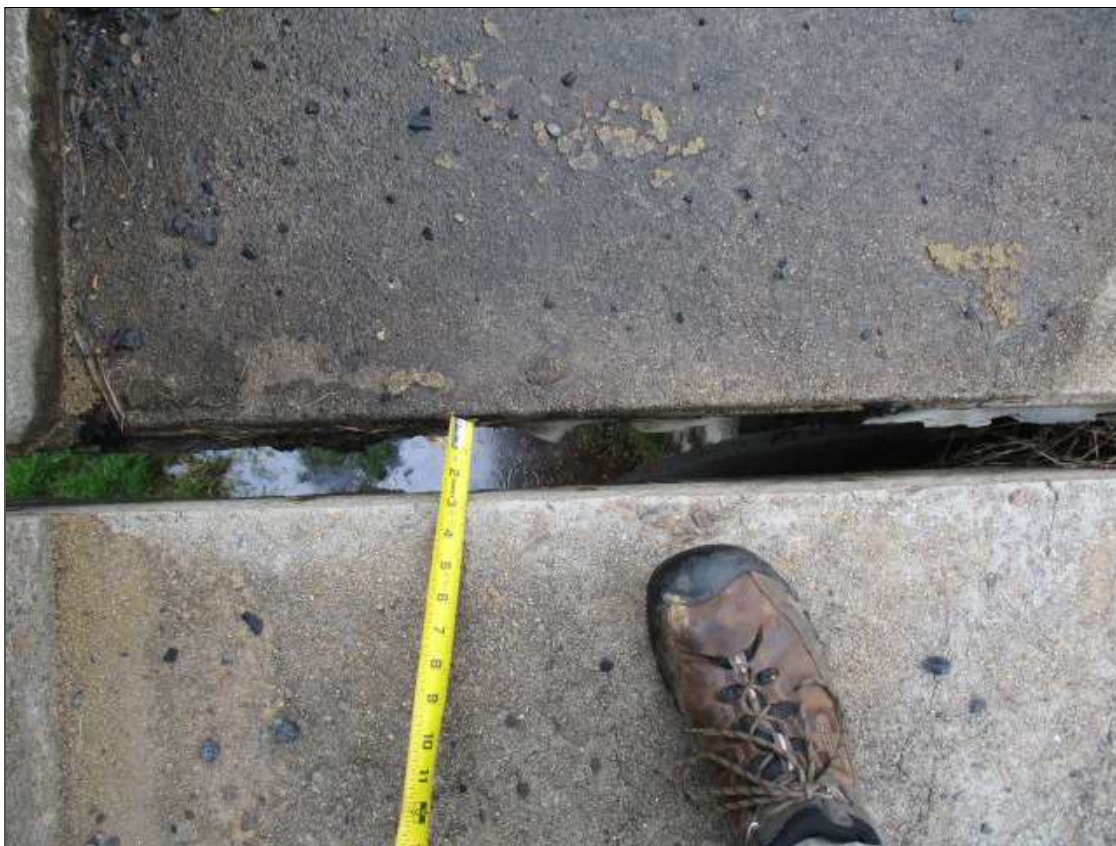
MISSING JOINT MATERIAL IN SIDEWALKS OVER INTERIOR BENTS WITH 3" GAP

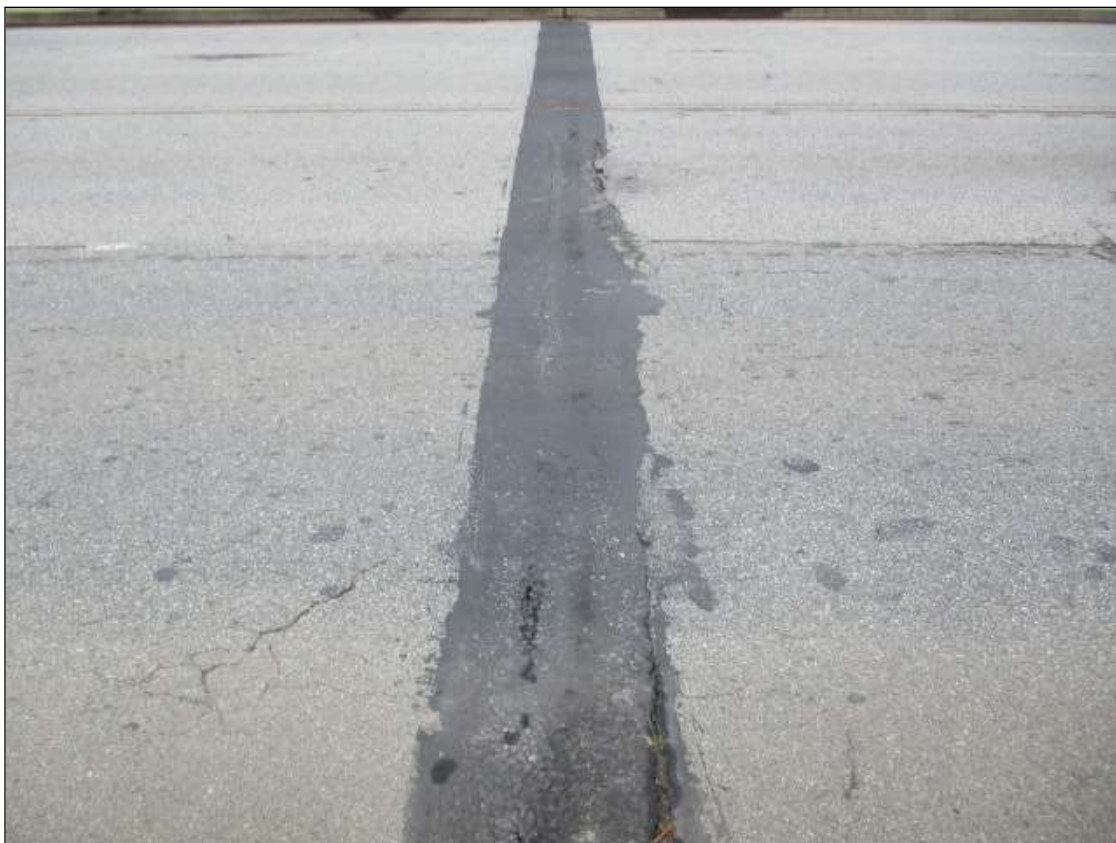
Span 3 Wearing Surface: PATCHED AREA OVER BENT 2

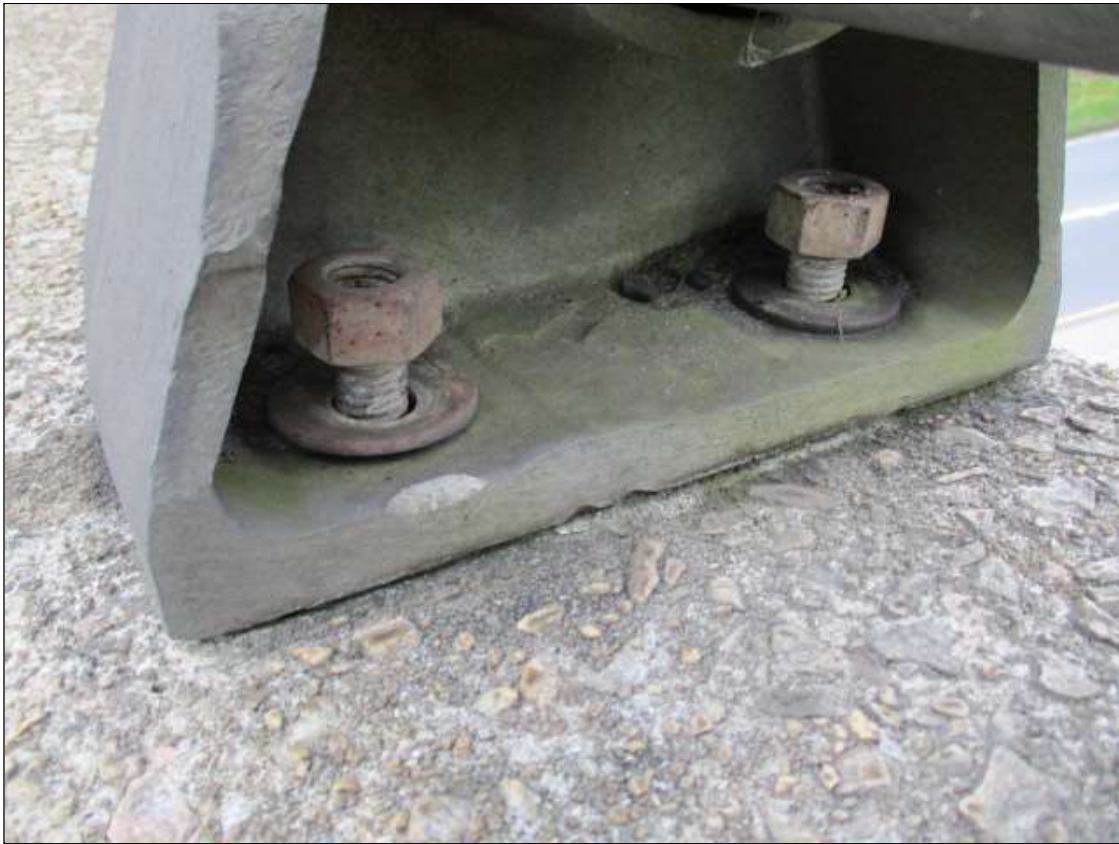
Span 2 Left Bridge Rail: RAISED ANCHOR NUTS ON 2ND TO LAST RAIL POST

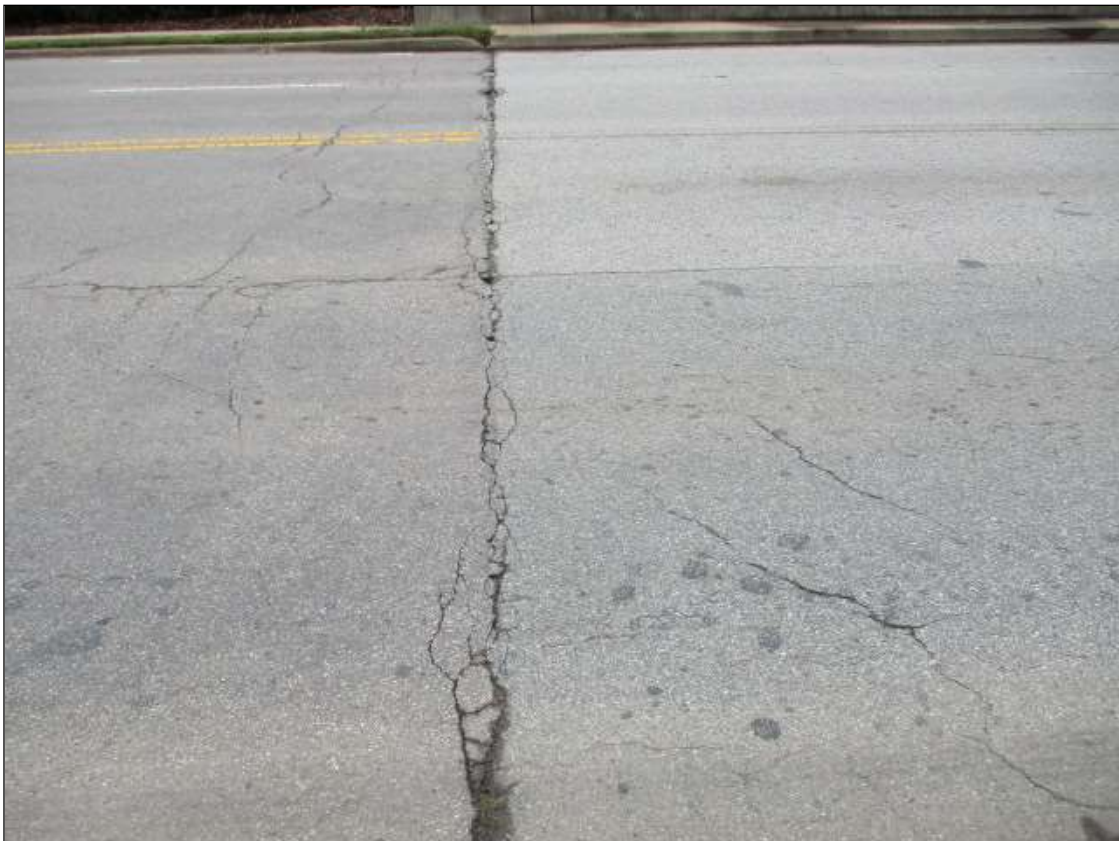
Span 3 Wearing Surface: 1" TRANSVERSE CRACK OVER END BENT 2

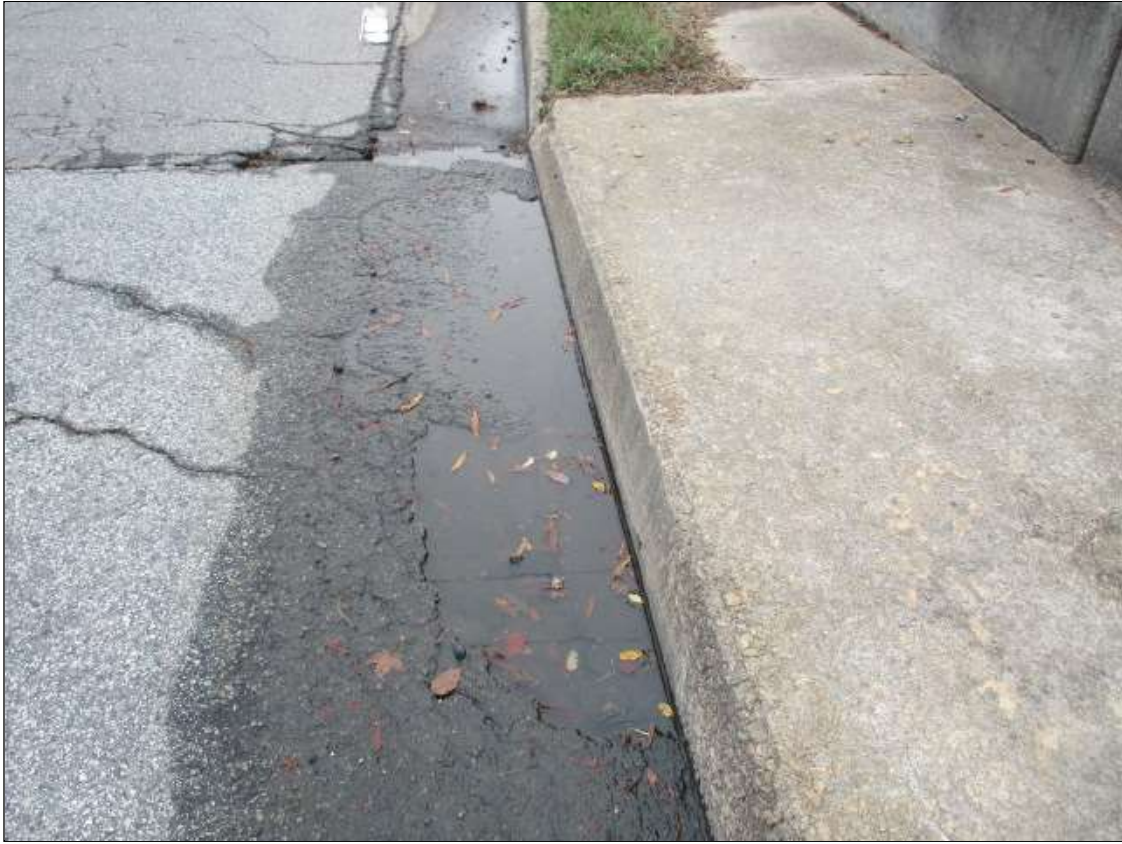
Span 3 Wearing Surface: 8' X 16" X 1 1/2" DEEP POTHOLE IN RIGHT EAST BOUND LANE AT END BENT 2

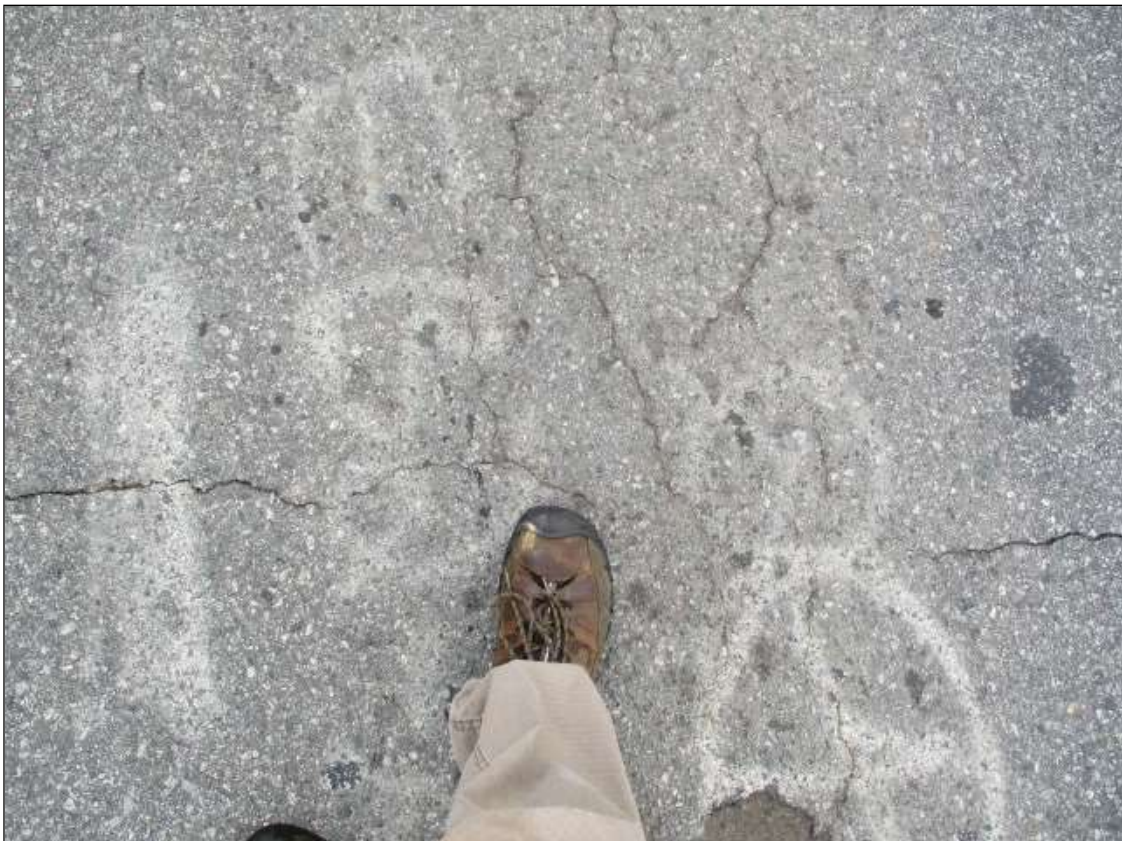
Span 3 Wearing Surface: 1/8" wide map cracking thru out the top of the wearing surface

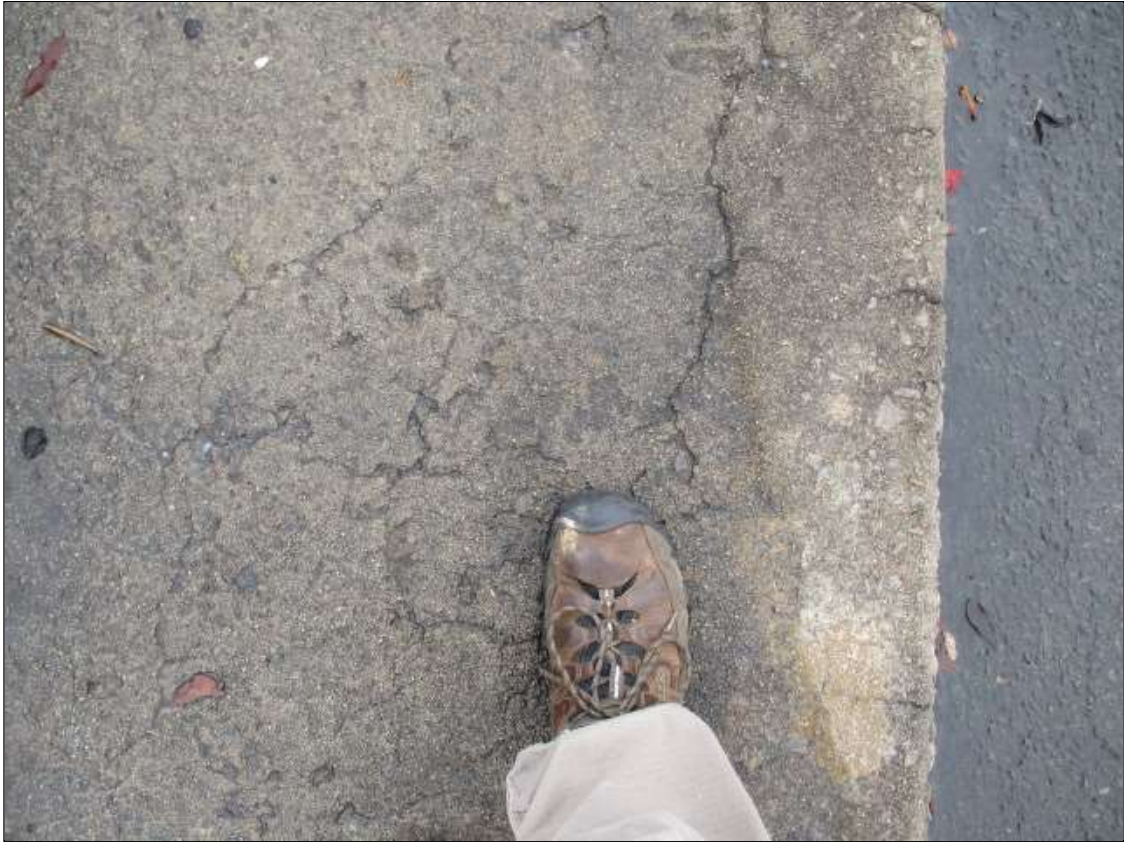
1/32" MAP CRACKING ALONG SIDEWALKS

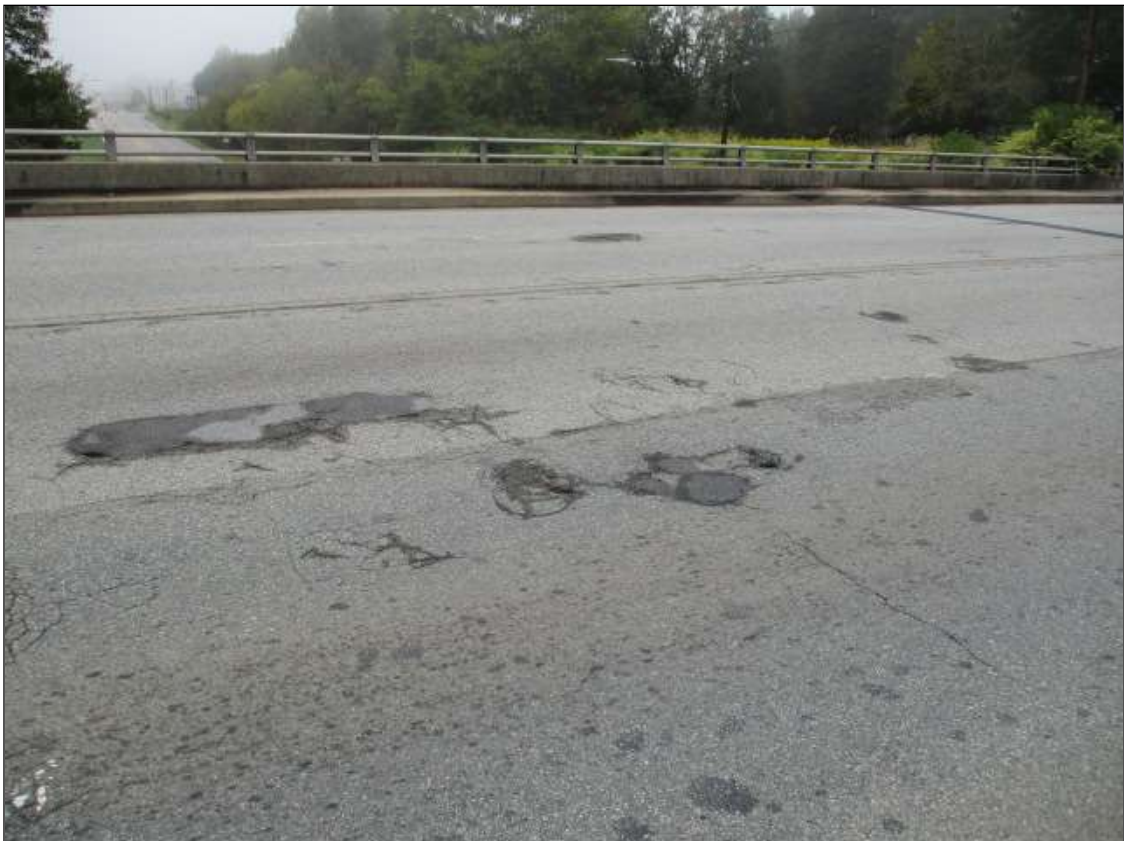
Span 2 Wearing Surface: MINOR POTHOLING IN TRAVEL LANES

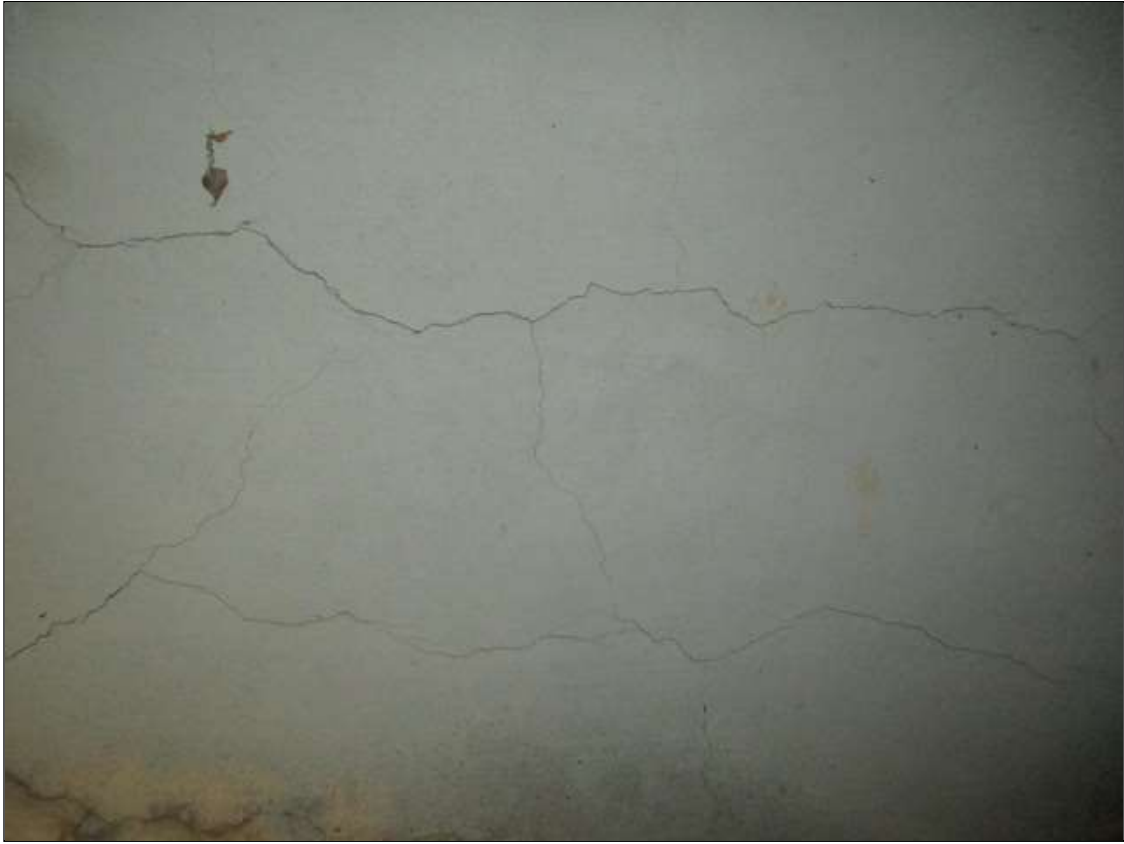
End Bent 1 Abutment: 1/32" MAP CRACKING THROUGHOUT BACKWALL

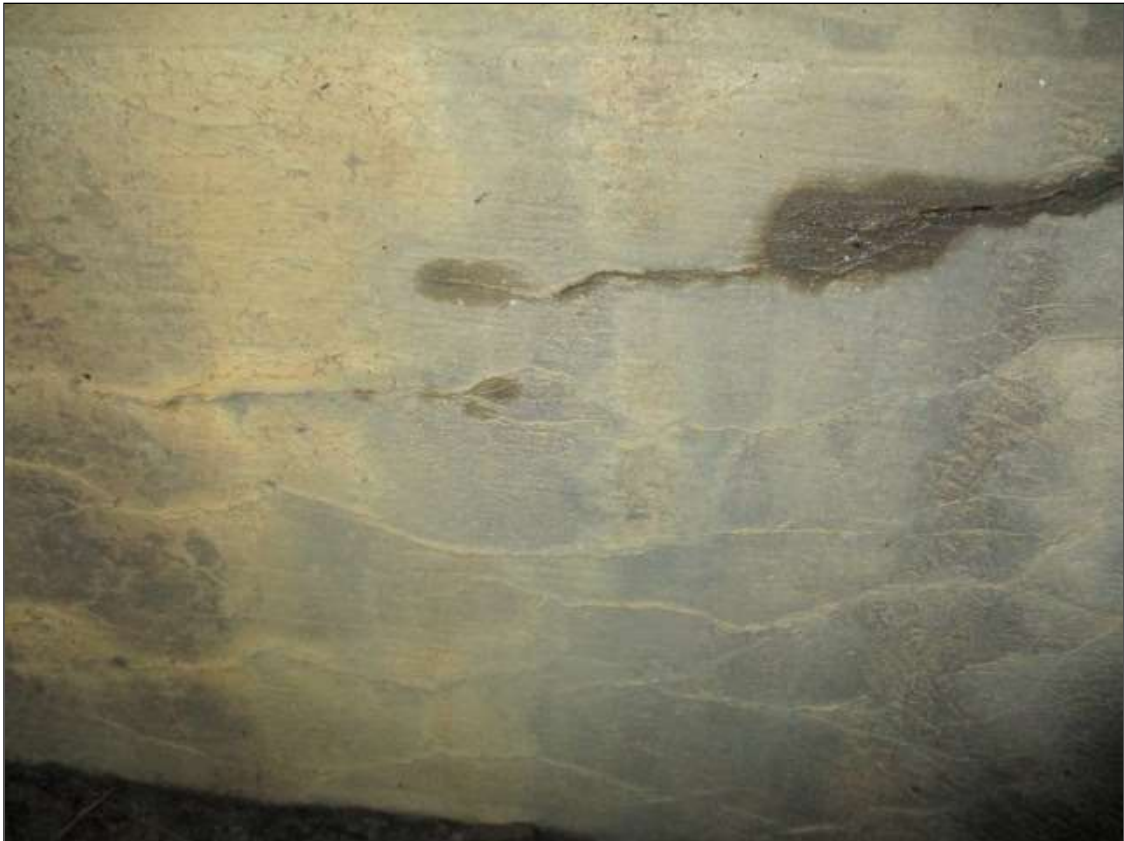
End Bent 1 Cap 1: 1/16" HORIZONTAL CRACKING THROUGHOUT

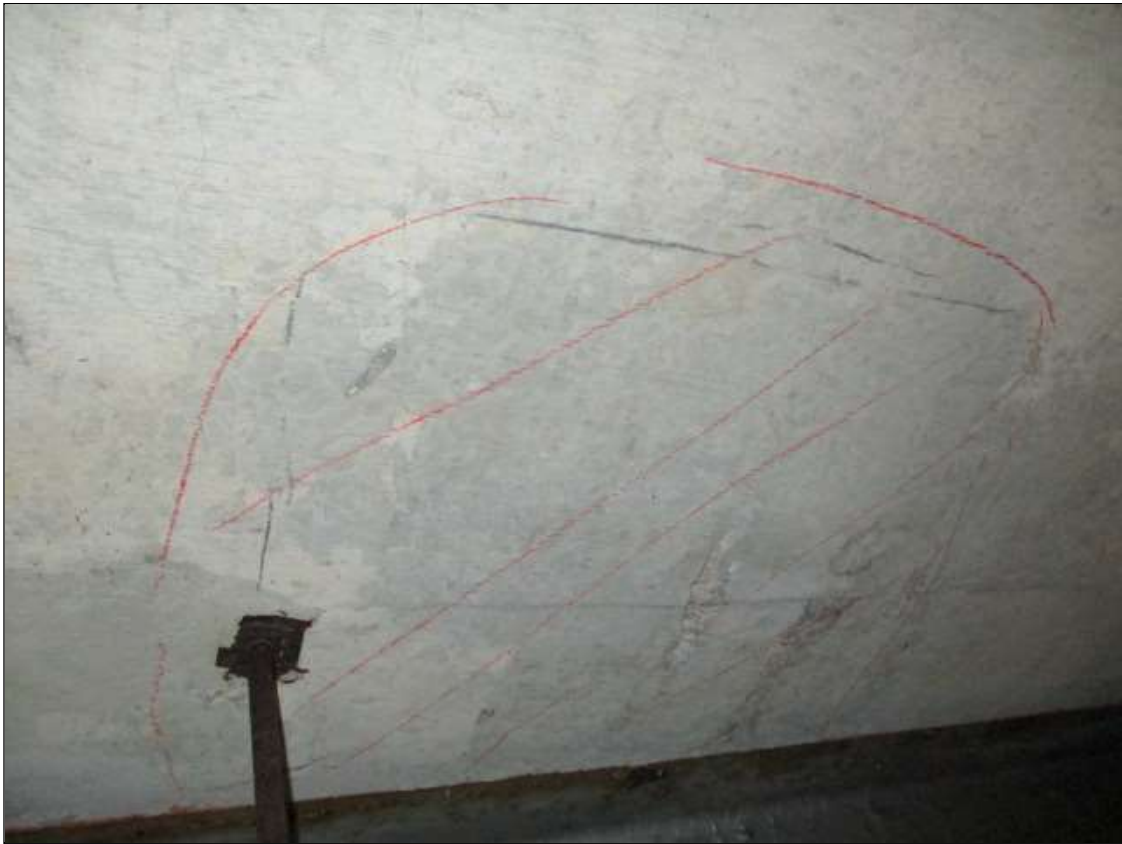
Span 1 Deck: 30" X 24" DELAMINATION IN BAY 8 NEAR END BENT 1

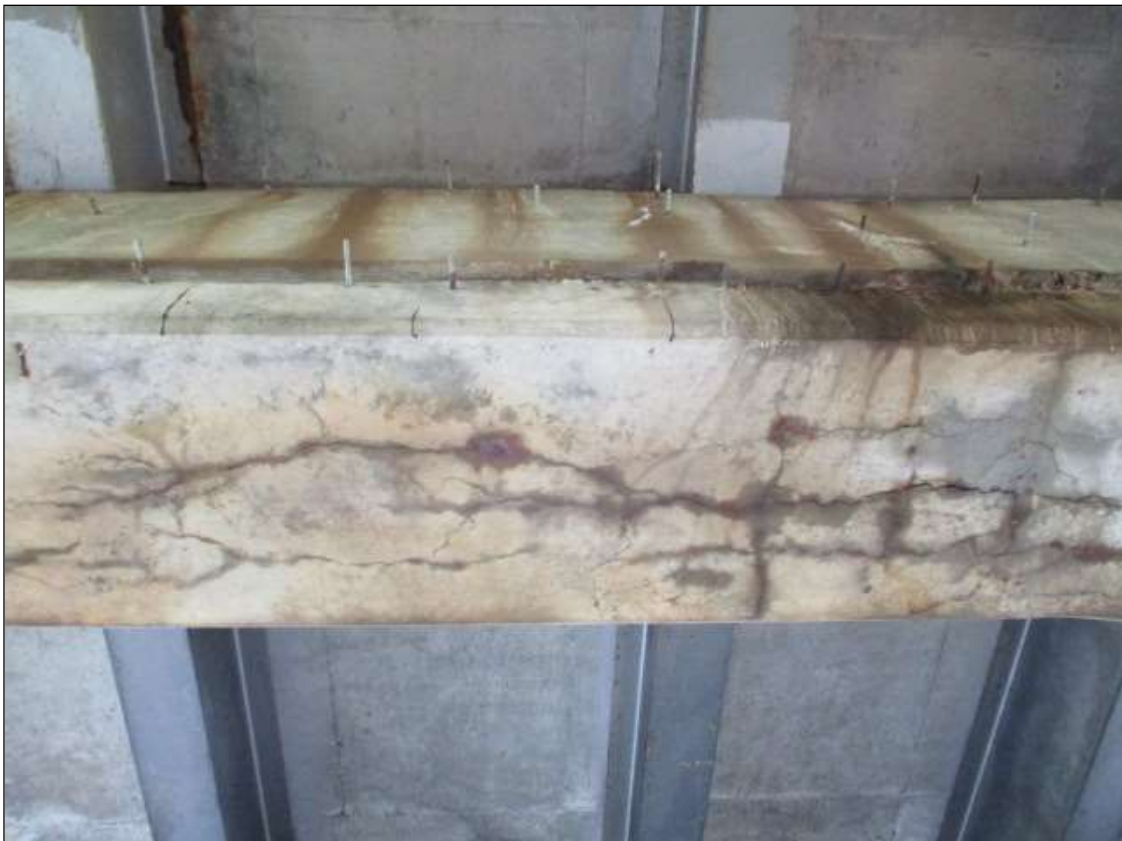
Bent 1 Cap 1: 1/32" MAP CRACKING THROUGHOUT UNDERSIDE

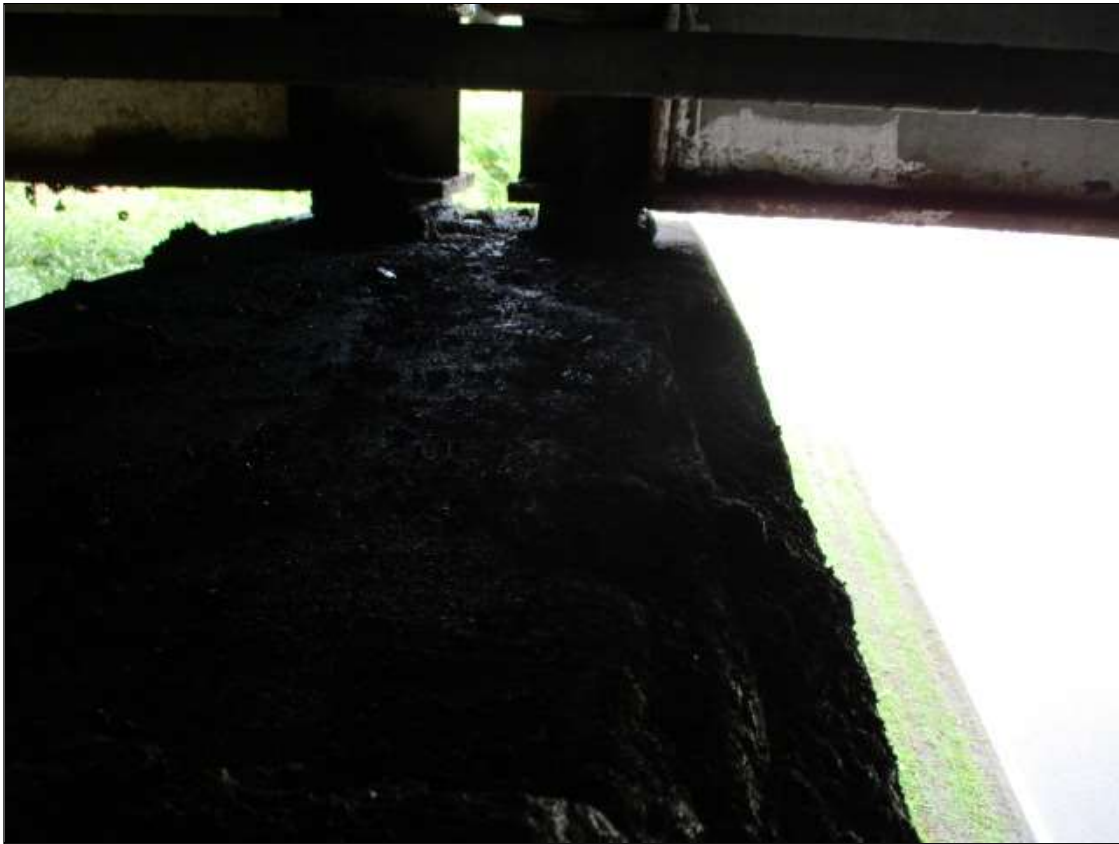
Bent 1 Cap 1: 4' X 6" X 5" SPALL WITH EXPOSED REBAR ON TOP OF CAP IN BAY 1 ON SPAN 2 SIDE

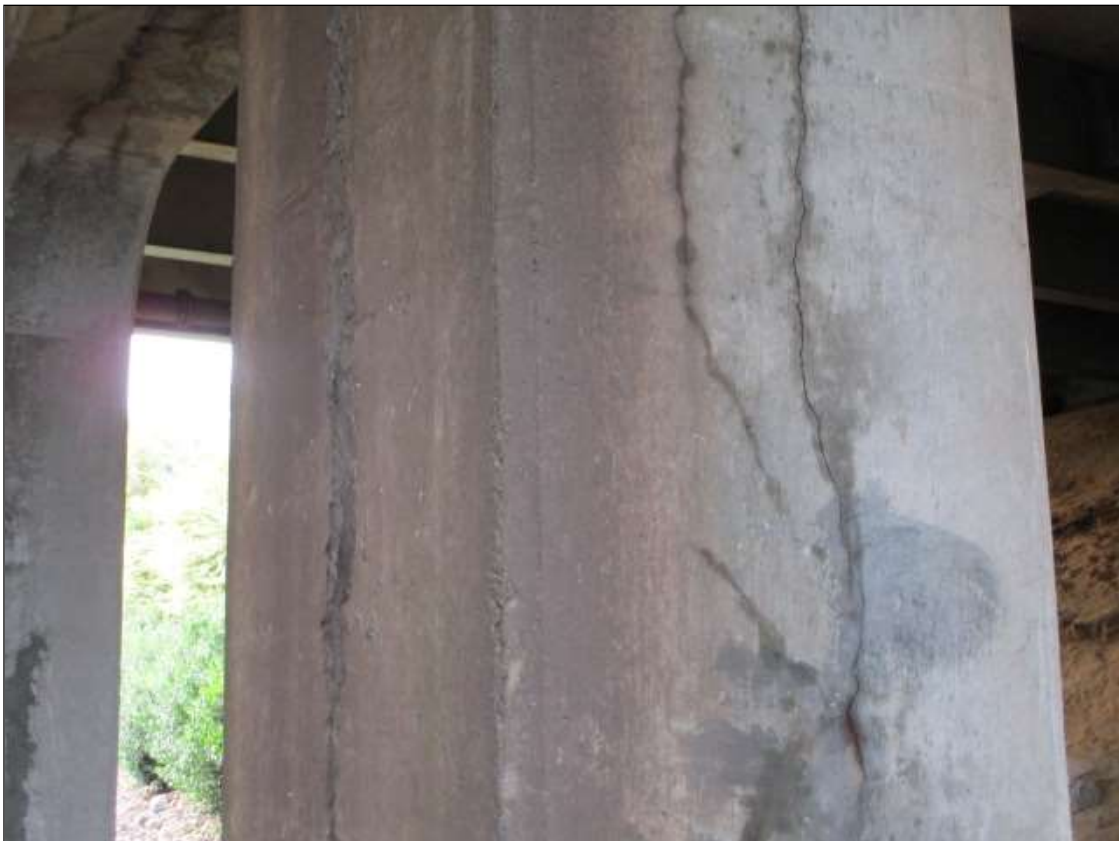
Bent 1 Pile 2: 1/16" wide cracking and unsound patches on all sides, full height

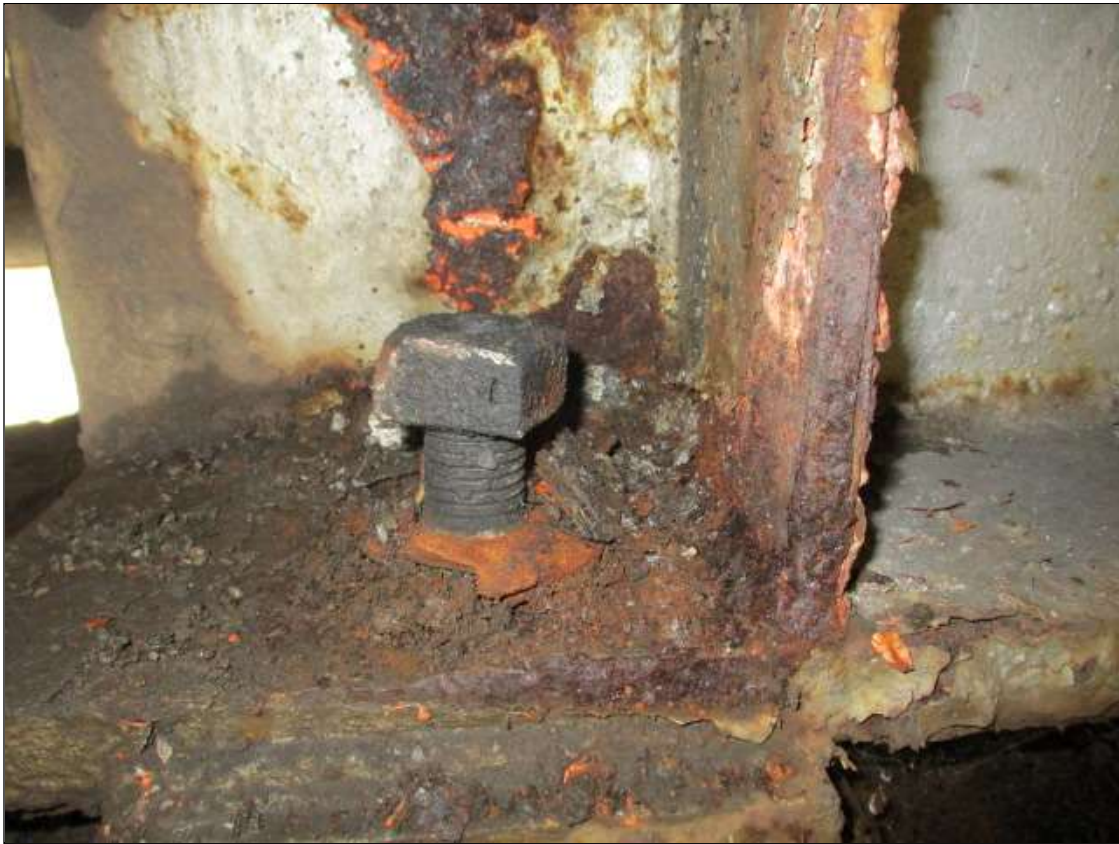
Span 1 Beam 8 Far Bearing: RAISED LEFT ANCHOR BOLT NUT BUT CANNOT BE MOVED BY HAND

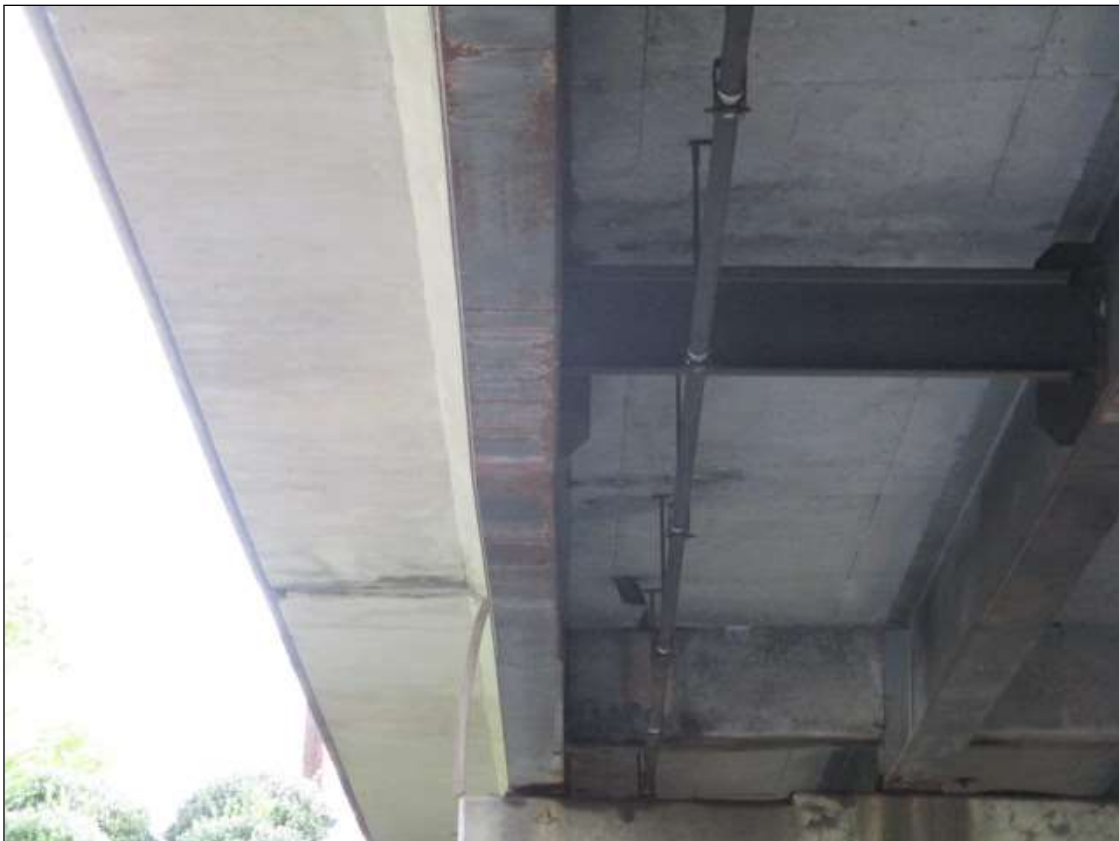
Span 2 Beam 1: at 22ft-9in from Bent 2, impact damage - lower web pushed out 1in x 8in high with divot on bottom flange [3/16in deep] and bottom flange bent upwards [1/4in]

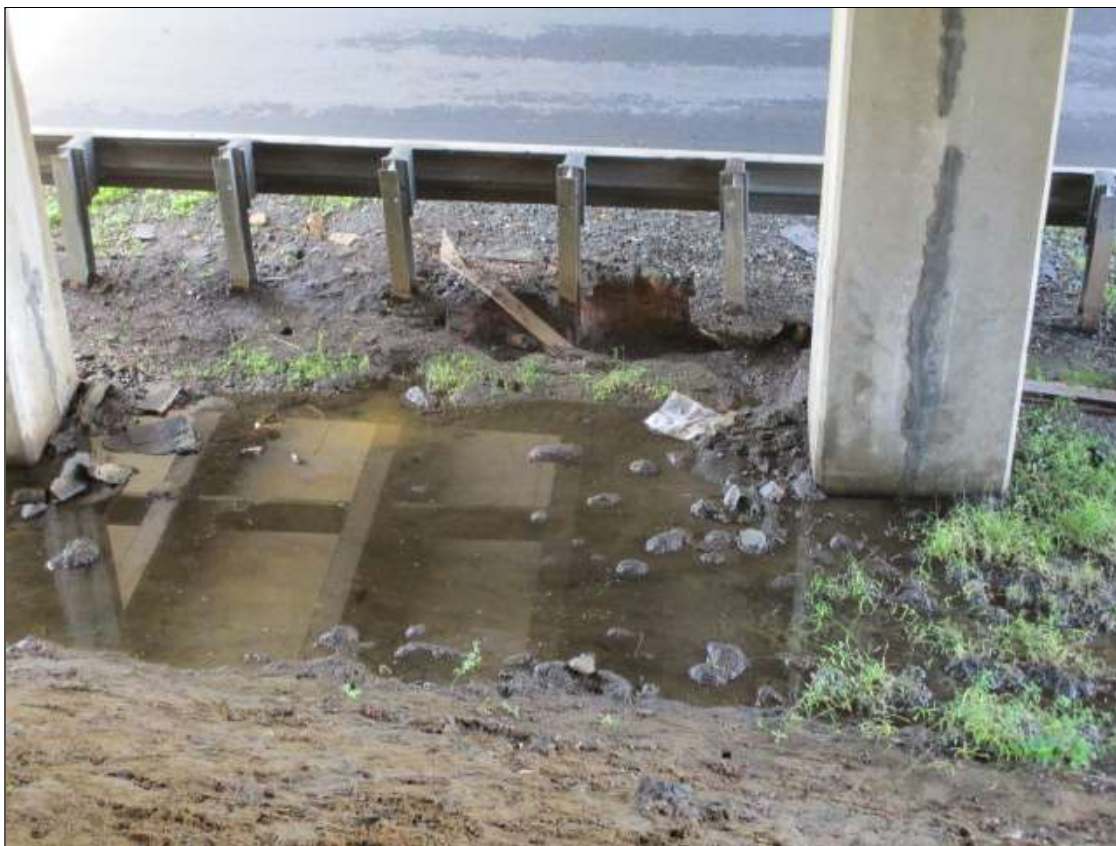
8' X 3' X 12" DEEP SINK HOLE UNDER BENT 2 BETWEEN COLUMNS 2 AND 3 AGAINST GUARDRAIL

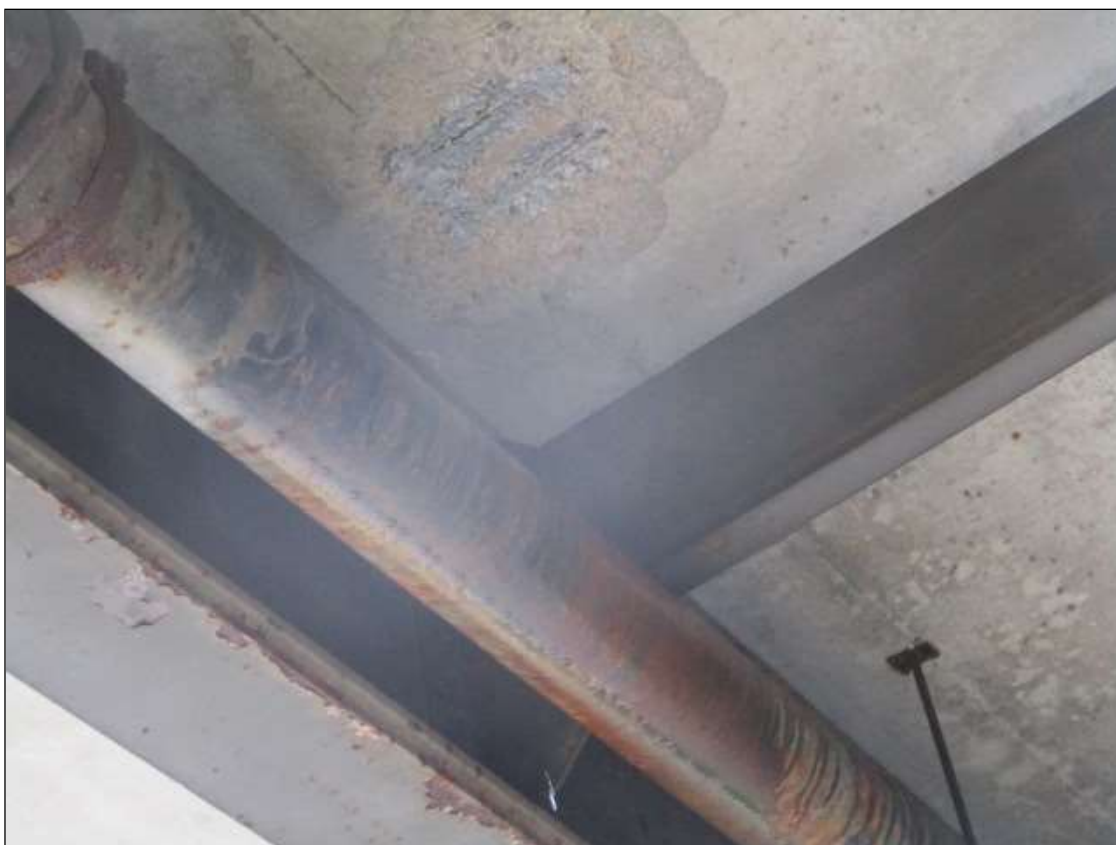
LEAKING UTILITY SECTION IN BAY 8 SPAN 2 OVER SOUTH BOUND LANES

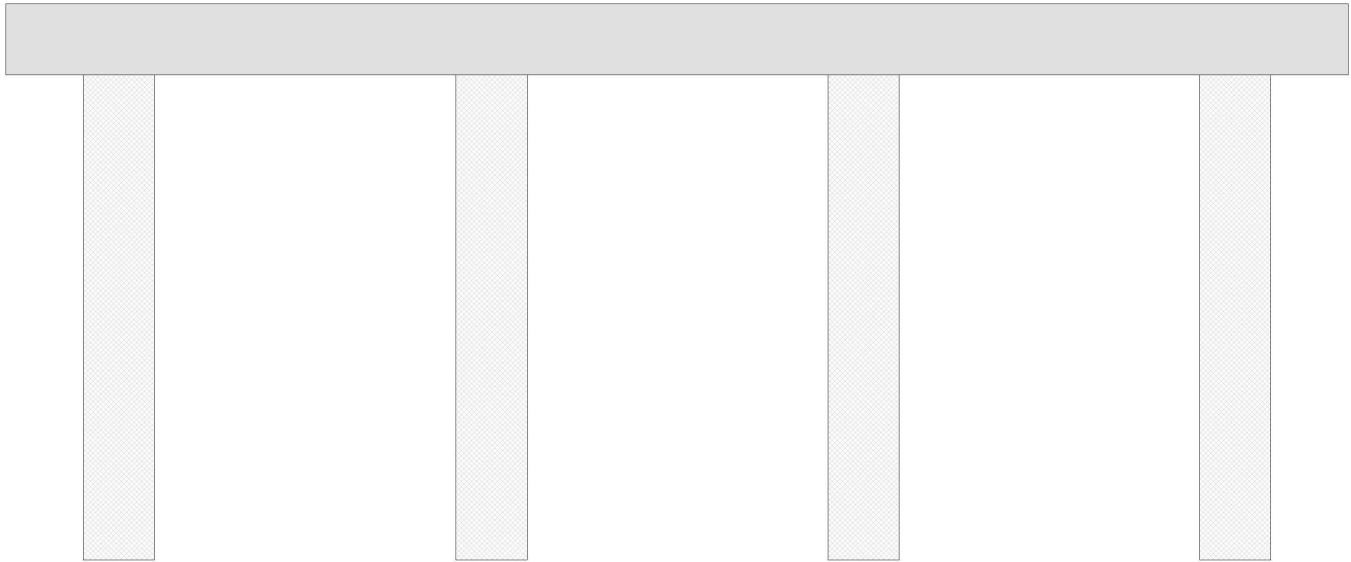
Cap Information			Material Cast-in-Place Concrete							
Length	Width	Height	Left Overhang	Right Overhang	Left Beam to End of Cap.	Right Beam to End of Cap.				
56.470 ft.	2.500 ft.	3.000 ft.	4.750 ft.	4.750 ft.	1.375 ft.	1.375 ft.				
Subcap Information			Material							
Length	Width	Height	Left Overhang	Right Overhang	Left Pile to Splice.					
Sill Information			Material							
Length	Width	Height								
Pile #	Material	Spacing	Width/Dia.	Height	Length	Orientation	Driven?	Replacement?	Removed?	Collar?
1	Concrete	15.68 ft.	3 ft.			Vertical	No	No	No	No
2	Concrete	15.65 ft.	3 ft.			Vertical	No	No	No	No
3	Concrete	15.64 ft.	3 ft.			Vertical	No	No	No	No
4	Concrete		3 ft.			Vertical	No	No	No	No
