PROJECT NO. 15BPR.49 **WAKE** COUNTY 910240 BRIDGE NO. \_\_\_

STATE OF NORTH CAROLINA DEPARTMENT OF TRANSPORTATION

## SUBSTRUCTURE REPAIRS

BENT 3 SPAN C FACE

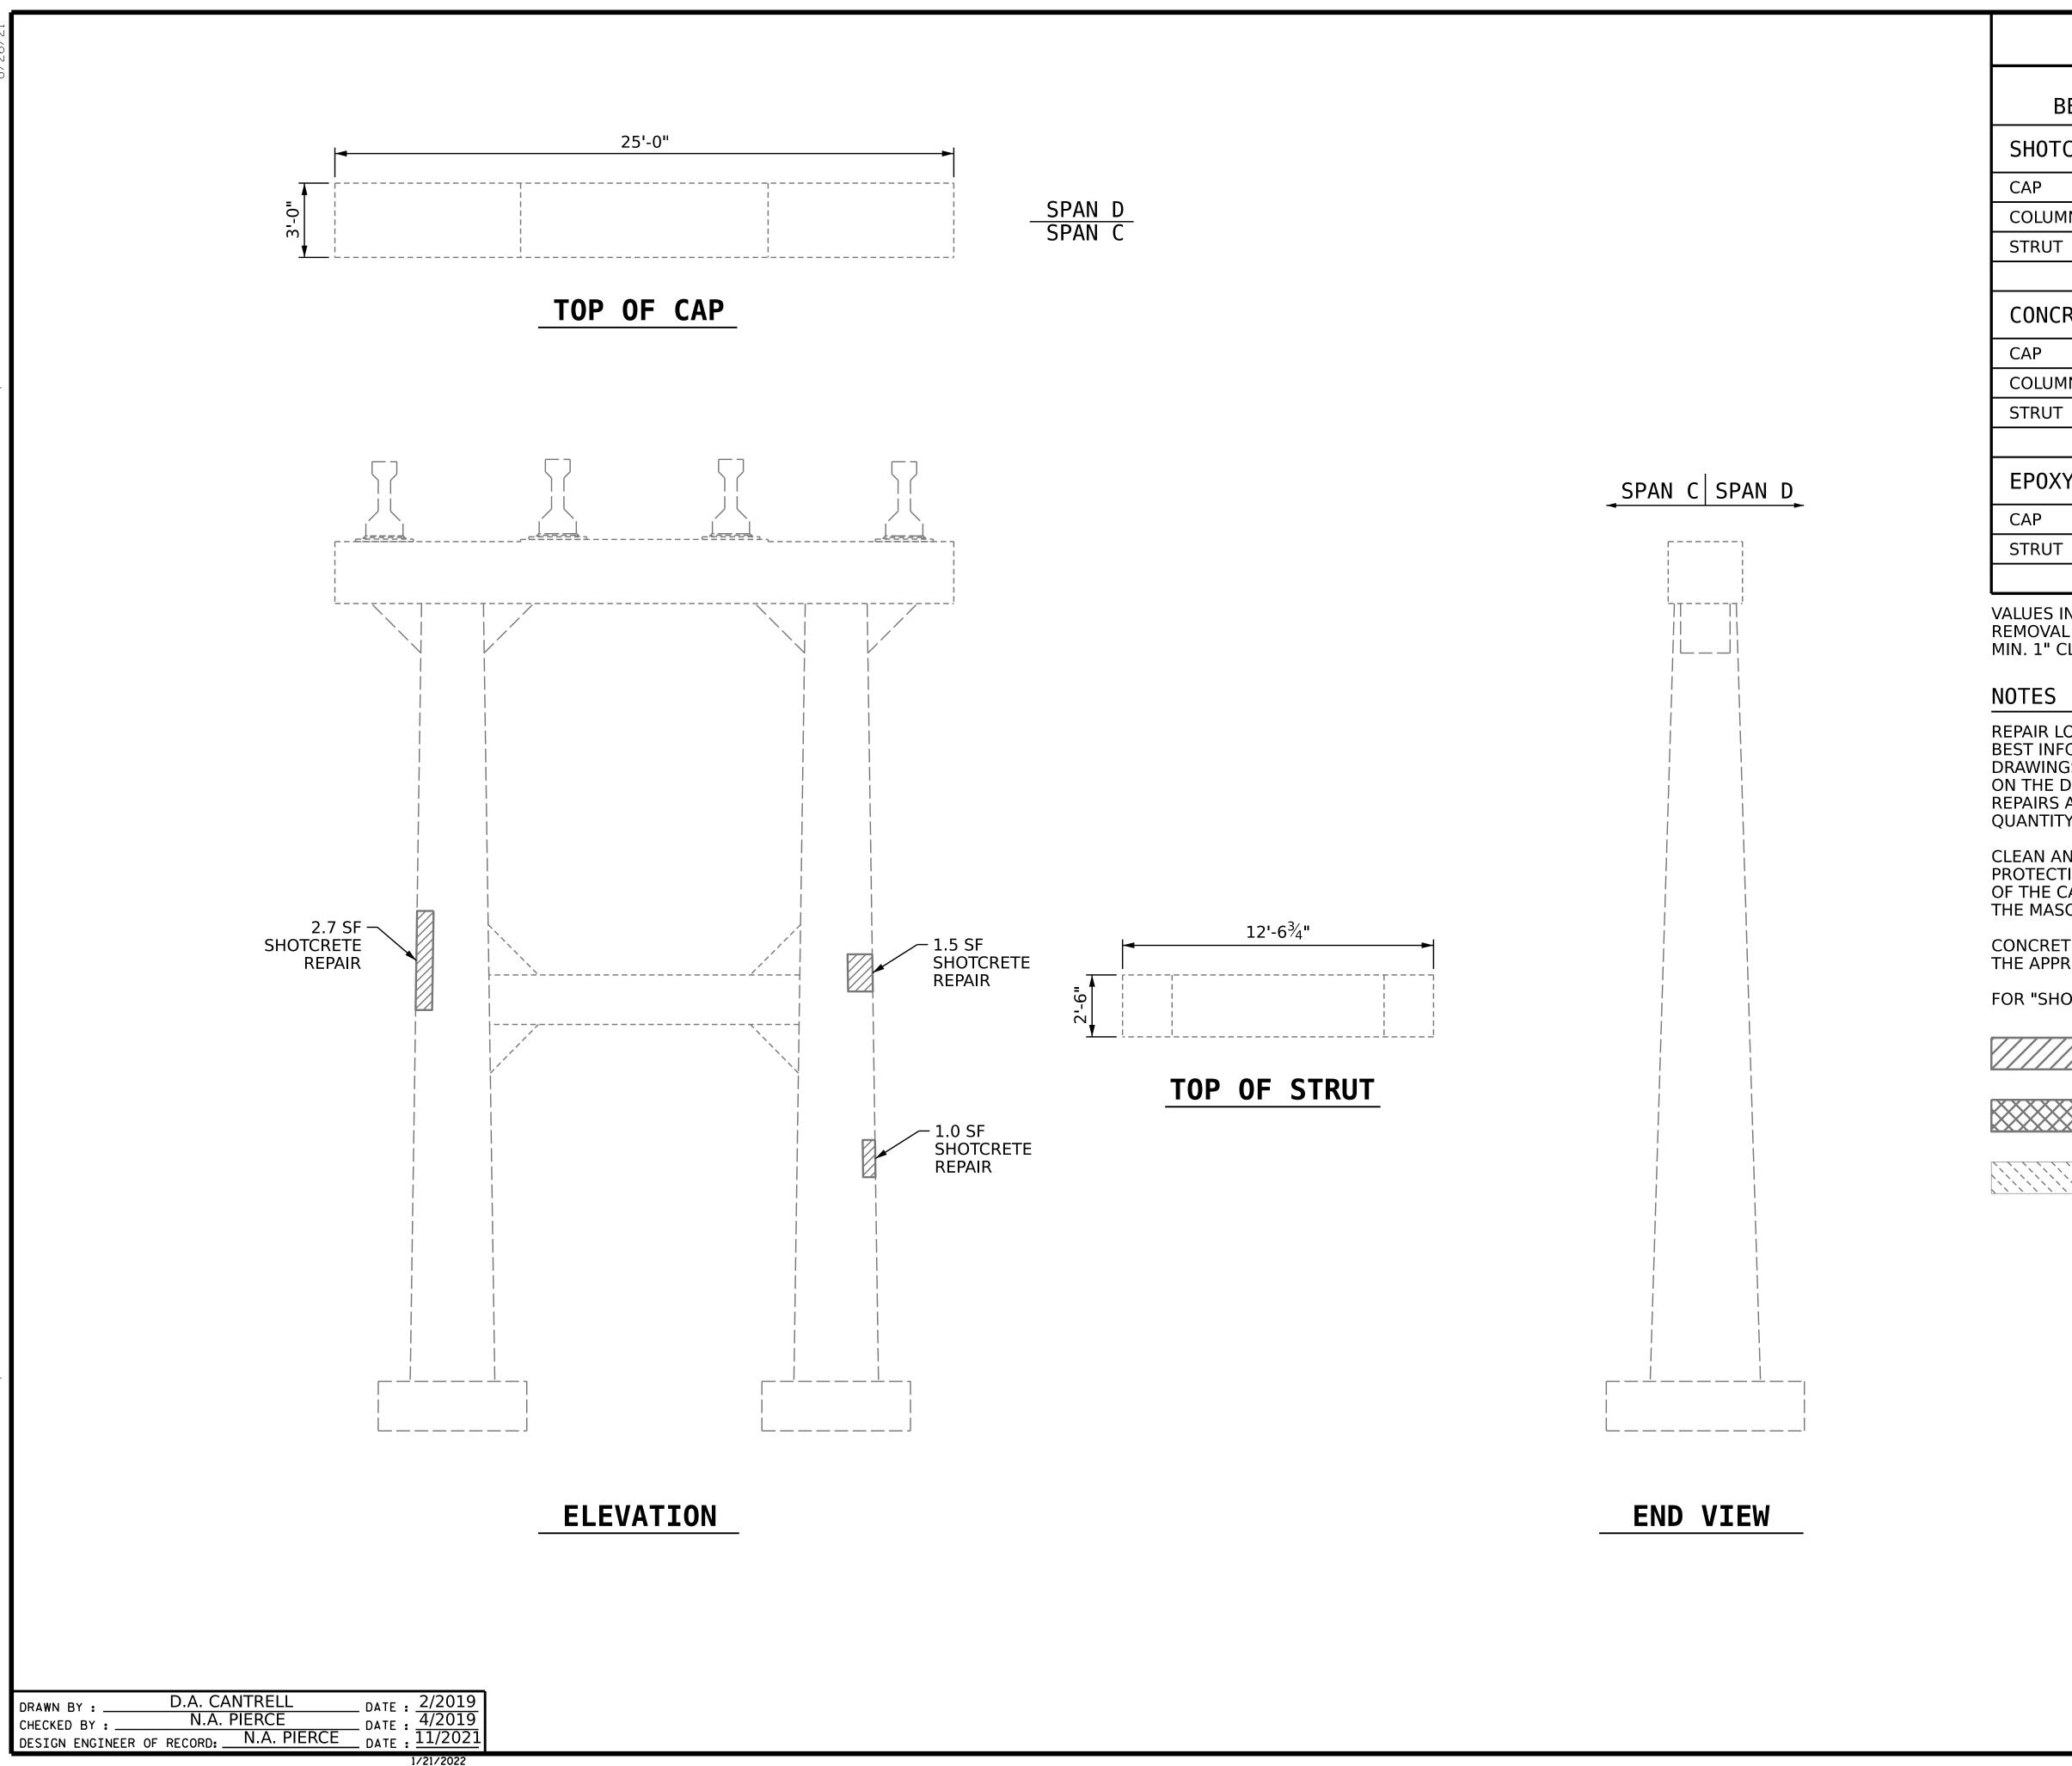
SHOTCRETE REPAIR AREA

CONCRETE REPAIR AREA

AREA PREVIOUSLY ACCOUNTED FOR ON ADJACENT FACE

VALUES IN CHART REPRESENT ESTIMATED REPAIR TOTALS AFTER REMOVAL OF UNSOUND CONCRETE, MIN. OF 1" BEHIND REBAR AND MIN. 1" CLEAR TO SAWCUT. SEE REPAIR DETAILS.

CLEAN AND REMOVE DEBRIS FROM THE TOP OF THE CAP AND APPLY EPOXY PROTECTIVE COATING. EPOXY COATING SHALL BE APPLIED TO THE TOP SURFACE OF THE CAP. THE CONTRACTOR SHALL NOT COAT THE AREA OF THE CAP BENEATH THE MASONRY PLATES. FOR EPOXY COATING, SEE SPECIAL PROVISIONS.

CONCRETE REPAIRS MAYBE SUBSTITUTED IN LIEU OF SHOTCRETE REPAIRS WITH THE APPROVAL OF THE ENGINEER.

FOR "SHOTCRETE REPAIRS", SEE SPECIAL PROVISIONS.
