PROJECT NO. I-5831A  
MADISON COUNTY  
 BRIDGE NO. 560547

STATE OF NORTH CAROLINA  
 DEPARTMENT OF TRANSPORTATION  
 RALEIGH

**BENT 1  
 SPAN A FACE**

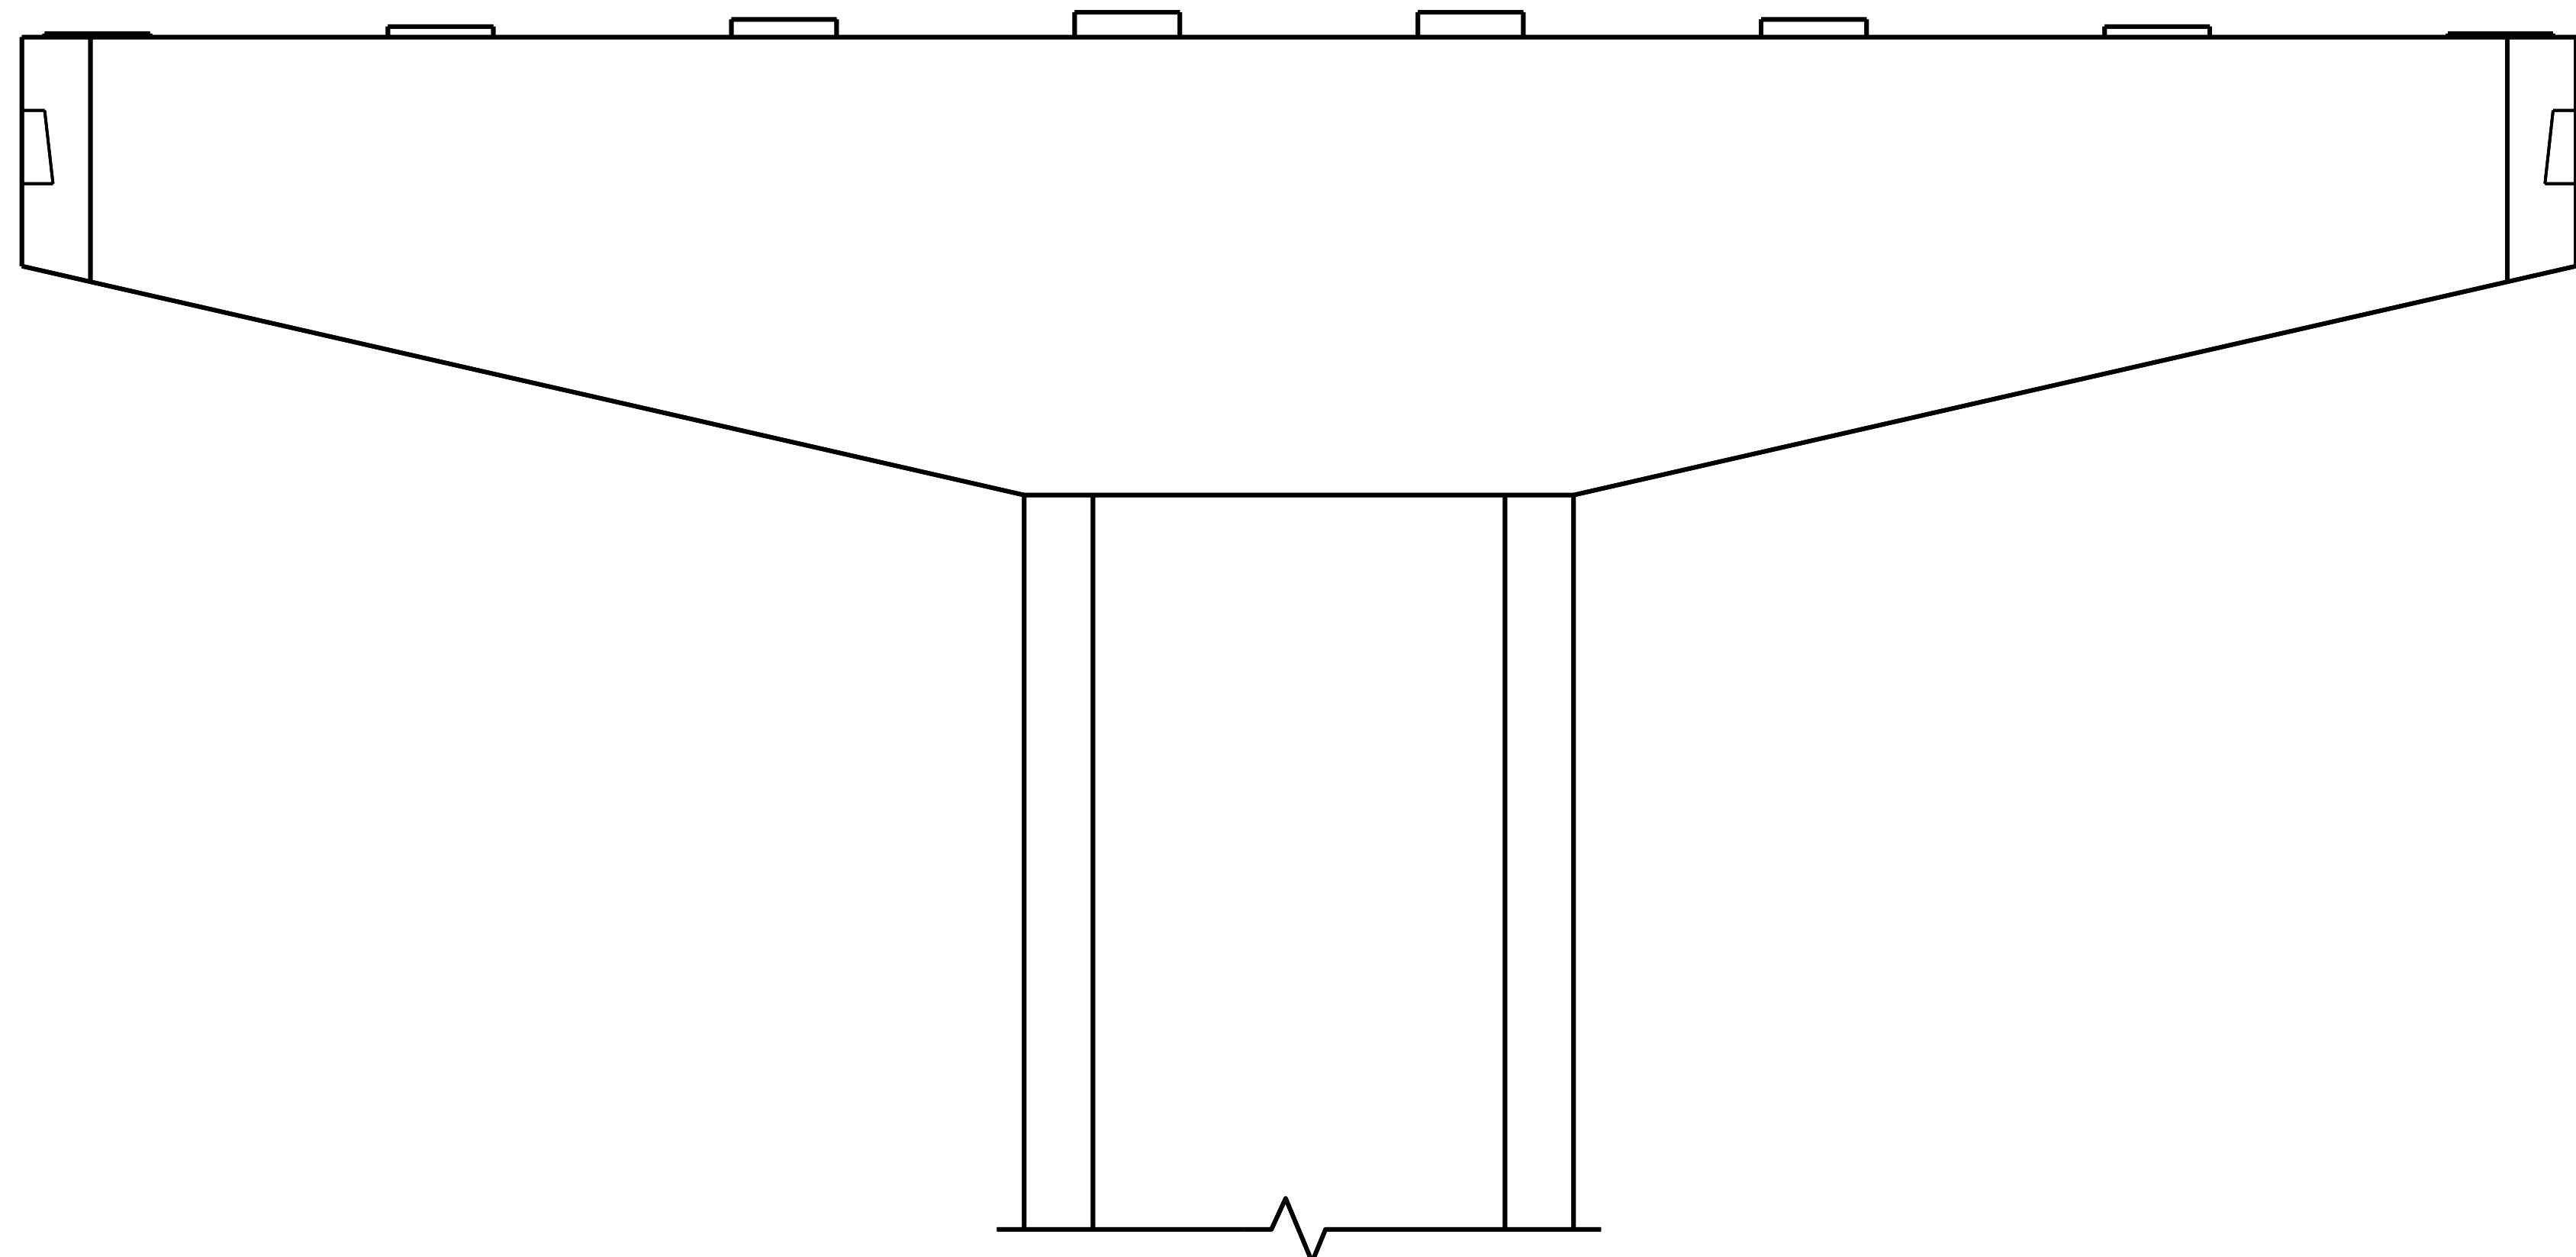
ELEVATION

EPOXY COATING (TYP. EA. END)

EPOXY COATING SHALL BE APPLIED AT ENDS OF CAP AND SHALL INCLUDE 3" MINIMUM TO TOP AND BOTTOM OF CAP.
