PROJECT NO.	<u>I-5831A</u>
MADIS	SON COUNTY
BRIDGE NO	560547

STATE OF NORTH CAROLINA DEPARTMENT OF TRANSPORTATION RALEIGH

BE	2	
SPAN	С	FACE

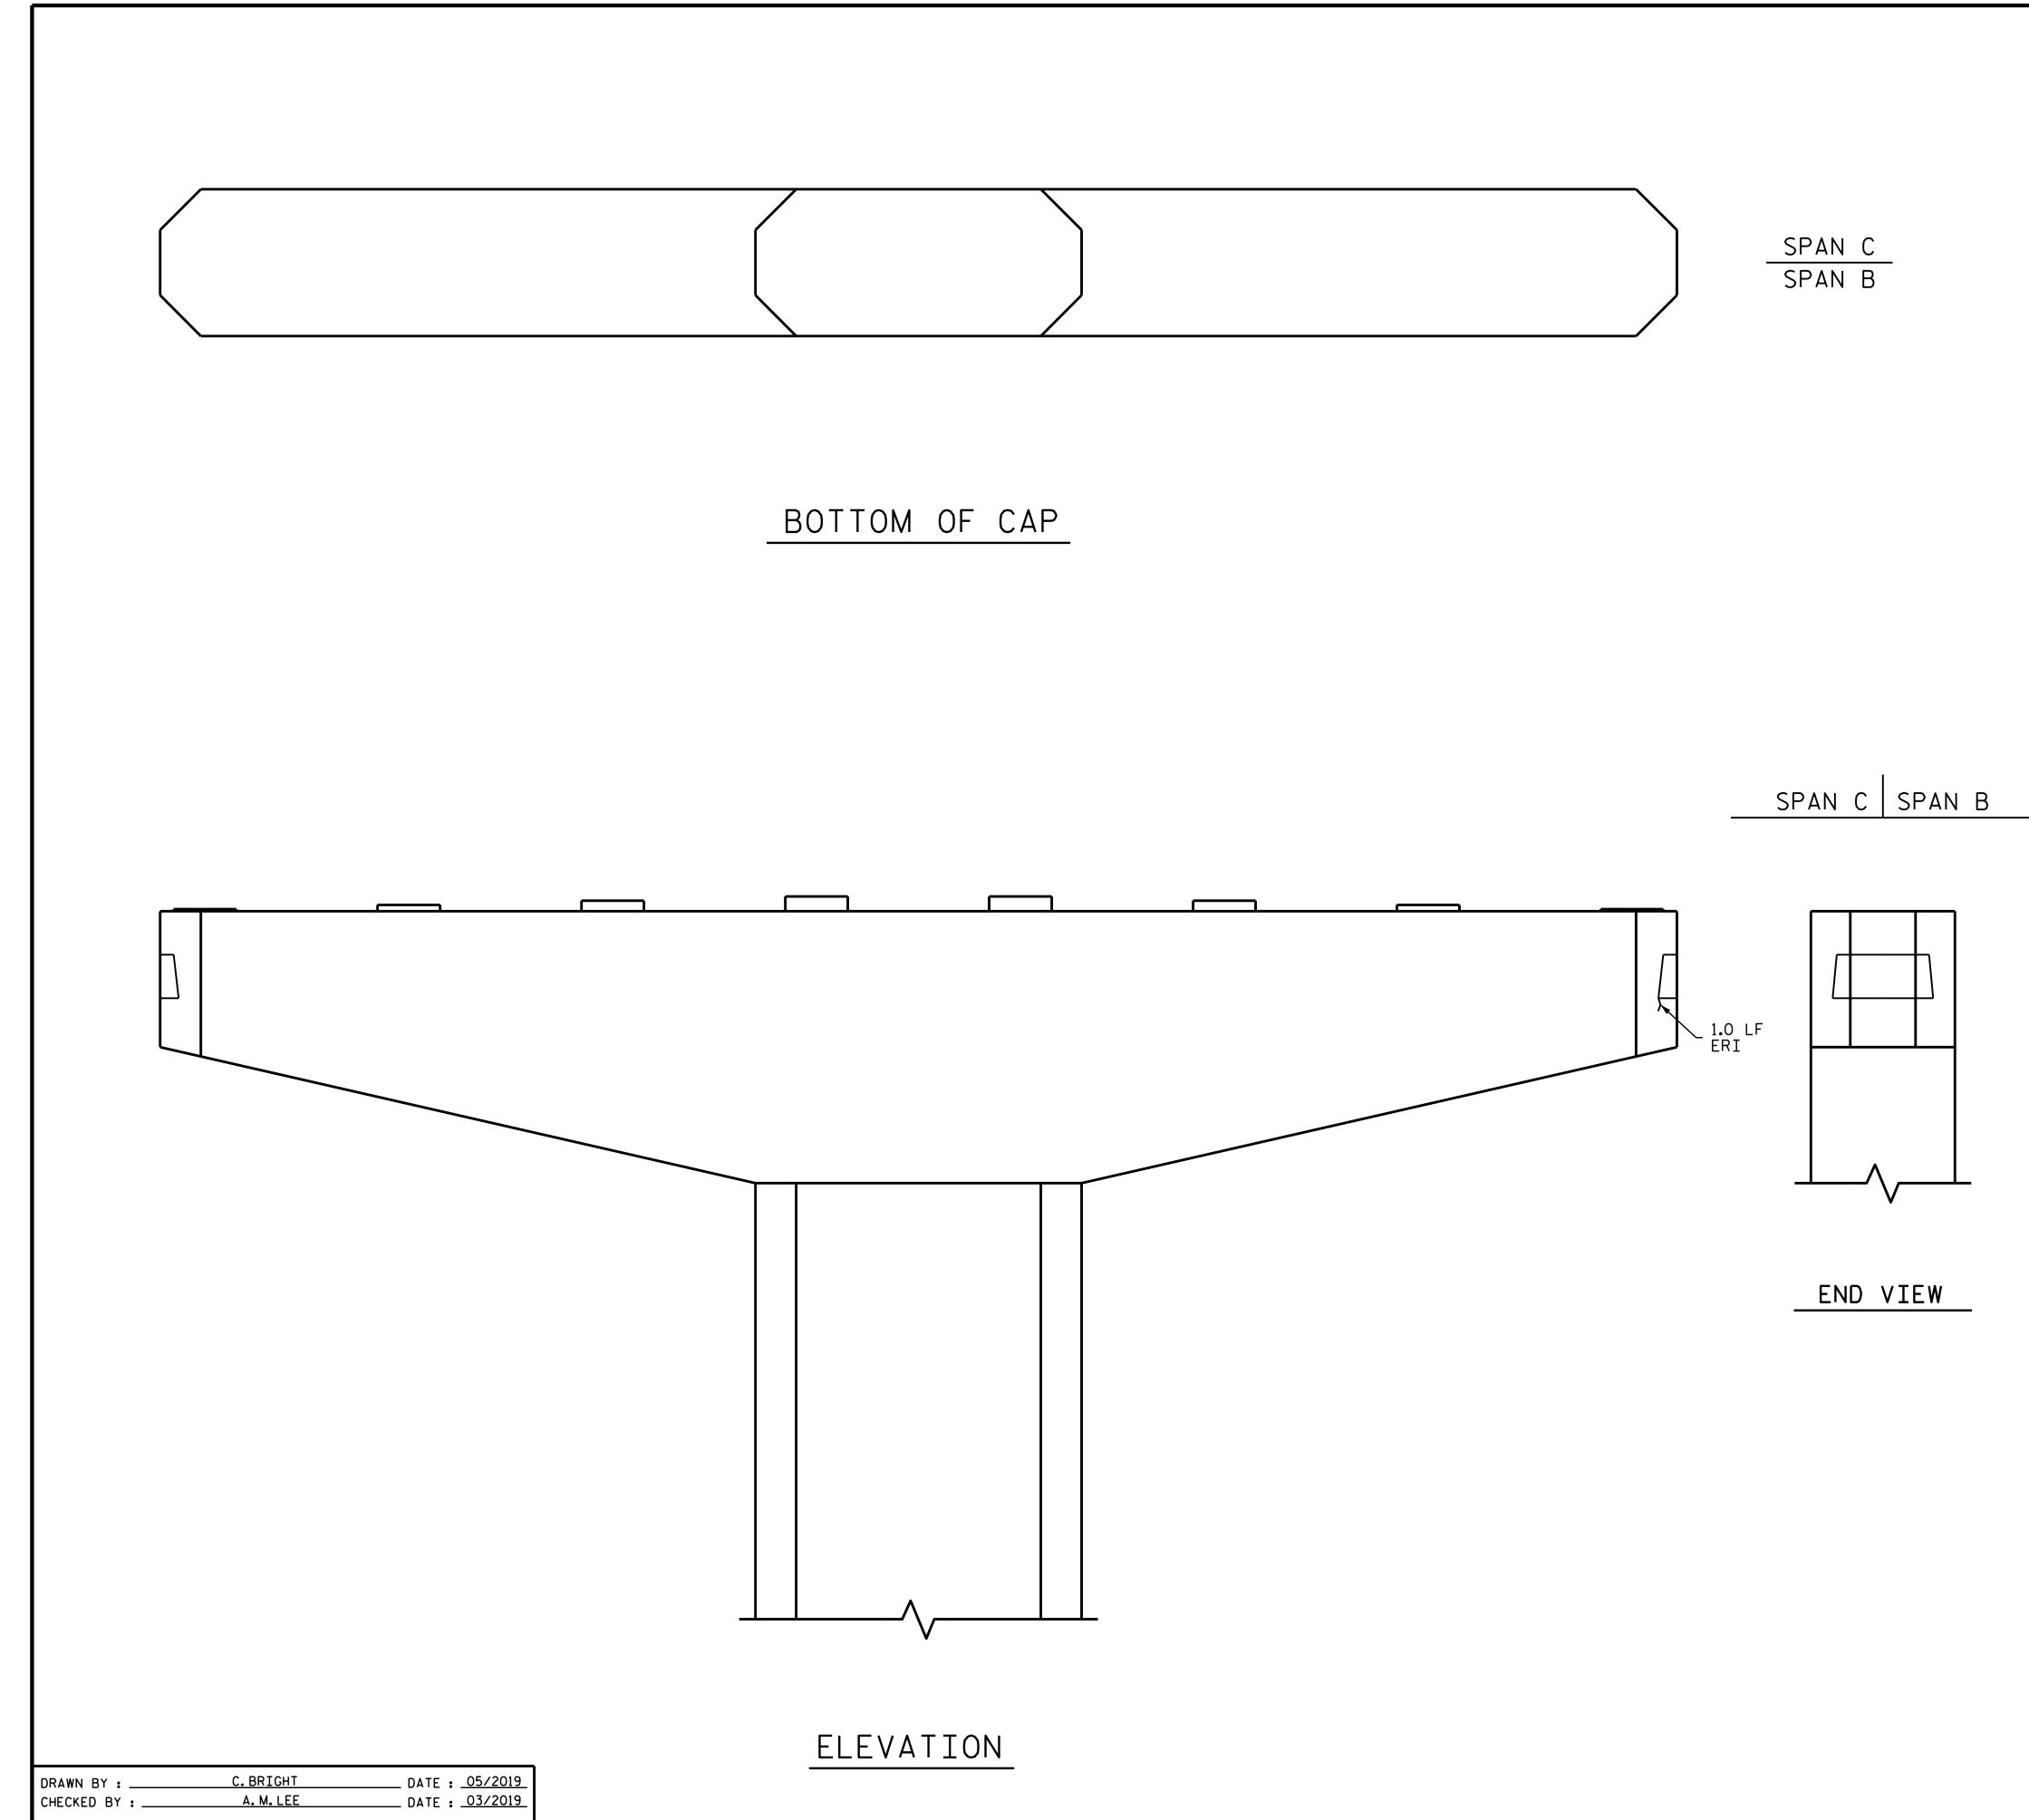
AS-BUILT REPAIR QUANTITY TABLE								
BENT 2 SPAN C FACE	QUANTITIES							
	ESII	ΜΑΤΕ	ACTUAL					
SHOTCRETE REPAIRS	AREA SQ.FT.	VOLUME CU.FT.	AREA SQ.FT.	VOLUME CU.FT.				
САР	0.0	0.0						
COLUMN	0.0	0.0						
CONCRETE REPAIRS	AREA SQ.FT.	VOLUME CU.FT.	AREA SQ.FT.	VOLUME CU.FT.				
САР	0.0	0.0						
COLUMN	0.0	0.0						
EPOXY RESIN INJECTIO	LIN.FT.	LIN.FT.						
САР	1.0							
COLUMN	0.0

VALUES IN CHART REPRESENT ESTIMATED REPAIR TOTALS AFTER REMOVAL OF UNSOUND CONCRETE, MINIMUM OF 1"BEHIND REBAR AND MINIMUM 2"CLEARANCE TO SAWCUT. SEE ``TYPICAL CAP AND COLUMN REPAIR DETAILS'' SHEET SD-01.
