PROJECT NO. 15BPR.56
BEAUFORT COUNTY
 BRIDGE NO. 060028

SHEET 11 OF 48

STATE OF NORTH CAROLINA
 DEPARTMENT OF TRANSPORTATION
 RALEIGH
SUBSTRUCTURE
BENT 11 REPAIR

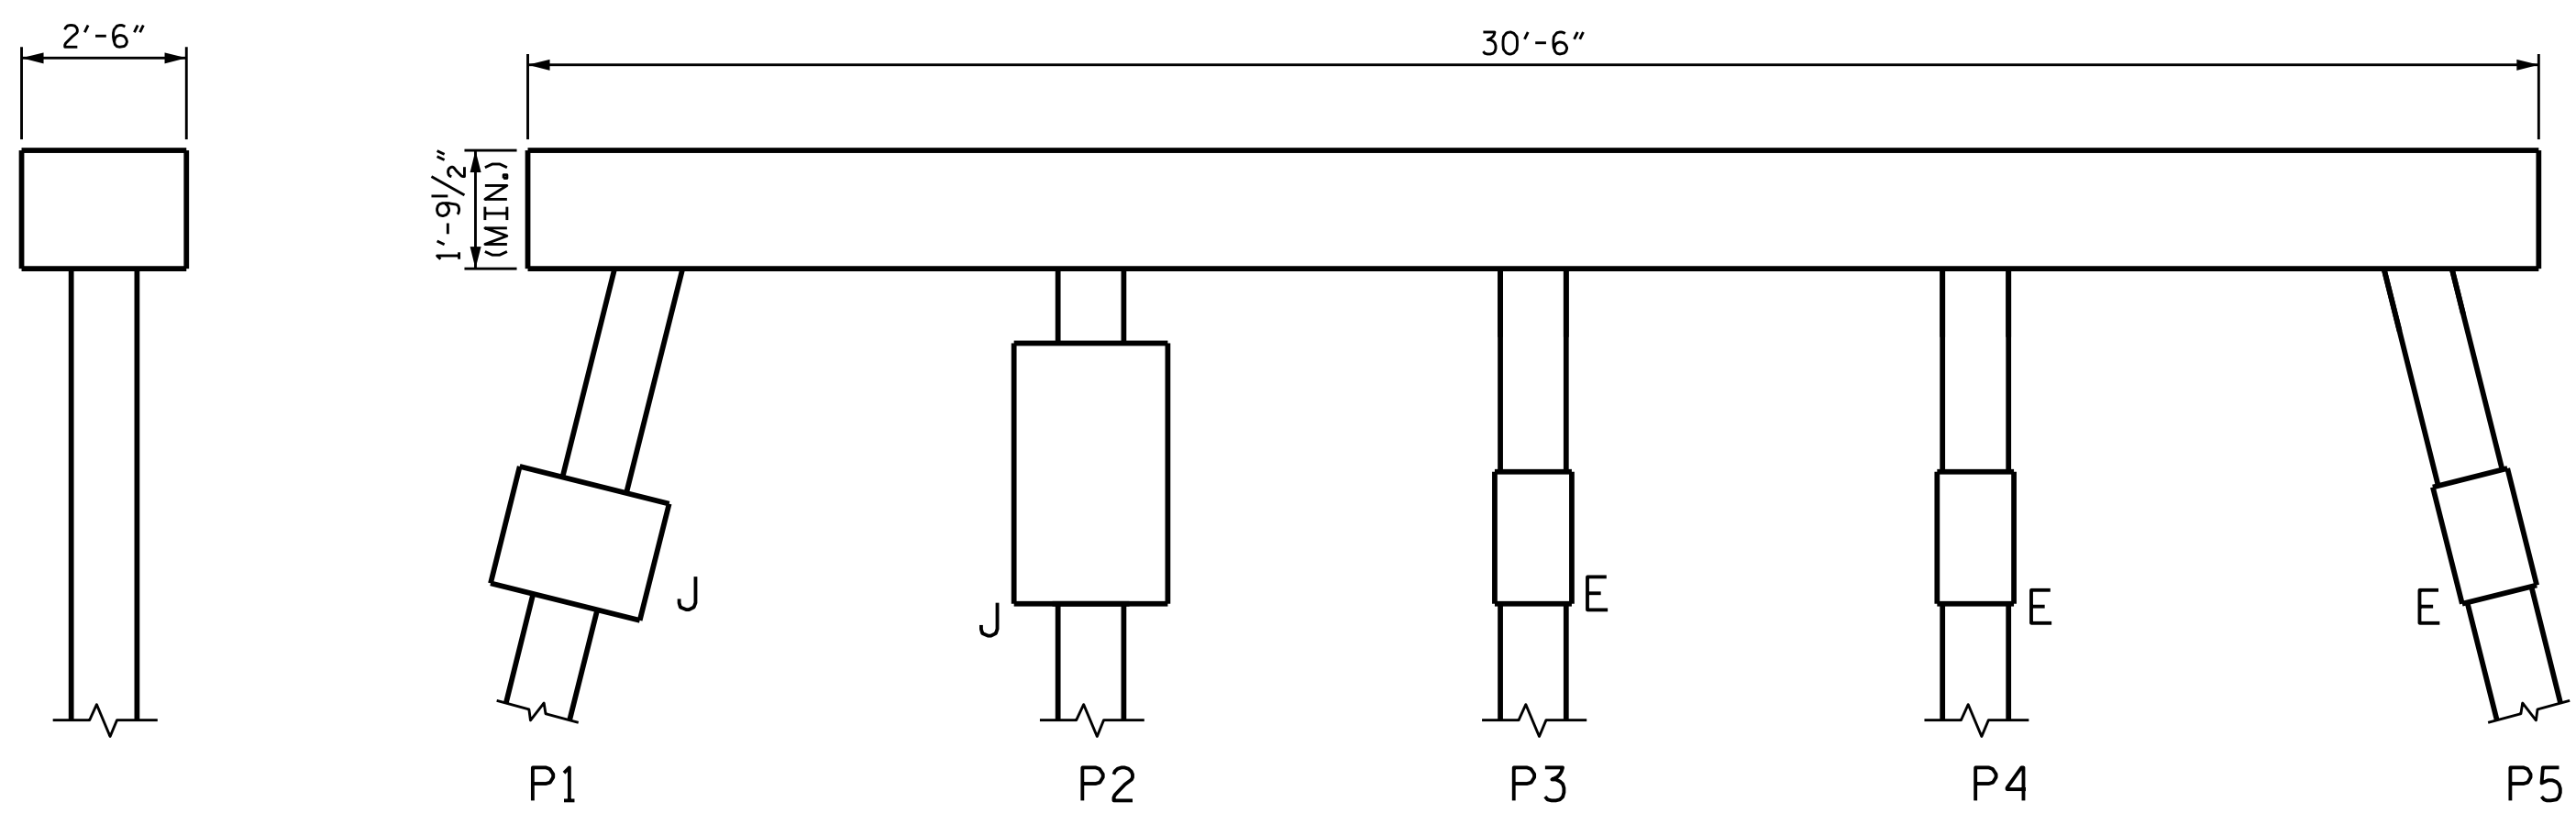
ELEVATION
(WEST SIDE)

NORTH END

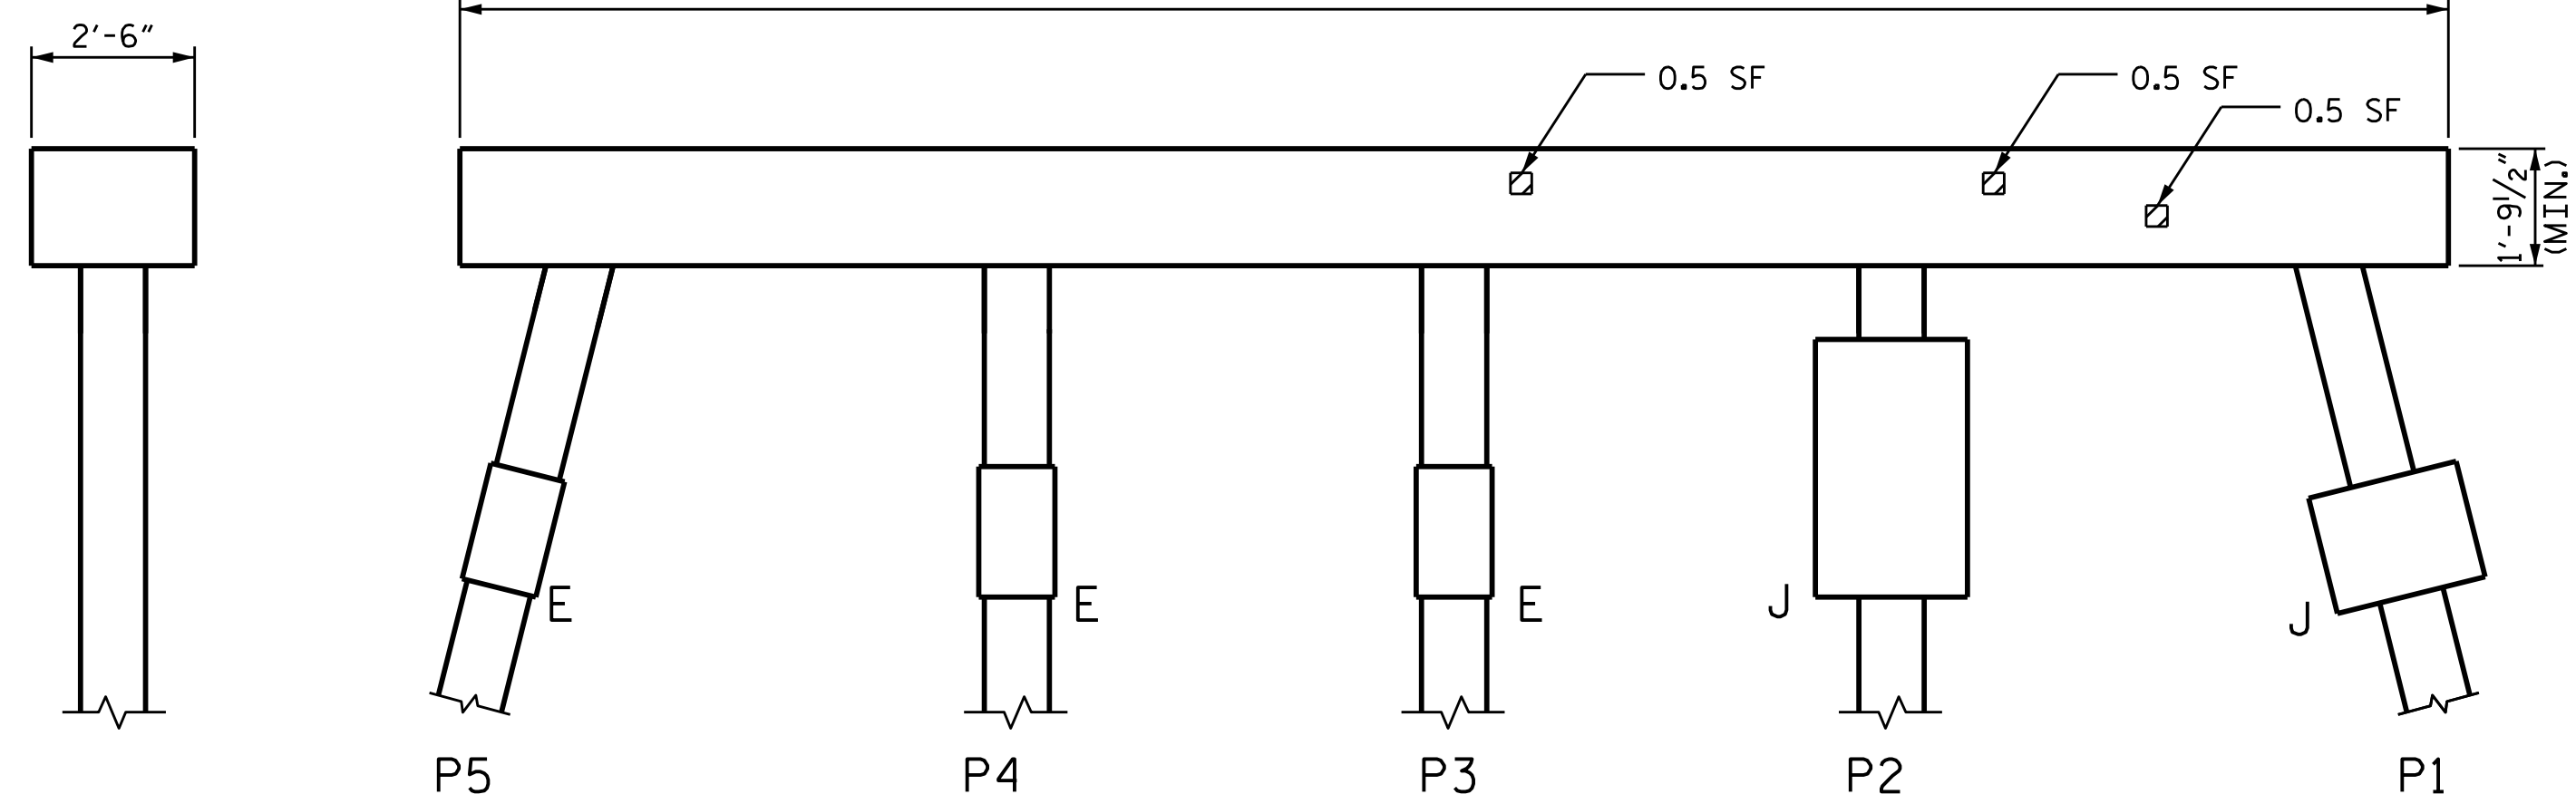
ELEVATION
(EAST SIDE)

SOUTH END

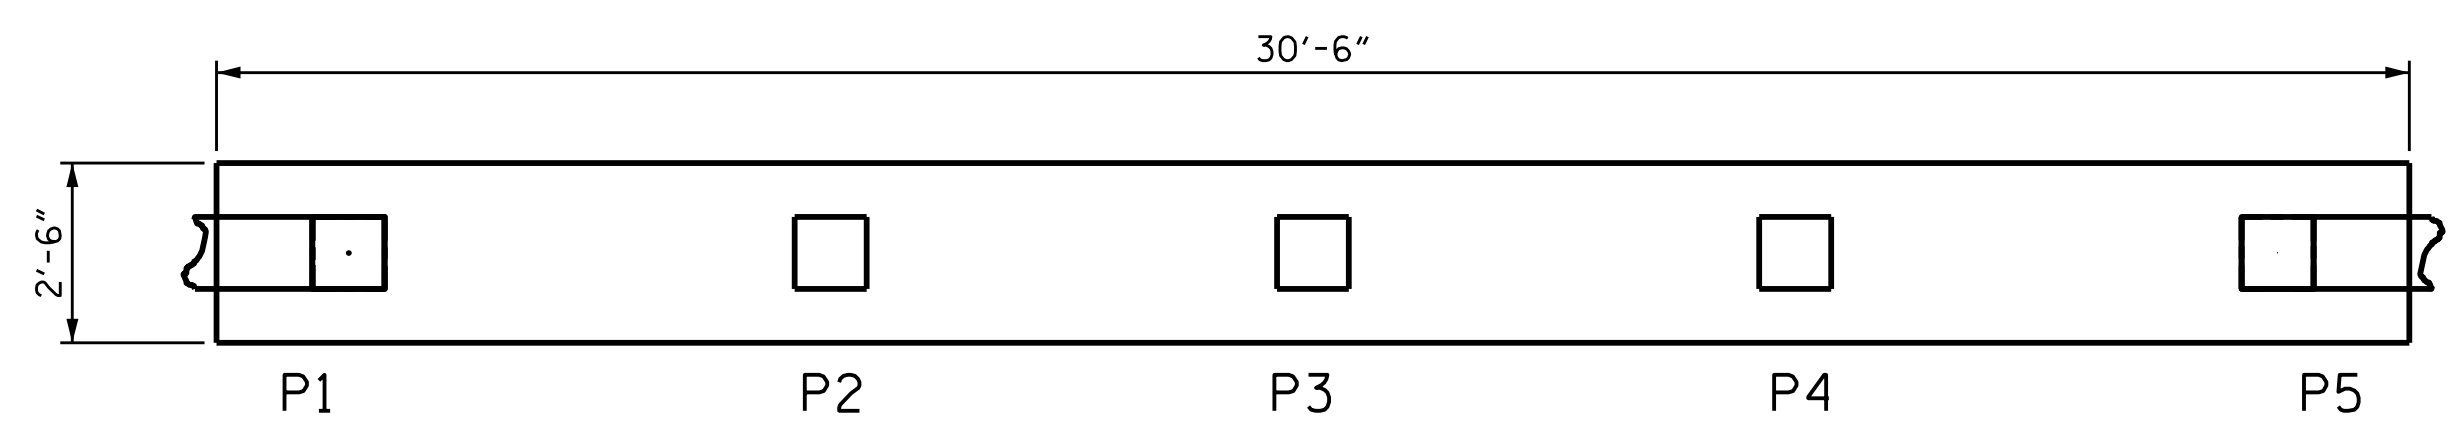
BOTTOM OF CAP

SPAN 11
SPAN 12
