PROJECT NO. 15BPR.56
BEAUFORT COUNTY
 BRIDGE NO. 060028

SHEET 21 OF 48

STATE OF NORTH CAROLINA
 DEPARTMENT OF TRANSPORTATION
 RALEIGH

**SUBSTRUCTURE
 BENT 21 REPAIR**

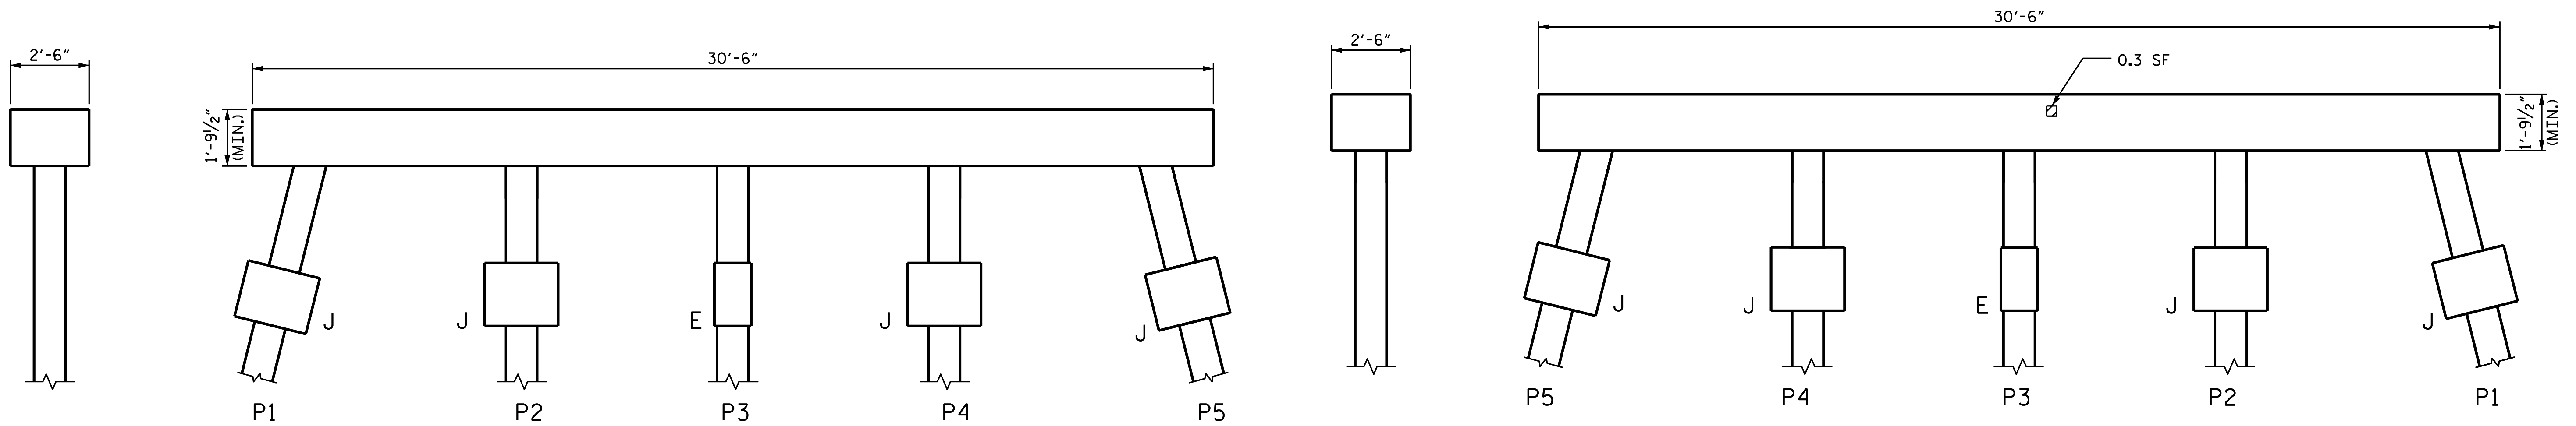
BENT 21	QUANTITIES			
	ESTIMATE		ACTUAL	
SHOTCRETE REPAIR	AREA SF	VOLUME CF	AREA SF	VOLUME CF
CAP (VERTICAL FACE)	0.3	0.2		
CAP (HORIZONTAL FACE)	0.0	0.0		
COLUMN	0.0	0.0		
CONCRETE REPAIR				
CAP (VERTICAL FACE)	0.0	0.0		
CAP (HORIZONTAL FACE)	0.0	0.0		
COLUMN	0.0	0.0		
EPOXY RESIN INJECTION		LF		LF
CAP		0.0		
COLUMN		0.0
