PROJECT NO. 15BPR.56  
BEAUFORT COUNTY  
 BRIDGE NO. 060028

SHEET 41 OF 48

**SUBSTRUCTURE  
 BENT 41 REPAIR**

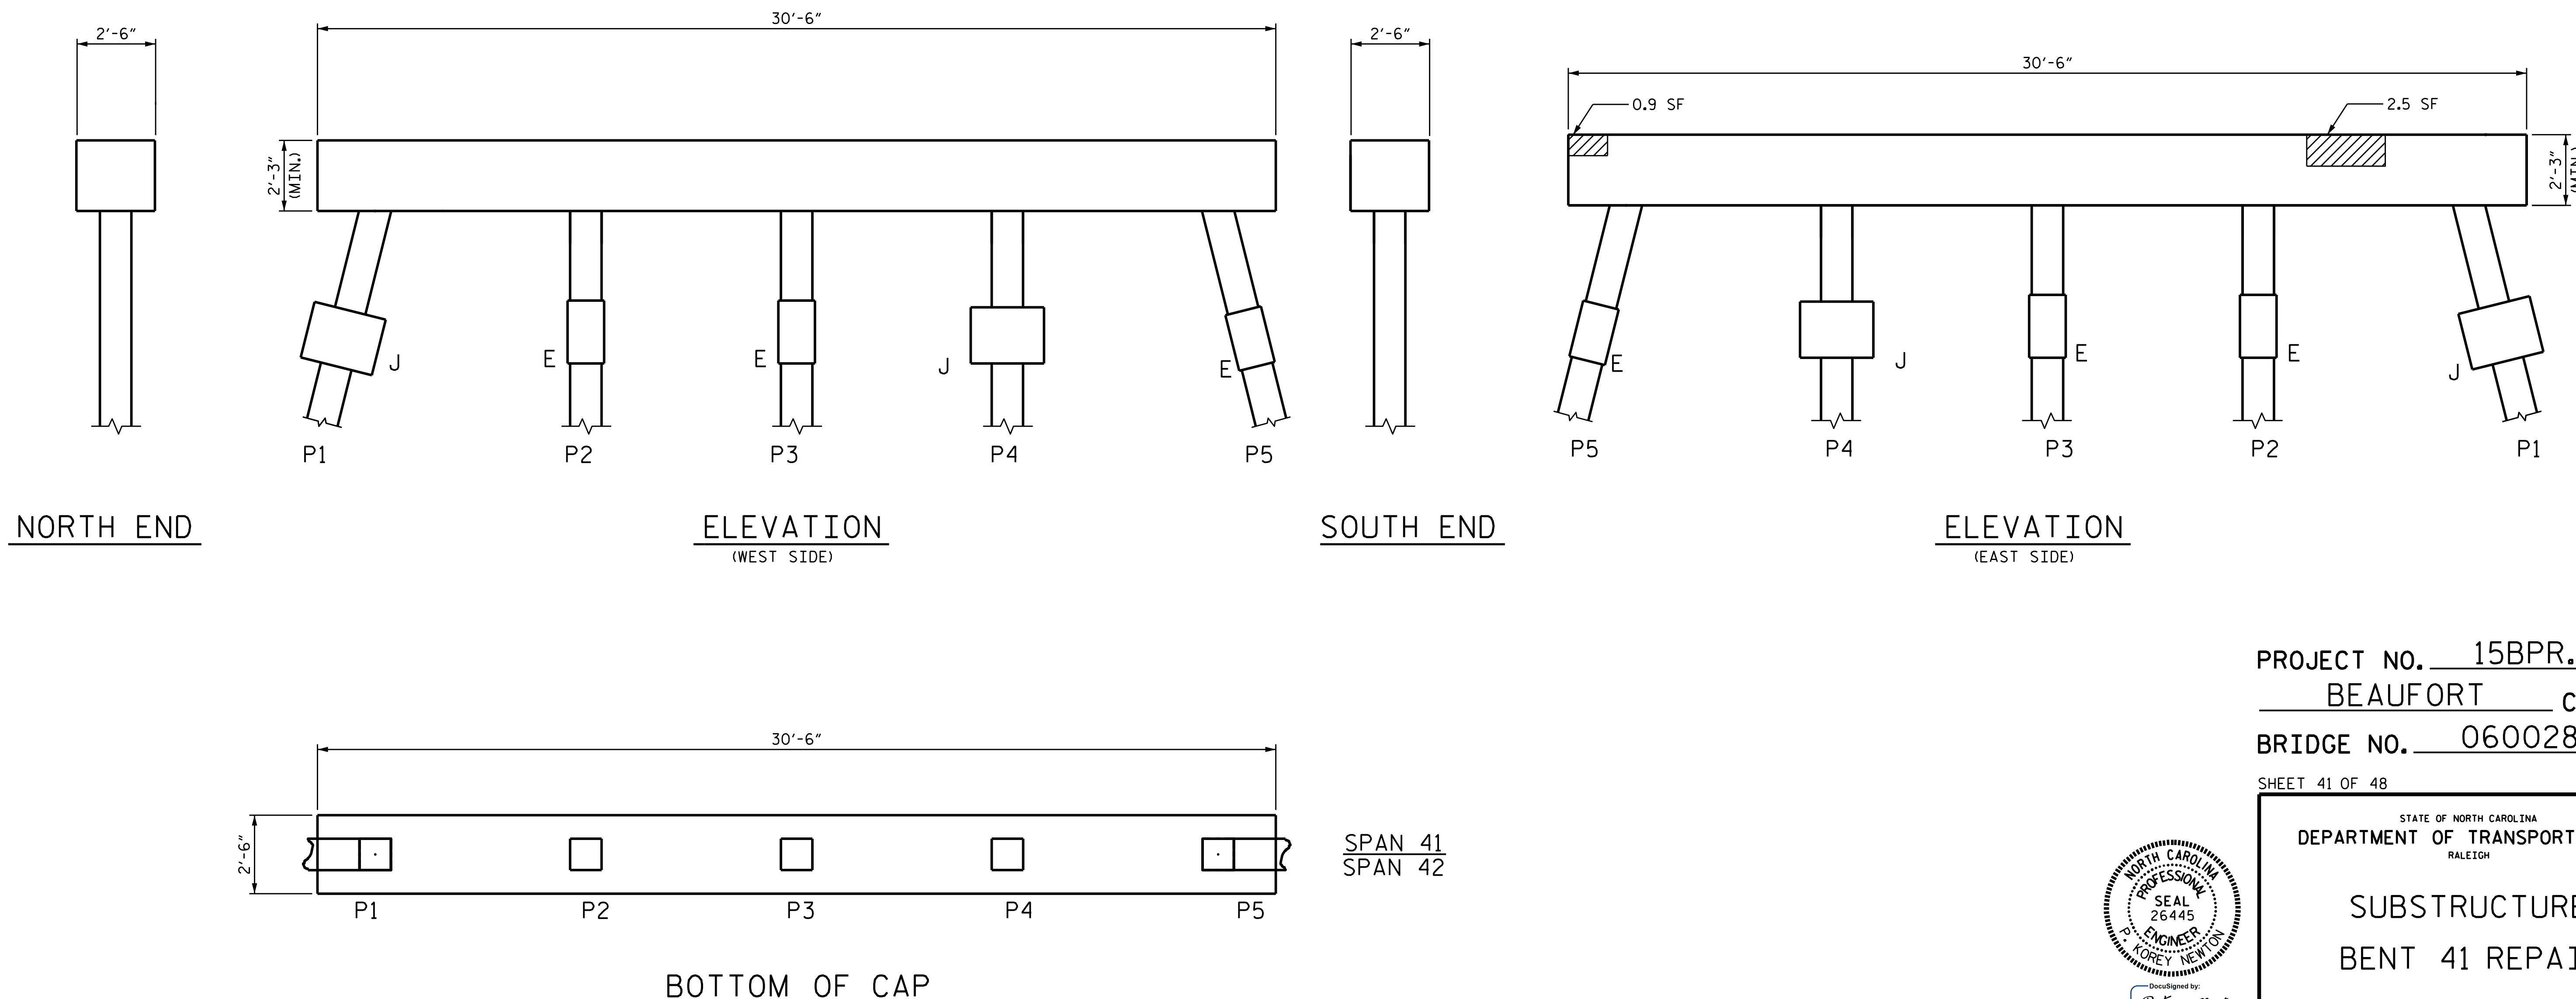
BENT 41	QUANTITIES			
	ESTIMATE		ACTUAL	
SHOTCRETE REPAIR	AREA SF	VOLUME CF	AREA SF	VOLUME CF
CAP (VERTICAL FACE)	3.4	1.7		
CAP (HORIZONTAL FACE)	0.0	0.0		
COLUMN	0.0	0.0		
CONCRETE REPAIR				
CAP (VERTICAL FACE)	0.0	0.0		
CAP (HORIZONTAL FACE)	0.0	0.0		
COLUMN	0.0	0.0		
EPOXY RESIN INJECTION		LF		LF
CAP		0.0		
COLUMN		0.0

VALUES IN CHART REPRESENT ESTIMATED REPAIR TOTALS AFTER REMOVAL OF UNSOUND CONCRETE, MINIMUM OF 1" BEHIND REBAR AND MINIMUM 2" CLEARANCE TO SAWCUT. SEE "TYPICAL CAP AND COLUMN REPAIR DETAILS" SHEET.
