PROJECT NO. I-5915B  
IREDELL COUNTY  
 BRIDGE NO. 480006

STATE OF NORTH CAROLINA  
 DEPARTMENT OF TRANSPORTATION  
 RALEIGH

## BEARING REPAIRS

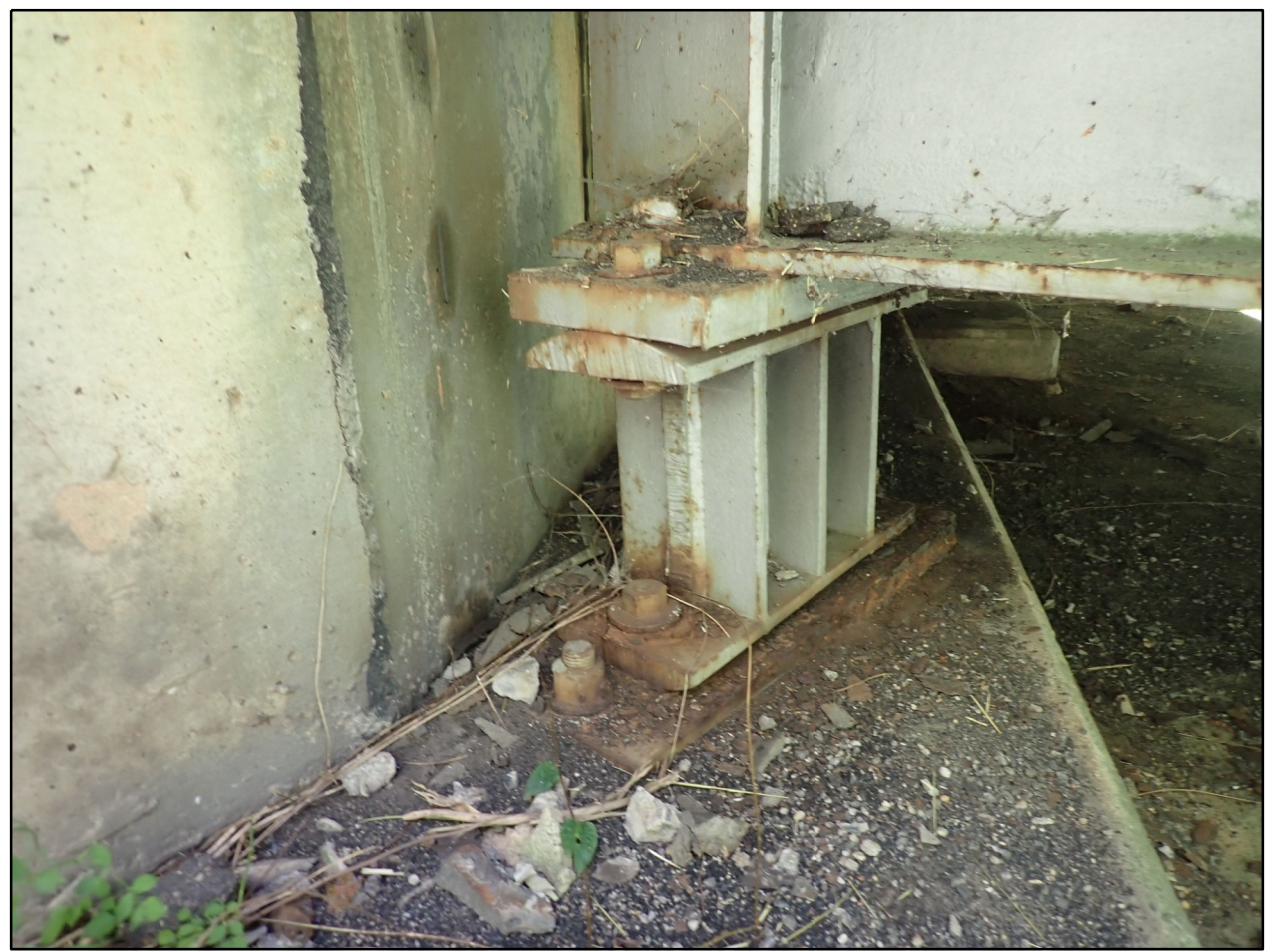
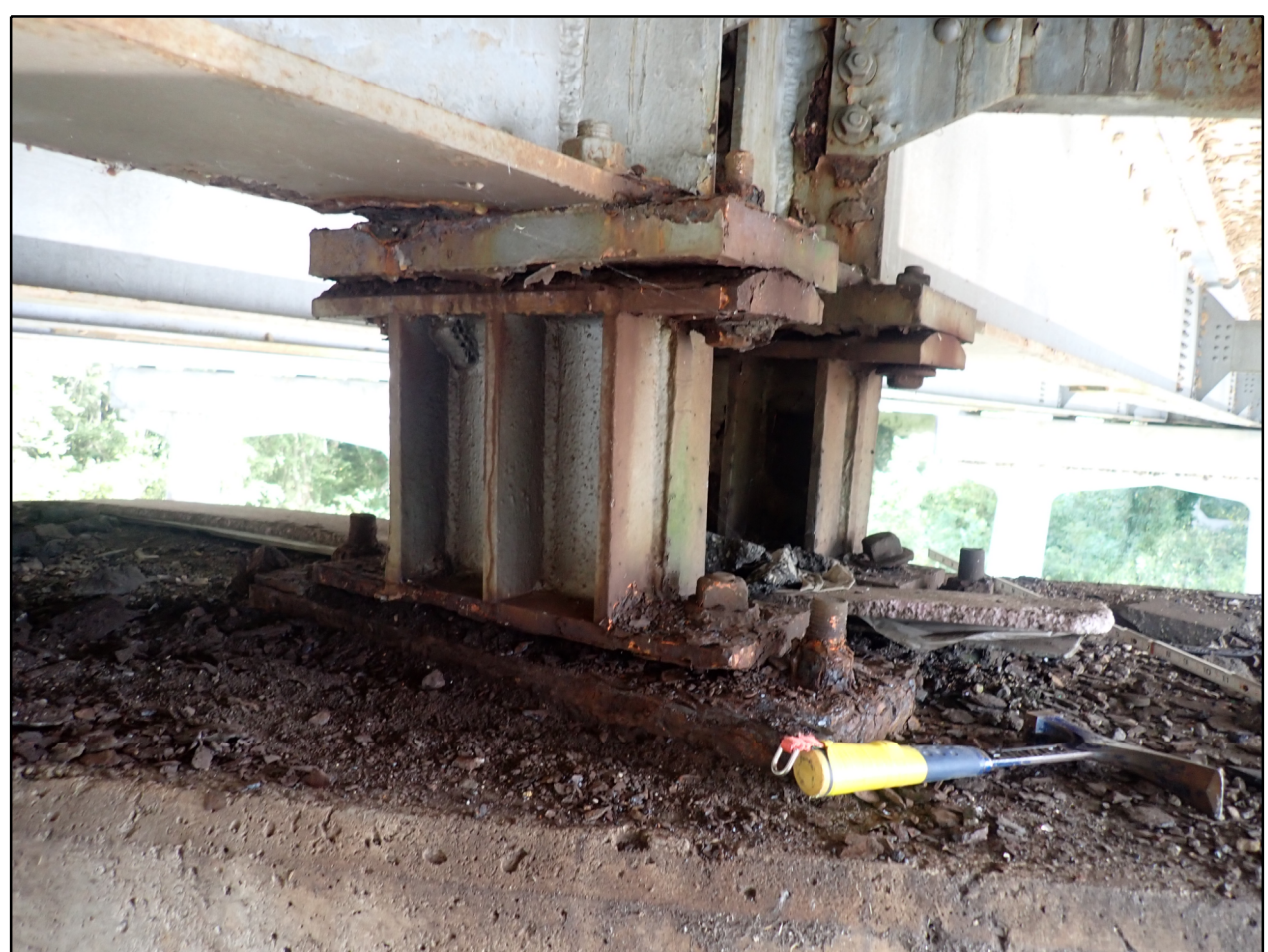
### EXISTING ROCKER BEARINGS

- TYPICAL DAMAGE INCLUDES:
- CORROSION AND SECTION LOSS THROUGHOUT
  - MISSING/BROKEN ROCKER BEARING BOLTS
  - MISALIGNED/ROTATED AND/OR SHIFTED ROCKER BEARINGS

- CLEAN AND REMOVE PACK RUST FROM ROCKER BEARING AND CONNECTING PLATES. IF, AFTER THE BEARING CLEANING PROCESS, VISIBLE STEEL CRACKS OR MORE THAN 30% SECTION LOSS ARE OBSERVED, OR IF PERMANENT DEFORMATIONS DUE TO SECTION LOSS AND PACK RUST DO NOT ALLOW ROCKER BEARINGS TO FUNCTION APPROPRIATELY, ALL WORK SHALL STOP AND THE ENGINEER SHALL BE NOTIFIED IMMEDIATELY.

- PERFORM JACKING OPERATIONS AS INDICATED IN THE "JACKING DETAILS" SHEET.
- DISCONNECT BOTH TOP AND BOTTOM ROCKER BEARING BOLTS.
- ALIGN AND/OR ROTATE ROCKER BEARINGS SUCH THAT THE VERTICAL AXIS SHALL BE AT 90° WITH RESPECT TO THE TOP FACE OF THE CAP, WITH A TOLERANCE OF +/- 2°. IN PLAN VIEW, THE CL OF THE BEARING ASSEMBLY SHALL BE ALIGNED WITH THE C GIRDER AND C BEARING LINES ON THE CAP. CONDUCT THE WORK WHEN TEMPERATURES ARE BETWEEN 45° F AND 75° F. WORK WITH THE ENGINEER TO ADJUST AS REQUIRED WHEN WORKING UNDER EXTREME TEMPERATURES.

- REPLACE MISSING/BROKEN BOLTS IN KIND AT THE GIRDER-SOLE PLATE CONNECTION, AND AT TOP ROCKER BEARING CONNECTIONS; BOLTS SHALL BE FINGER TIGHT AND THEN BACKED OFF 1/2 TURN. FOR BOTTOM ROCKER BEARING CONNECTIONS, WELD A KEEPER PLATE TO BOTH SIDES OF THE ROCKER BEARING BOTTOM FLANGE.
