PROJECT NO. I-5915B
IREDELL COUNTY
 BRIDGE NO. 480007

STATE OF NORTH CAROLINA
 DEPARTMENT OF TRANSPORTATION
 RALEIGH

BEARING REPAIRS

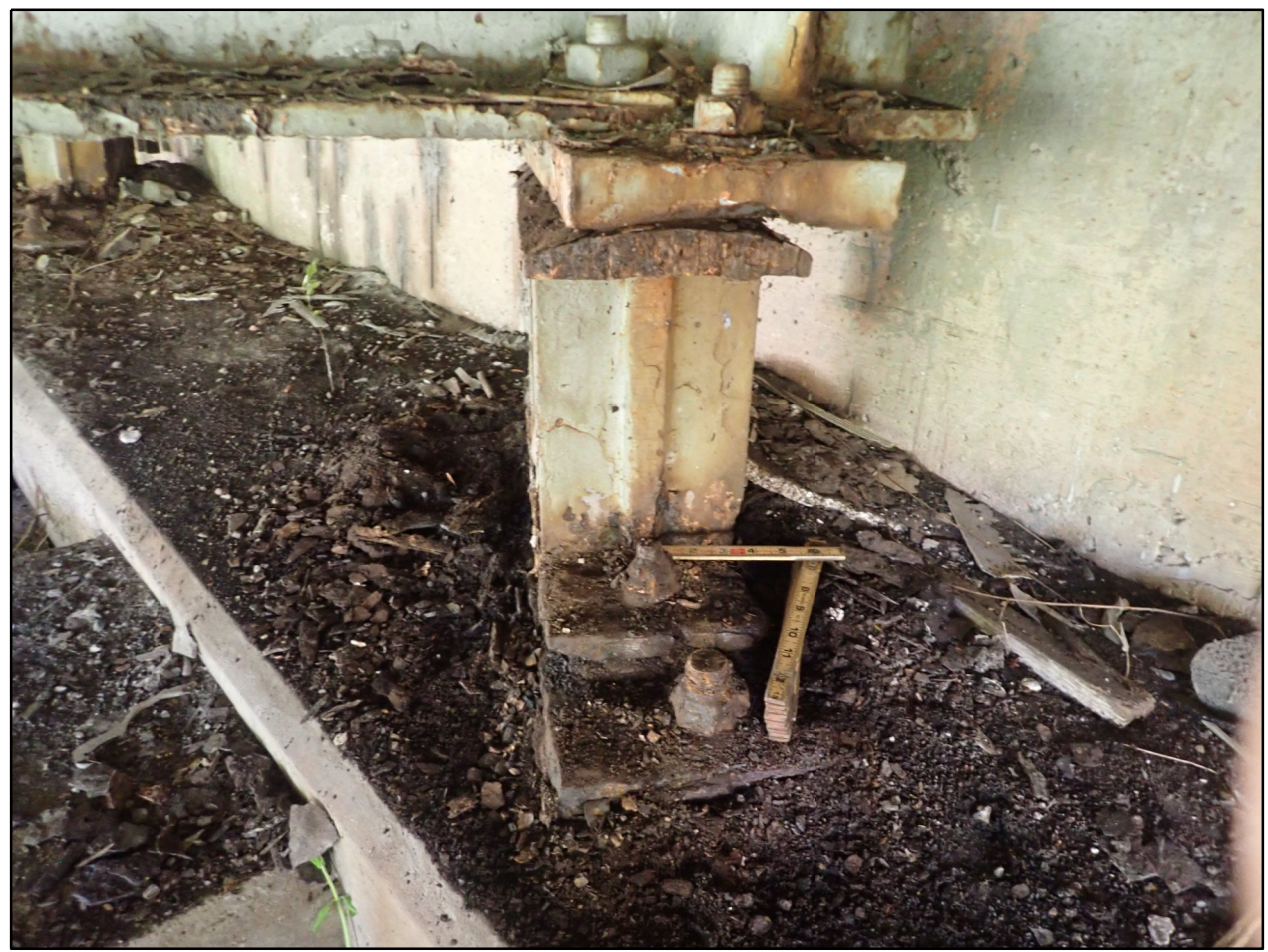
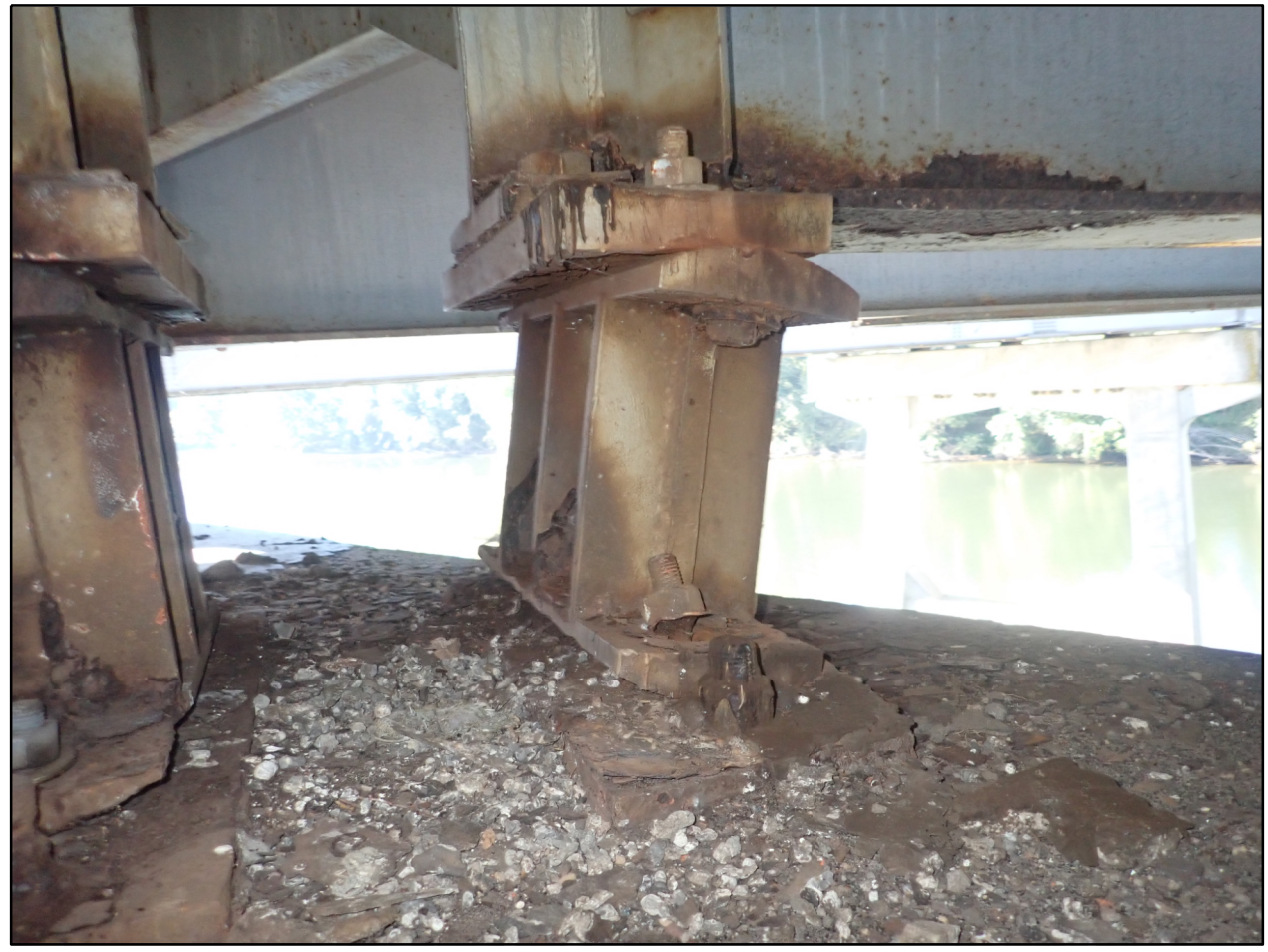
EXISTING ROCKER BEARINGS

- TYPICAL DAMAGE INCLUDES:
- CORROSION AND SECTION LOSS THROUGHOUT
 - MISSING/BROKEN ROCKER BEARING BOLTS
 - MISALIGNED/ROTATED AND/OR SHIFTED ROCKER BEARINGS

- CLEAN AND REMOVE PACK RUST FROM ROCKER BEARING AND CONNECTING PLATES. IF, AFTER THE BEARING CLEANING PROCESS, VISIBLE STEEL CRACKS OR MORE THAN 30% SECTION LOSS ARE OBSERVED, OR IF PERMANENT DEFORMATIONS DUE TO SECTION LOSS AND PACK RUST DO NOT ALLOW ROCKER BEARINGS TO FUNCTION APPROPRIATELY, ALL WORK SHALL STOP AND THE ENGINEER SHALL BE NOTIFIED IMMEDIATELY.

- PERFORM JACKING OPERATIONS AS INDICATED IN THE "JACKING DETAILS" SHEET.
- DISCONNECT BOTH TOP AND BOTTOM ROCKER BEARING BOLTS.
- ALIGN AND/OR ROTATE ROCKER BEARINGS SUCH THAT THE VERTICAL AXIS SHALL BE AT 90° WITH RESPECT TO THE TOP FACE OF THE CAP, WITH A TOLERANCE OF +/- 2°. IN PLAN VIEW, THE CL OF THE BEARING ASSEMBLY SHALL BE ALIGNED WITH THE C GIRDER AND C BEARING LINES ON THE CAP. CONDUCT THE WORK WHEN TEMPERATURES ARE BETWEEN 45° F AND 75° F. WORK WITH THE ENGINEER TO ADJUST AS REQUIRED WHEN WORKING UNDER EXTREME TEMPERATURES.

- REPLACE MISSING/BROKEN BOLTS IN KIND AT THE GIRDER-SOLE PLATE CONNECTION, AND AT TOP ROCKER BEARING CONNECTIONS; BOLTS SHALL BE FINGER TIGHT AND THEN BACKED OFF 1/2 TURN. FOR BOTTOM ROCKER BEARING CONNECTIONS, WELD A KEEPER PLATE TO BOTH SIDES OF THE ROCKER BEARING BOTTOM FLANGE.

- CONCLUDE JACKING OPERATIONS AS INDICATED IN THE "JACKING DETAILS" SHEET.
- ENSURE THAT THE BEARINGS ARE NOT LEFT UNRESTRAINED DURING TEMPERATURE MOVEMENTS. IF THE CONTRACTOR MUST DE-MOBILIZE, WORK WITH THE ENGINEER TO PROVIDE TEMPORARY REPLACEMENT OF THE BOLTS TO PROHIBIT UNWANTED ROTATION OF THE ROCKER BEARINGS.
