PROJECT NO. 15BPR.47 EDGECOMBE COUNTY BRIDGE NO. 320051

STATE OF NORTH CAROLINA DEPARTMENT OF TRANSPORTATION
RALEIGH UNDERSIDE DECK REPAIRS SPAN F

REVISIONS SHEET NO. S1-15 NO. BY: DATE: DATE: DOCUMENT NOT CONSIDERED FINAL UNLESS ALL SIGNATURES COMPLETED TOTAL SHEETS

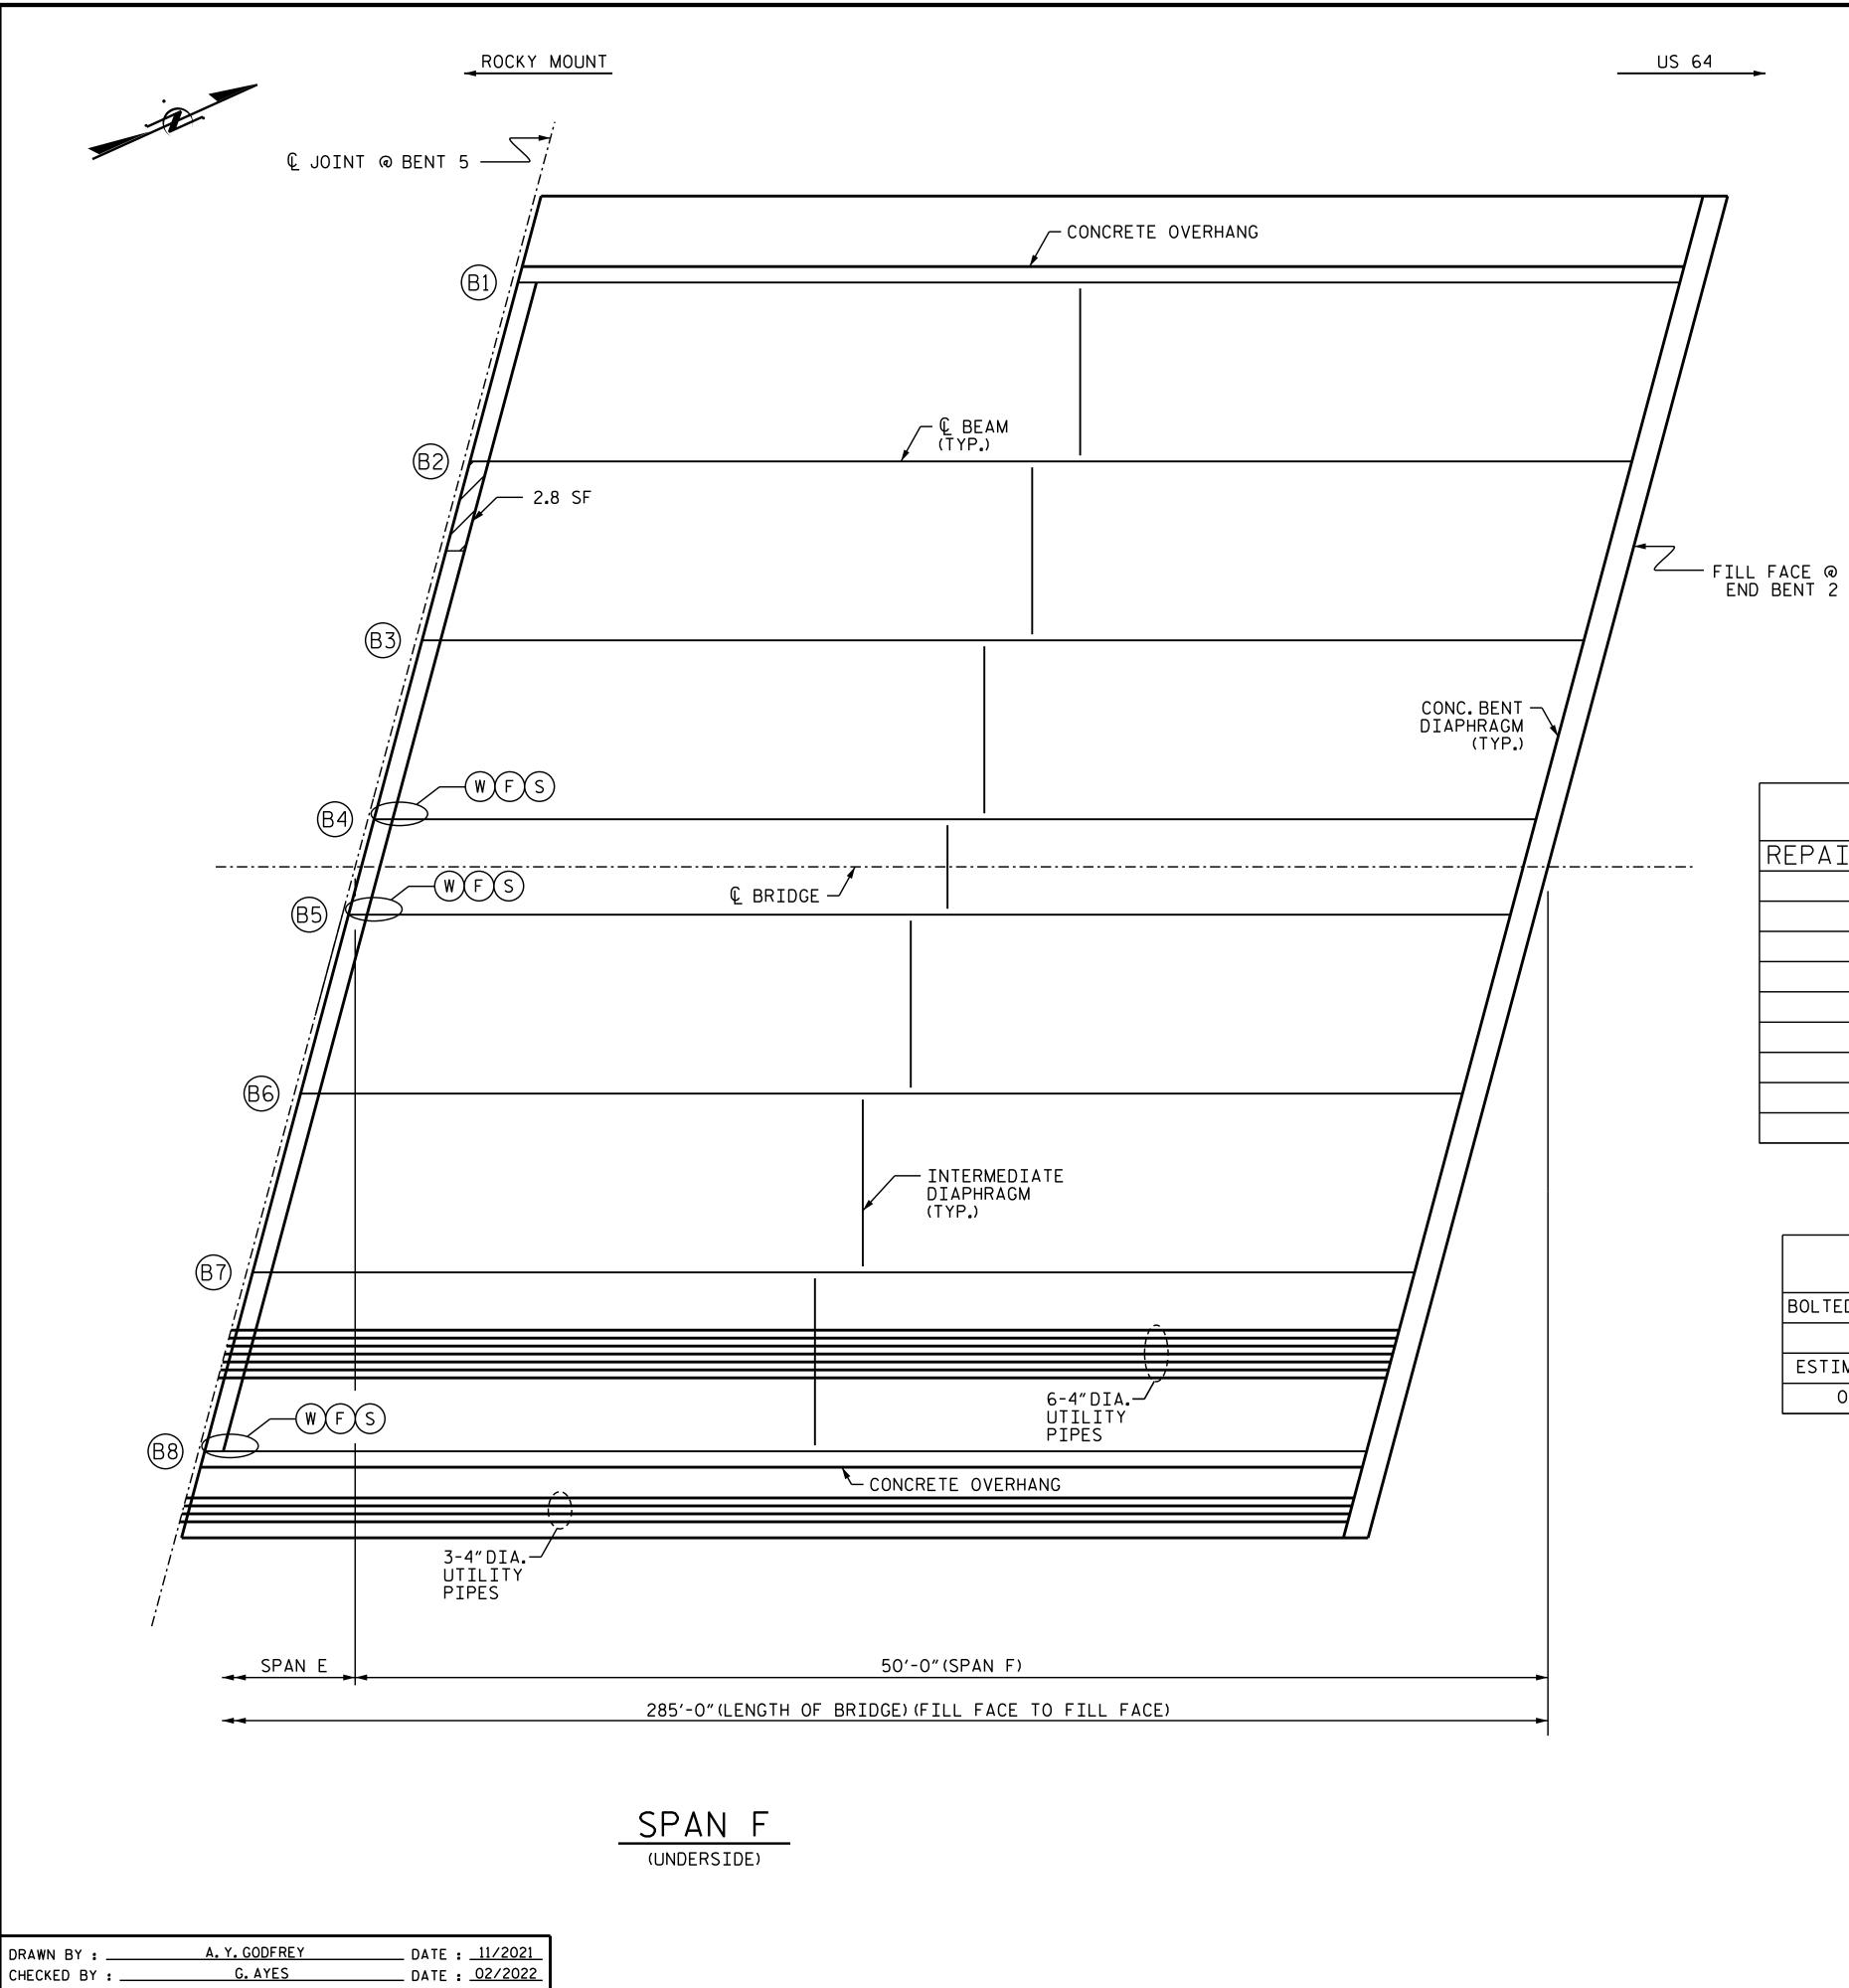
| STEEL REPAIR | | | | LOCATIONS | | | | |
|---|---|---|---|---|---|---|---|--|
| W | F | 4 | BENT 5 | 6" | 9″ | - | - | |
| F | F | 4 | BENT 5 | 51/4" | 24" | - | - | |
| S | F | 4 | BENT 5 | 3″ | - | - | - | |
| W | F | 5 | BENT 5 | 6" | 9″ | - | - | |
| F | F | 5 | BENT 5 | 5 ¹ / ₄ " | 24" | - | - | |
| S | F | 5 | BENT 5 | 4" | - | - | - | |
| W | F | 8 | BENT 5 | 8″ | 60″ | - | - | |
| F | F | 8 | BENT 5 | 51/4" | 60" | - | - | |
| S | F | 8 | BENT 5 | 5″ | _ | - | _ | |

(SEE SHEETS S1-27 AND S1-28 FOR BEAM REPAIR DETAILS AND DIMENSIONS.)
