NC DEPARTMENT OF TRANSPORTATION  
 DIVISION OF HIGHWAYS  
 STRUCTURE MANAGEMENT UNIT

ATTENTION: DATA CHANGES

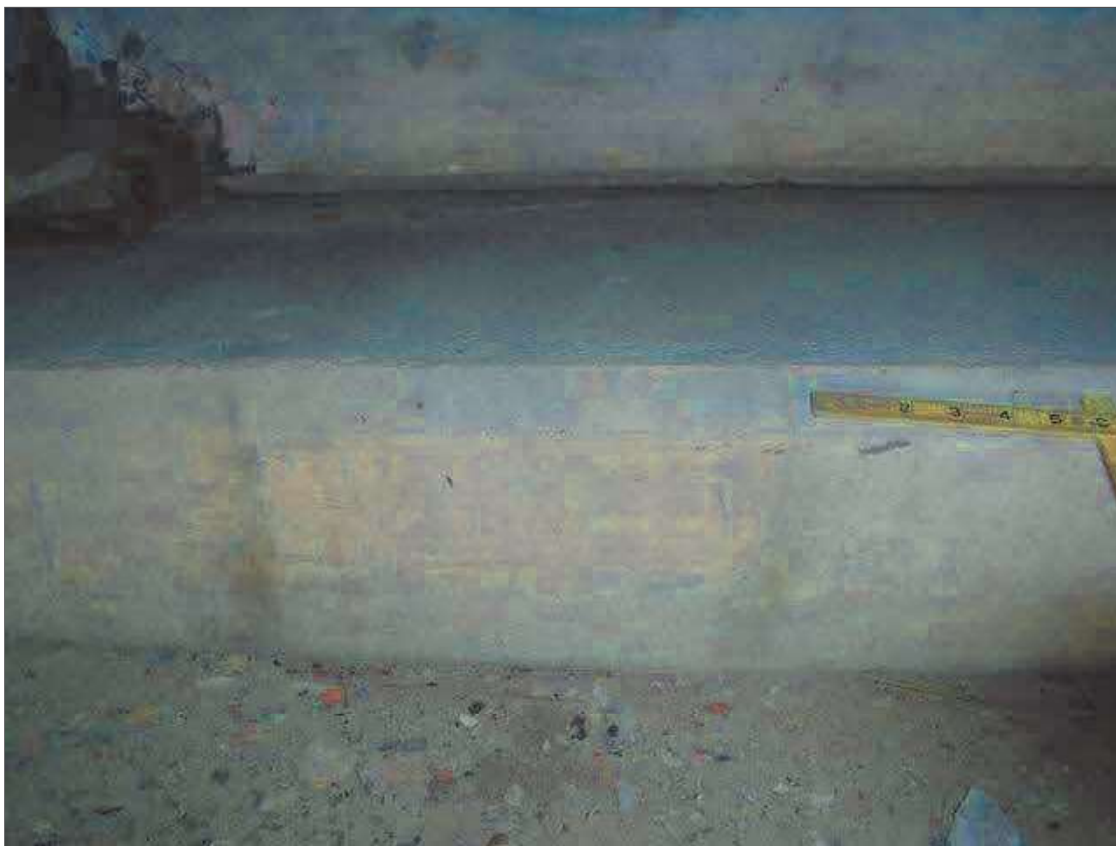
End Bent 1 Cap 1: Several hairline cracks at various locations along the top and front face of cap.

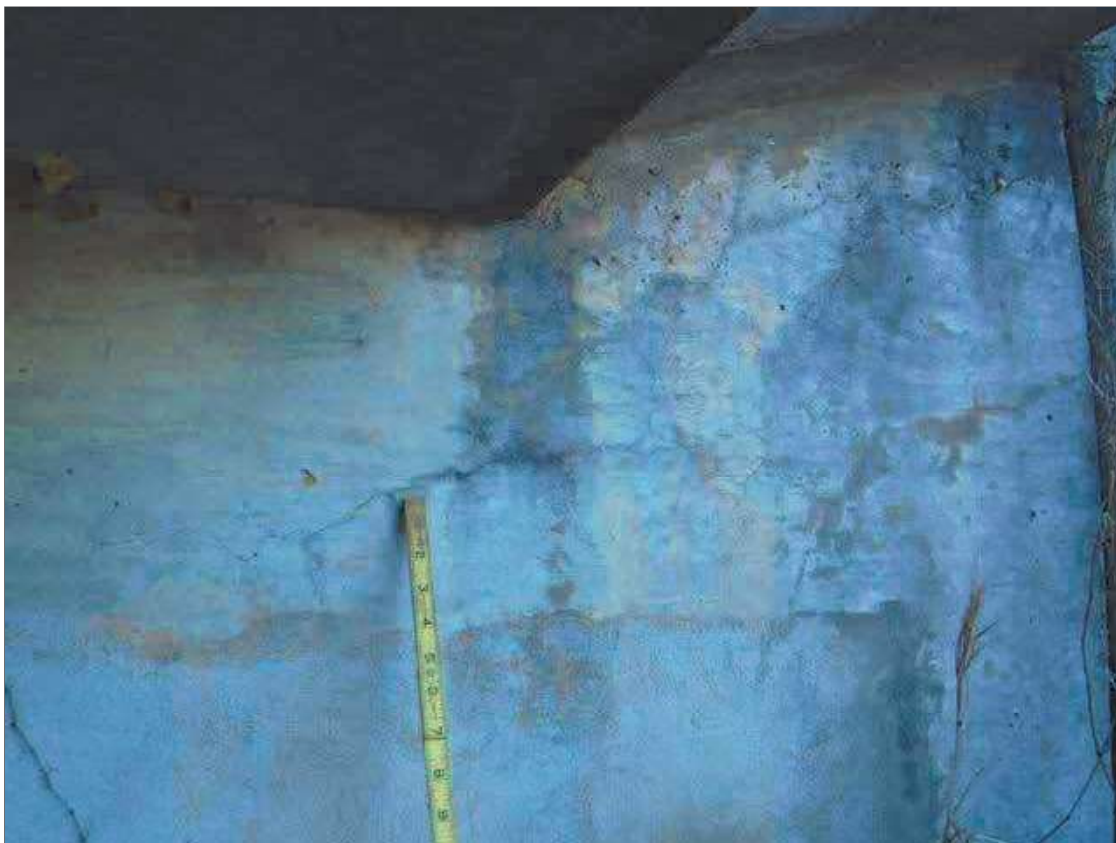
End Bent 1 Abutment: Hairline map cracking in on north end near wing wall

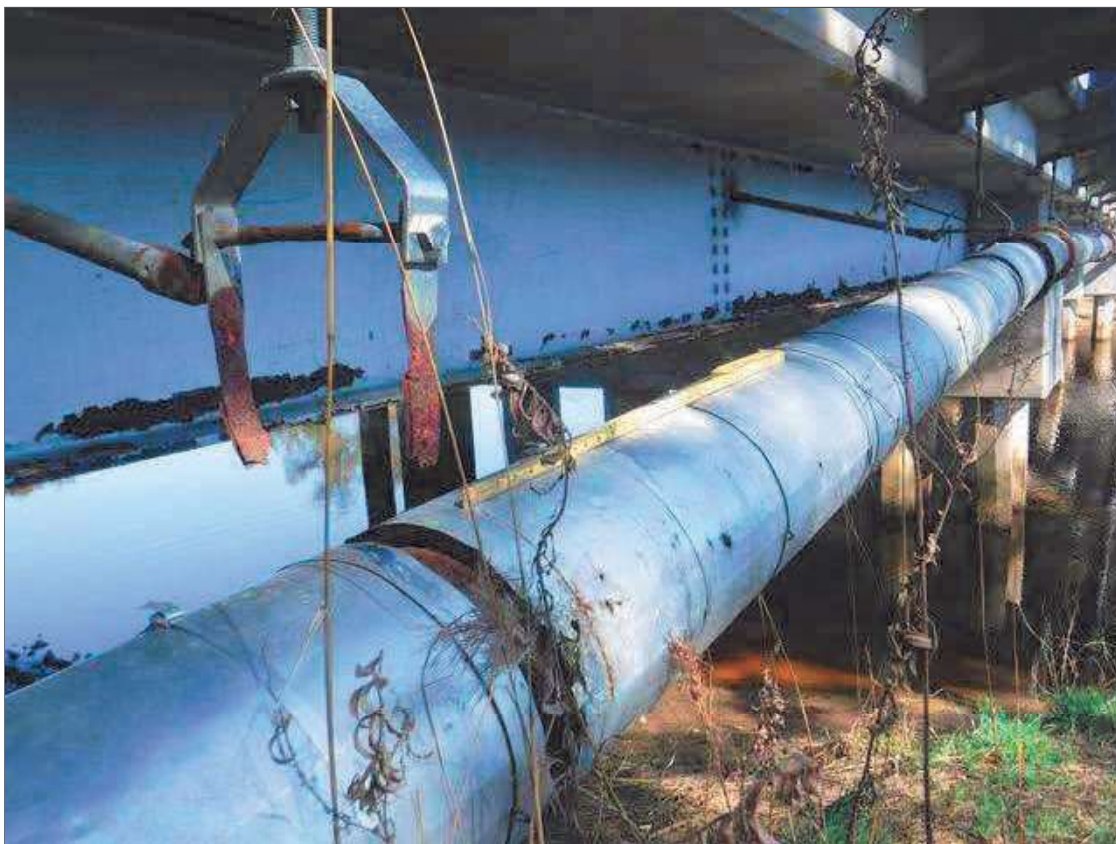
(2) BROKEN UTILITY HANGERS ATTACHED TO RIGHT OVERHANG AND BEAM 4 NEAR END BENT 1

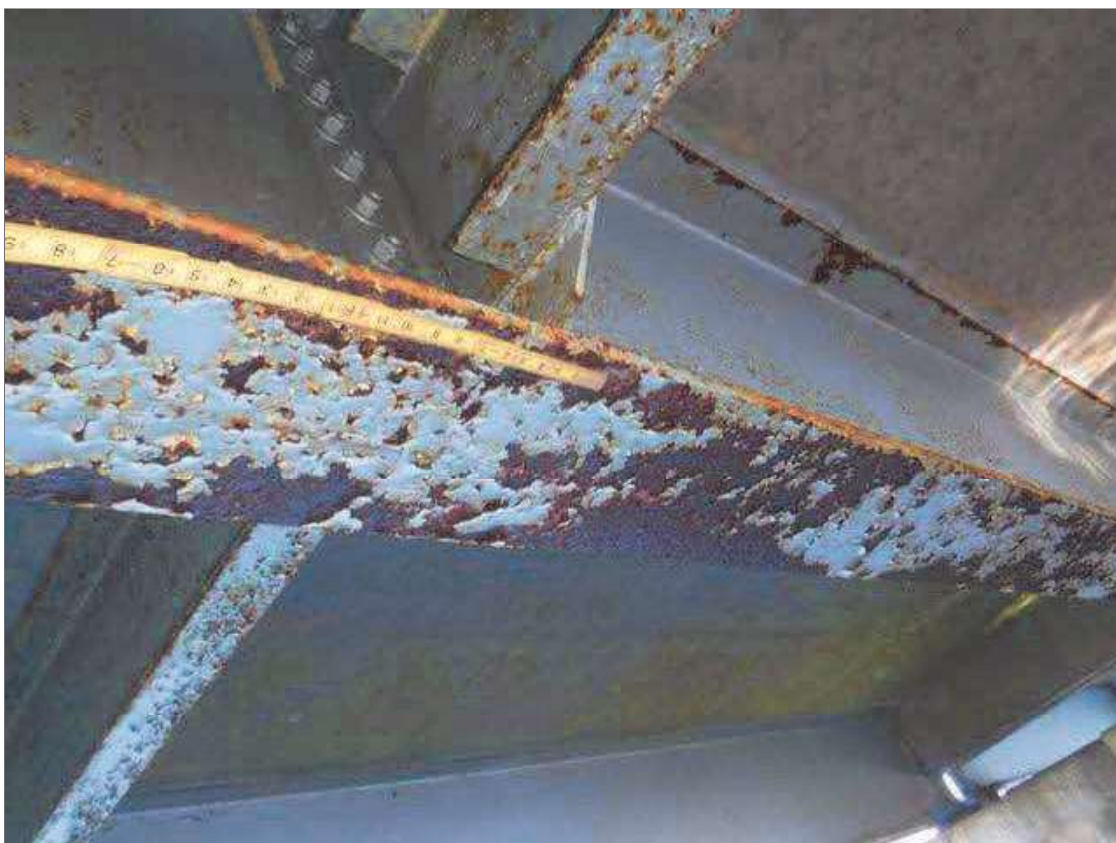
Span 1 Beam 2: Minor corrosion with pack rust initiating with no measurable section loss on bottom 9" web and bottom flange for 1' at pier 1. Light surface rust on bottom of web and top and bottom flanges along full length of beam.

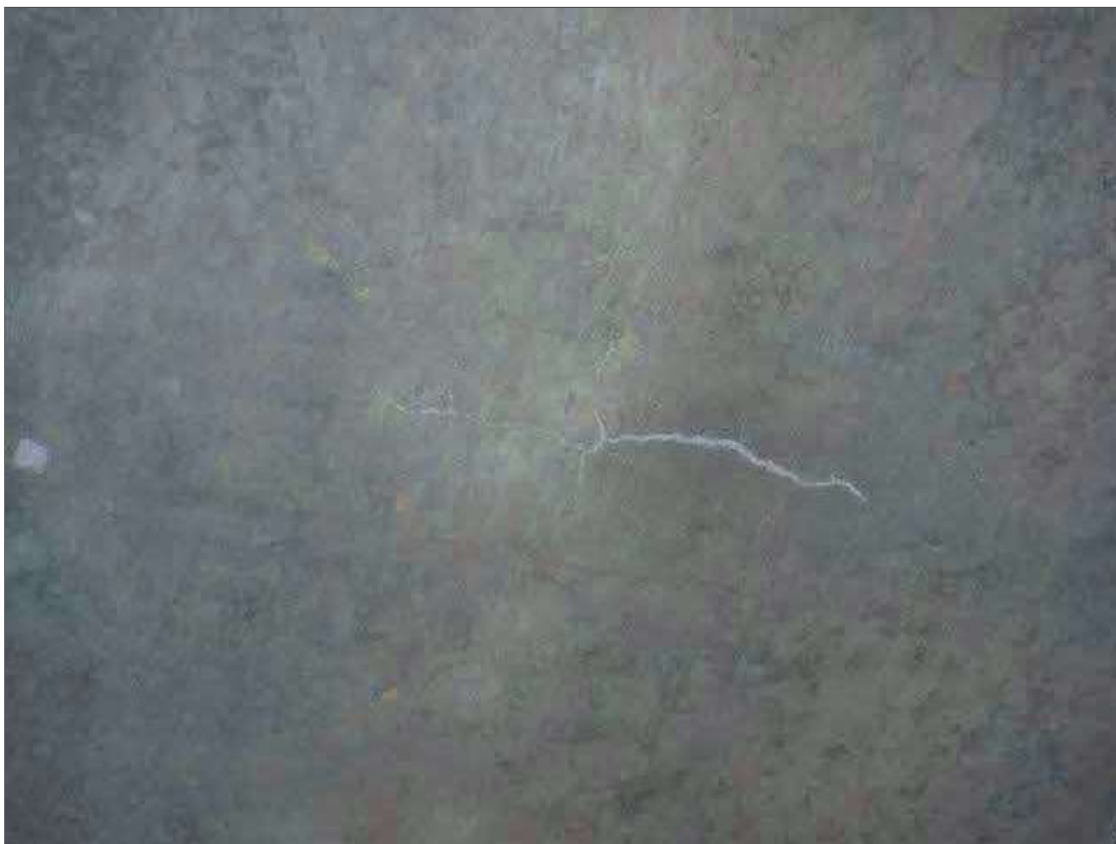
Span 1 Deck: UP TO 0.012" TRANSVERSE CRACKS WITH EFFLORESCENCE IN VARIOUS LOCATIONS THROUGHOUT BOTTOM OF DECK

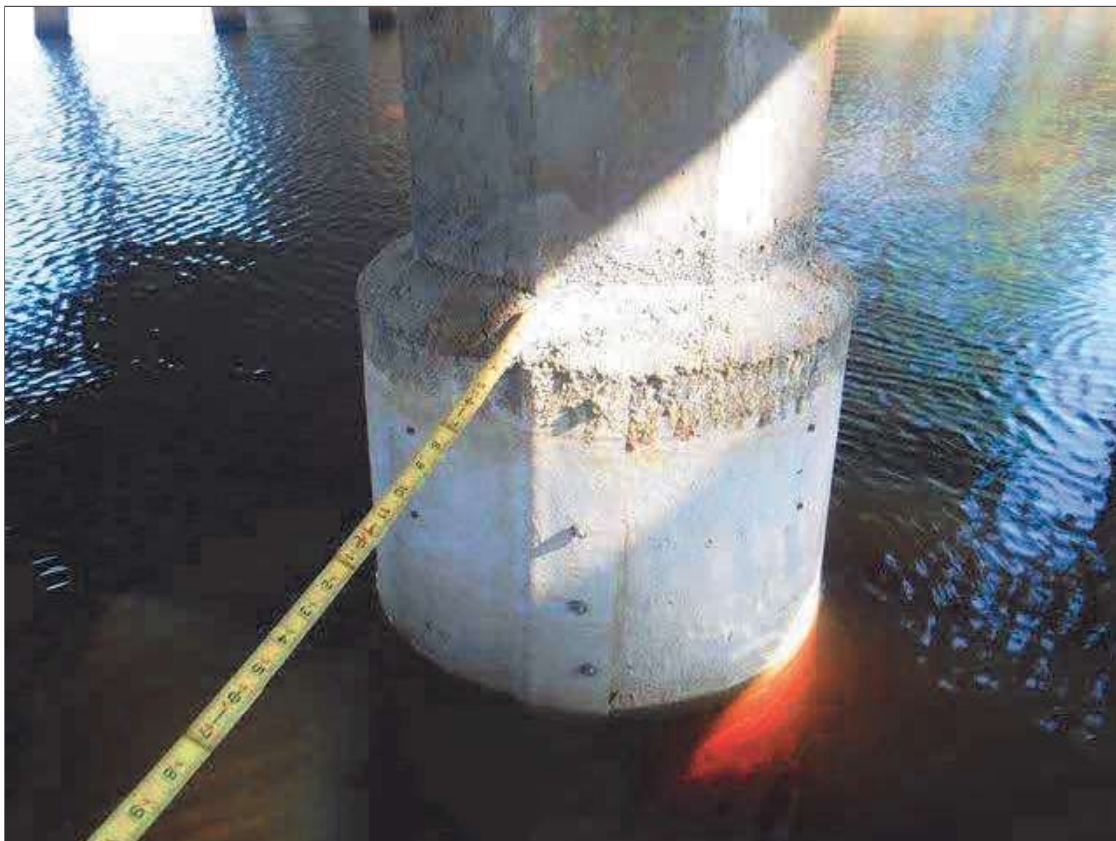
Bent 1 Pile 5: Hairline to 1/64" vertical cracks on faces 1, 2 & 8 from waterline up 4'.

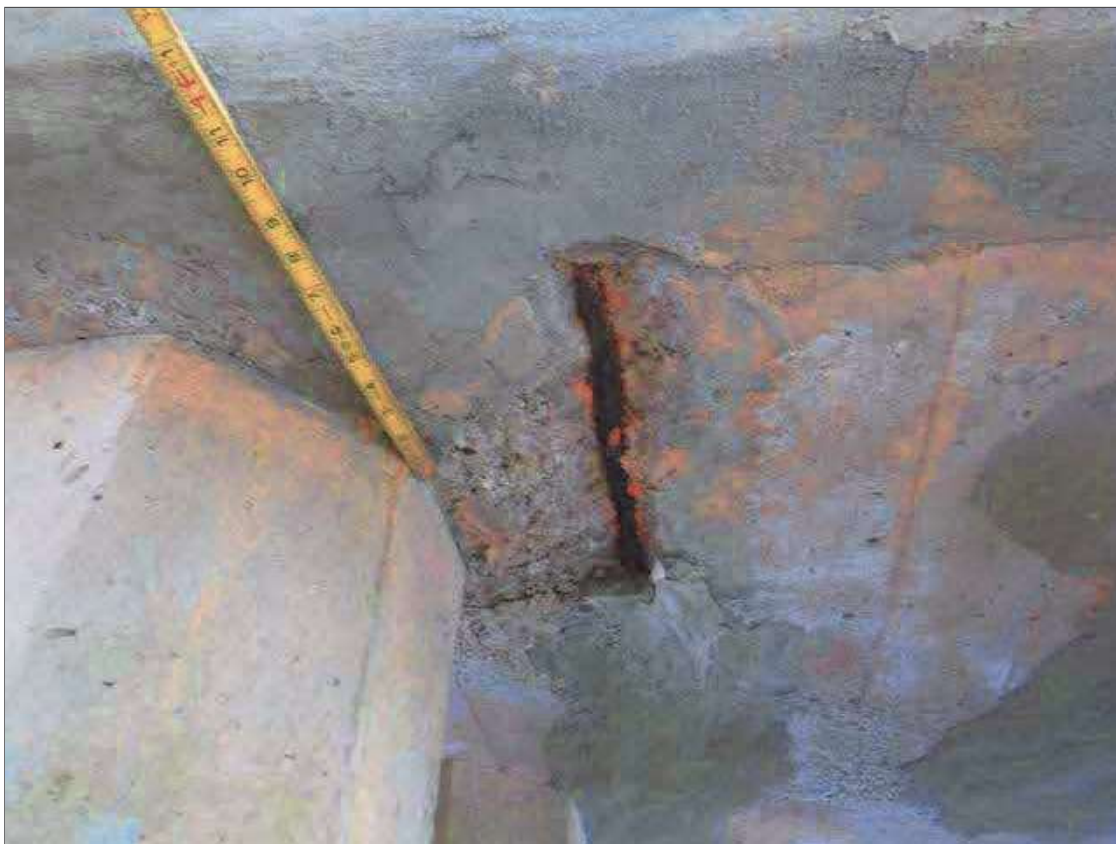
Bent 1 Cap 1: (2) FAILED PATCHES WITH UP TO 36" X 12" AREA OF DELAMINATION AND UP TO 14" X 7" X 1" DEEP SPALL WITH EXPOSED REBAR IN BOTTOM OF CAP AT PILE 5

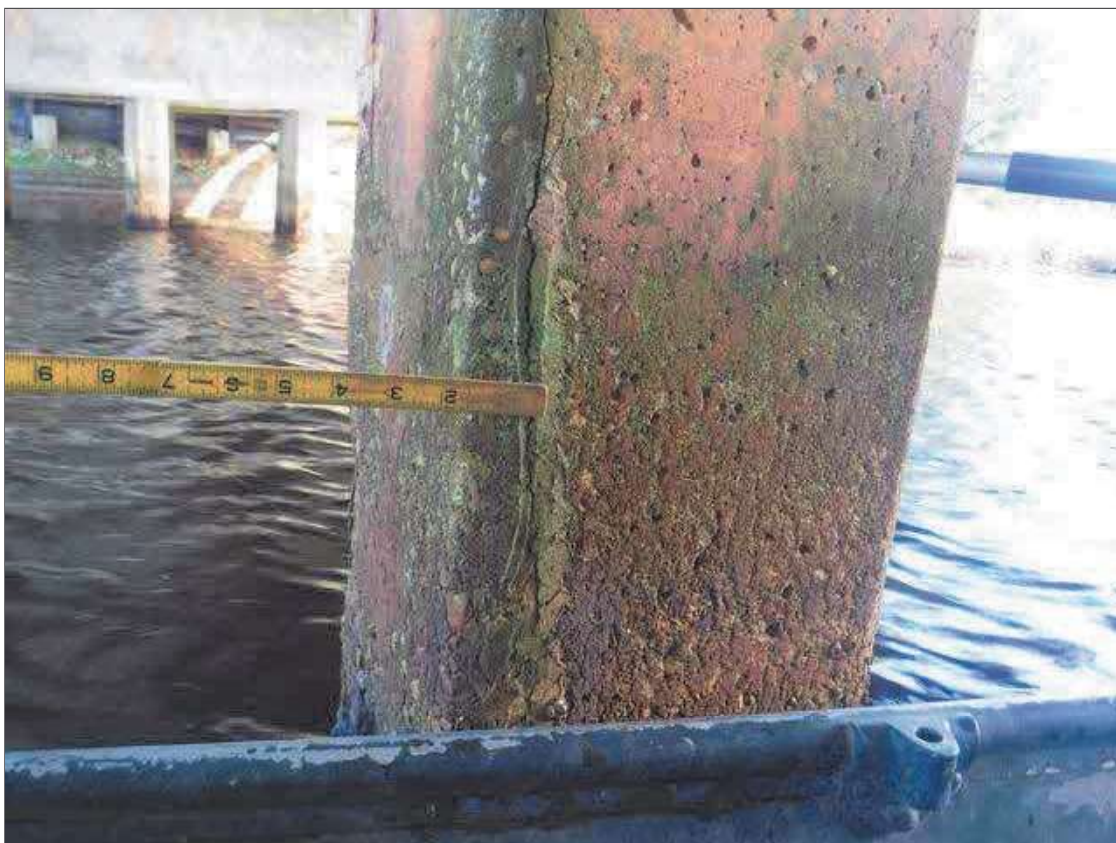
Bent 2 Pile 3: Up to 0.025" vertical cracks on west and north faces from waterline up 3'.

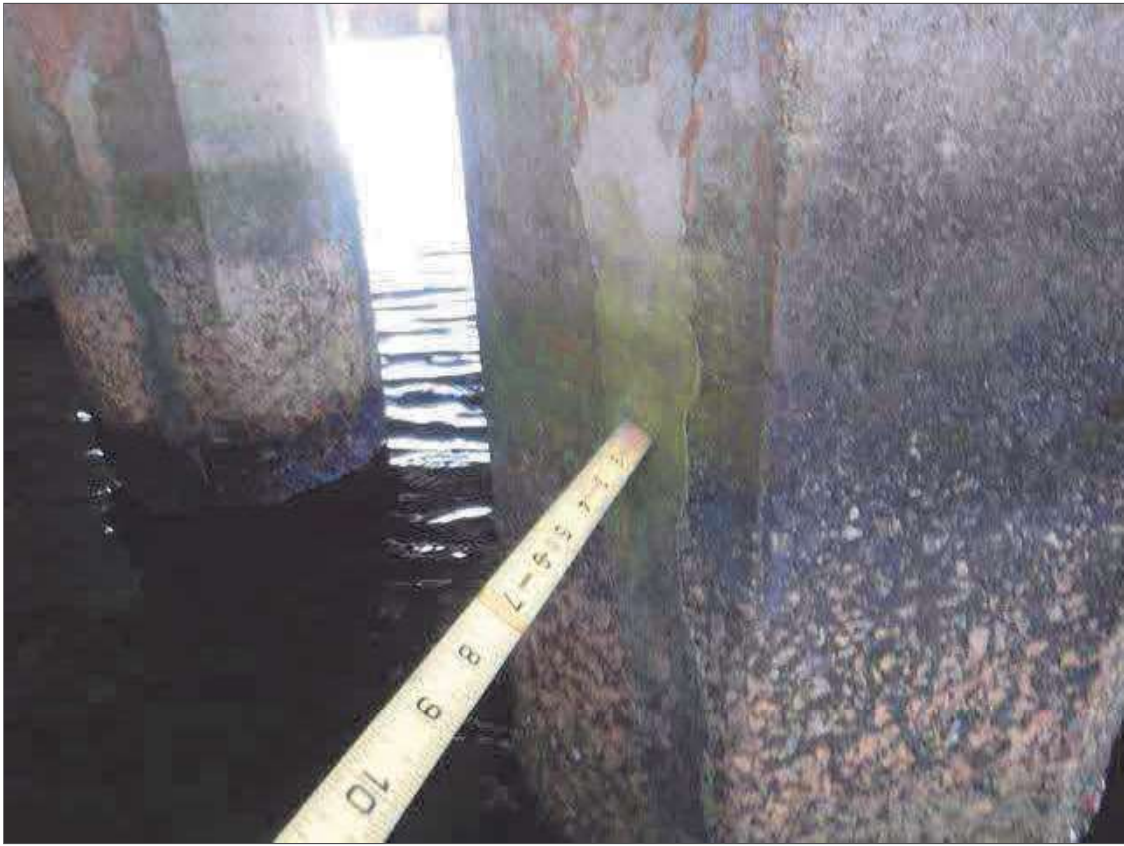
Bent 3 Pile 1: Vertical cracks on faces 5, 6 & 7 have been sealed.

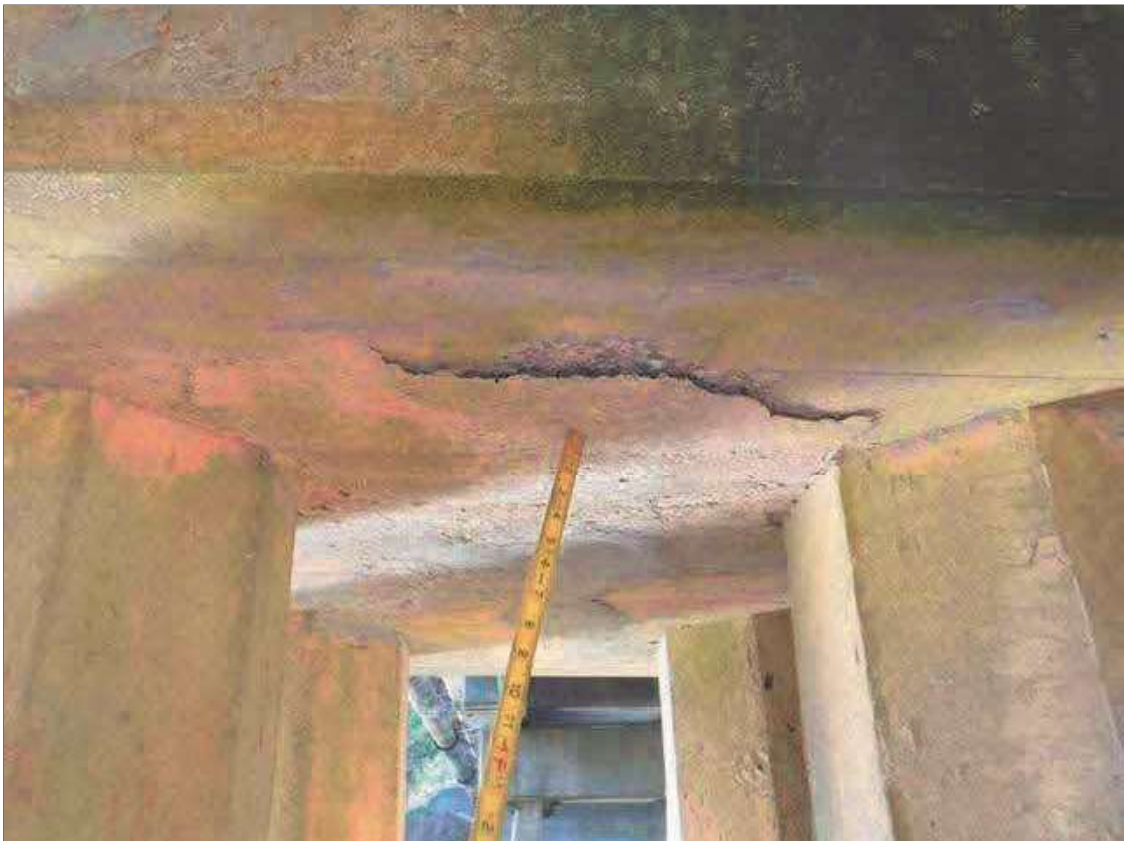
Bent 3 Cap 1: 18" X 21" AREA OF DELAMINATION IN BOTTOM OF CAP BETWEEN PILES 6 AND 8

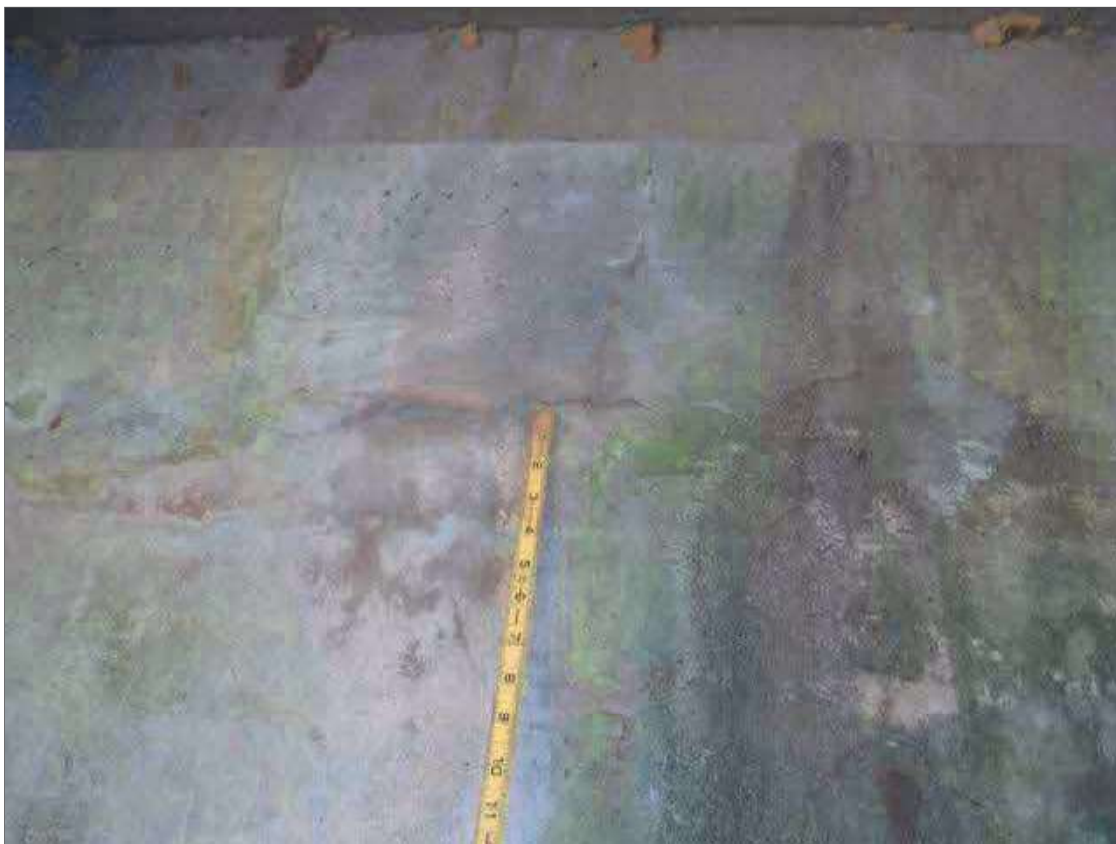
Bent 3 Cap 1: 30' OF UP TO 0.012" HORIZONTAL CRACKS IN SPAN 2 FACE OF CAP

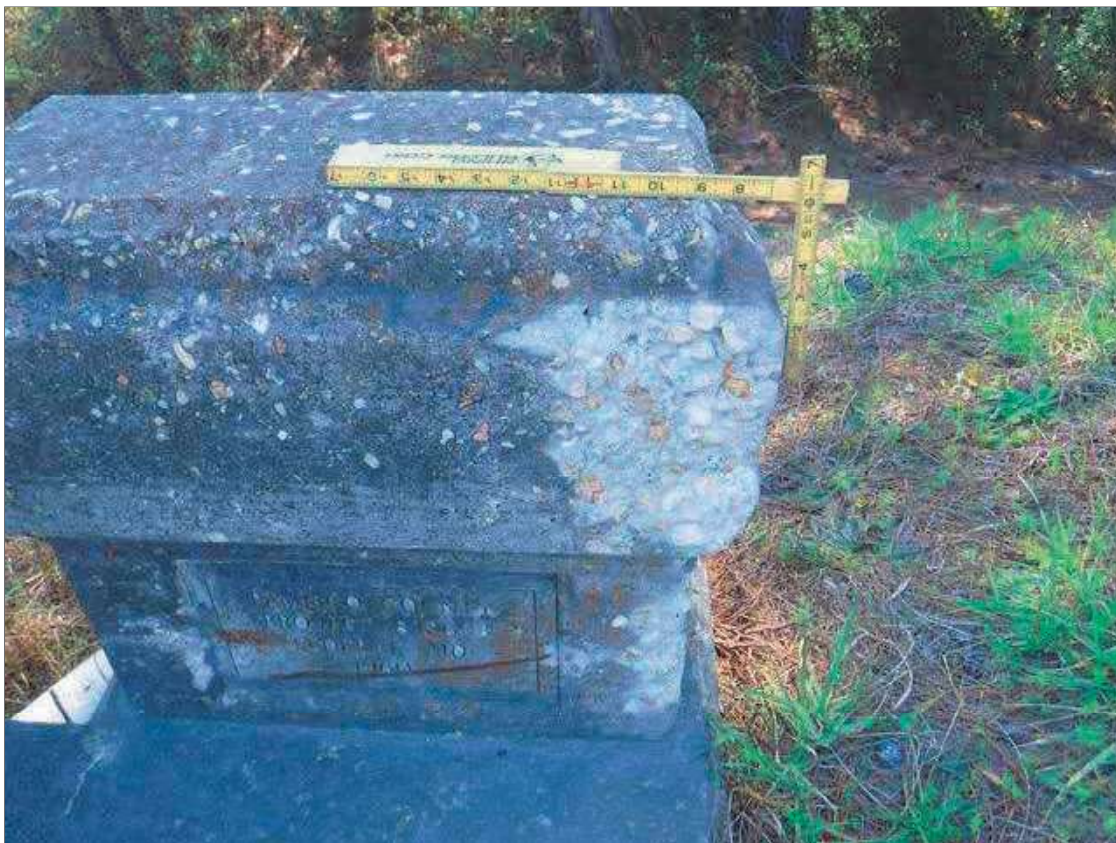
Span 1 Right Bridge Rail: 18" X 8" X 1" DEEP SPALL IN FACE OF END POST AT END BENT 1

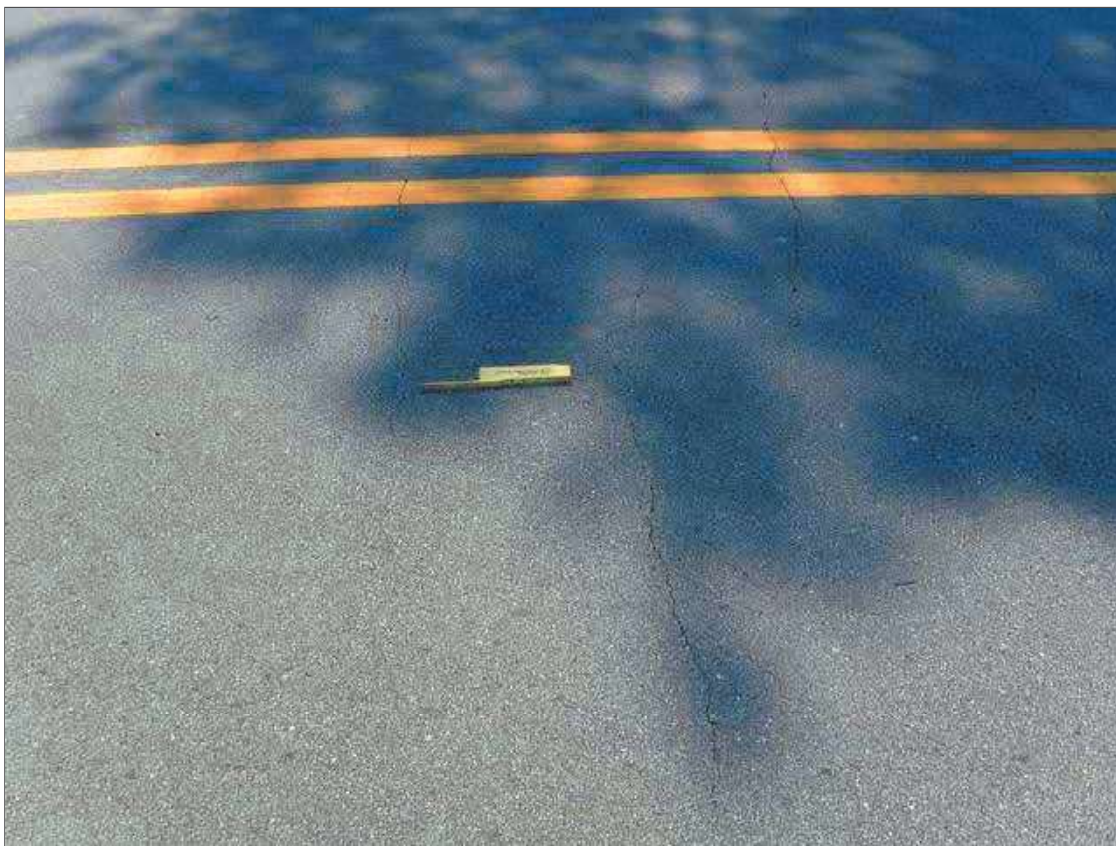
Span 1 Wearing Surface: UP TO 1/16" TRANSVERSE CRACK ALONG END BENT 1 FILL FACE IN WESTBOUND LANE

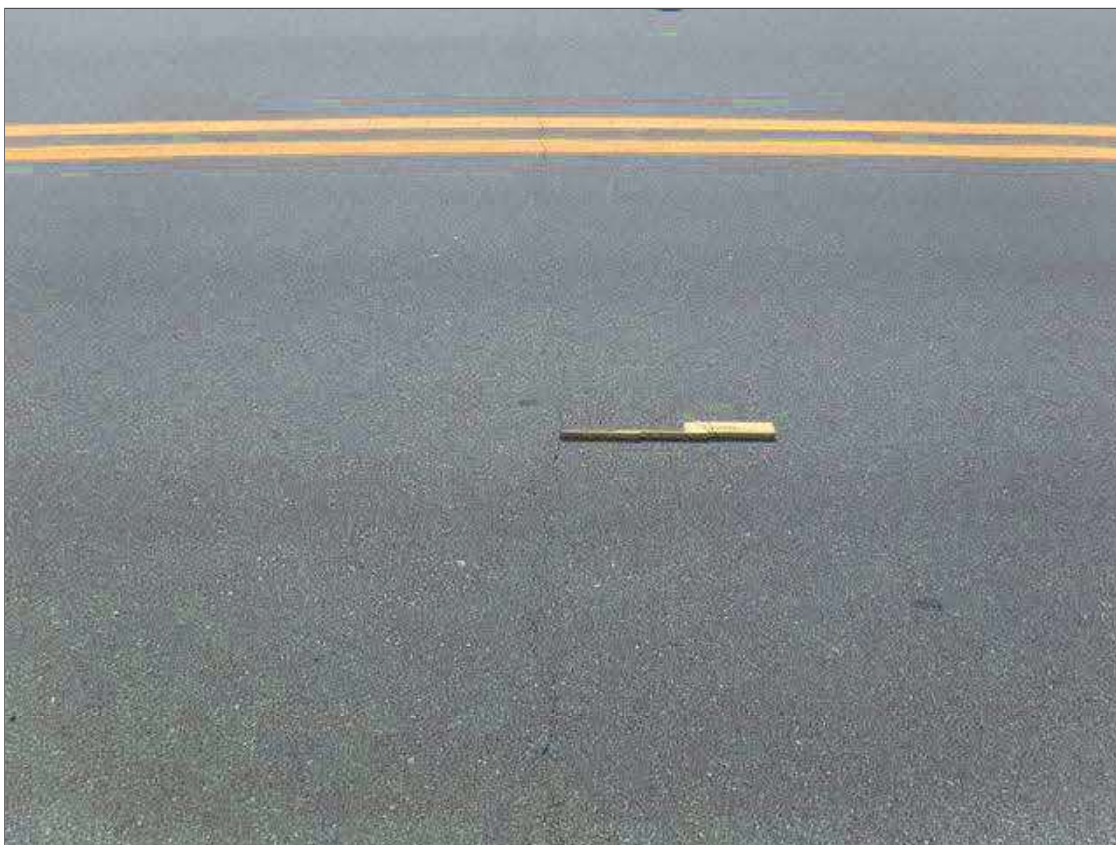
Span 3 Wearing Surface: UP TO 1/16" TRANSVERSE CRACK ALONG BENT 2

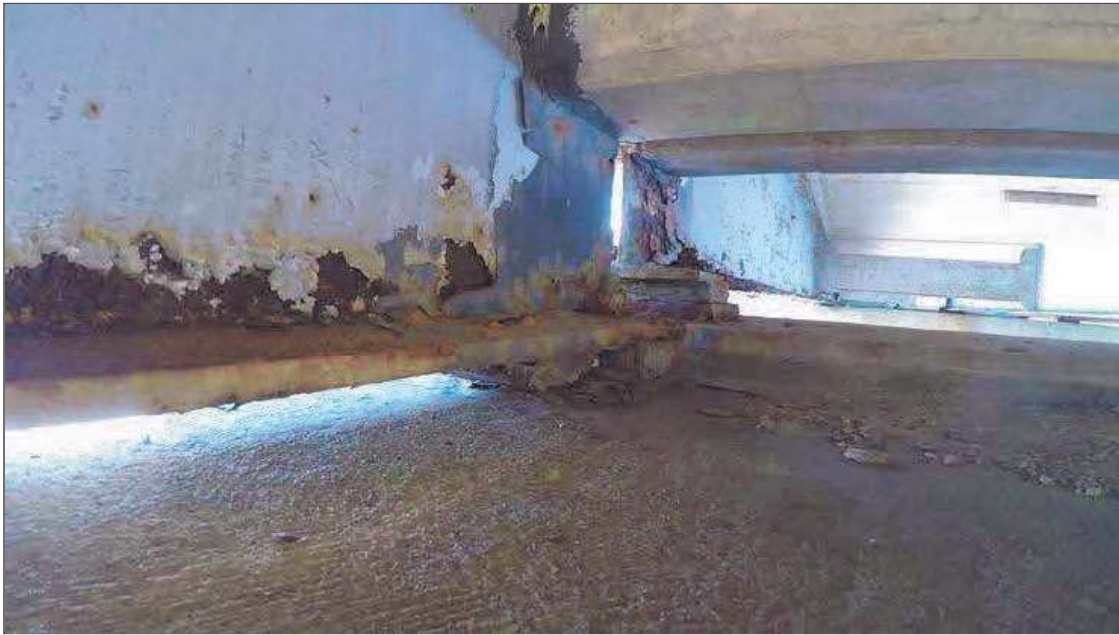
Span 4 Beam 4: Minor corrosion with pack rust initiating with minor section loss ( $< 1/16$ " ) on bottom 9" web and bottom flange for 1' at pier 3. Light surface rust on bottom of web and top and bottom flanges along full length of beam.

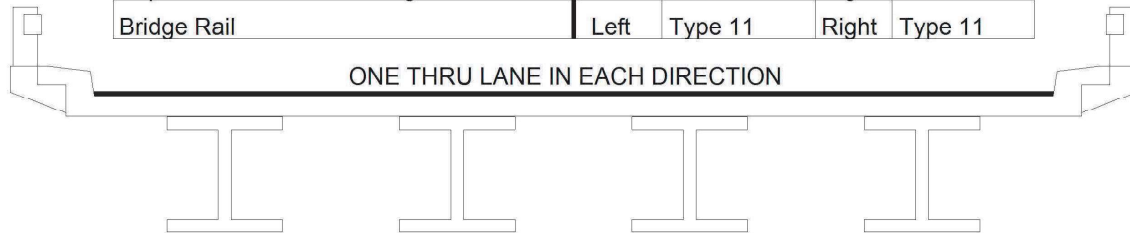
Measurements for Spans	1 and 4		
Deck Thickness	0.604	Left Overhang	4.50*
Top of Rail to Bottom of Beam	5.583	Right Overhang	4.50*

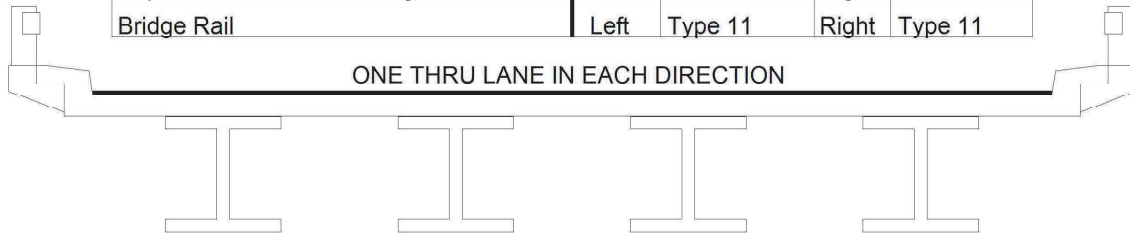
Measurements for Spans	2 and 3		
Deck Thickness	0.604	Left Overhang	4.50*
Top of Rail to Bottom of Beam	5.583	Right Overhang	4.50*

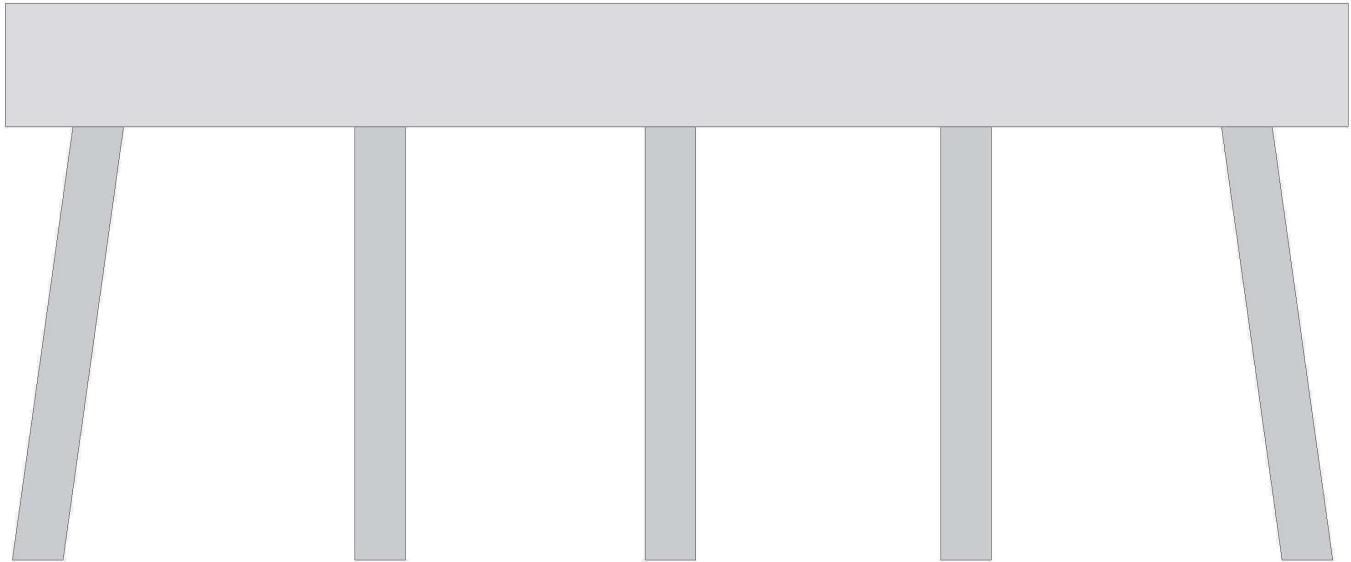
<b>Cap Information</b>			<b>Material</b> Cast-in-Place Concrete							
Length	Width	Height	Left Overhang	Right Overhang	Left Beam to End of Cap.	Right Beam to End of Cap.				
26.50 ft.	2.50 ft.	2.417 ft.	1.833 ft.	1.917 ft.	1.292 ft.	1.292 ft.				
<b>Subcap Information</b>			<b>Material</b>							
Length	Width	Height	Left Overhang	Right Overhang	Left Pile to Splice.					
<b>Sill Information</b>			<b>Material</b>							
Length	Width	Height								
Pile #	Material	Spacing	Width/Dia.	Height	Length	Orientation	Driven?	Replacement?	Removed?	Collar?
1	Concrete	5.646 ft.	1.00 ft.	1.00 ft.		Battered	Yes	No	No	No
2	Concrete	5.729 ft.	1.00 ft.	1.00 ft.		Vertical	Yes	No	No	No
3	Concrete	5.833 ft.	1.00 ft.	1.00 ft.		Vertical	Yes	No	No	No
4	Concrete	5.542 ft.	1.00 ft.	1.00 ft.		Vertical	Yes	No	No	No
5	Concrete					Battered	Yes	No	No	No
<b>Bent:</b> 2
